Mining Risk Assessment

Rockwood Garage
Wakefield Rd
Grange Moor
Huddersfield
WF4 4DS

Amended 25th September 2018

On behalf of Bradbury Project Management.

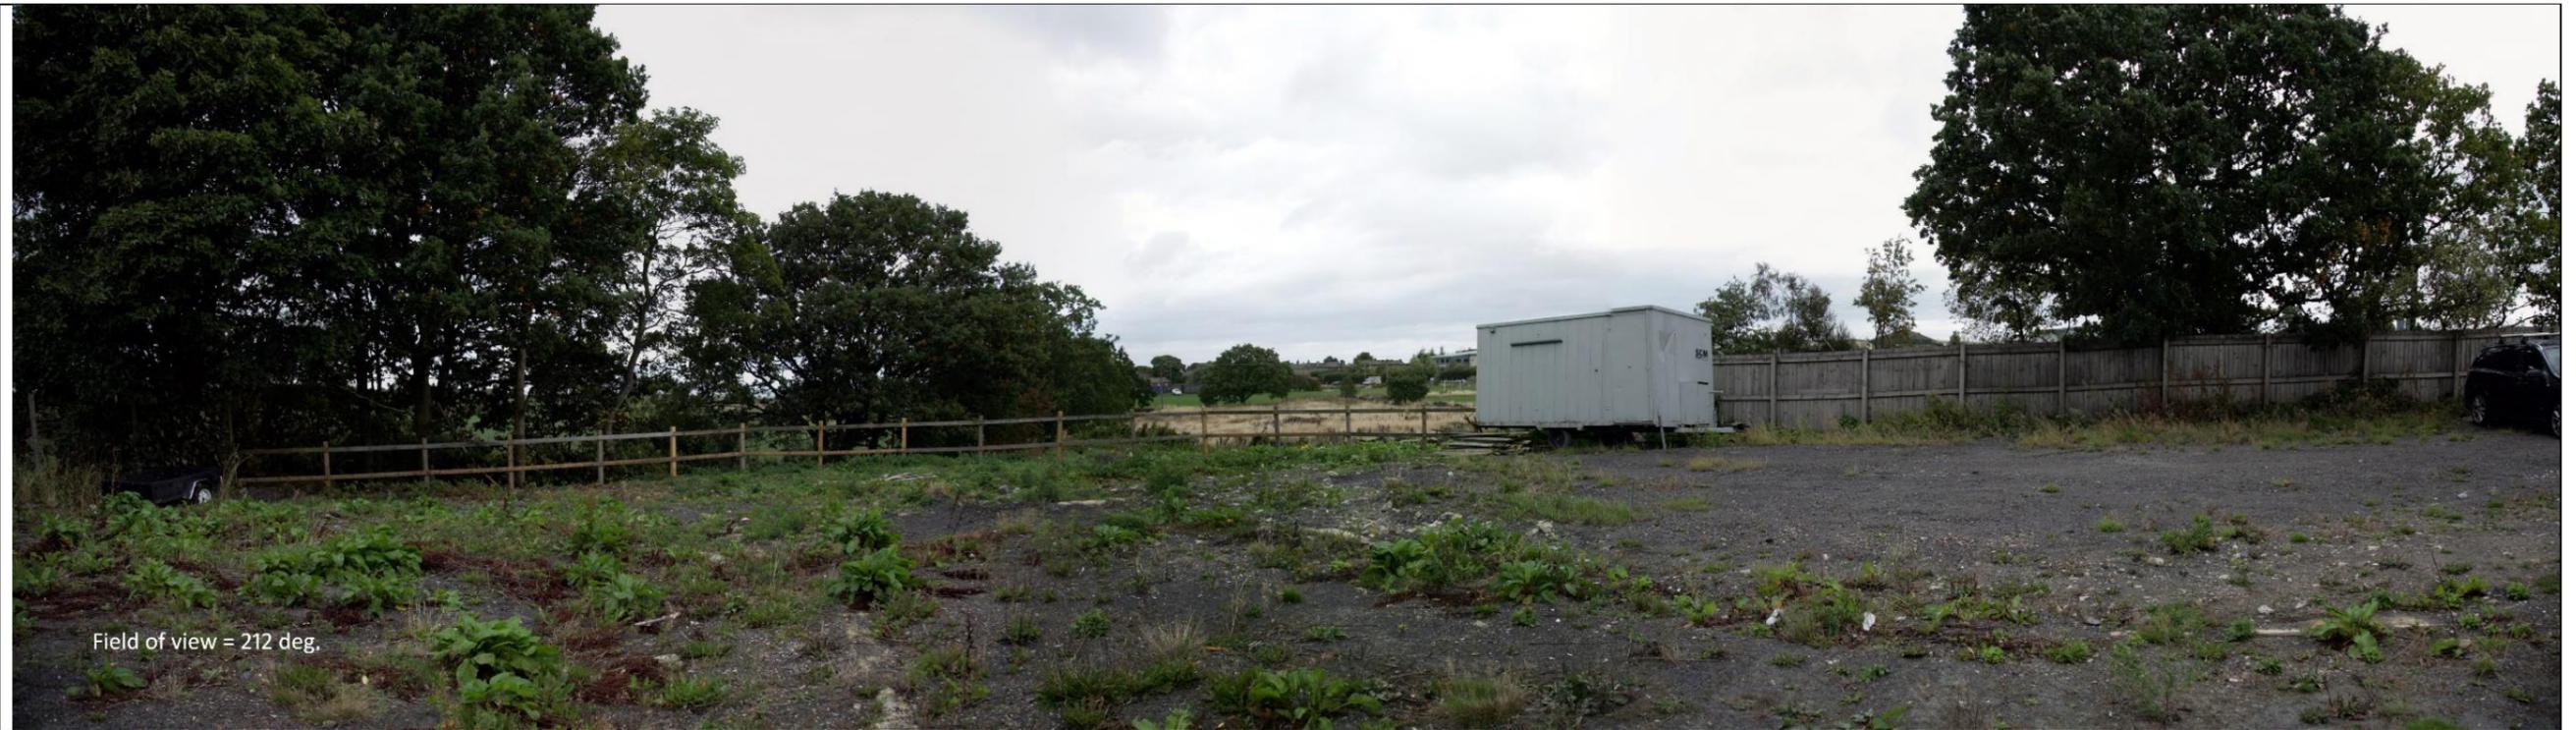
Rockwood Garage, Grange Moor. Proposed site. Northern View.

The remainder of the site beyond the wooden fence is rough pasture. See App 2.
