## **Phase I / II**

# **Contaminated Land Site Assessment**

103 Heckmondwike Road  
Dewsbury Moor,  
WF13 3PG

03 May 2023  
Report ref. 23/1149.3.1

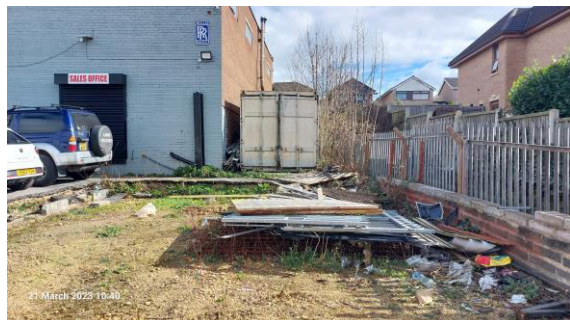
**Image 1:** Proposed development location, facing east.

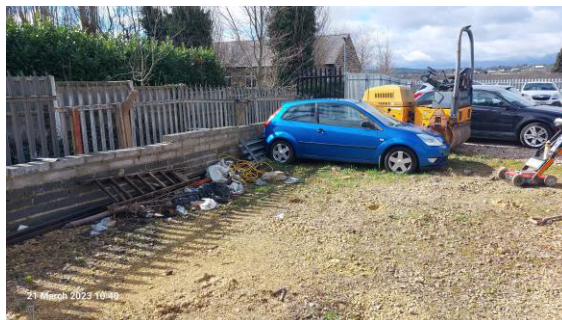
**Image 2:** Proposed development location, facing south.

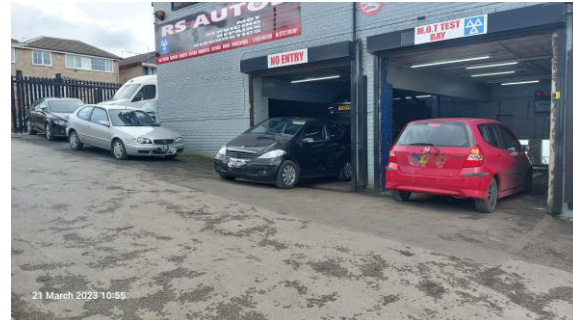
The site is located on Heckmondwike Road (B6117) and is accessed by one ingress/egress point on the eastern boundary. The site is currently a MOT garage (Image 3, Appendix B), comprising two main buildings located to the north and south and car parking area in the western segment (Image 4, Appendix B).

**Image 3:** MOT garage actively operating on site.

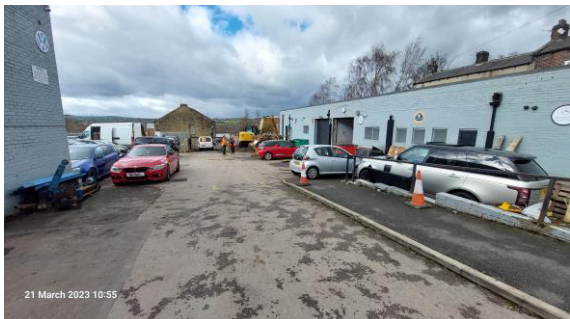
**Image 4:** Vehicle car park, facing west.

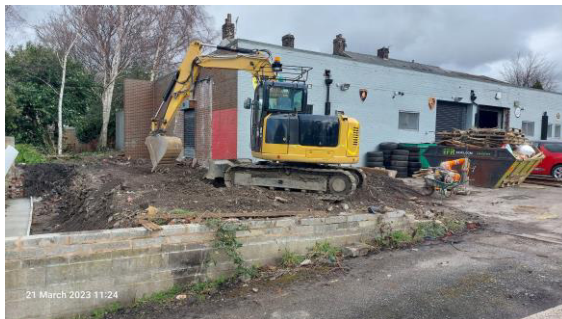
**Image 5:** Ongoing works in the northwest side of the site.

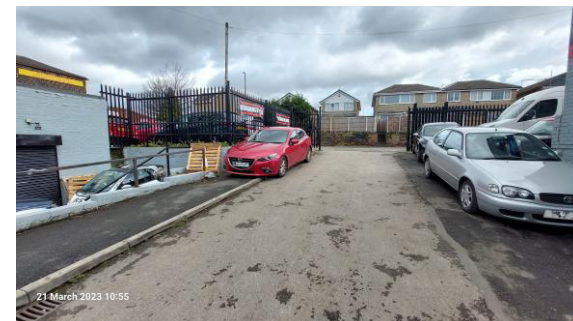
**Image 6:** Main Ingress/Egress to Heckmondwike Road.
