## PROPOSED RESIDENTIAL ACCESSES DOWKER STREET, MILNSBRIDGE, HUDDERSFIELD STAGE 1 – ROAD SAFETY AUDIT

REPORT REF: 23-1535-RSA1

**CLIENT:** Roberts Highway Consultants Limited

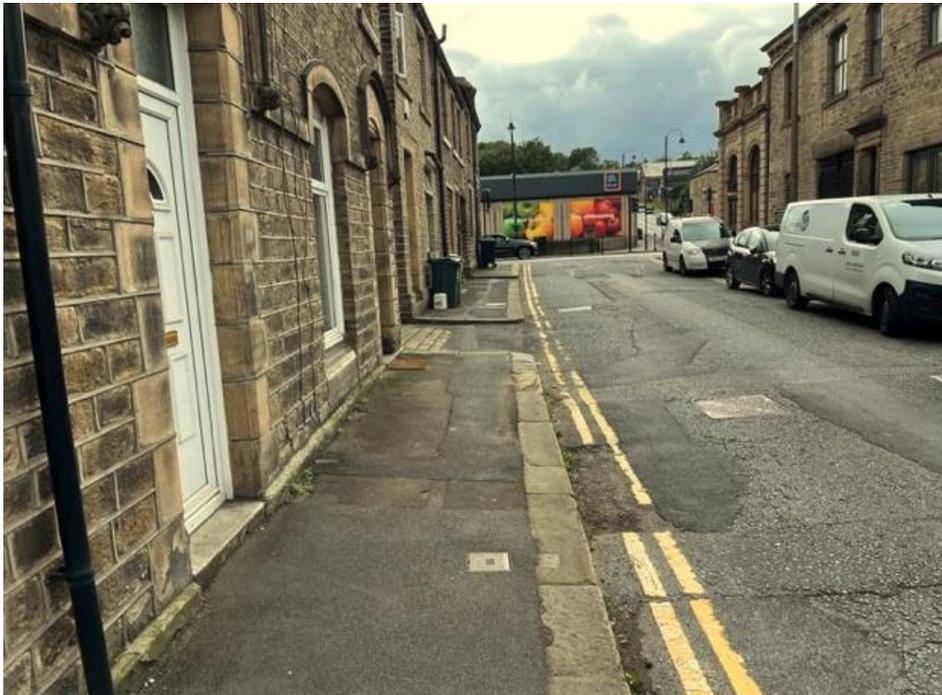
Location: George Street – Opposite southern access.

Summary: Location of sign may increase the risk of pedestrians entering the carriageway.

A sign indicating the one way street is proposed on the southern side of George Street in an already narrow footway. Should this sign be placed as indicated at the kerb edge, the clear footway width would be reduced such that a double width pram or wide mobility scooter may not be able to pass without entering the adjacent carriageway area. This problem could be exacerbated by utilities in the footway further influencing the placement of the sign. This may consequentially increase the risk of collisions between pedestrians and passing vehicles.

It is recommended that the one way sign is placed to the rear of the footway, against the wall of the house.

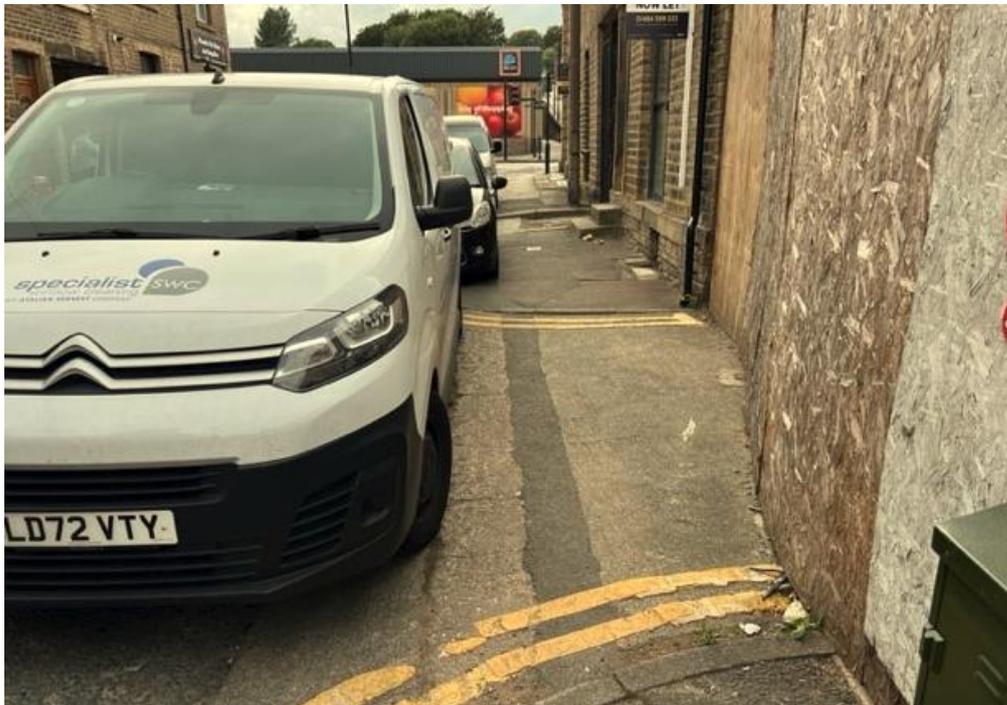
Location: George Street – West of southern access.

Summary: Parked/loading vehicles may increase the risk of junction related collisions.

Double yellow parking restrictions are currently provided on George Street. These appear to be largely abused, as observed on site and through Google Street View images from earlier dates, with vehicles also observed two wheels up on the footway. A visibility splay of 30m is indicated, but the speed of vehicles at this point on George Street is likely to be much closer to 15mph. Should the obstructive parking/loading continue, the junction visibility to the right for vehicles leaving via the southern access may be obscured by parked/loading vehicles. This may increase the risk of junction related collisions.

It is recommended that sufficient junction visibility is provided to the right for the anticipated speed of vehicles. This could be achieved by means of a kerb buildout, with bollards to prevent parking/loading in the visibility splay.

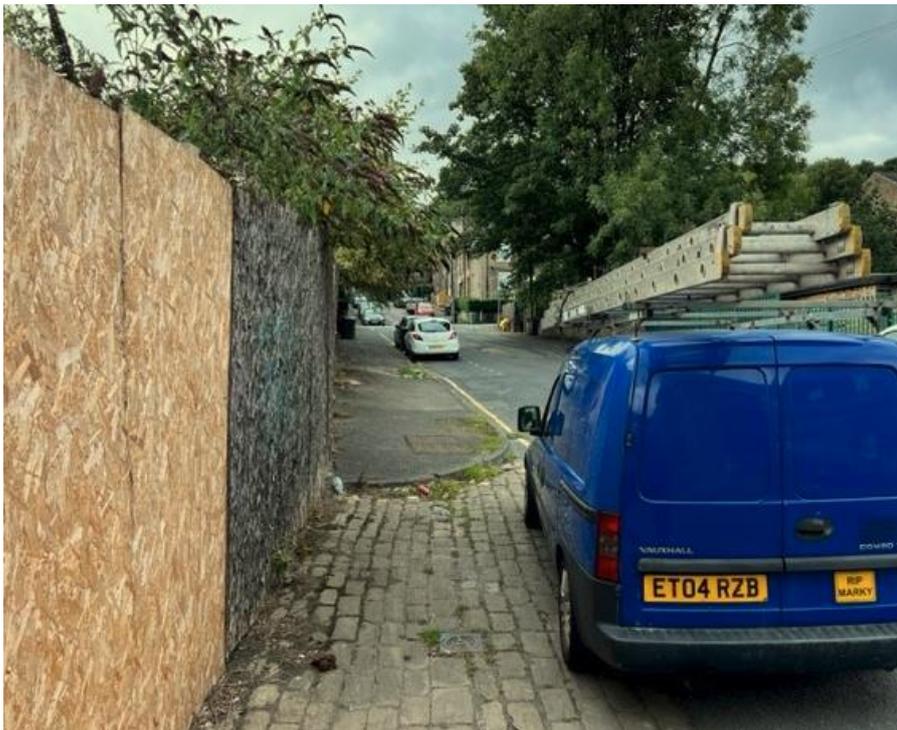
Location: Dowker Street – South of eastern access

Summary: Parked vehicles may increase the risk of junction related collisions.

Limited stay parking restrictions are currently provided on Dowker Street, these currently extend closer to the eastern access than is indicated on the drawings. A visibility splay of 43m is indicated, which is directly from Manual for Streets for 30mph. The speed of vehicles on Dowker Street is likely to be much closer to 15mph than 30mph at this location. Should these restrictions remain in place, the junction visibility to the right for vehicles leaving via the eastern access may be obscured by parked vehicles. This may increase the risk of junction related collisions.

It is recommended that sufficient junction visibility is provided to the right for the anticipated speed of vehicles.

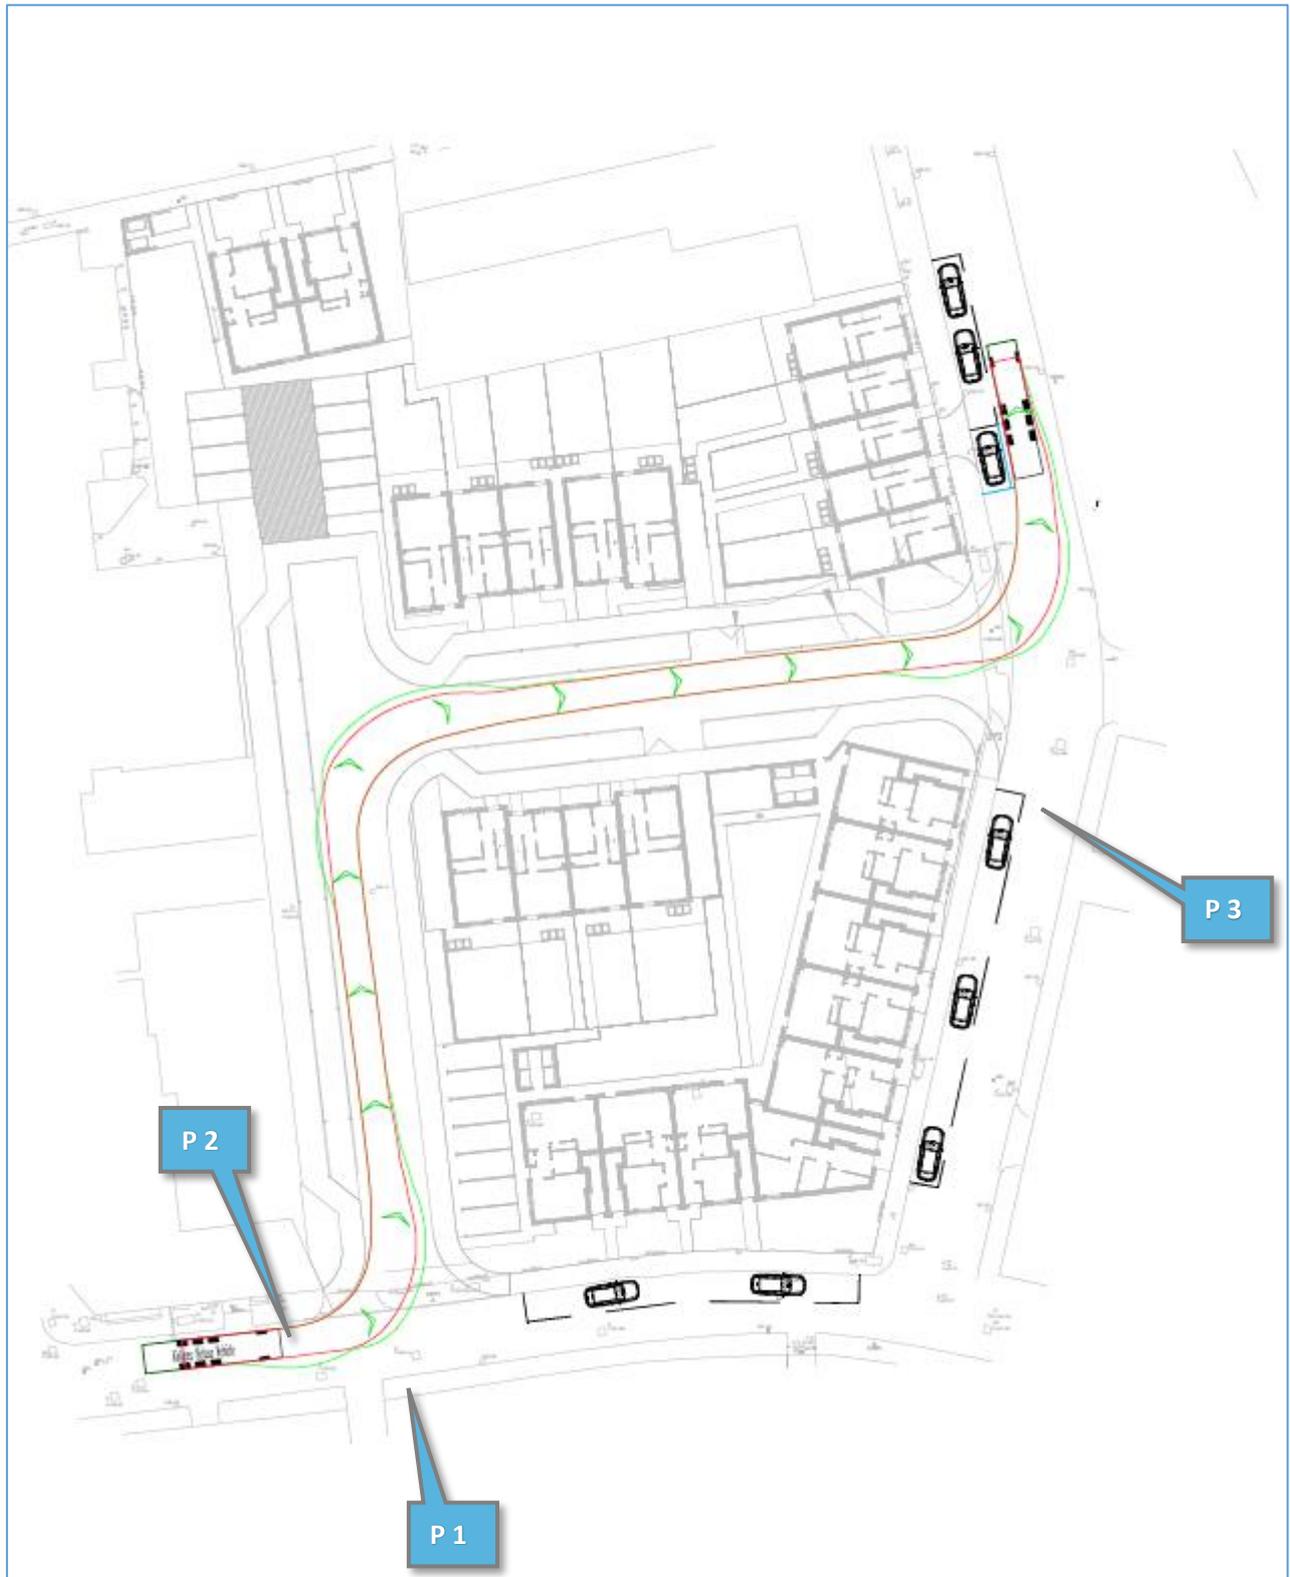
Figure 2 – Problem Location Plan

The location of any problems/observations that have been identified in Section 3 of this report can be seen on the extracts of the drawings supplied to the Audit Team, as listed in Appendix A.
