**Appendix A  
Photograph Schedule**

Original School (1868)

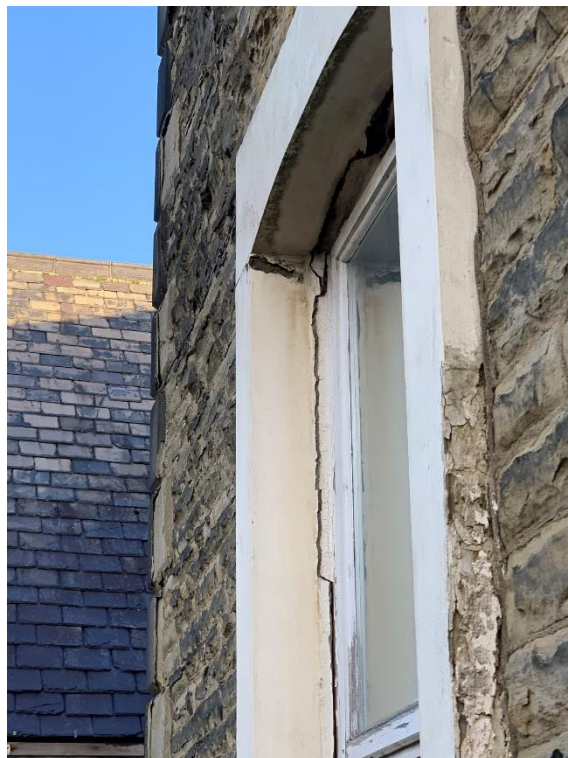
Typical movement and window condition

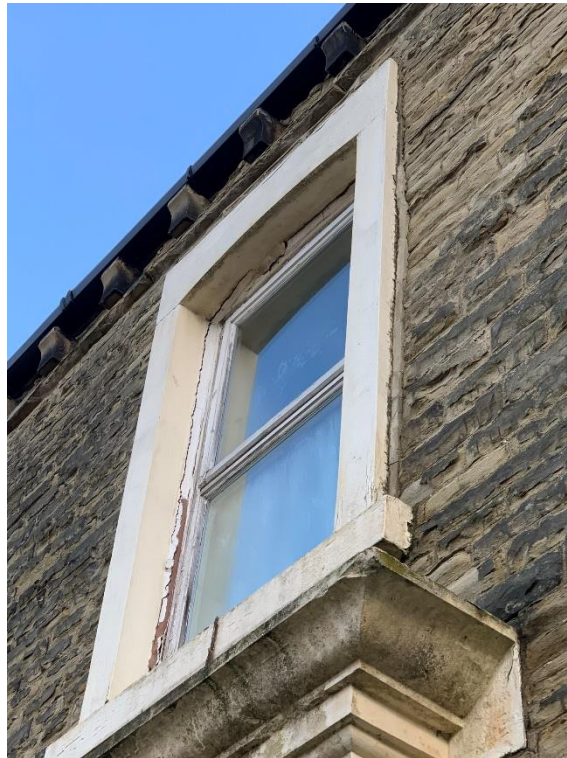
Typical Movement and window condition

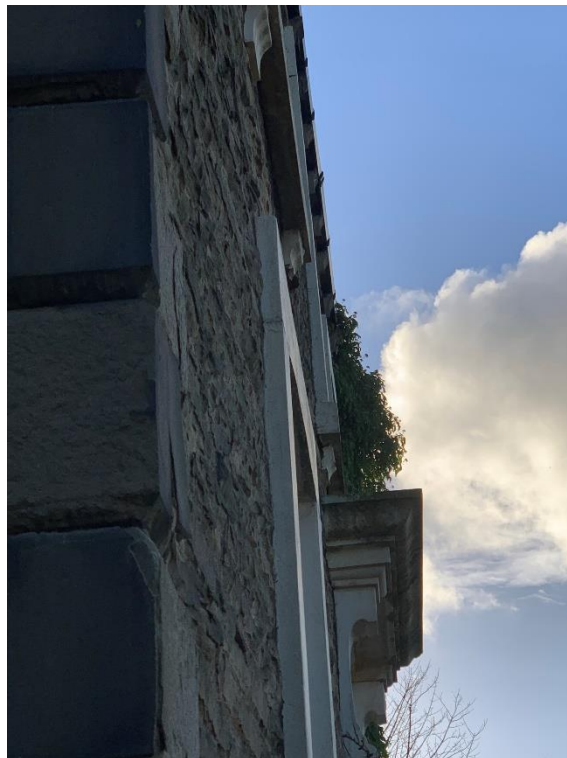
Front Elevation Buldge

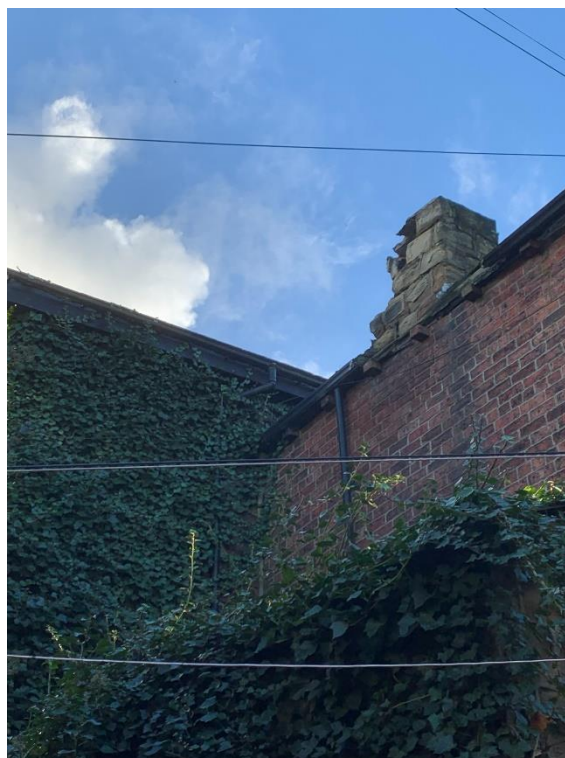
Rear Chimney collapse and gutter and fascia failure

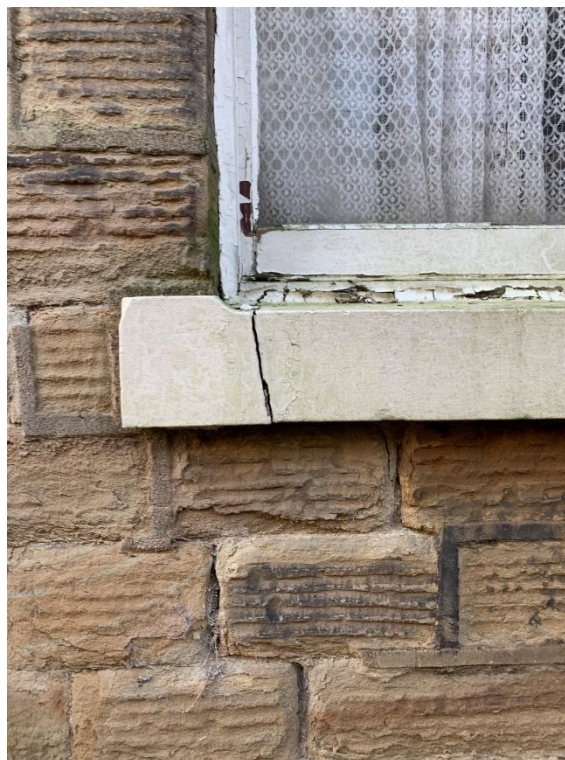
Cracking extending to stone cills

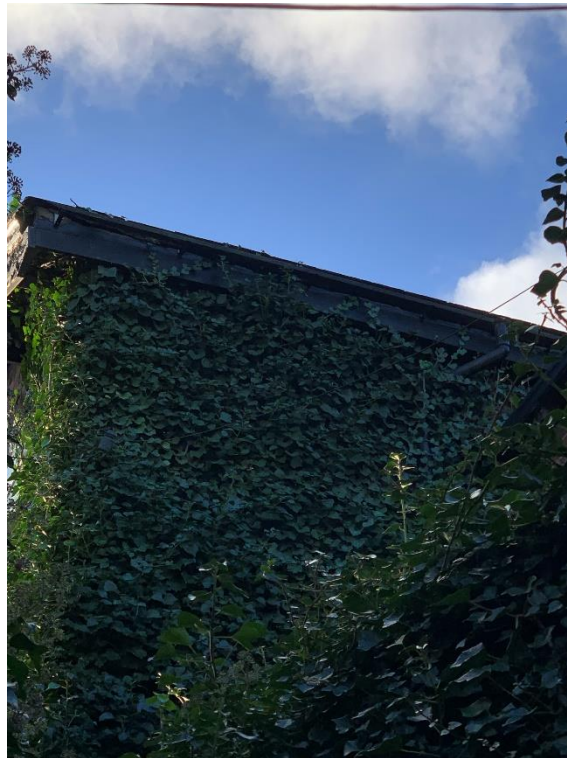
Over grown Ivy to RH Elevation

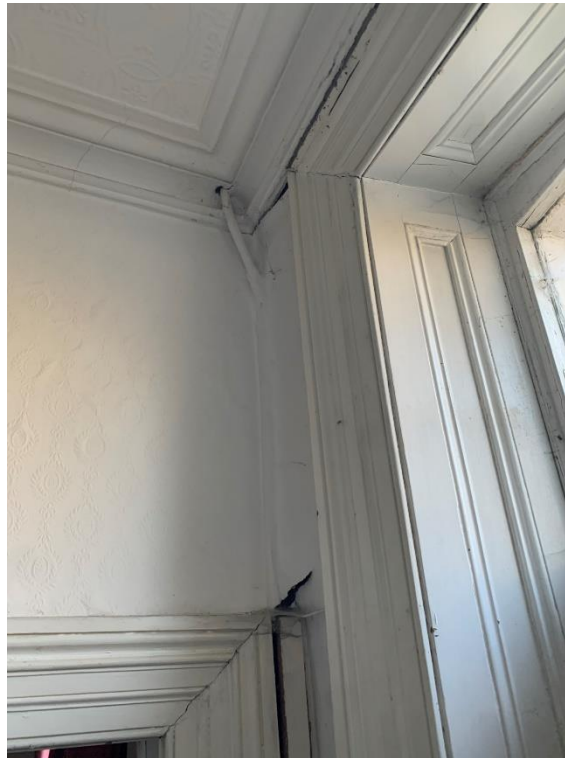
Internal cracking at GF level corresponding with external movement

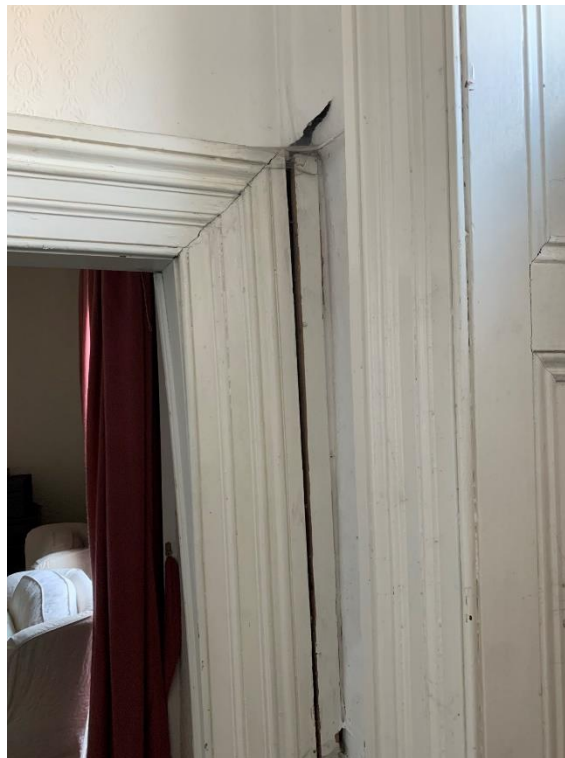
Internal cracking at GF level corresponding with external movement

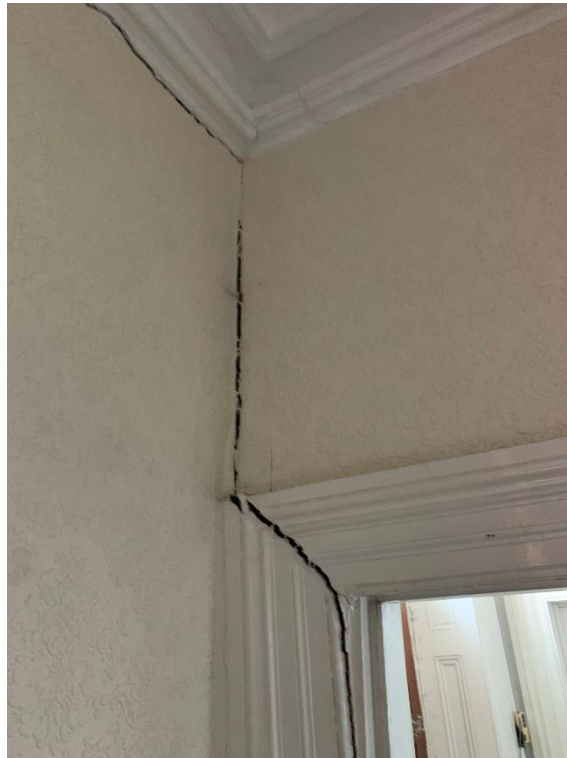
Internal cracking at GF level corresponding with external movement

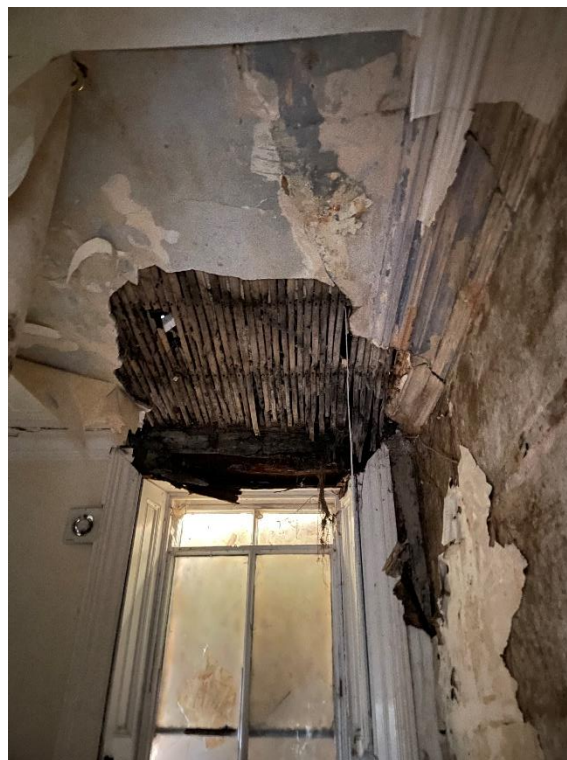
Ground floor ceiling damage from roof level water ingress

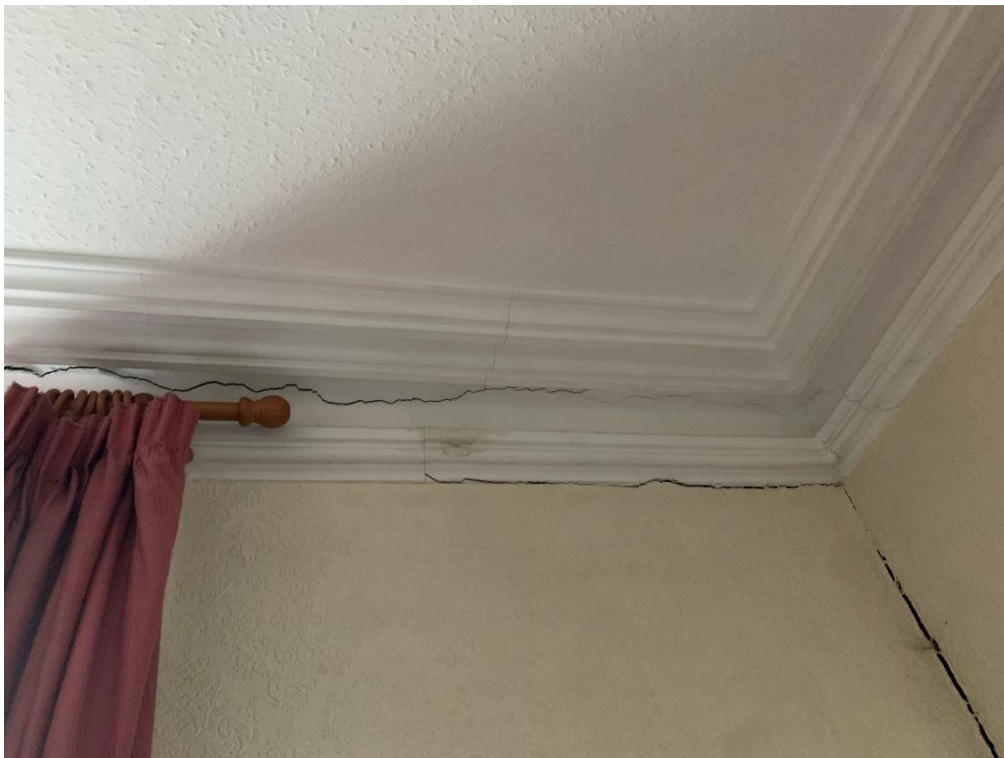
GF cracking and movement

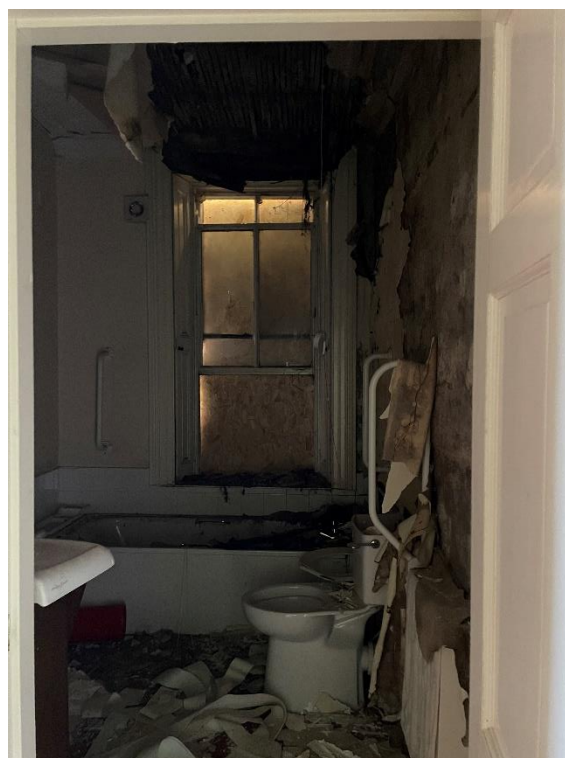
GF Bathroom affected by ceiling collapse and water ingress

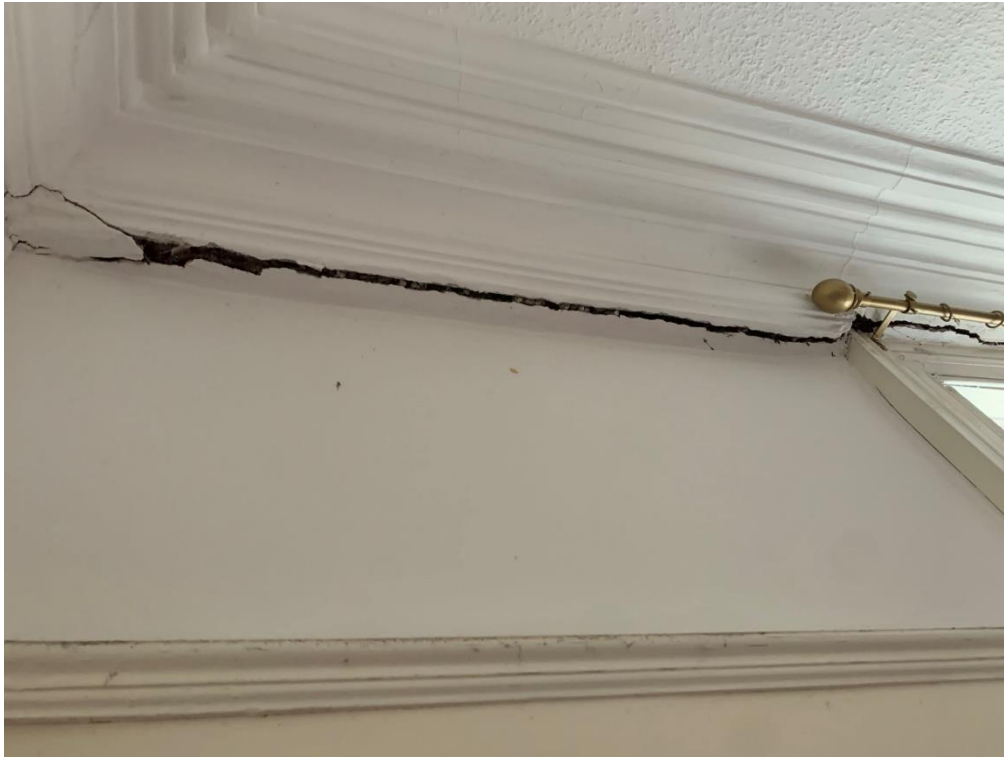
Further GF movement to front elevation

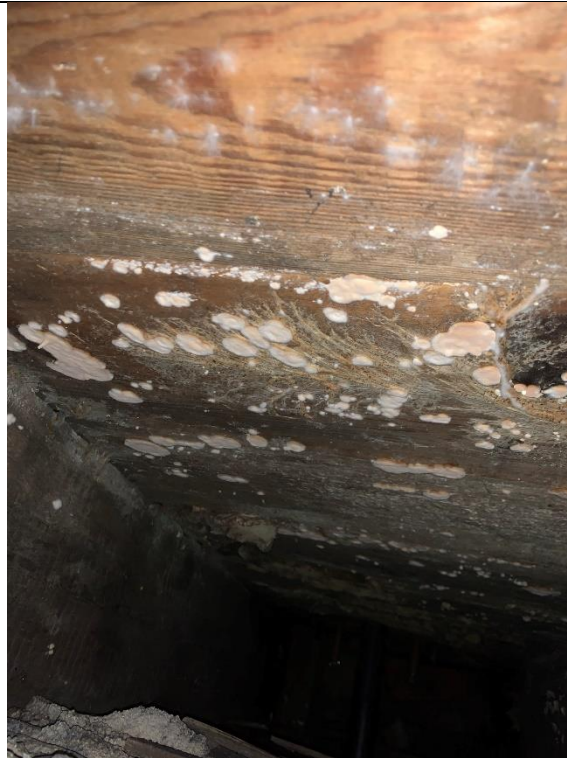
Wet rot to GF floor structure – taken from basement

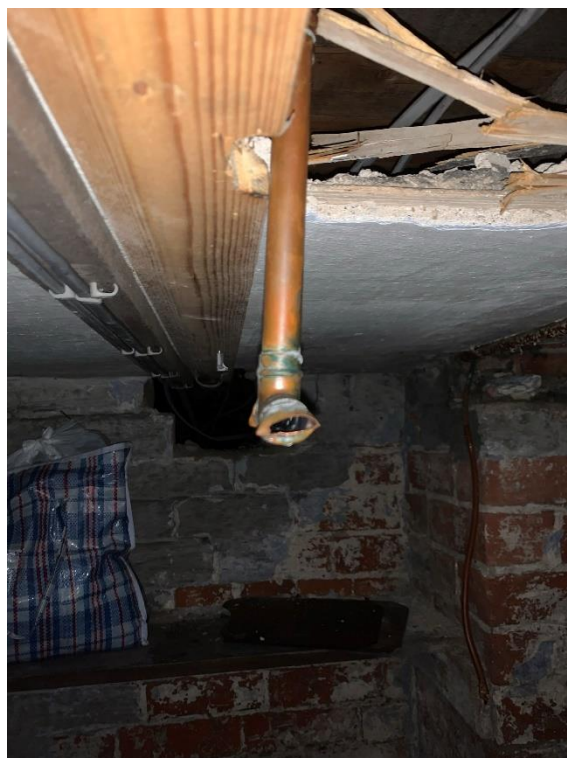
Copper distribution system has been 'stolen'

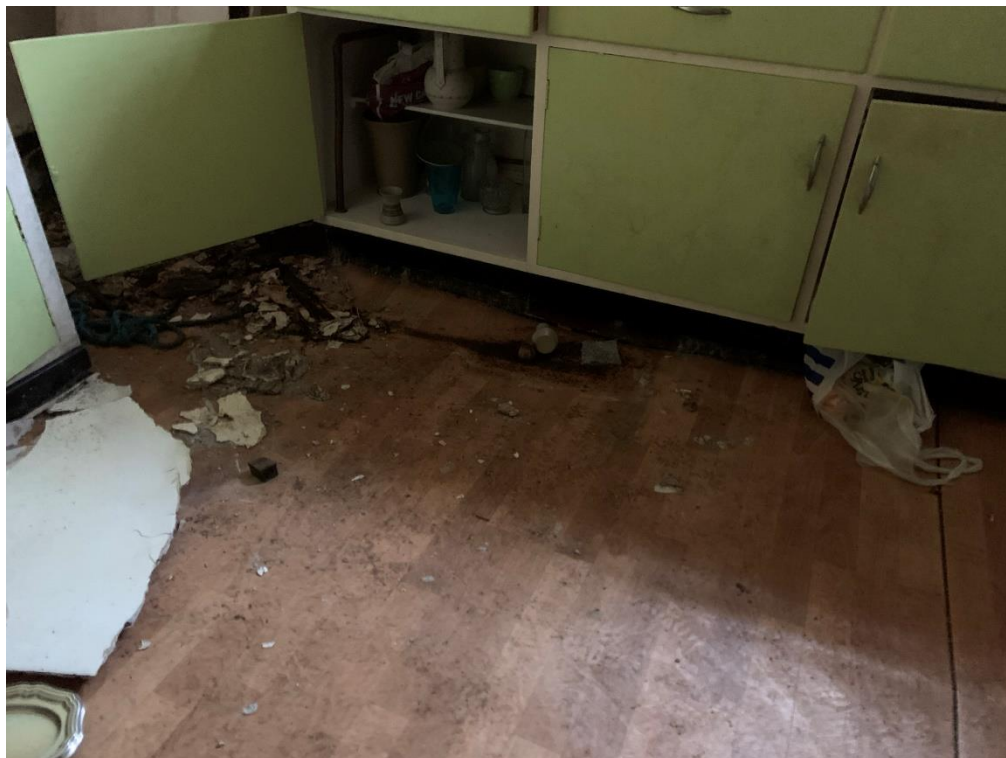
GF main kitchen floor slab sunk and rotated

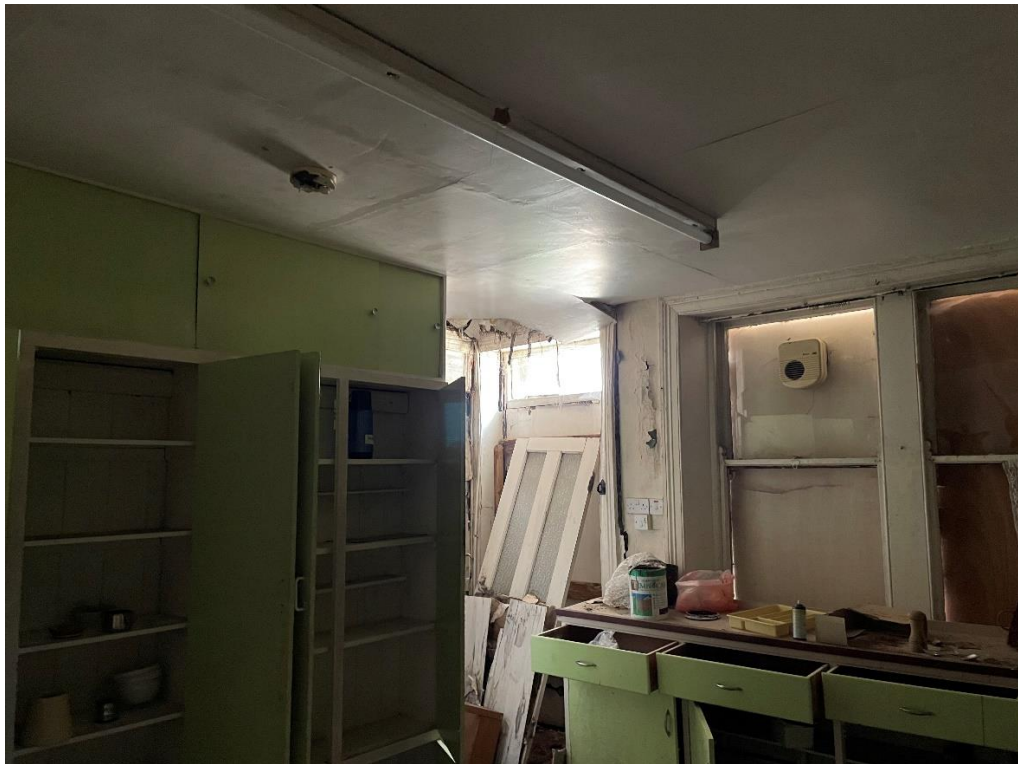
GF Kitchen damage

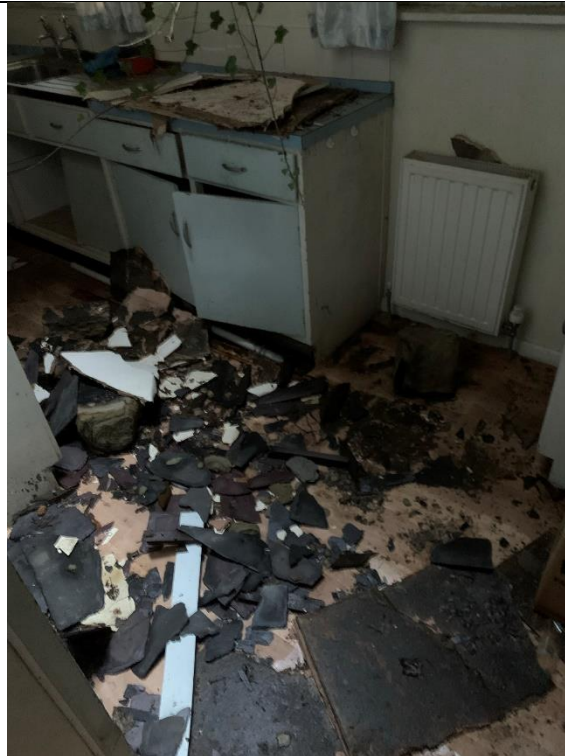
GF rear kitchen damage due to roof structure collapse

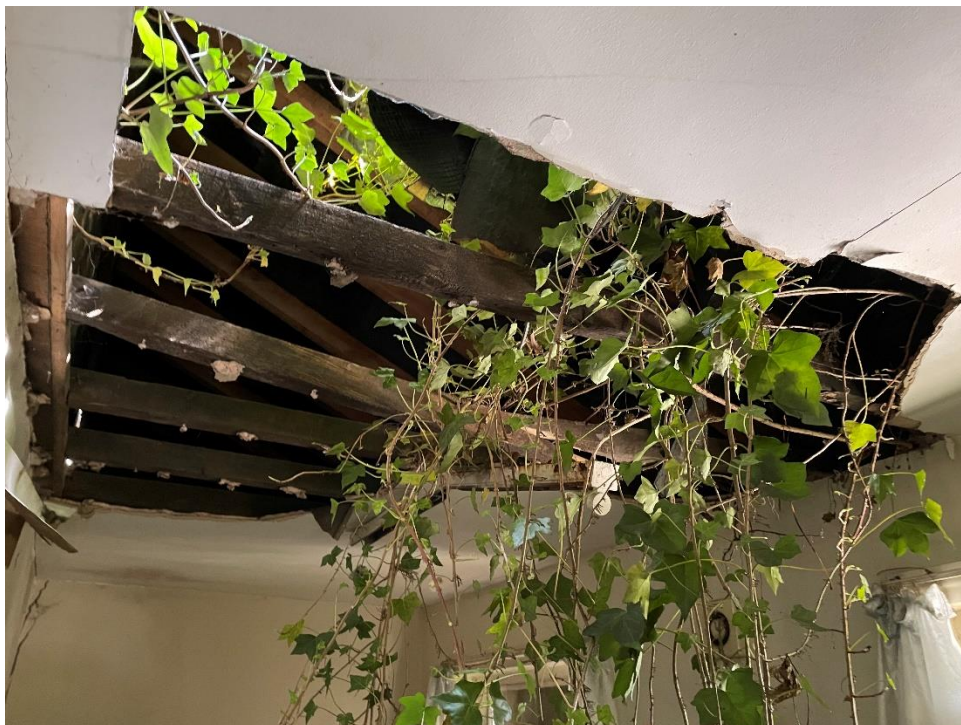
GF rear kitchen roof structure collapse

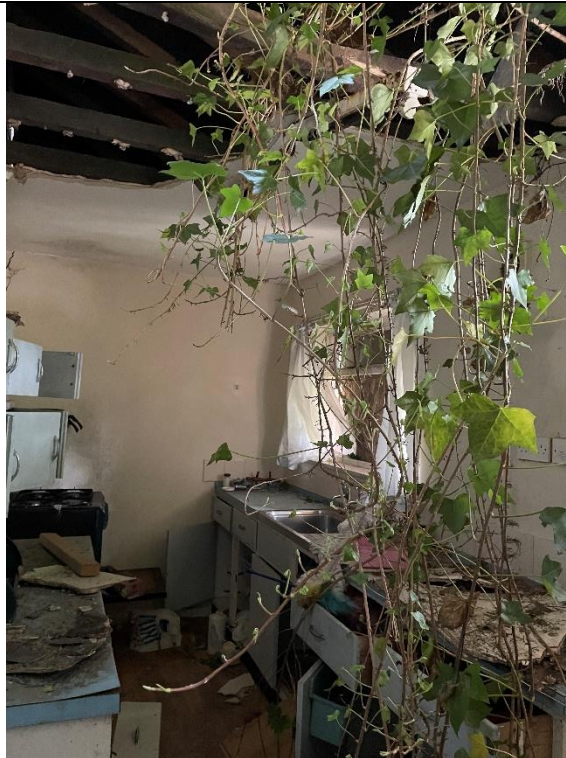
GF rear kitchen damage due to roof structure collapse

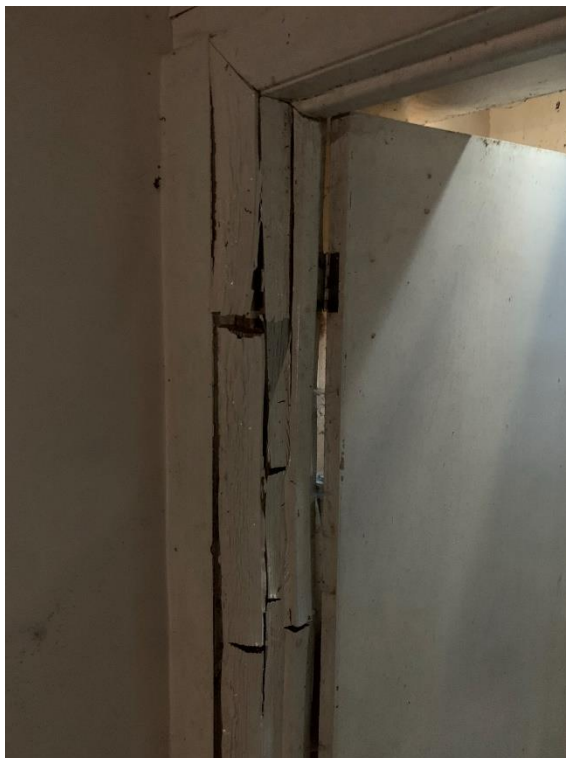
Typical wet rot to GF joinery

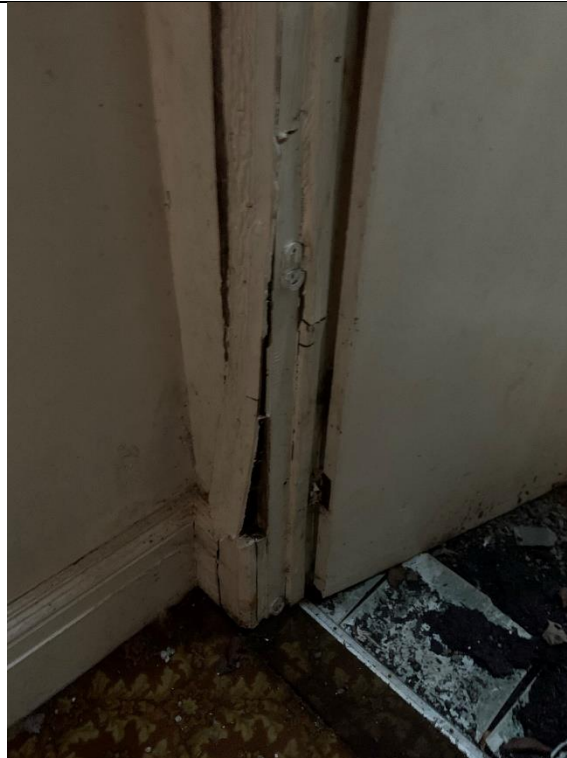
Typical wet rot to GF joinery

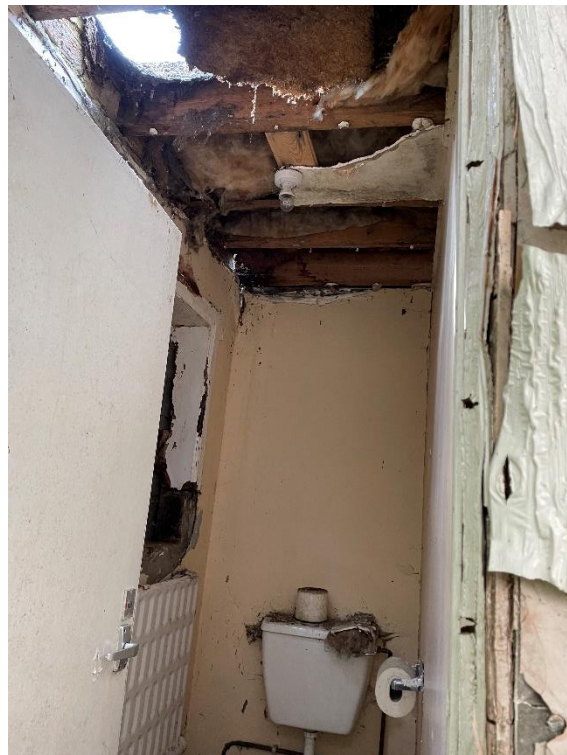
GF side toilet – roof collapse above

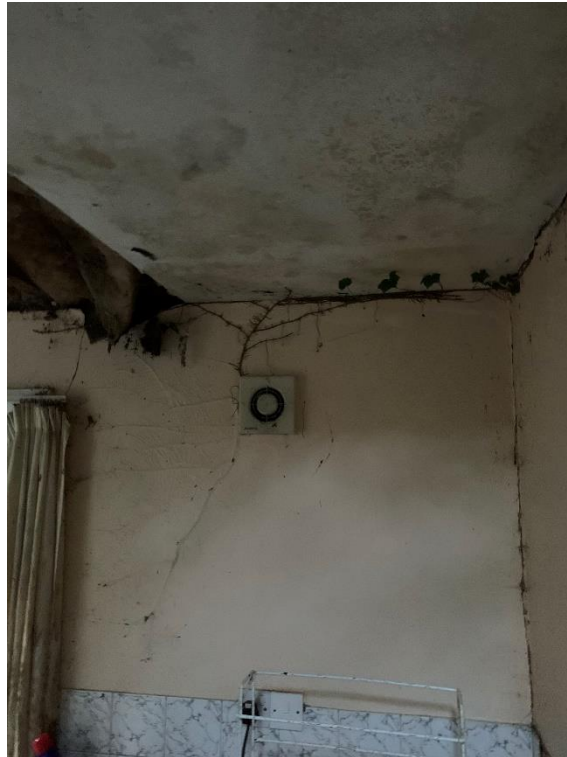
Extensive water damage due to roof collapse – Ivy and general growth internal

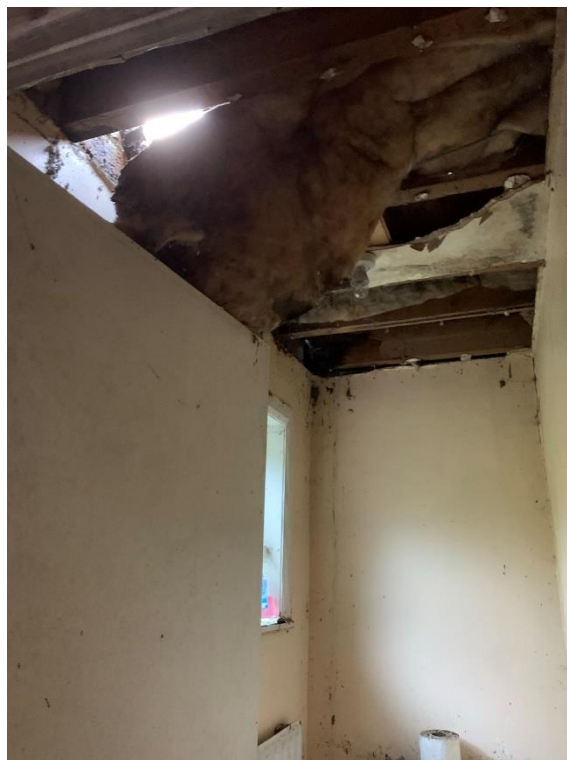
GF toilet roof collapse

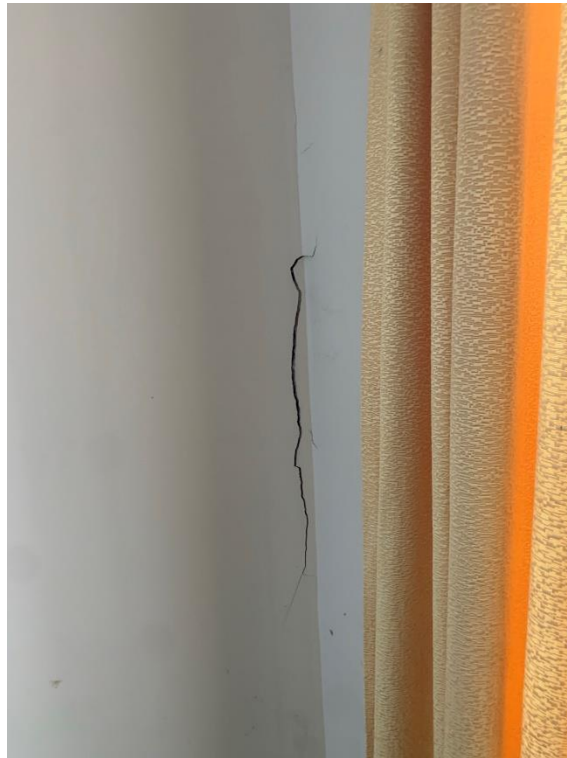
FF cracking to front elevation

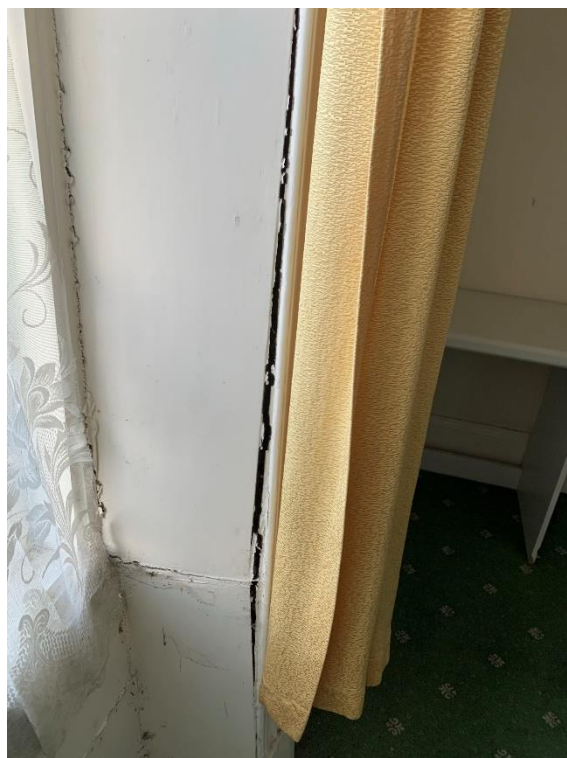
FF cracking and movement to front elevation

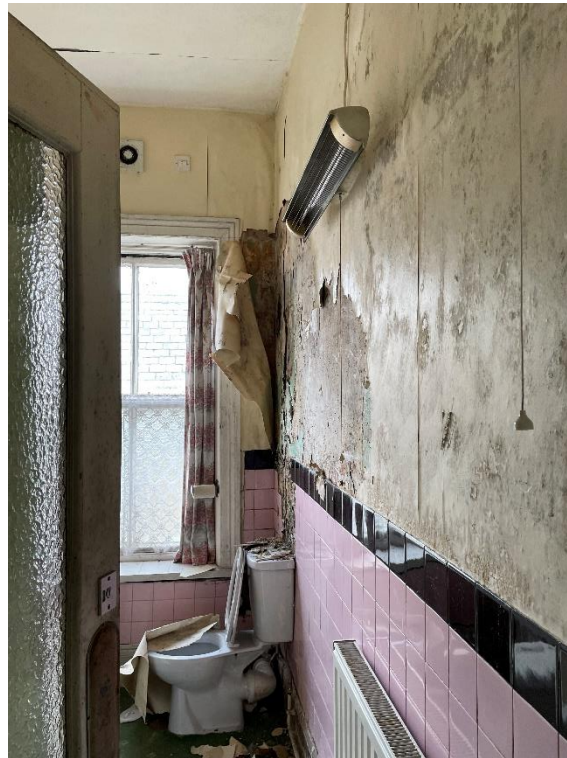
FF toilet damage due to water ingress

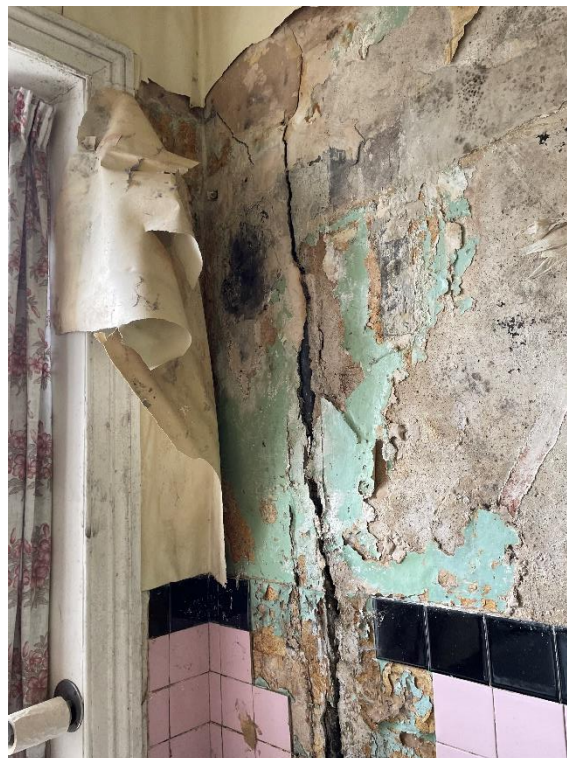
FF toilet damage due to water ingress

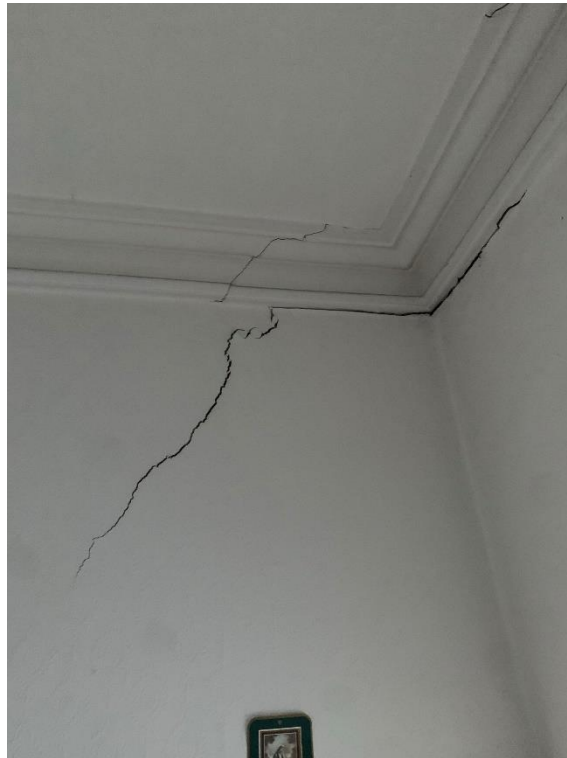
FF cracking and movement to side gable

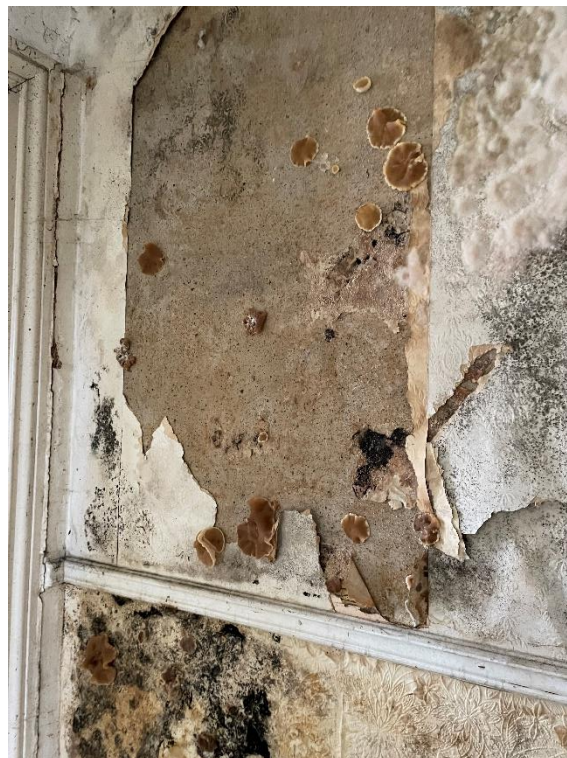
General dampness and water ingress at FF

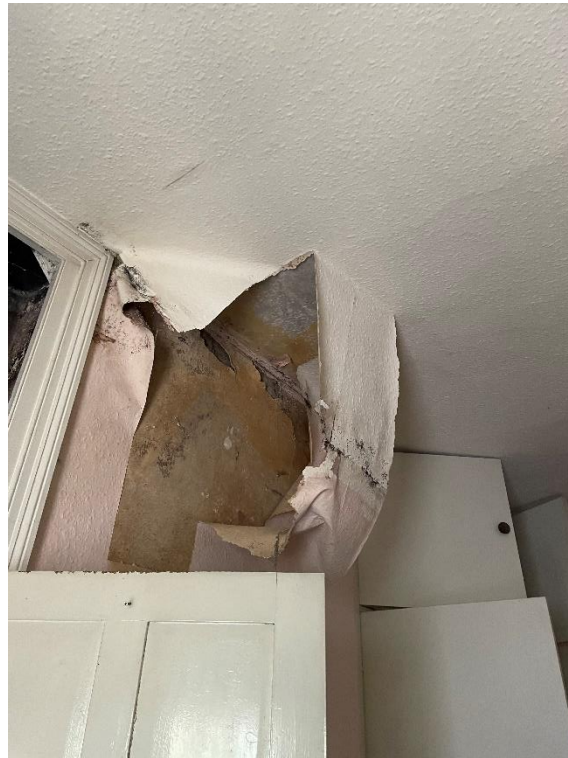
General dampness and water ingress at FF

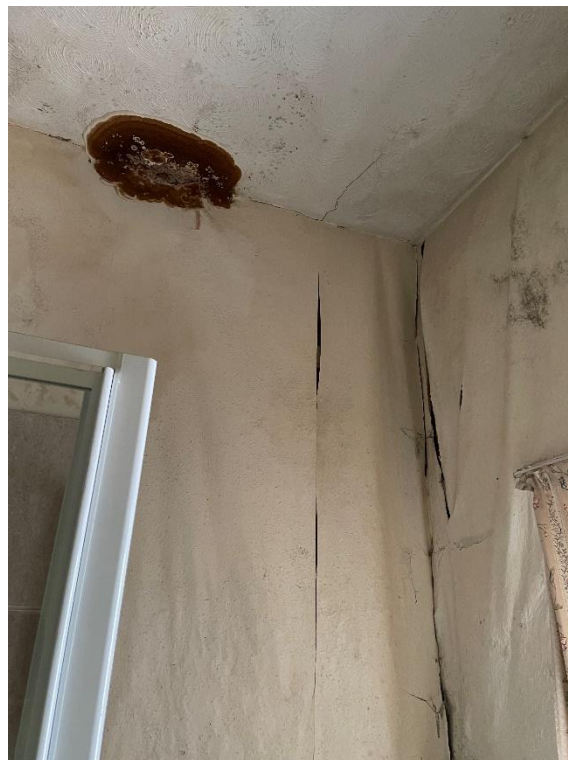
General dampness and water ingress at FF

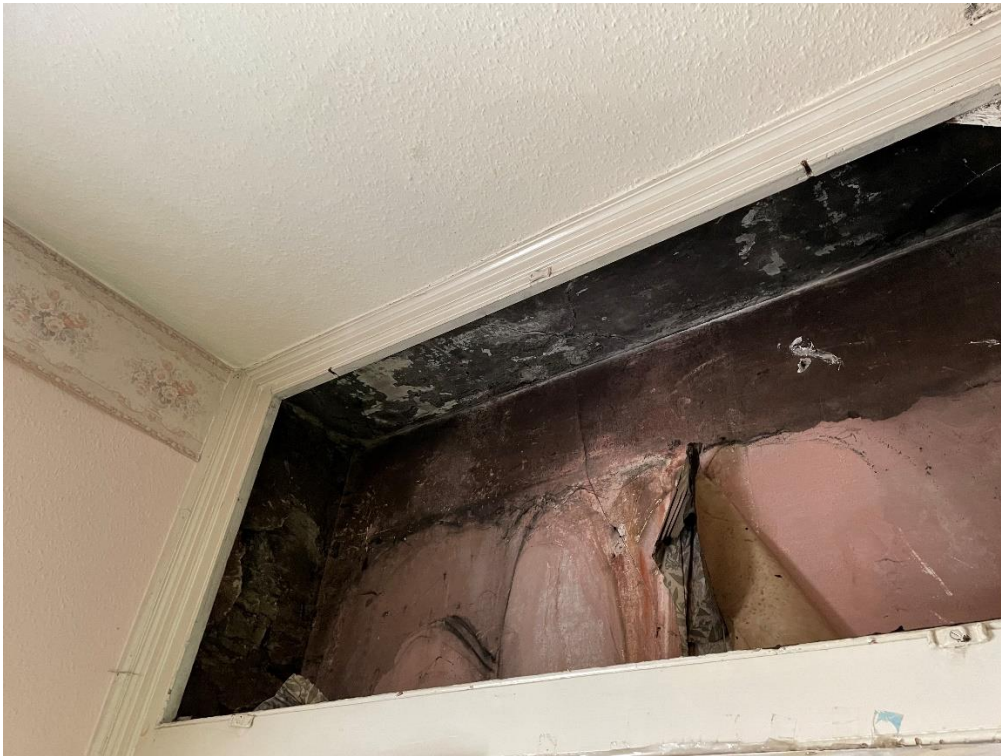
General dampness and water ingress at FF

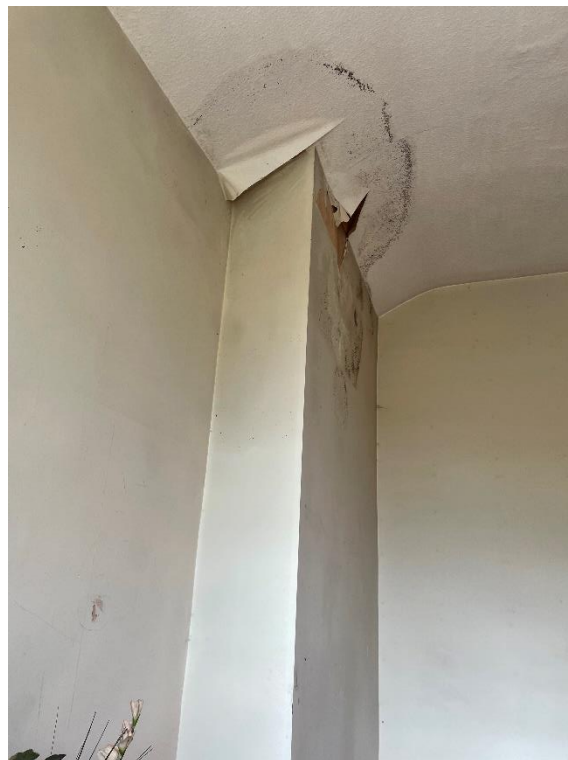
Water ingress around upper chimney

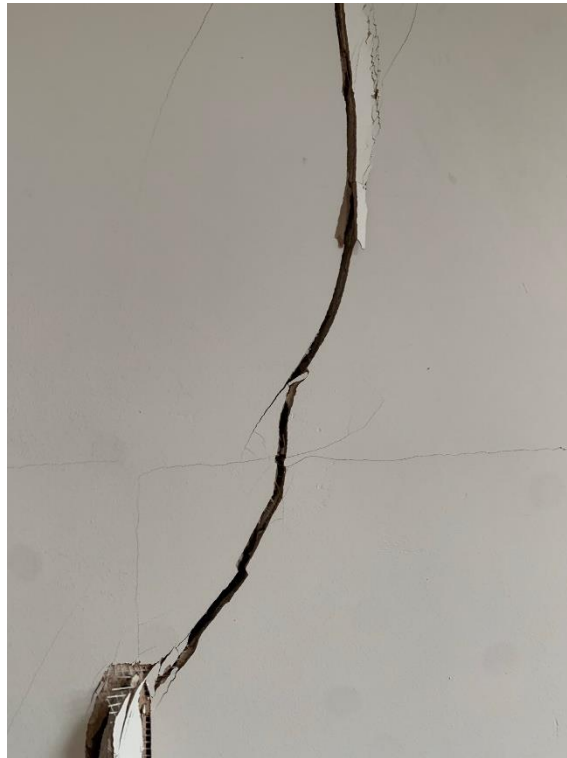
General cracking

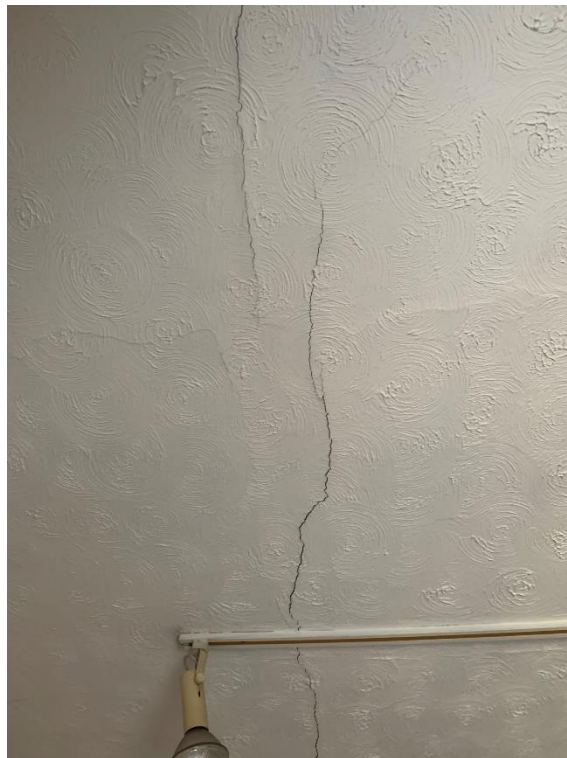
General cracking

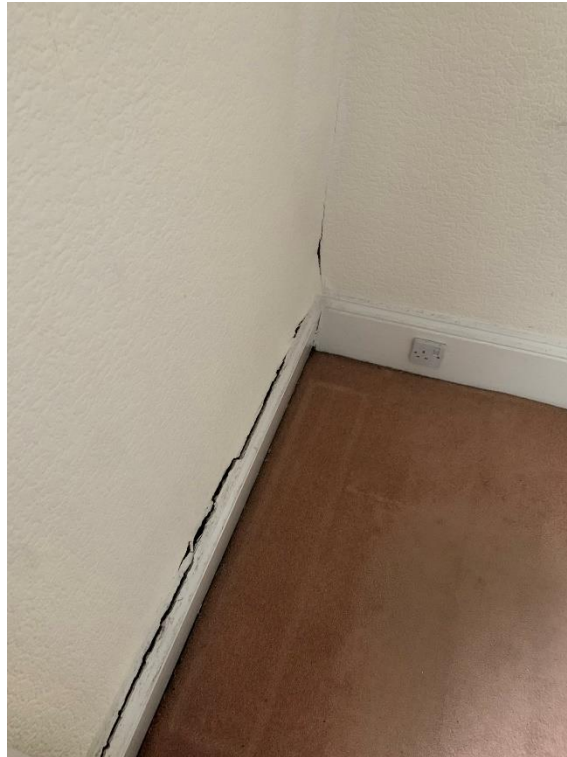
General cracking

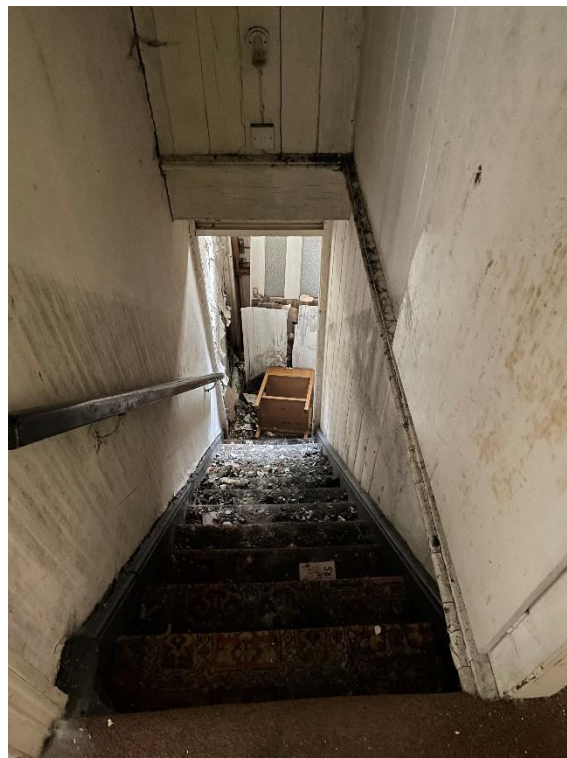
General poor condition of staircase

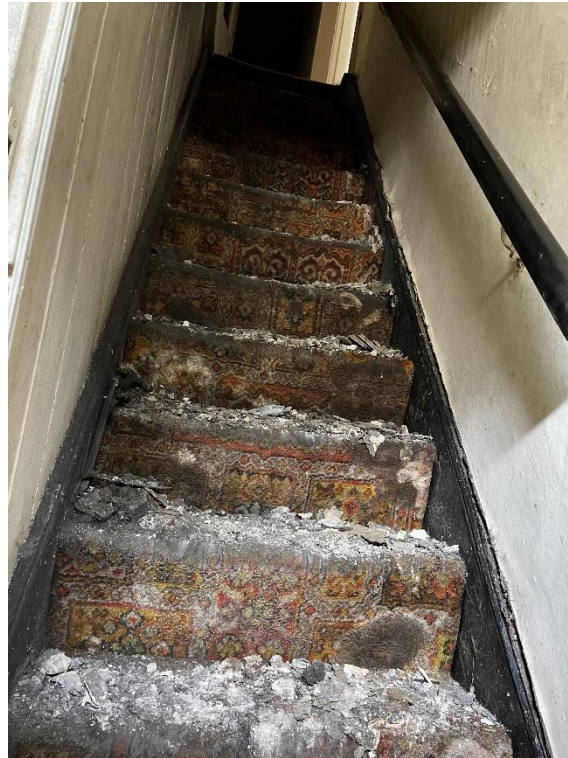
General poor condition of staircase

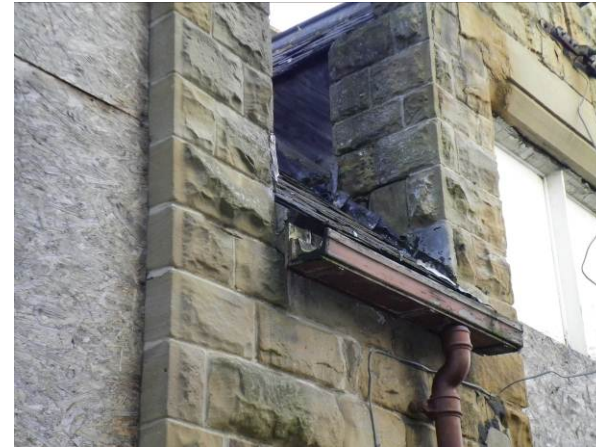
Photo 2  
Defective roof and gutter. Missing lead flashings and sheeting to dormer cheek.

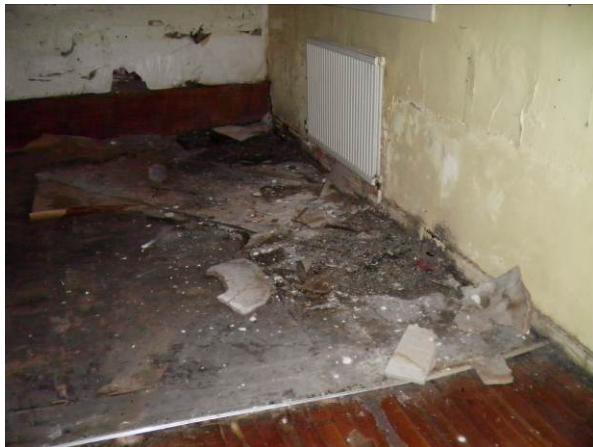
Photo 3  
Typical internal view showing damp walls and floors

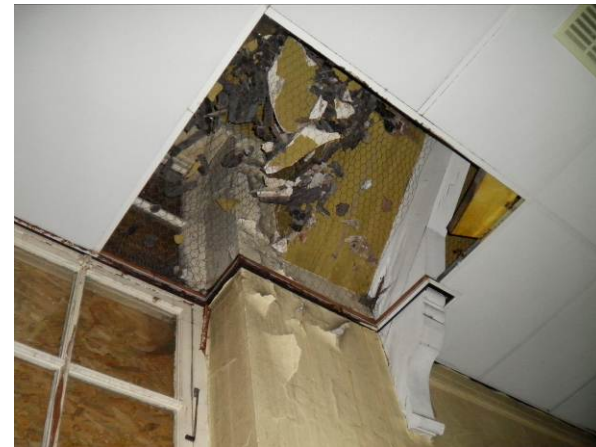
Photo 4  
Defective lath and plaster ceiling

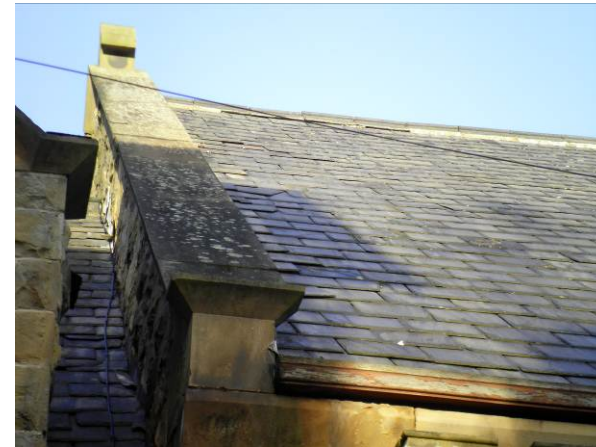
Photo 2  
Defective slating to main roof

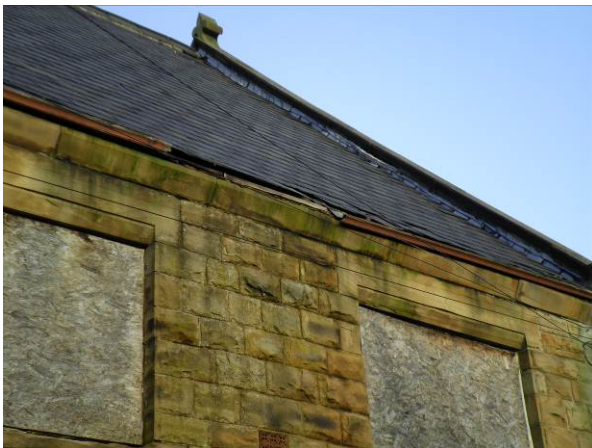
Photo 3  
Rotten eaves gutter

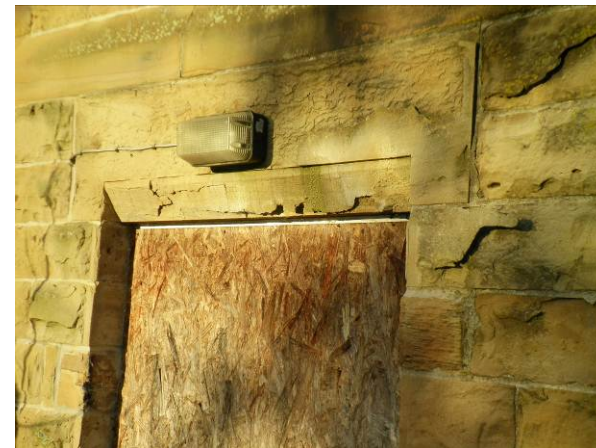
Photo 4  
Typical cracking and delaminating stonework

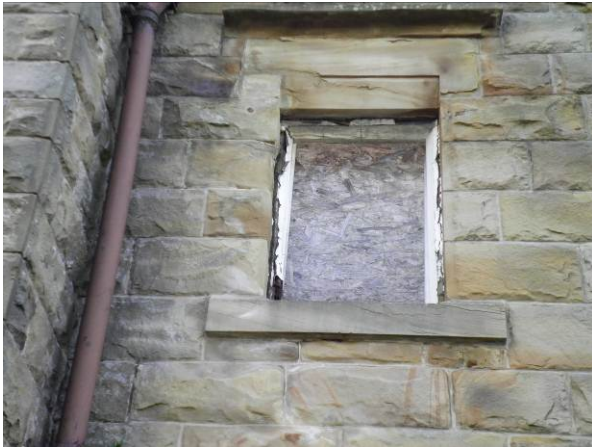
Photo 5  
Typical example of rotten window frame

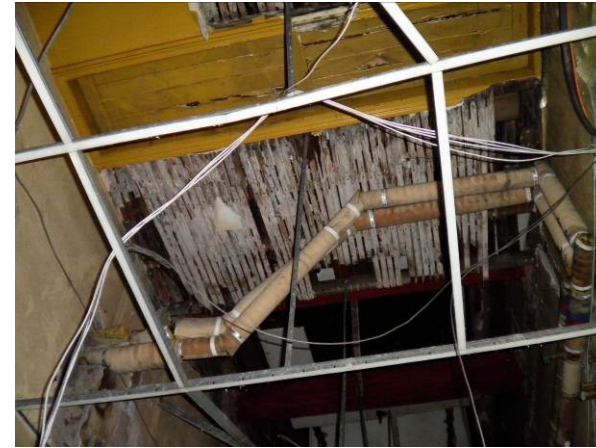
Photo 6  
Defective ceilings

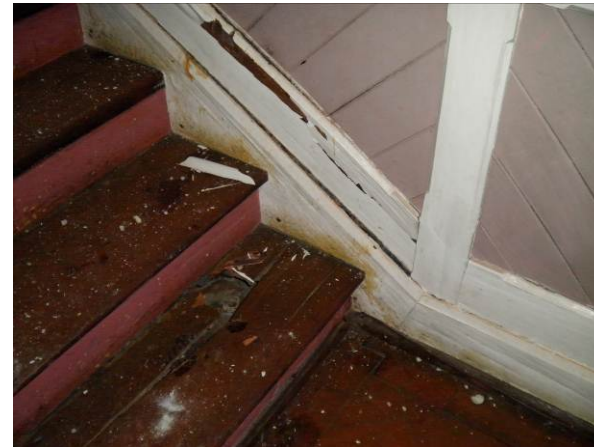
Photo 12  
Dry rot to stairs

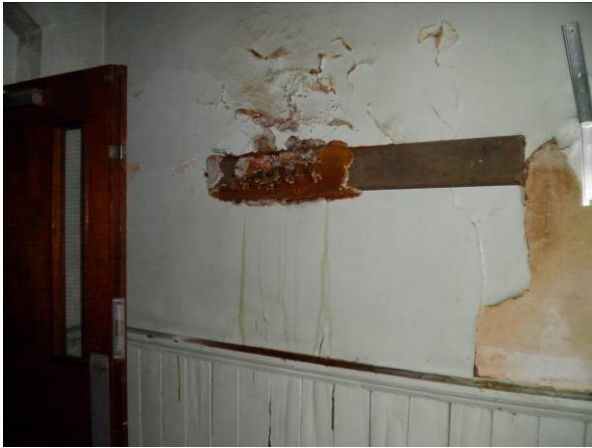
Photo 13  
Active dry rot to wall plaster and panelling

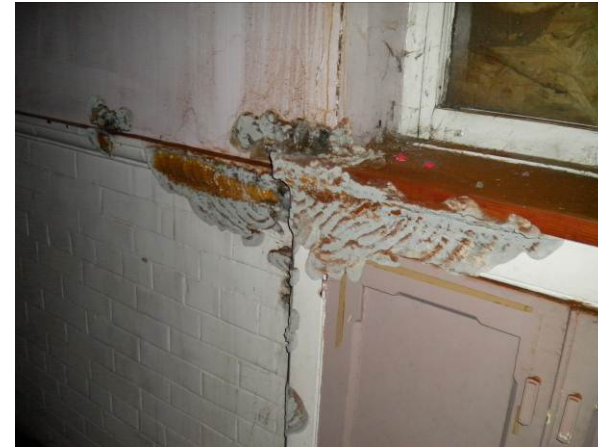
Photo 14  
Dry rot to window reveal, cill and built-in cupboard

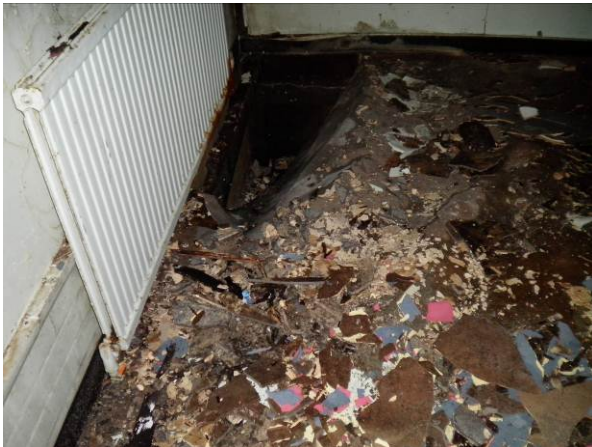
Photo 15  
Rotten and collapsed floor

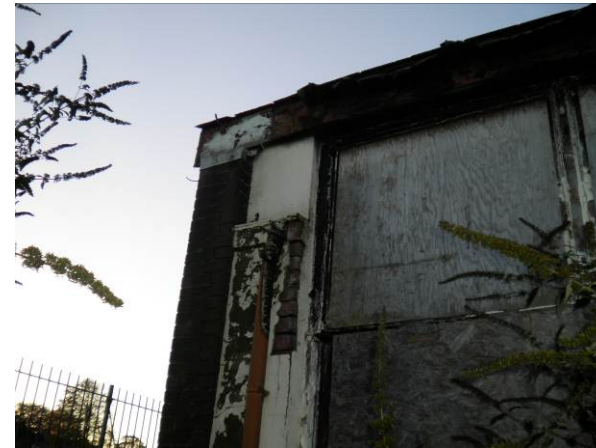
Photo 2  
Fire damaged window frame, fascia, melted rainwater goods etc
