**Appendix A  
Photograph Schedule**

Original School (1868)

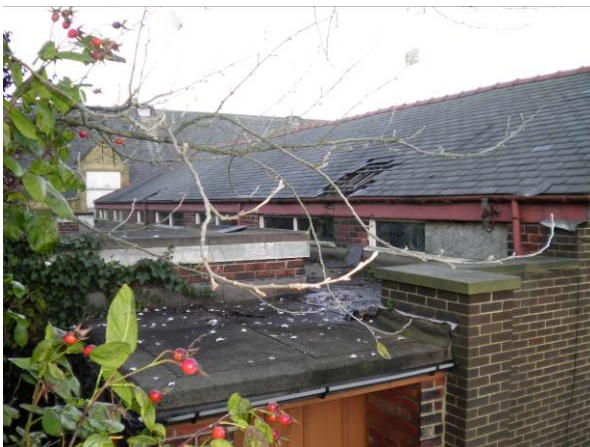
Photo 3  
Overall view of defective pitched and flat roofs

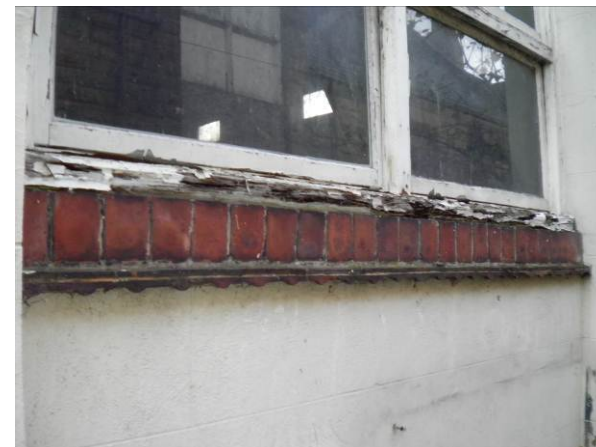
Photo 4  
Typical rotten window frame

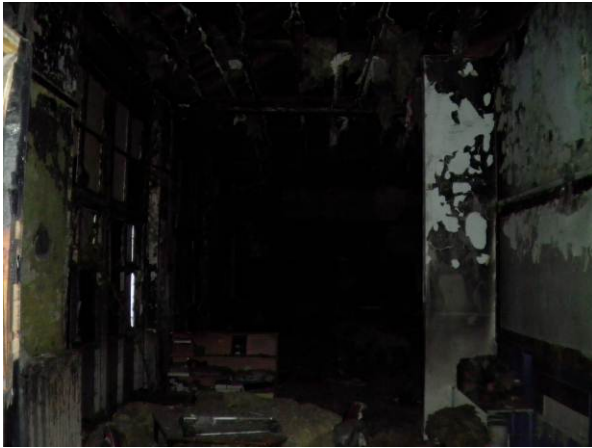
Photo 5  
Overall view of main fire damaged rooms

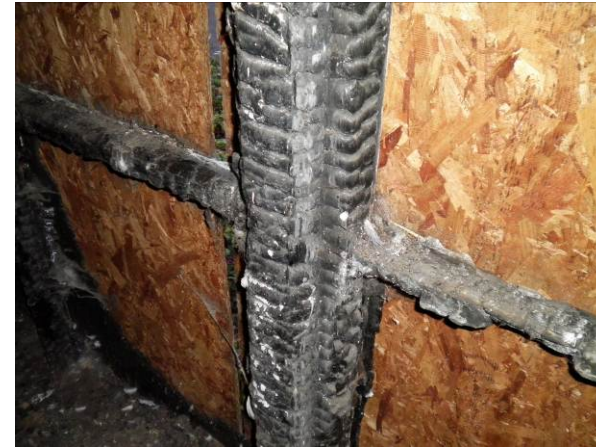
Photo 6  
Typical fire damage to external timber framing

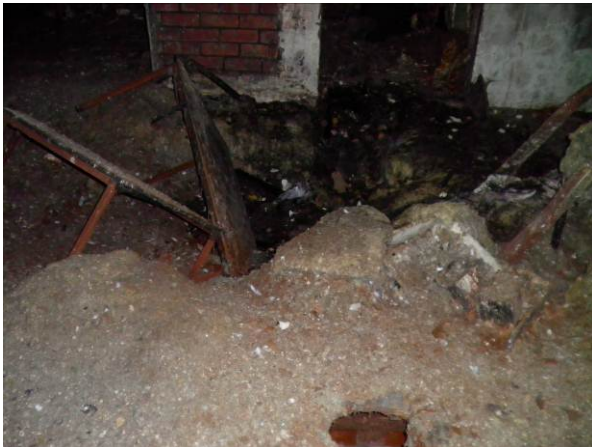
Photo 7  
Collapsed floor to central main room

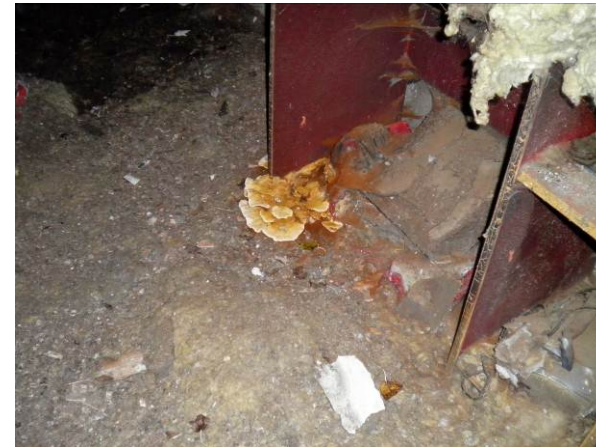
Photo 8  
Active dry rot to floor/internal joinery

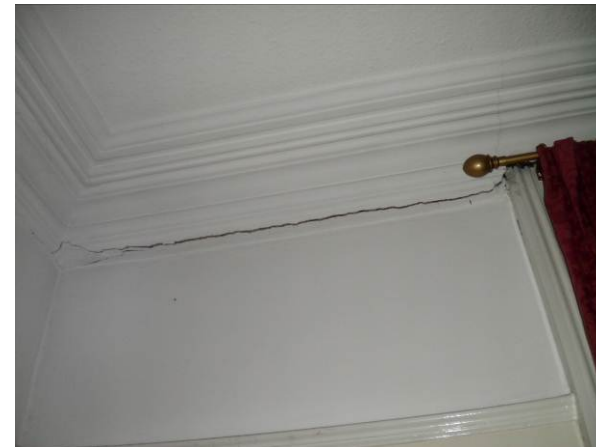
Photo 4  
Typical internal cracking

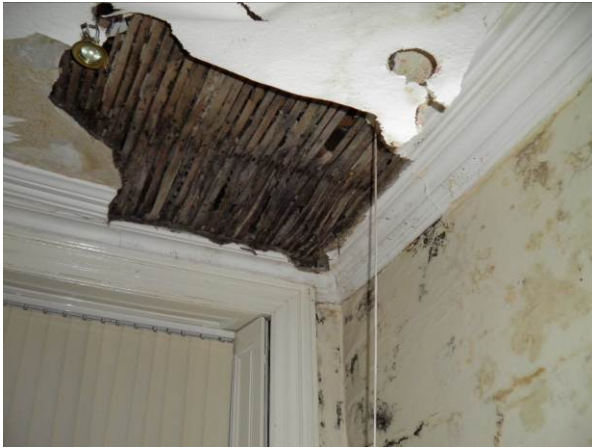
Photo 5  
Damaged ceiling and water ingress to 1<sup>st</sup> floor

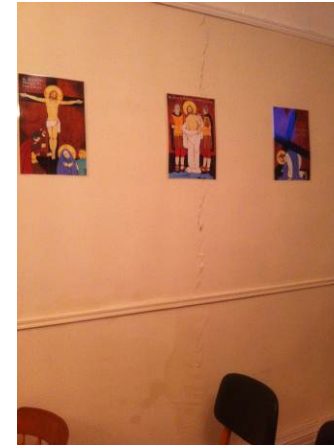
Photo 6  
Structural cracking to ground floor
