**Appendix A
Photograph Schedule**

Original School (1868)

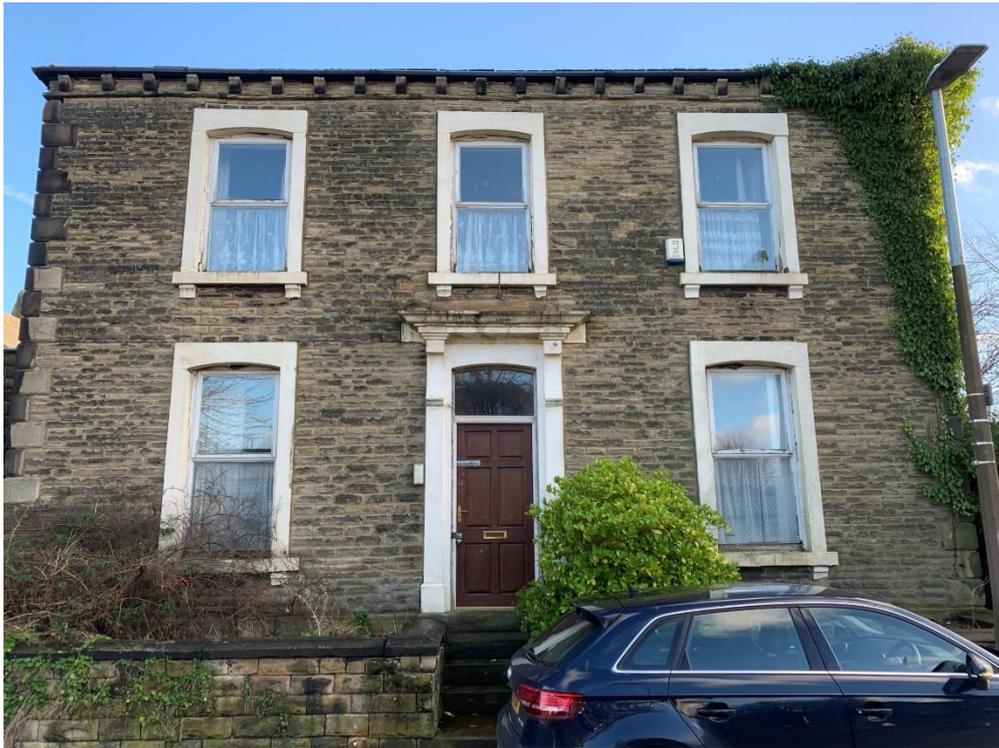
Front Elevation from Upton Street

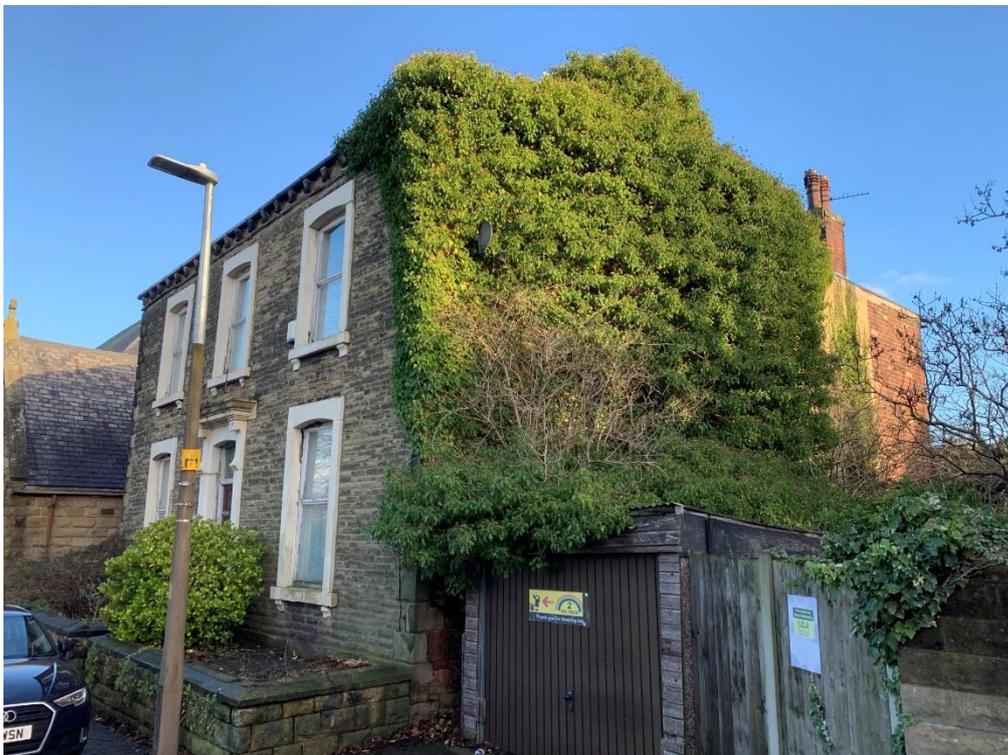
RH Side Elevation from Upton Street

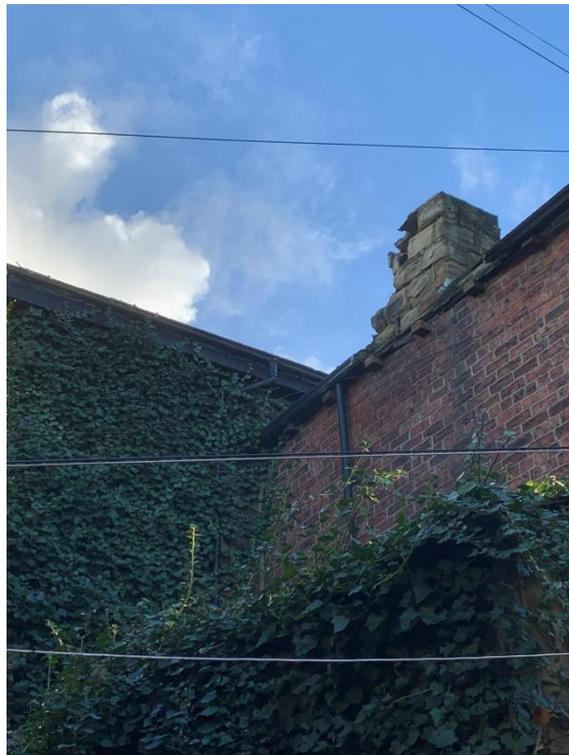
Rear Chimney collapse and gutter and fascia failure

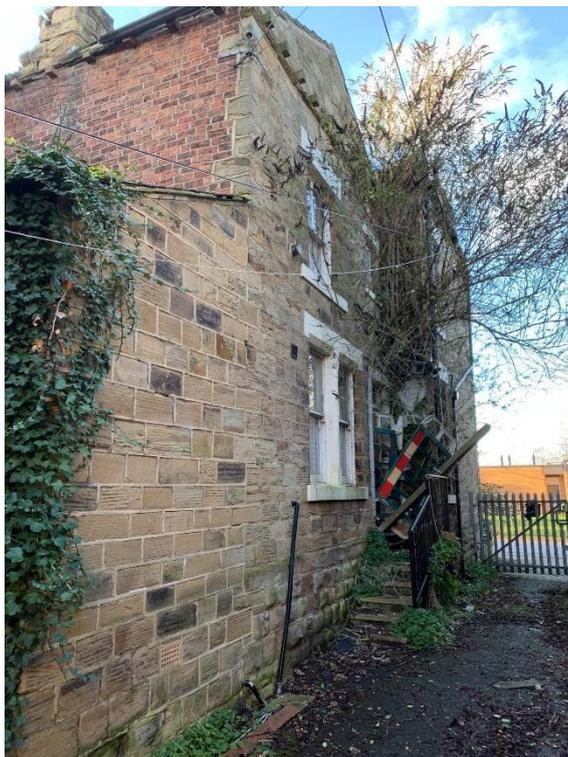
Typical LH Side Elevation

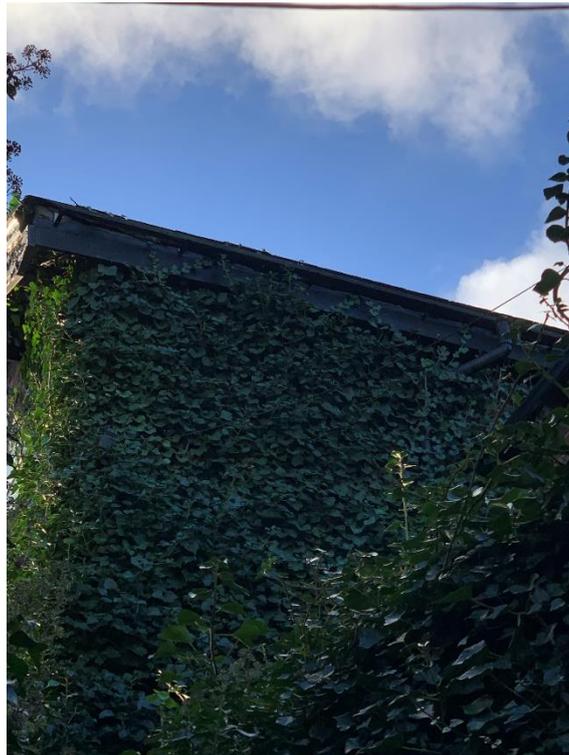
Over grown Ivy to RH Elevation

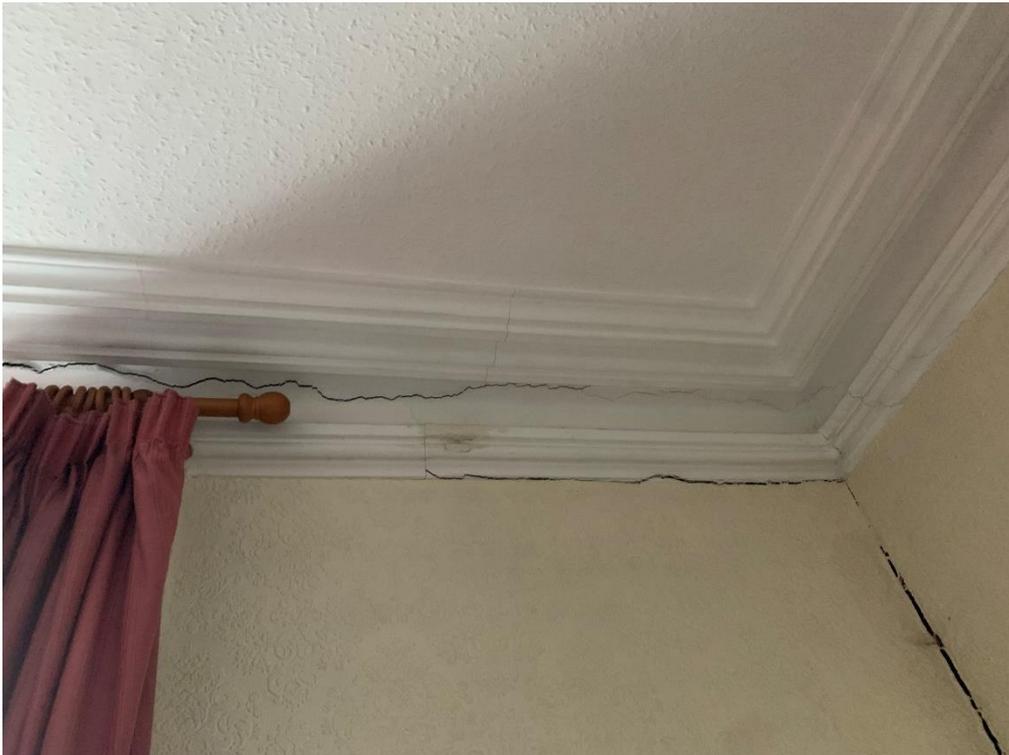
GF cracking and movement

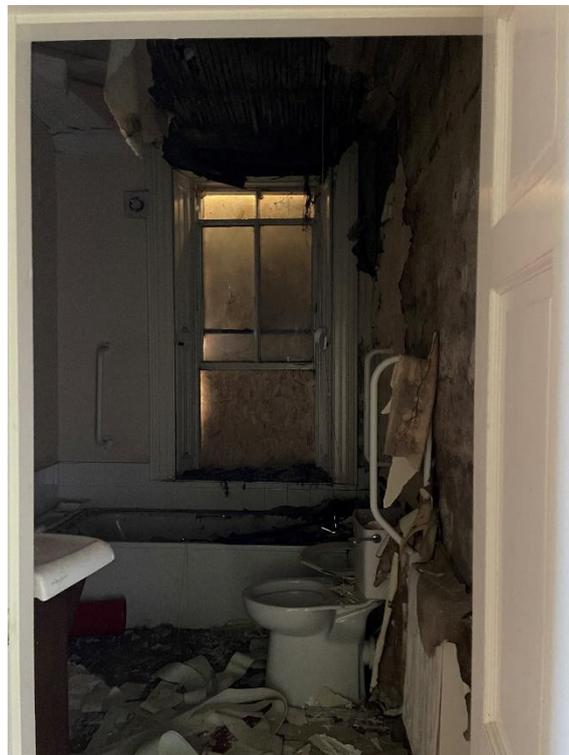
GF Bathroom affected by ceiling collapse and water ingress

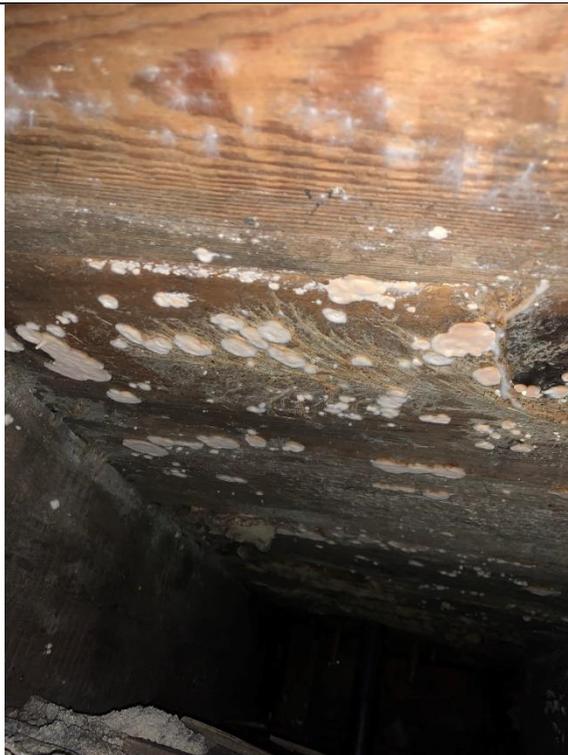
Wet rot to GF floor structure – taken from basement

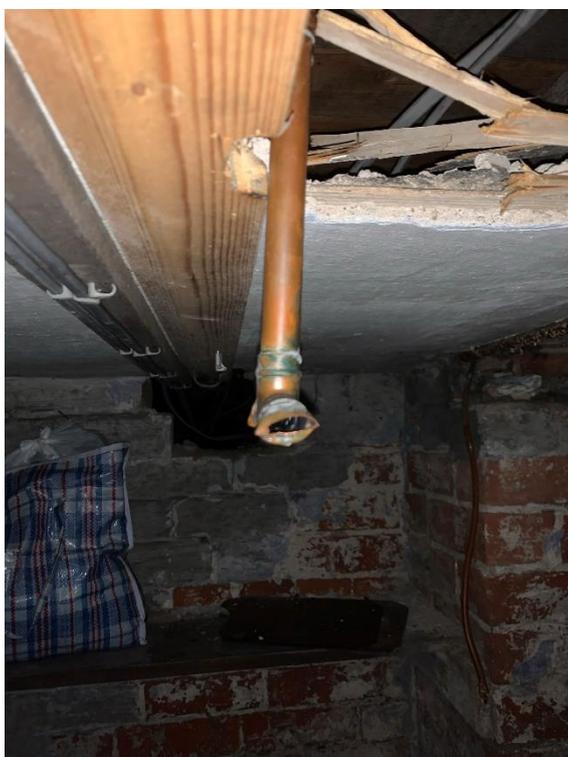
Copper distribution system has been 'stolen'

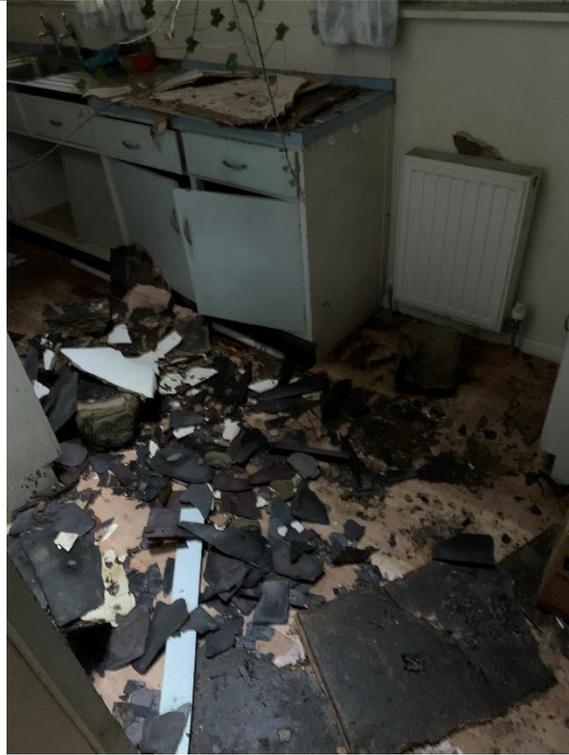
GF rear kitchen damage due to roof structure collapse

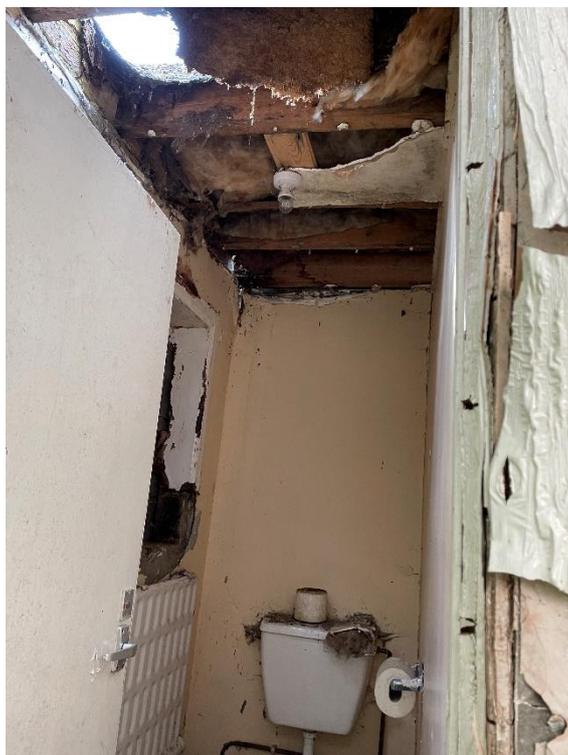
GF side toilet – roof collapse above

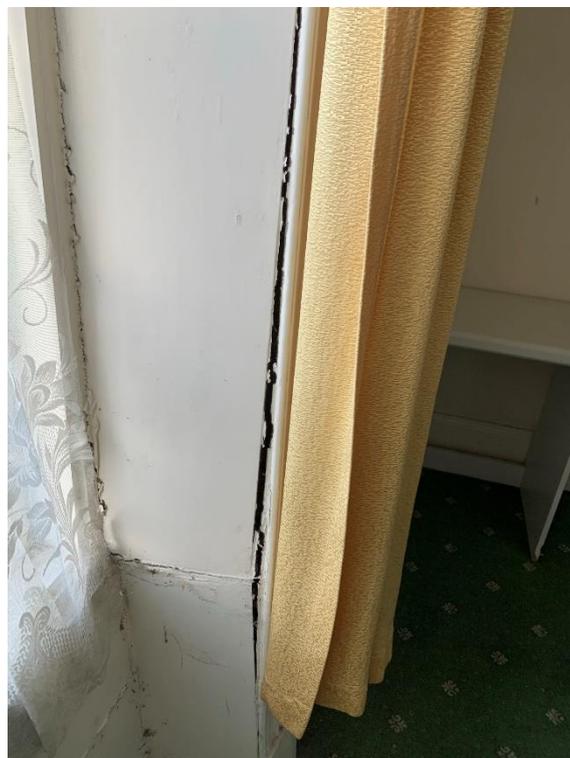
FF cracking and movement to front elevation

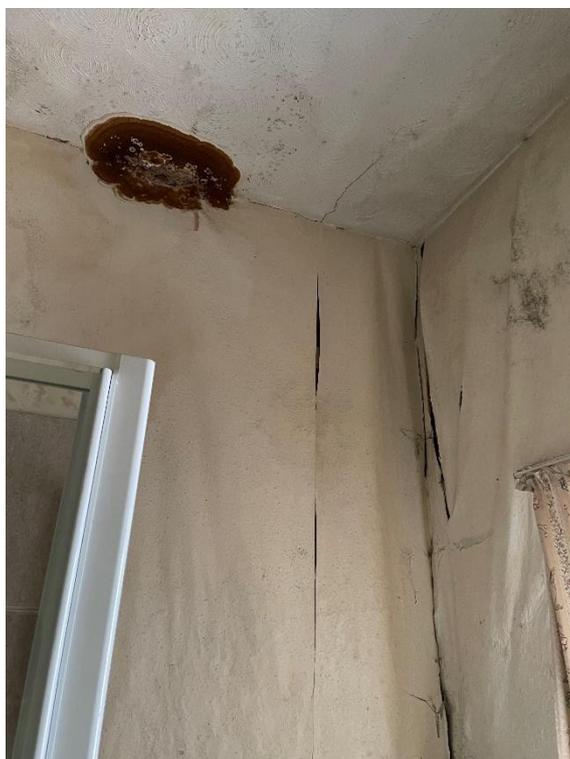
General dampness and water ingress at FF

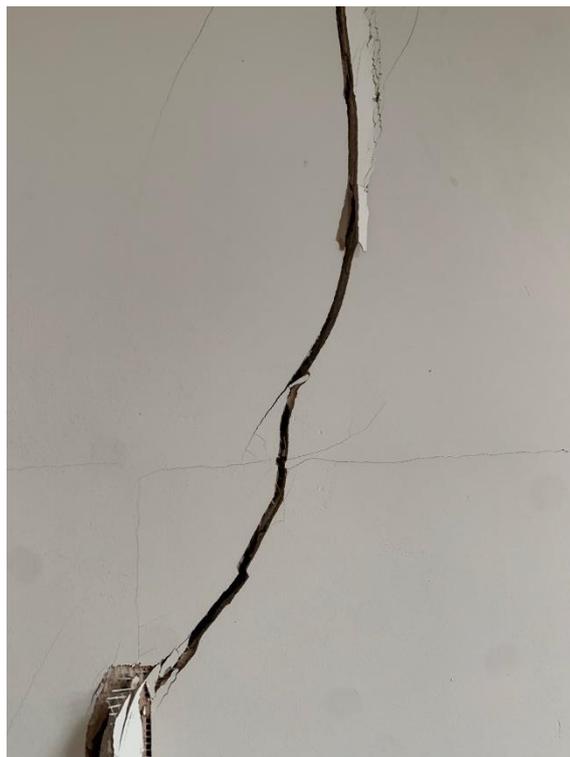
General cracking

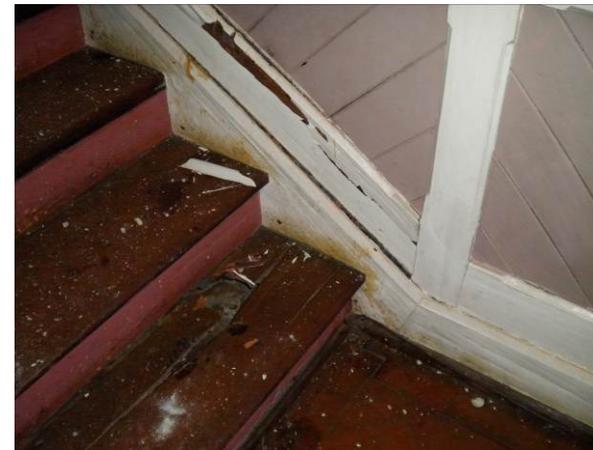
Photo 12
Dry rot to stairs

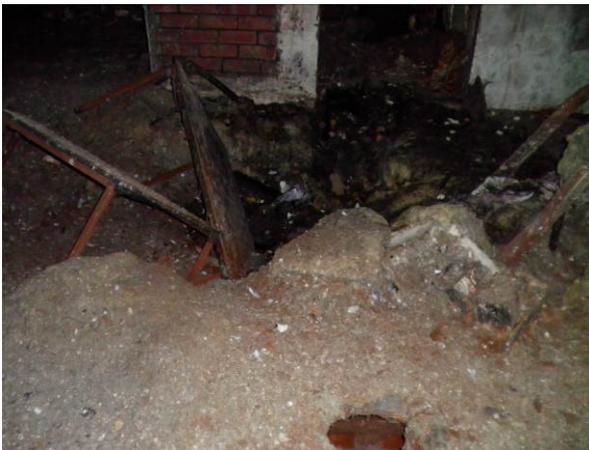
Photo 7
Collapsed floor to central main room

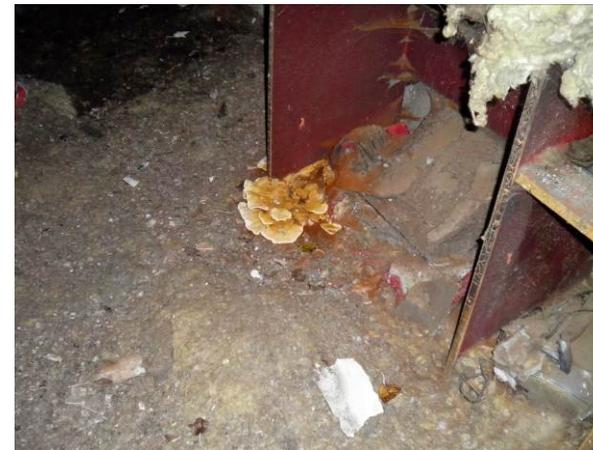
Photo 8
Active dry rot to floor/internal joinery
