26 May 2023
BC.HUD.2016.00001.005/02

**St Mary's Convent (Nunnery), Batley
Condition Review Update 2023**

Condition Statement in Support of Listed Building and Conservation Area Consent St Mary's (Old) Catholic Primary School, Batley

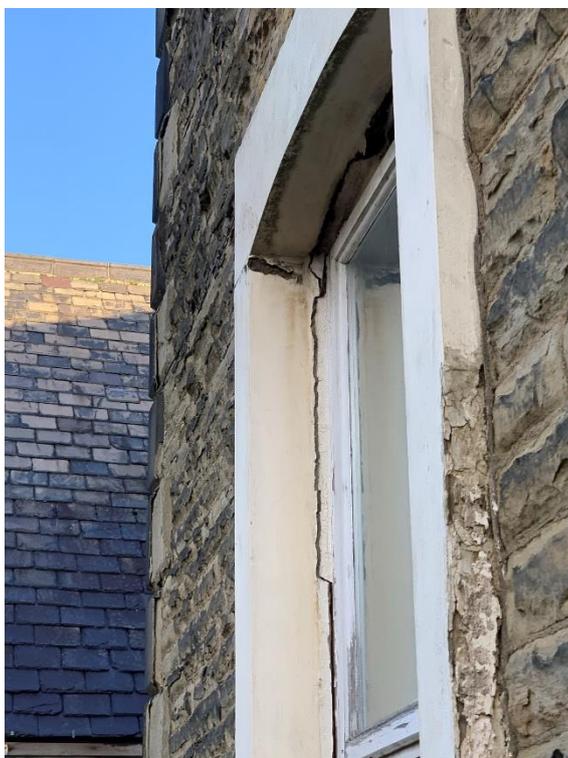
Typical movement and window condition

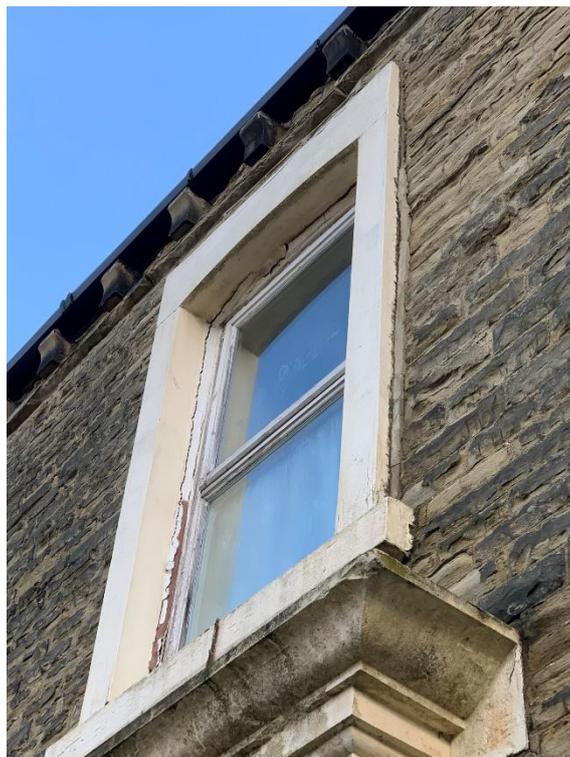
Typical Movement and window condition

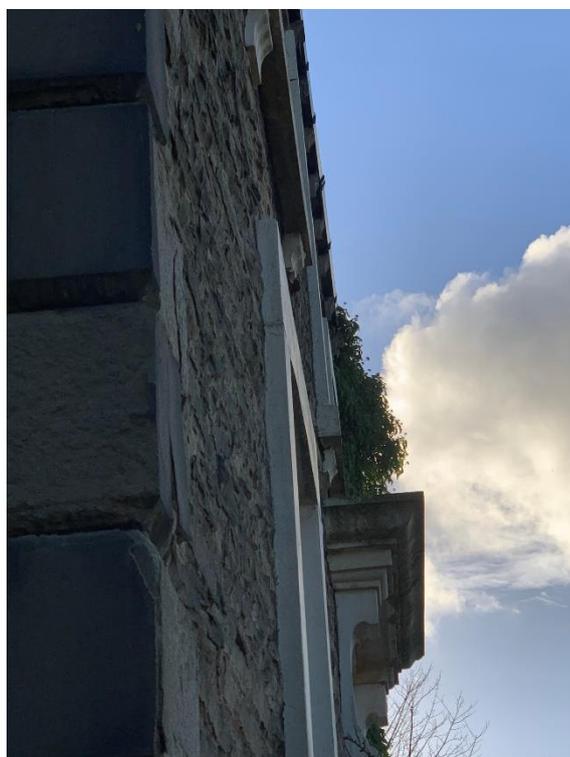
Visible and quite extensive cracking has developed at ground floor and first floor levels indicative of outwards rotation to the front elevation, particularly noticeable to the first floor and visible externally and internally, with bulging and buckling of the side gable both horizontally and vertically, again very noticeable both internally and externally.

Front Elevation Buldge

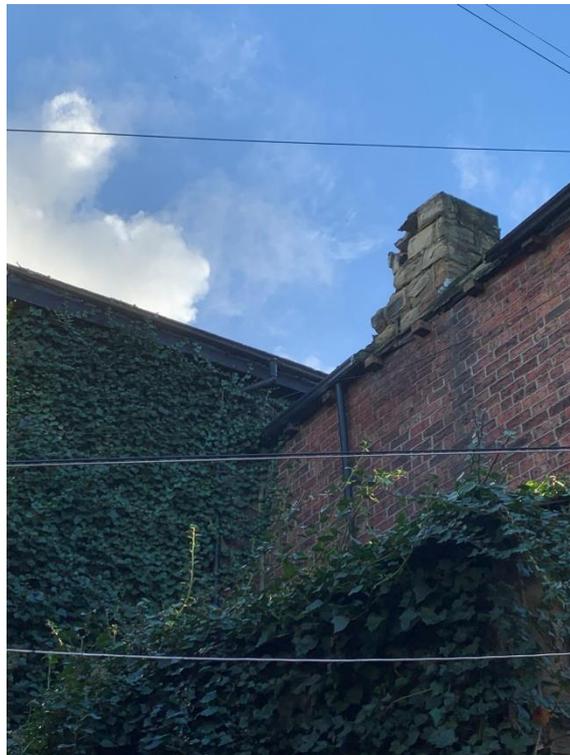
- Collapsed section of chimney from upper roof level has also caused significant structural damage to the rear roof areas, as well as high level gutter and fascia collapse having occurred further exasperating the issues

Rear Chimney collapse and gutter and fascia failure

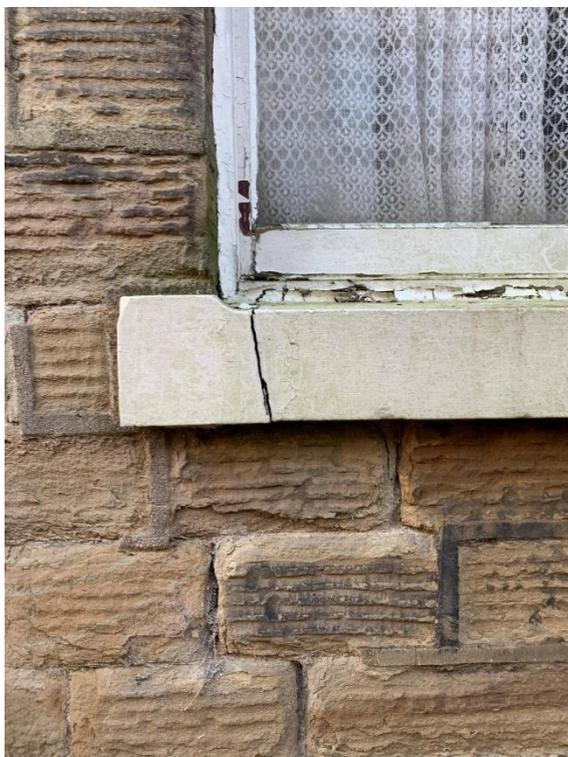
Cracking extending to stone cills

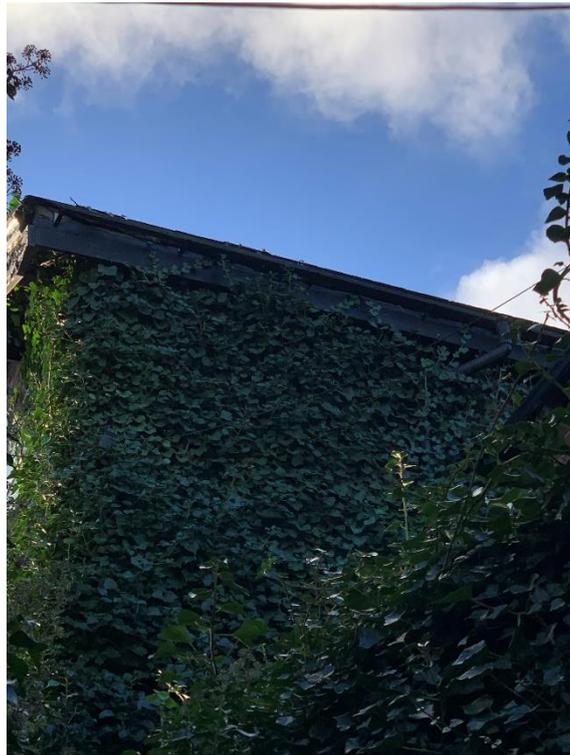
Over grown Ivy to RH Elevation

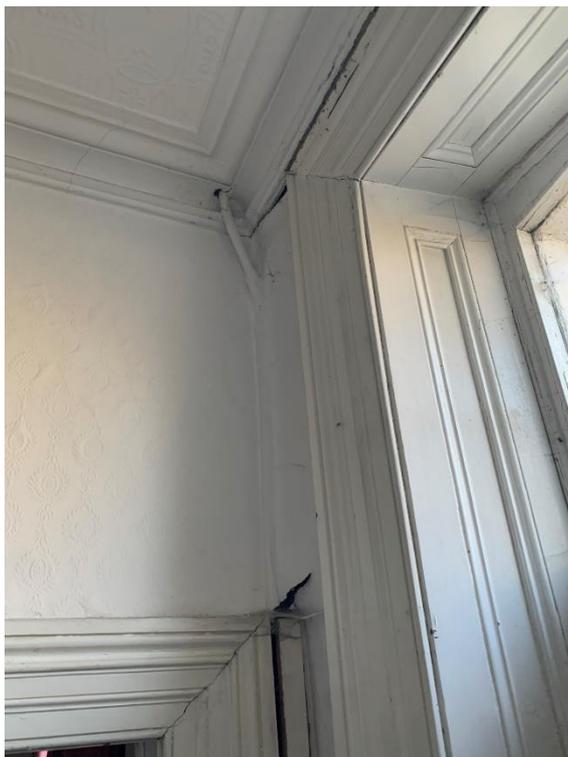
Internal cracking at GF level corresponding with external movement

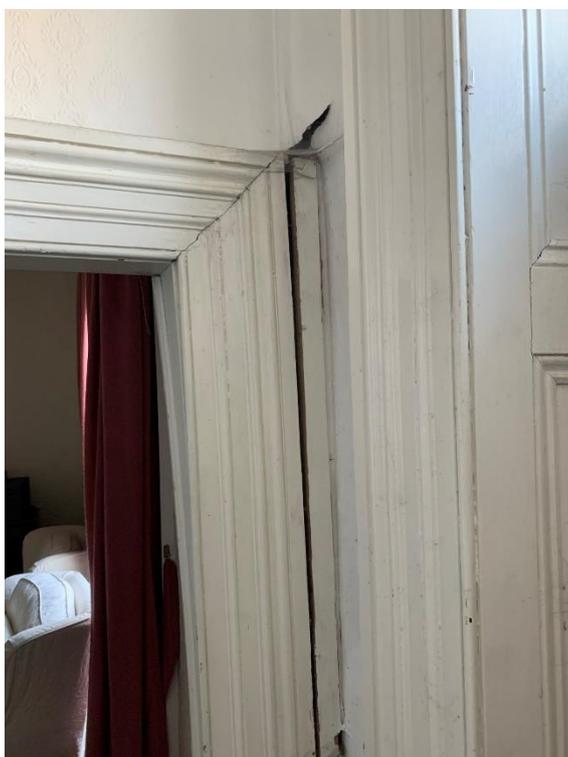
Internal cracking at GF level corresponding with external movement

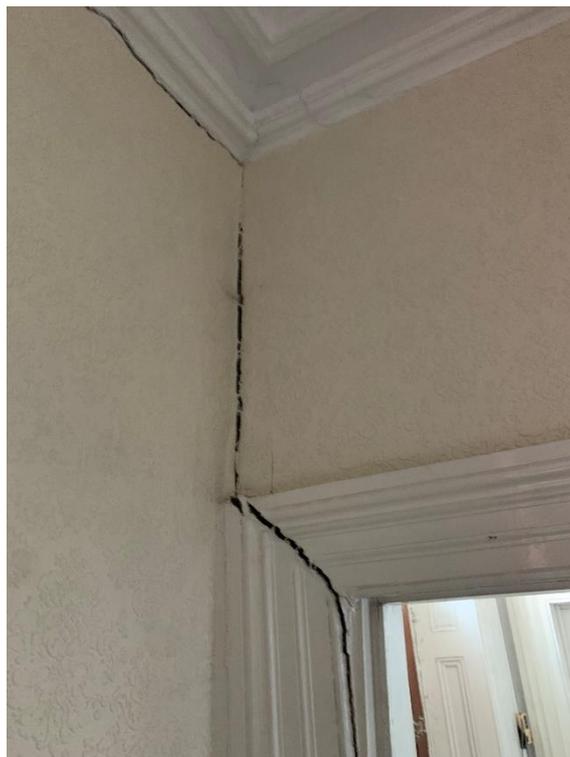
Internal cracking at GF level corresponding with external movement

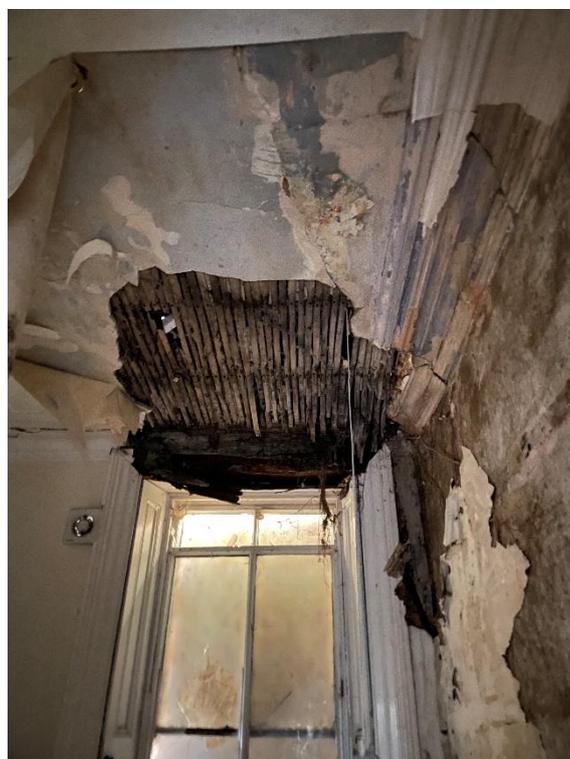
Ground floor ceiling damage from roof level water ingress

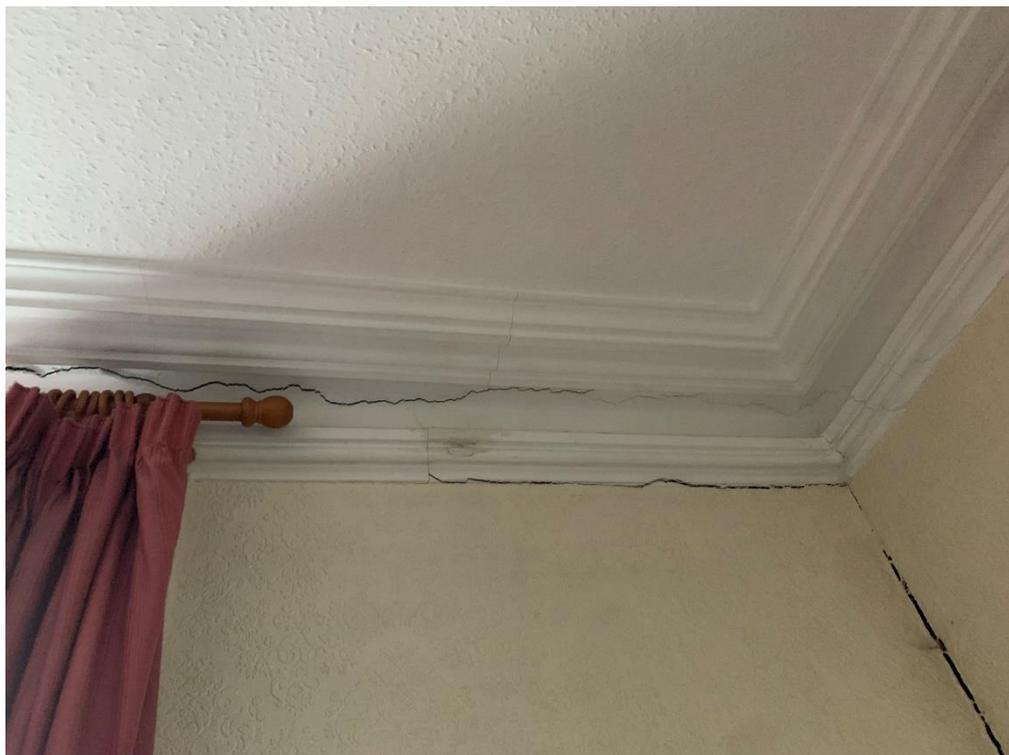
GF cracking and movement

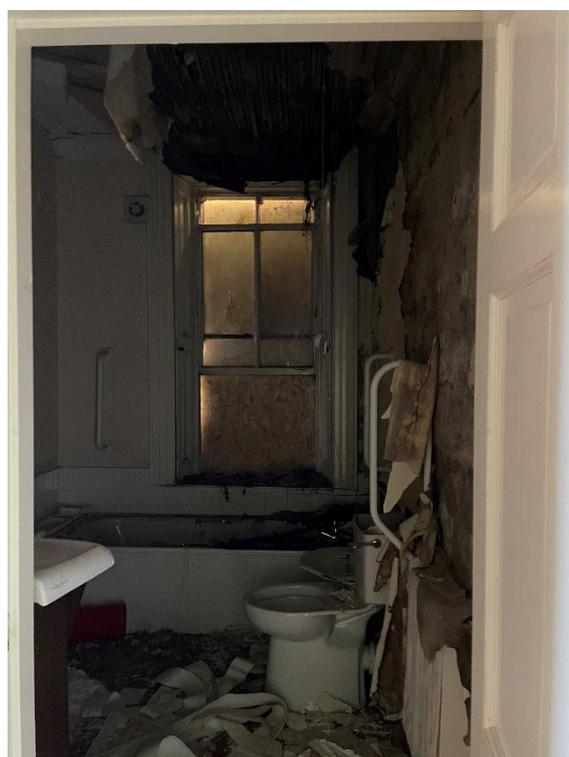
GF Bathroom affected by ceiling collapse and water ingress

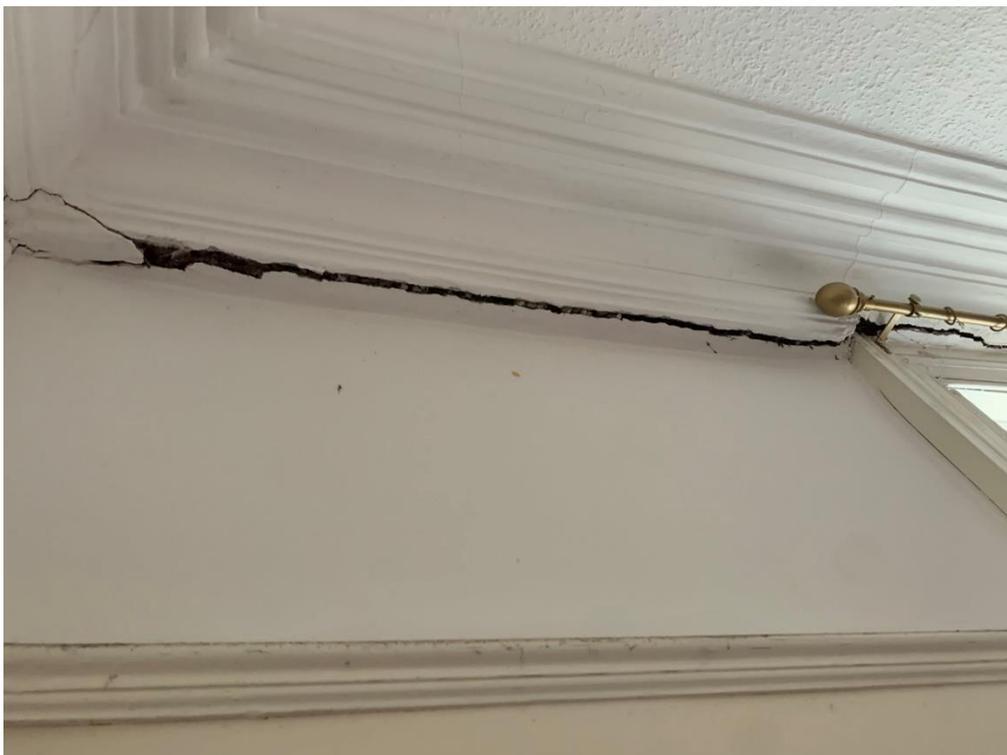
Further GF movement to front elevation

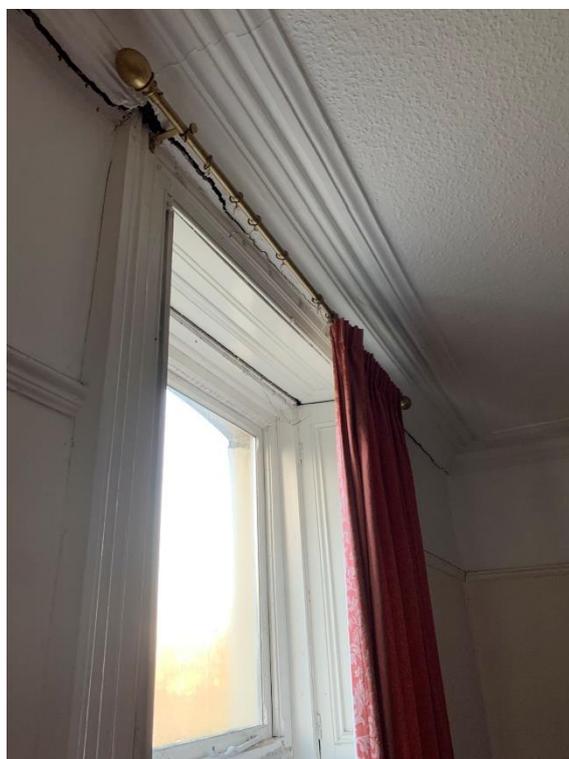
Further GF movement to front elevation

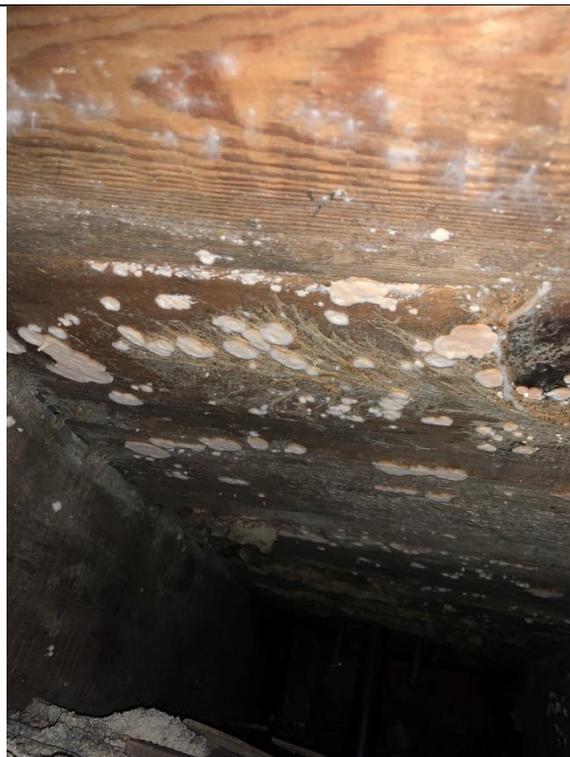
- Whilst the basement area was relatively dry, higher level water ingress issues have now reached the ground floor structure and it could be seen that wet rot is starting to spread in areas of the ground floor timbers which could be seen from within the basement

Wet rot to GF floor structure – taken from basement

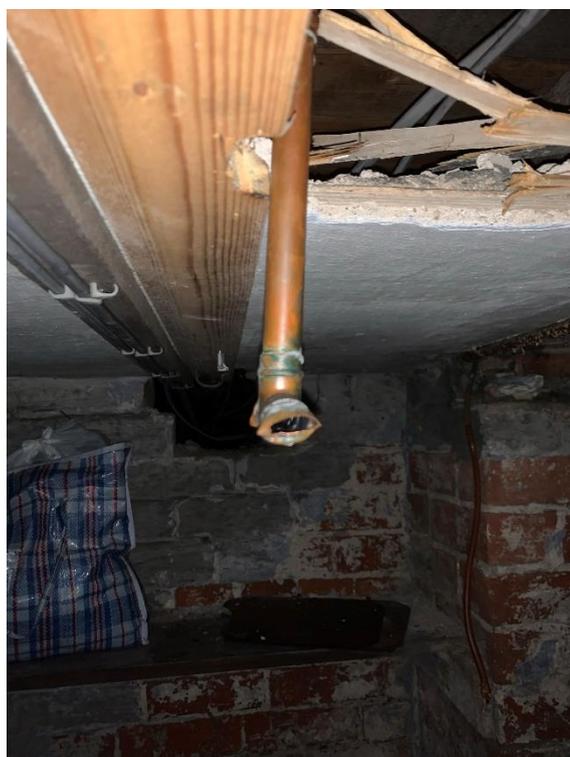
- The incoming gas supply meter has been removed and it appears that internal copper pipework has been 'ripped' out in wide areas of the basement, likely from an earlier break-in over the last 6 years

Copper distribution system has been 'stolen'

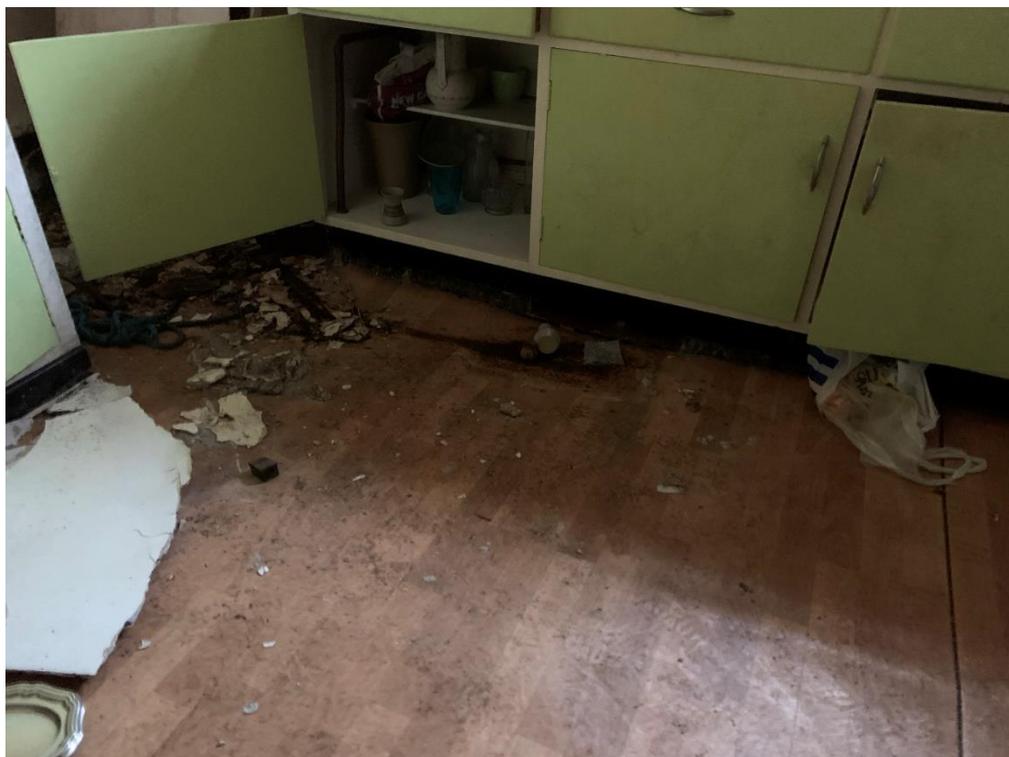
Within the ground floor main kitchen a section of concrete floor slab in front of the kitchen units has settled and rotated minimum 75mm downwards, corresponding very much with the other wider movement that has occurred over these last 10 years.

GF main kitchen floor slab sunk and rotated

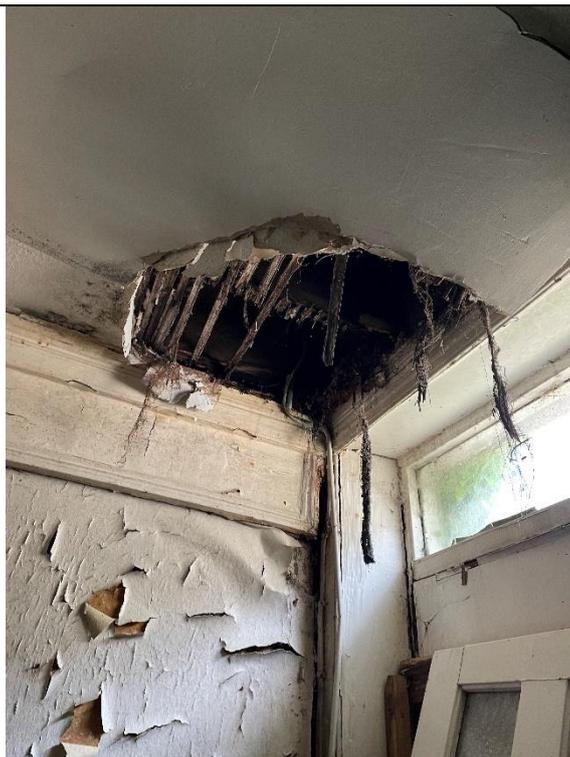
Collapsed ceiling and floor structure above GF main kitchen

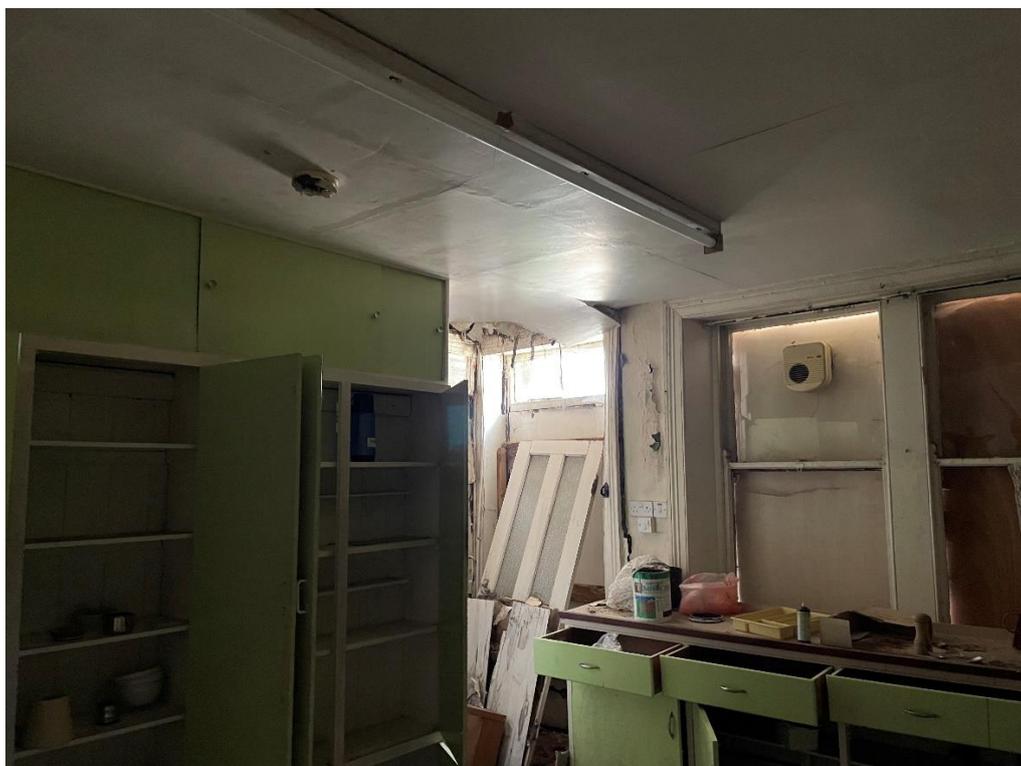
GF Kitchen damage

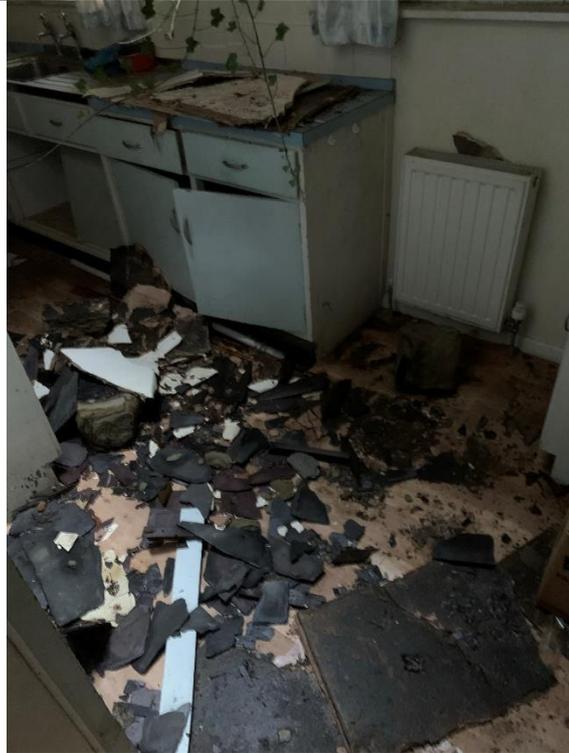
GF rear kitchen damage due to roof structure collapse

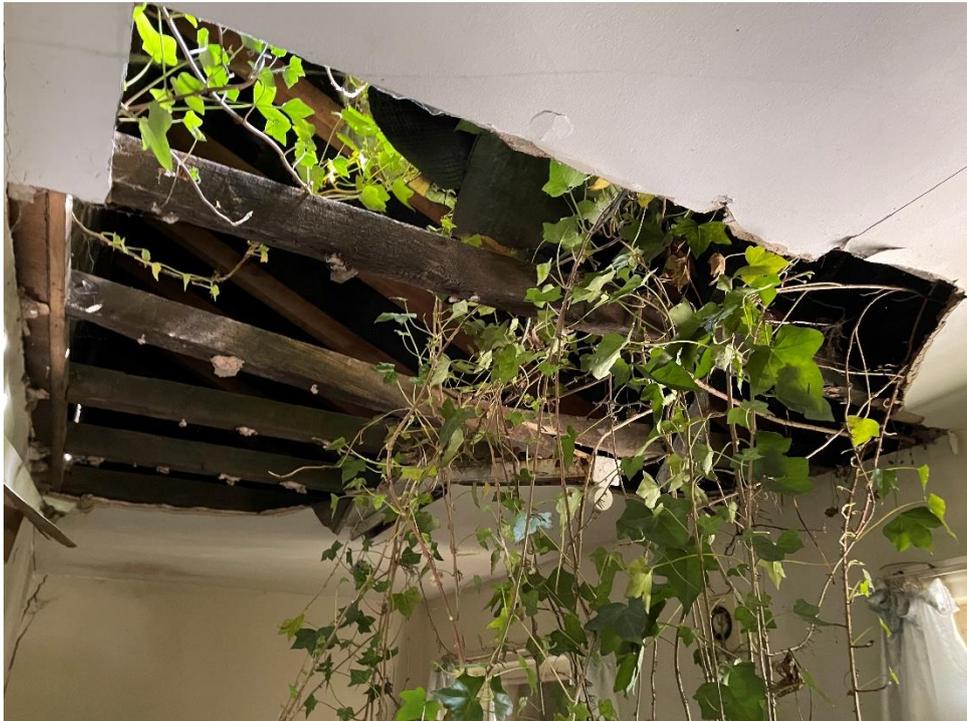
- Collapsed sections of roof structure and coverings to the rear lean-to buildings that form the rear kitchen, dining and toilet areas. These areas are particularly badly affected. Internal finishes are heavily affected by this as are fitted items. The roof structures in these areas are beyond repair. Ivy and other growths prevalent throughout

GF rear kitchen roof structure collapse

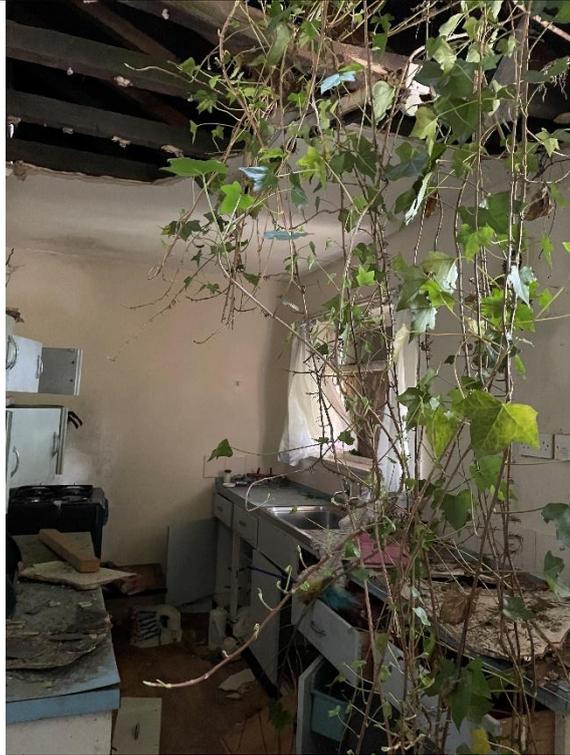
GF rear kitchen damage due to roof structure collapse

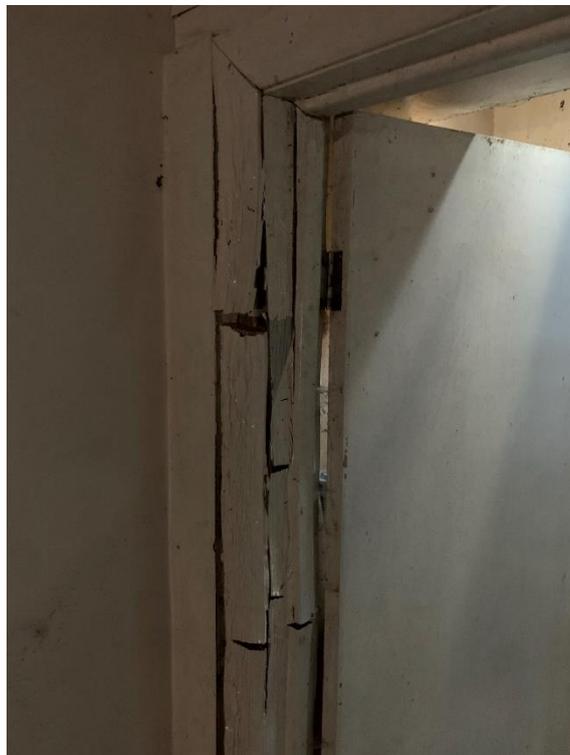
Typical wet rot to GF joinery

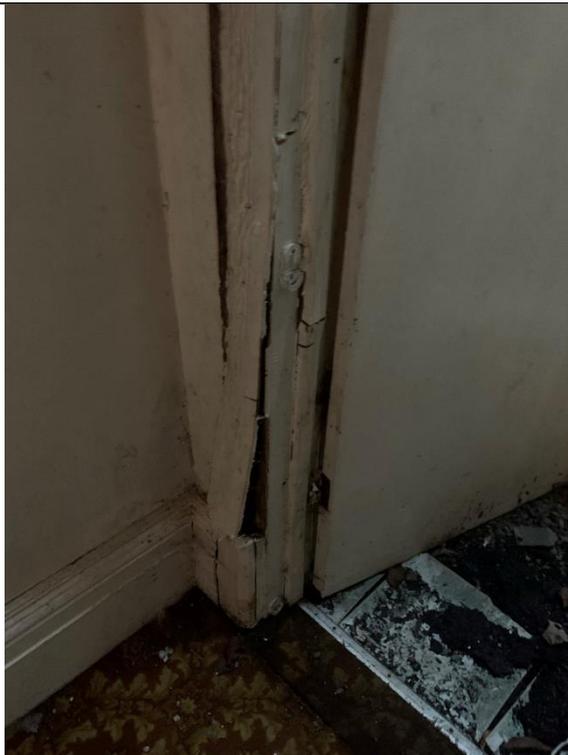
Typical wet rot to GF joinery

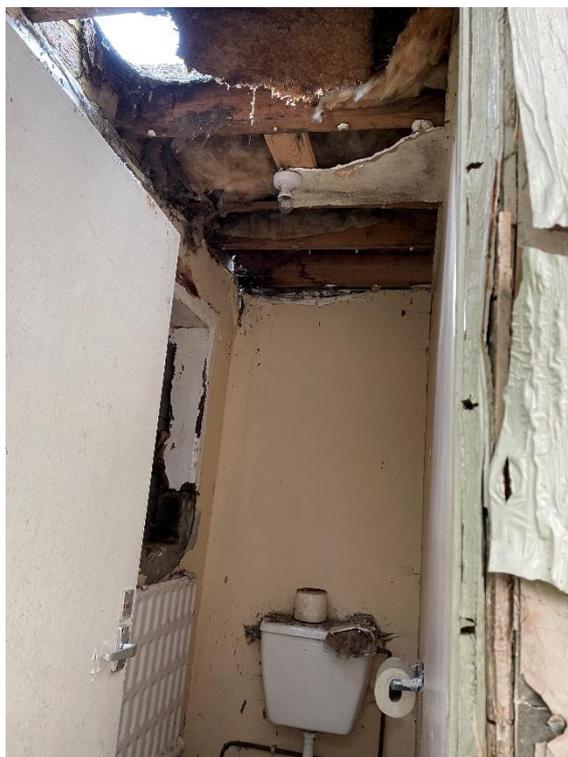
GF side toilet – roof collapse above

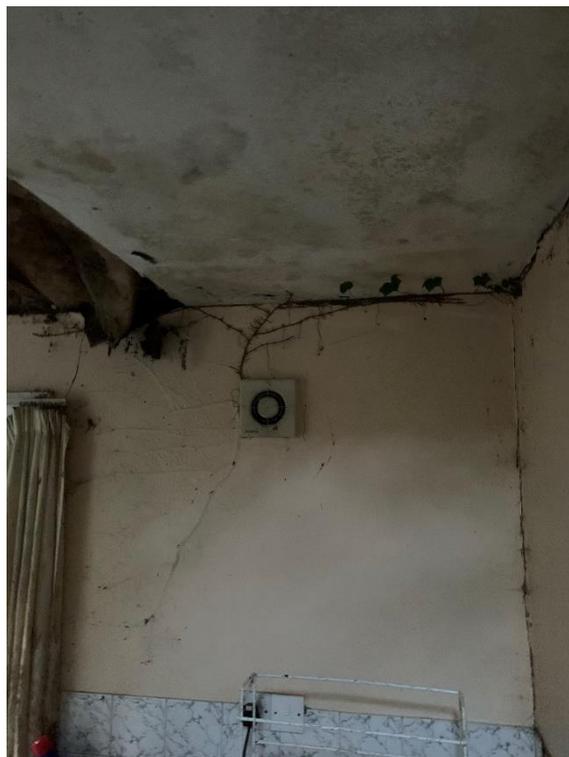
Extensive water damage due to roof collapse – Ivy and general growth internal

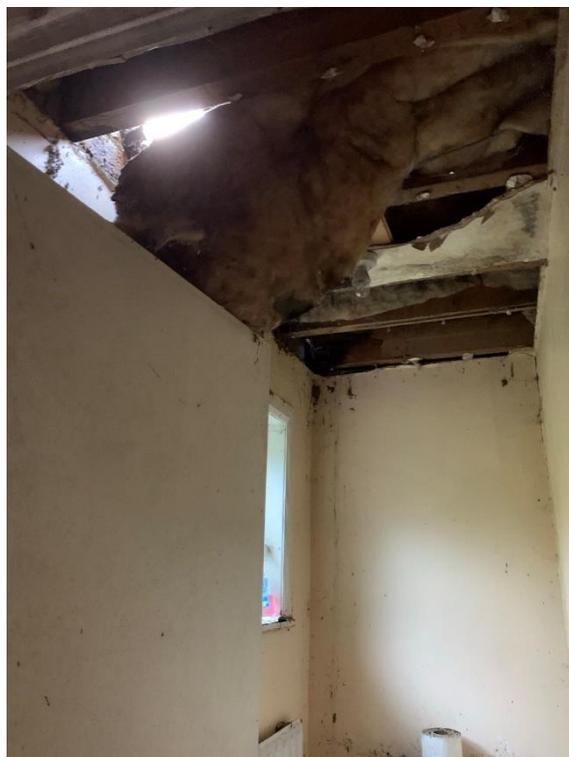
GF toilet roof collapse

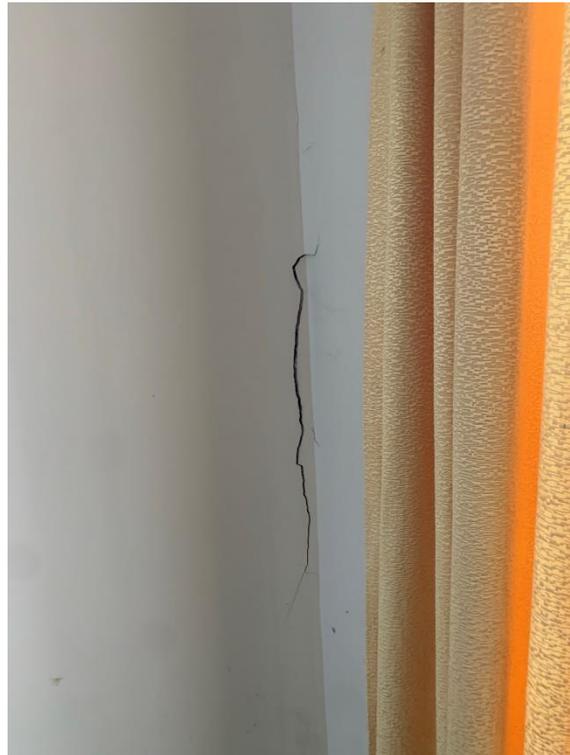
FF cracking to front elevation

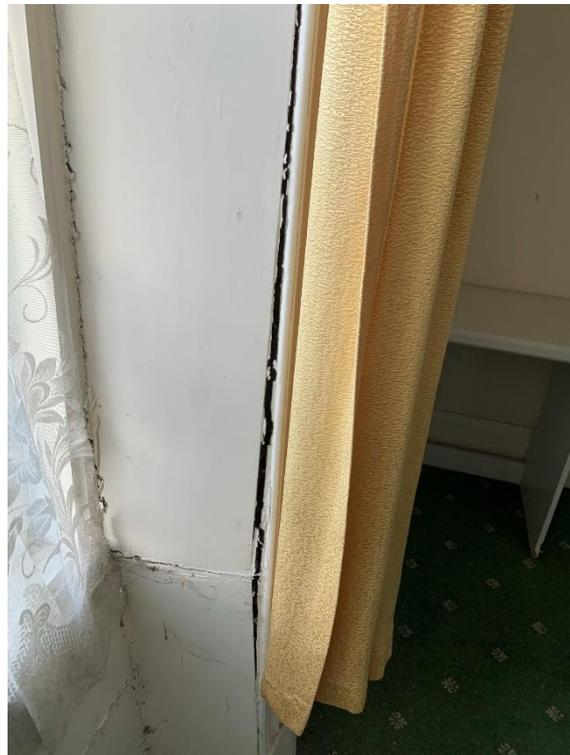
FF cracking and movement to front elevation

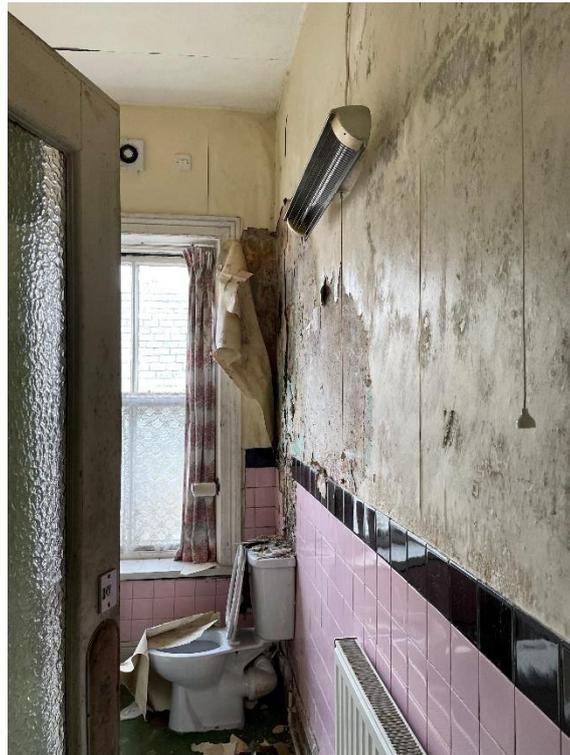
FF toilet damage due to water ingress

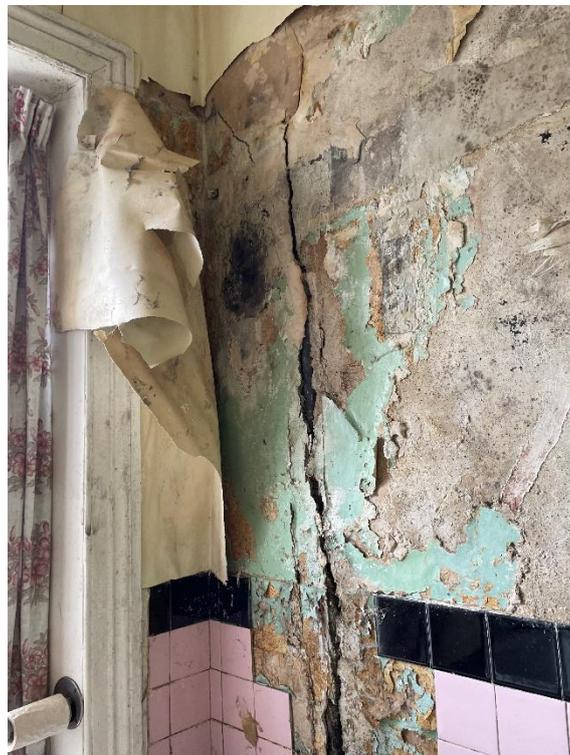
FF toilet damage due to water ingress

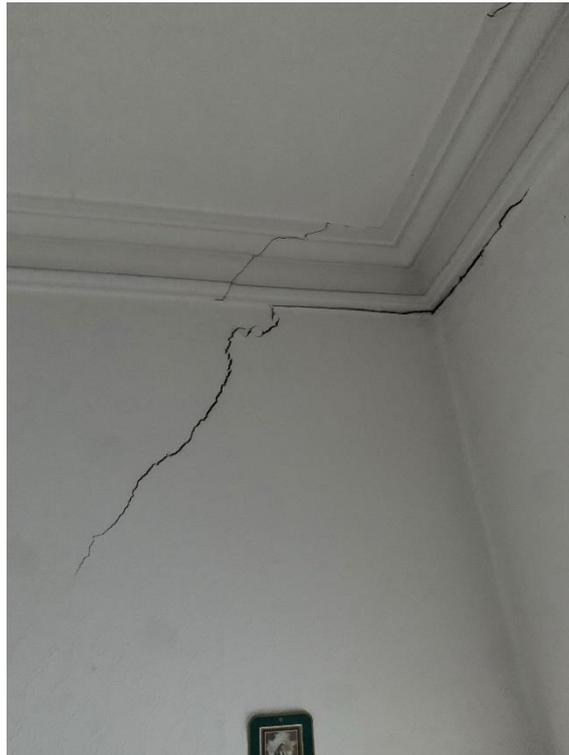
FF cracking and movement to side gable

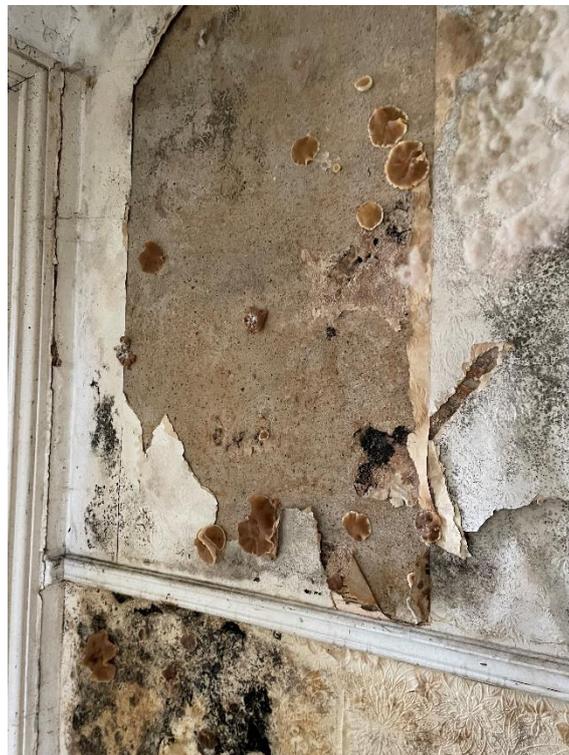
General dampness and water ingress at FF

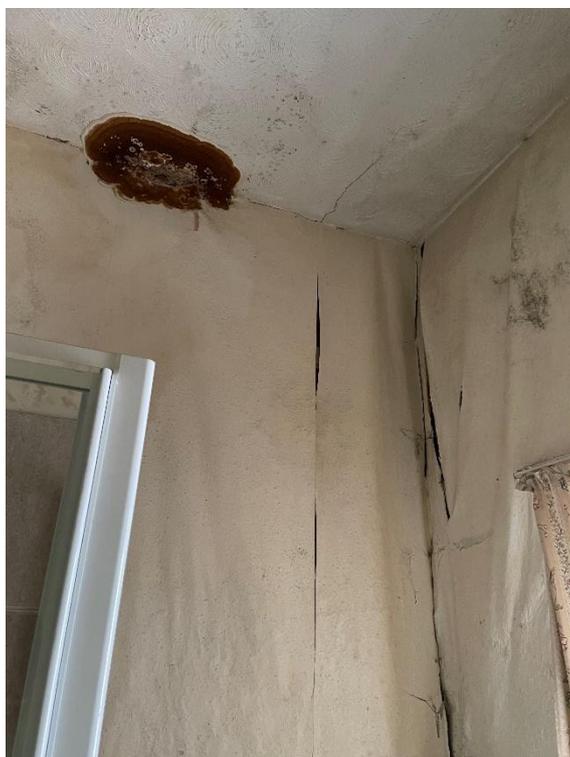
General dampness and water ingress at FF

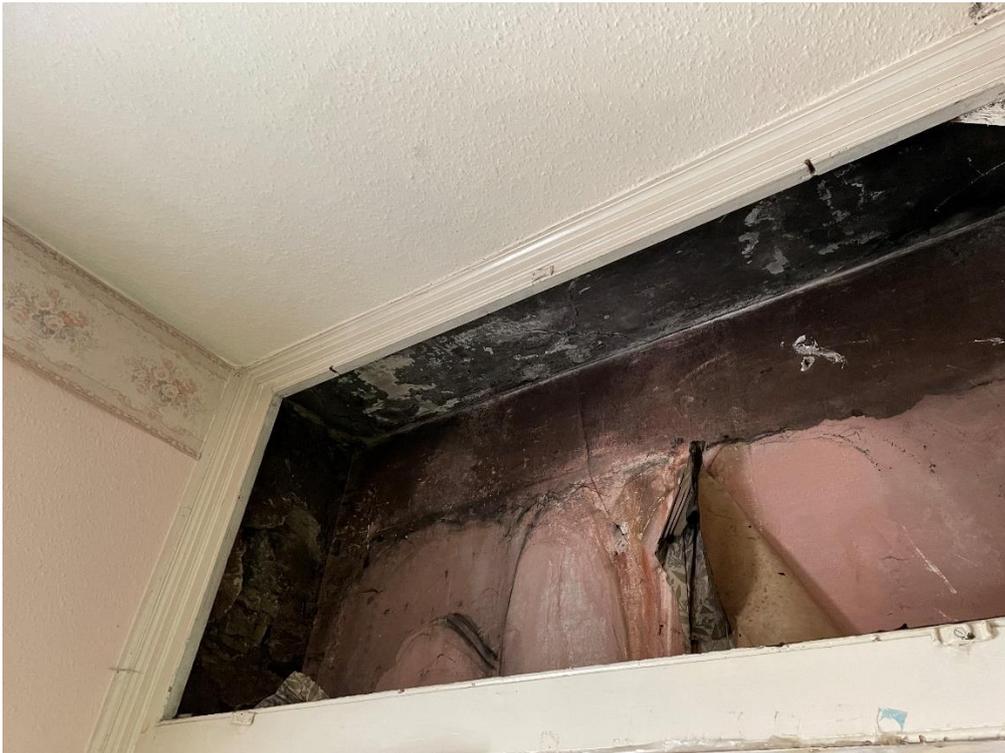
General dampness and water ingress at FF

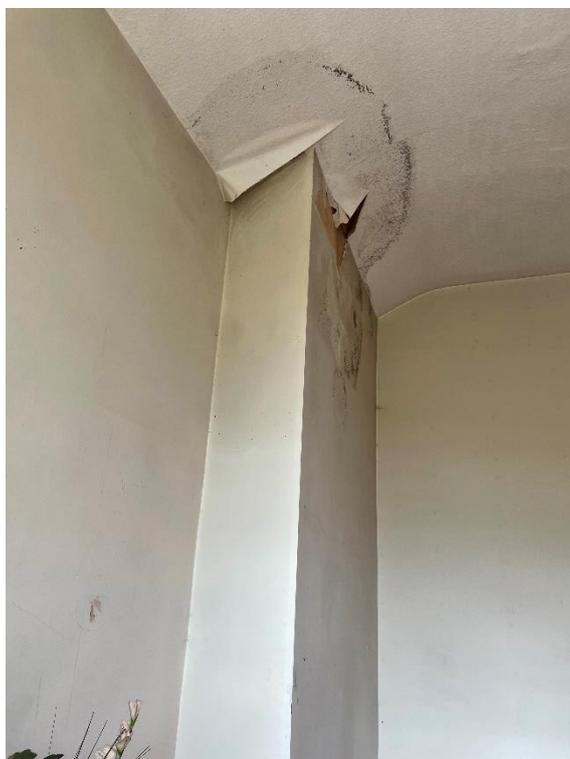
Water ingress around upper chimney

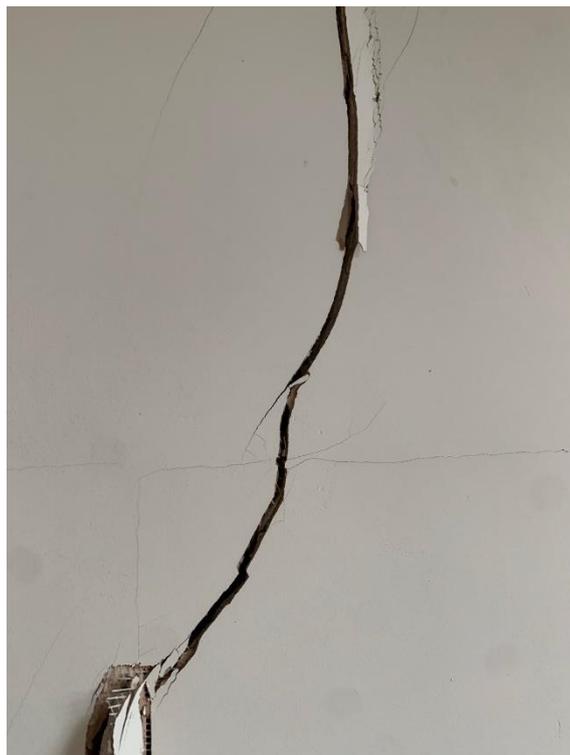
General cracking

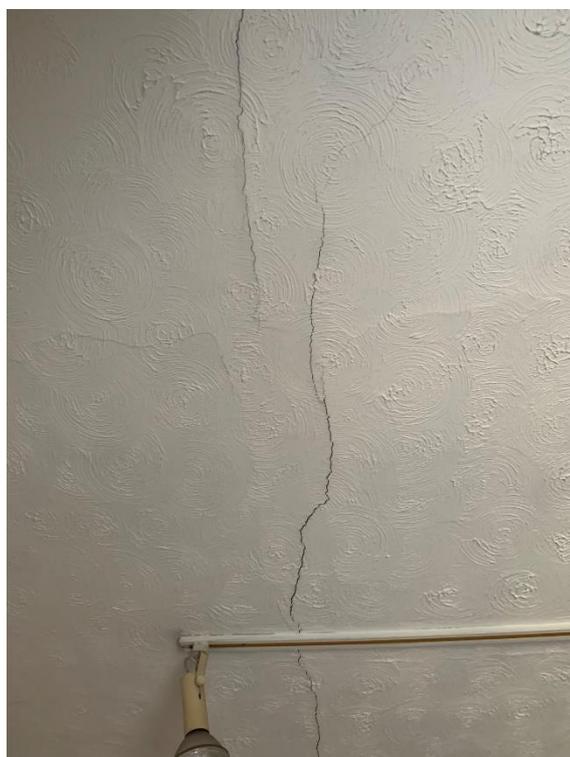
General cracking

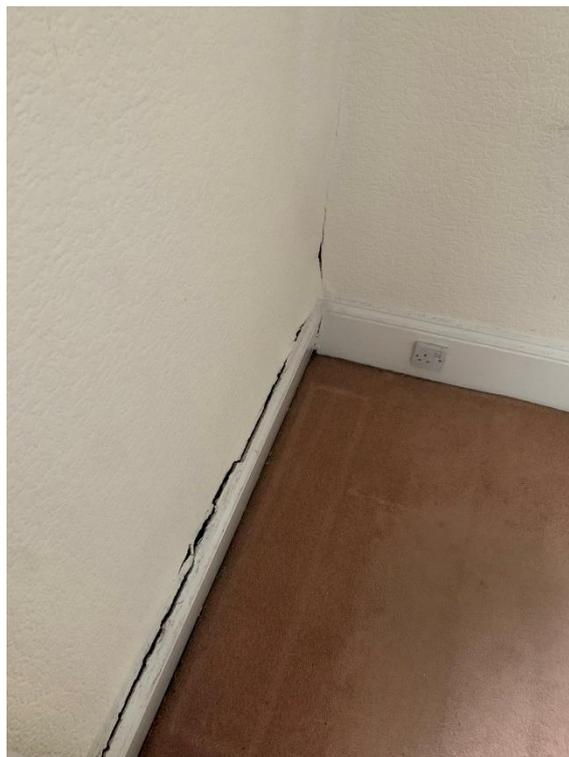
General cracking

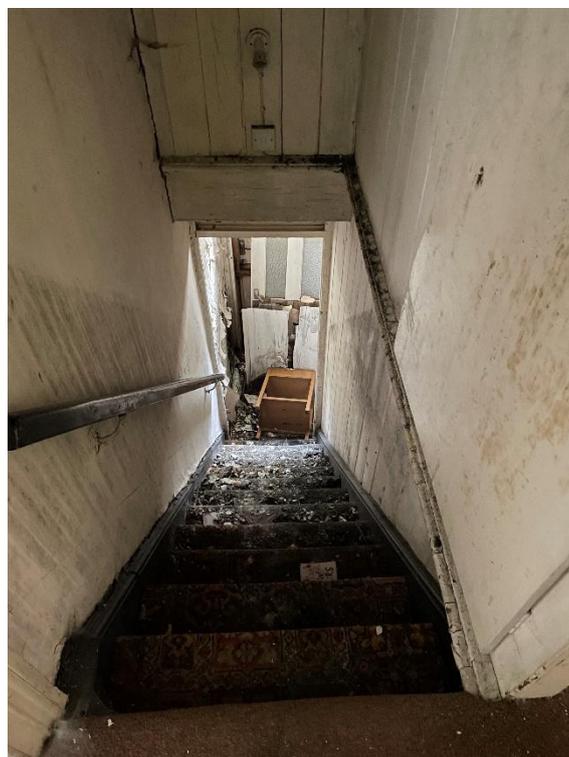
General poor condition of staircase

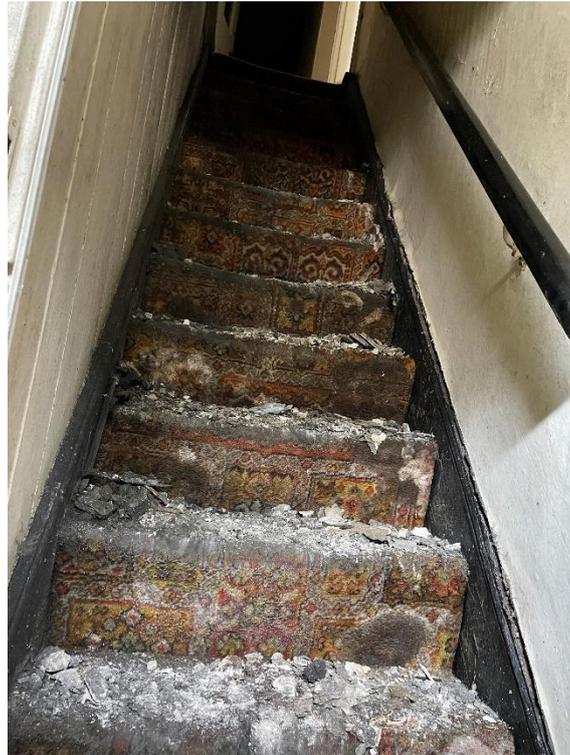
General poor condition of staircase

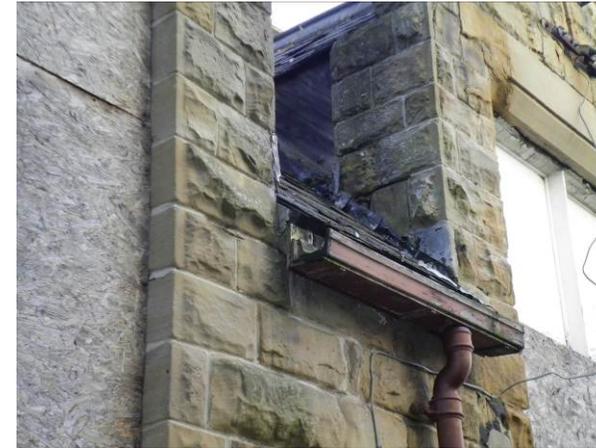
Photo 2
Defective roof and gutter. Missing lead flashings and sheeting to dormer cheek.

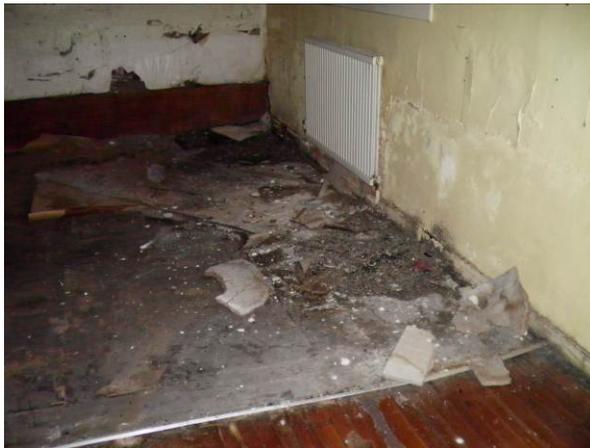
Photo 3
Typical internal view showing damp walls and floors

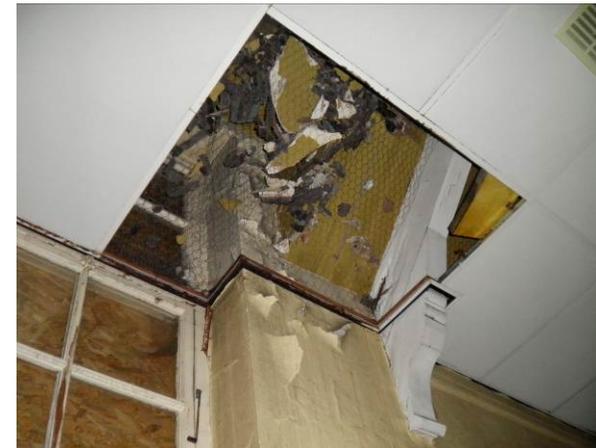
Photo 4
Defective lath and plaster ceiling

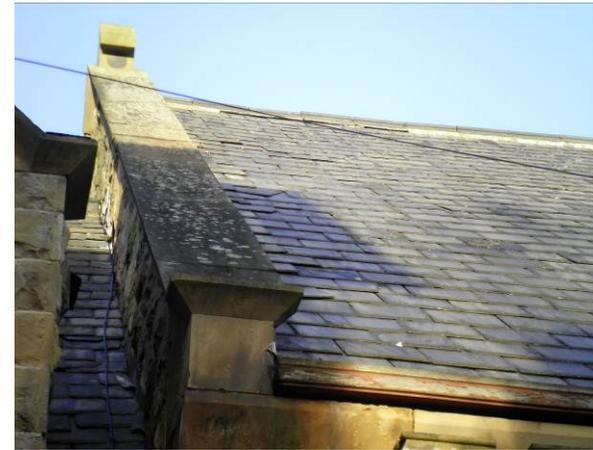
Photo 2
Defective slating to main roof

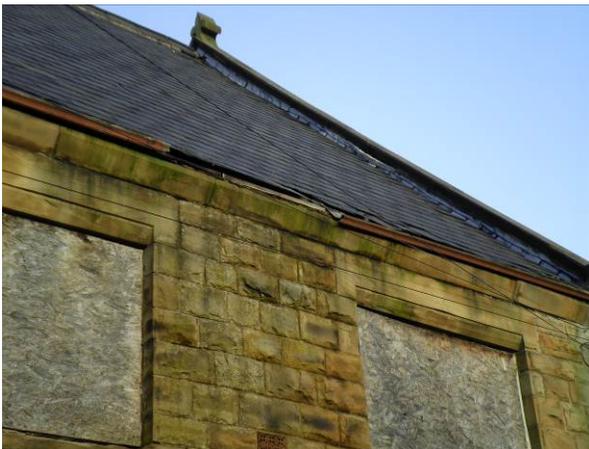
Photo 3
Rotten eaves gutter

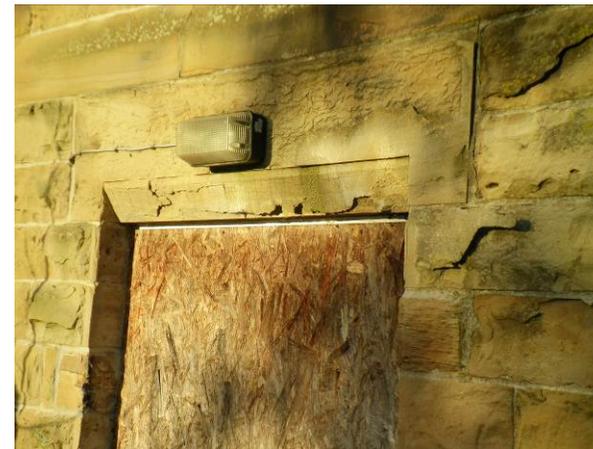
Photo 4
Typical cracking and delaminating stonework

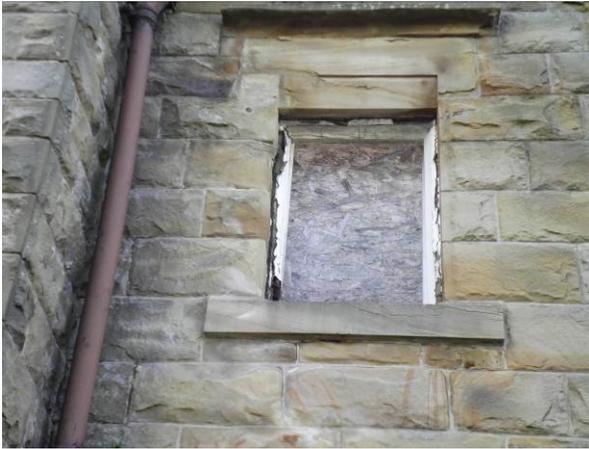
Photo 5
Typical example of rotten window frame

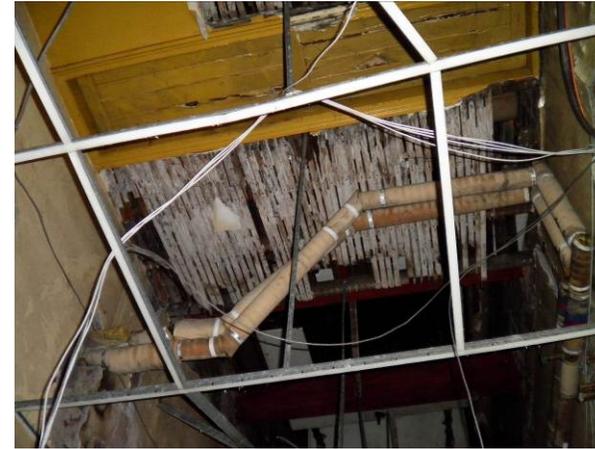
Photo 6
Defective ceilings

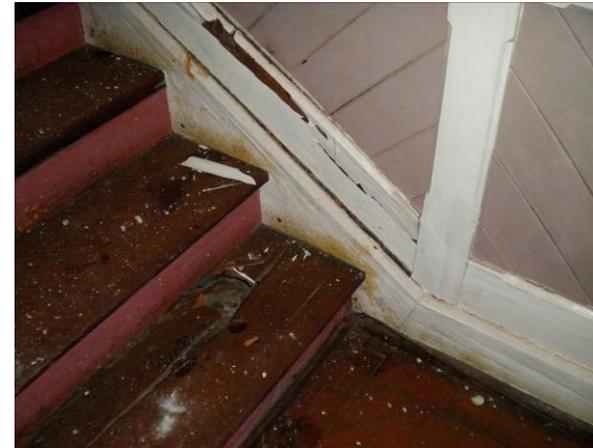
Photo 12
Dry rot to stairs
