26 May 2023
BC.HUD.2016.00001.005/02

**St Mary's Convent (Nunnery), Batley
Condition Review Update 2023**

Condition Statement in Support of Listed Building and Conservation Area Consent St Mary's (Old) Catholic Primary School, Batley

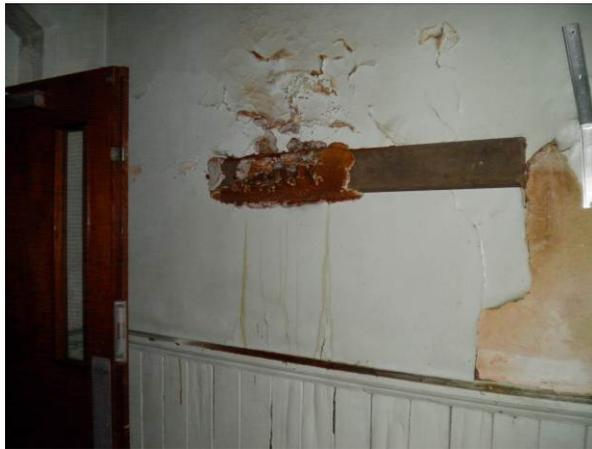
Photo 13
Active dry rot to wall panelling and skirting

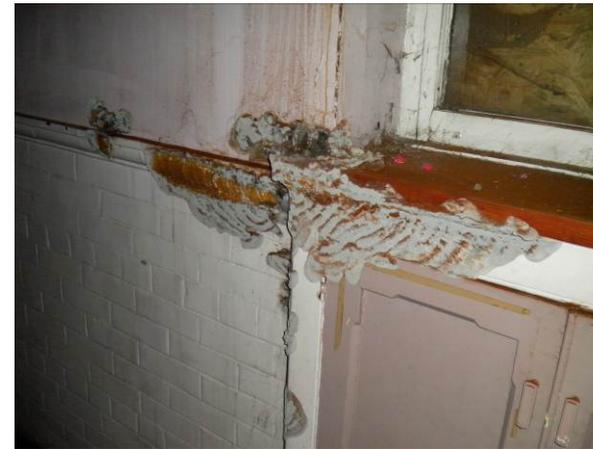
Photo 14
Dry rot to window reveal, cill and built in cupboard

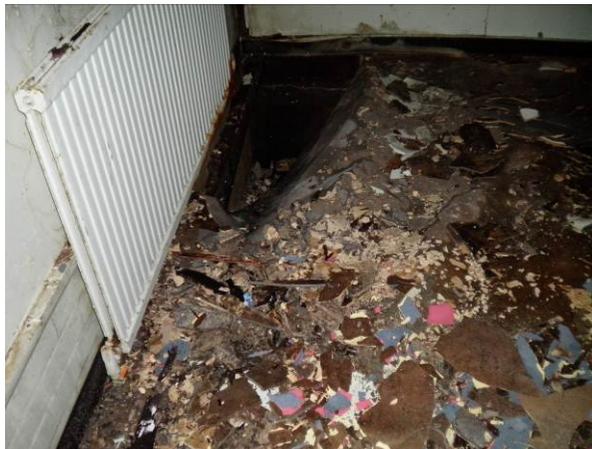
Photo 15
Rotten and collapsed floor

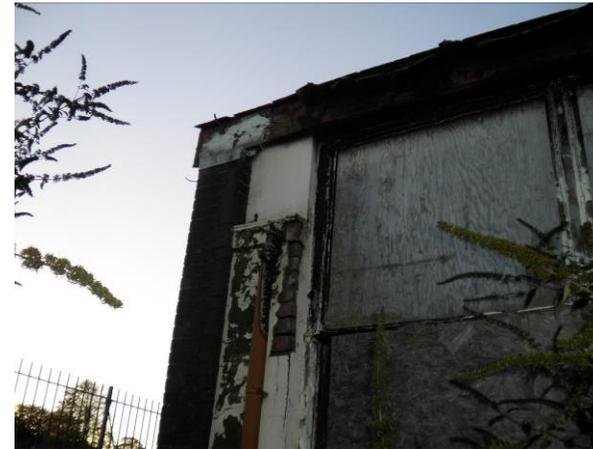
Photo 2
Fire damaged window frame, fascia, melted rainwater goods etc

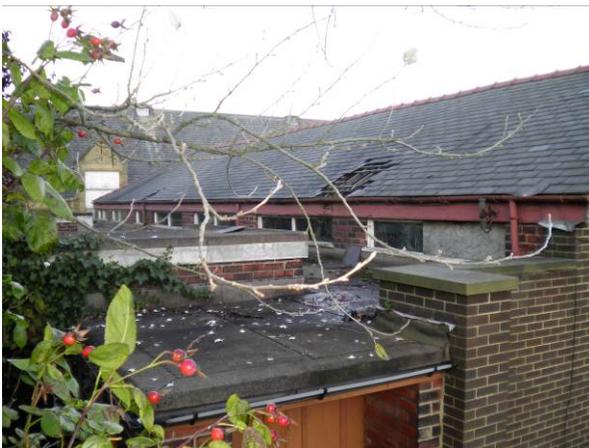
Photo 3
Overall view of defective pitched and flat roofs

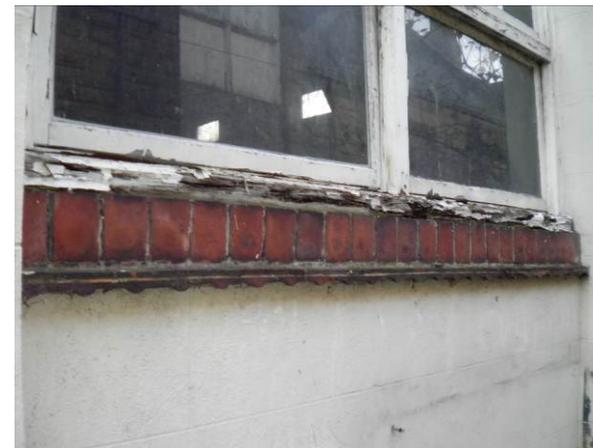
Photo 4
Typical rotten window frame

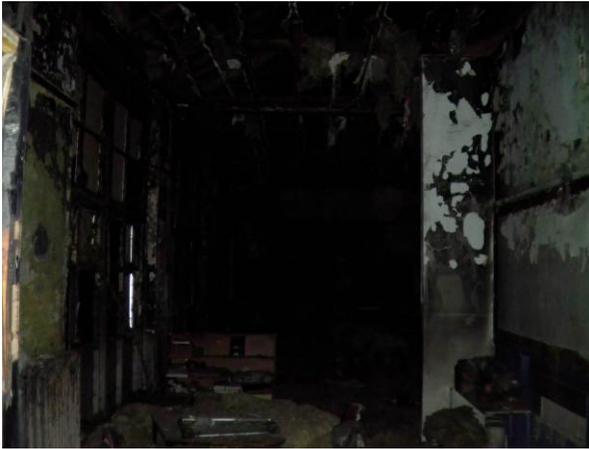
Photo 5
Overall view of main fire damaged rooms

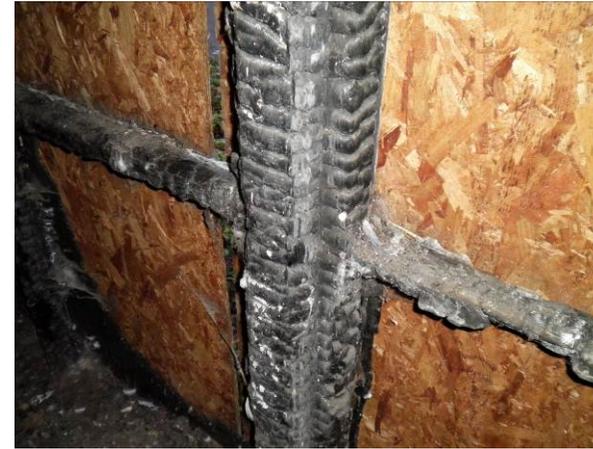
Photo 6
Typical fire damage to external timber framing

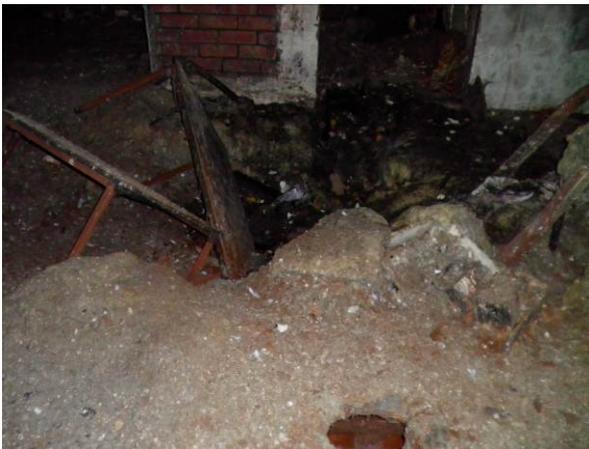
Photo 7
Collapsed floor to central main room

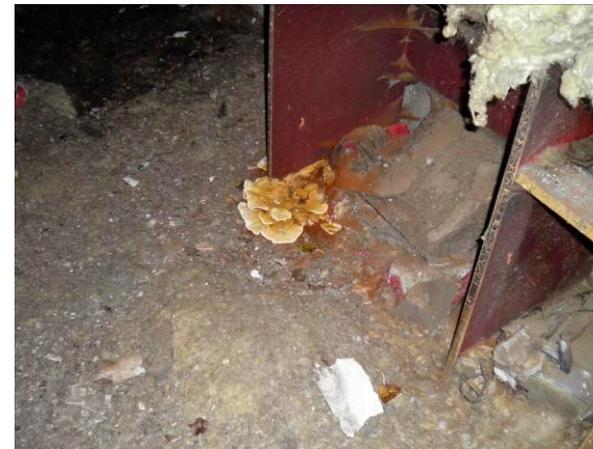
Photo 8
Active dry rot to floor/internal joinery

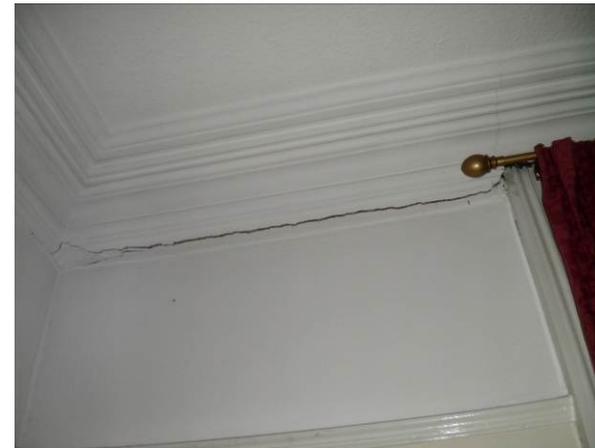
Photo 4
Typical internal cracking

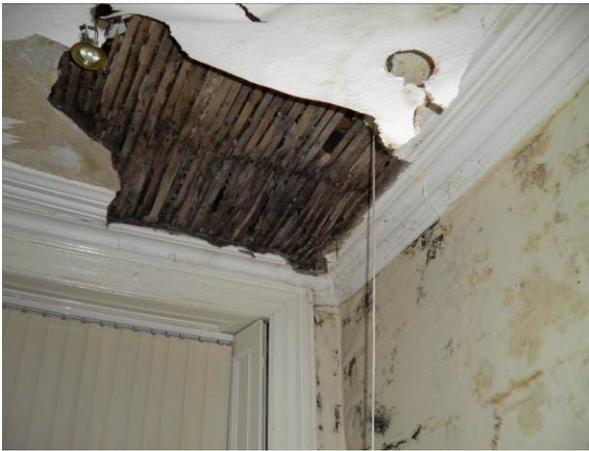
Photo 5
Damaged ceiling and water ingress to 1st floor

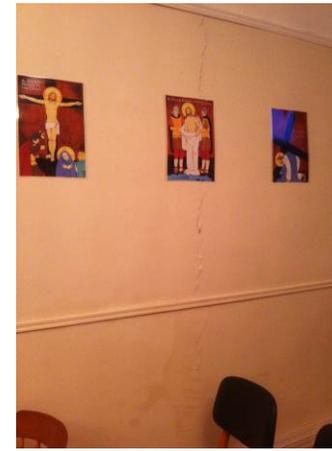
Photo 6
Structural cracking to ground floor
