# GEOSHIELD Verification Report

GEO102848

Galiford Try Building

Gas membrane to specification BS8485 2015

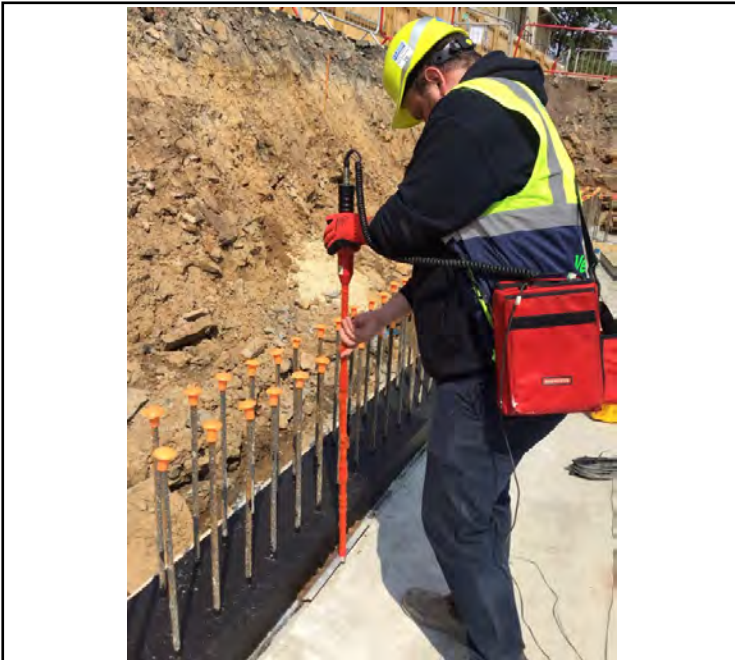
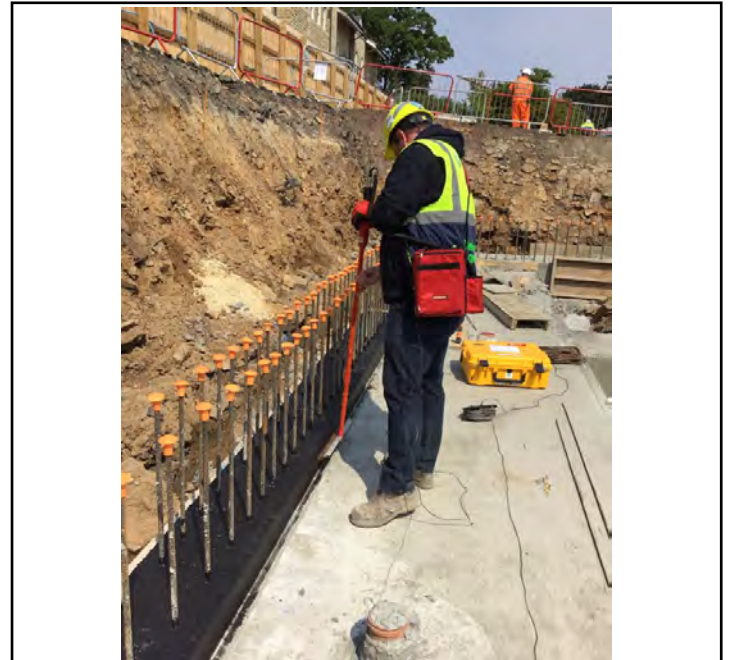
A visual inspection was first carried out to make sure a good coverage had been achieved and no water was on the wall. The dielectric test was then carried out on the retaining wall kicker. Some small pinholes were found during the testing, indicated by

the machine beeping, some were then picked up visually. Where they were not visible a larger area was then remediated.

Above shows the remediation of a larger area. All areas indicated by the dielectric machine were remediated on site.

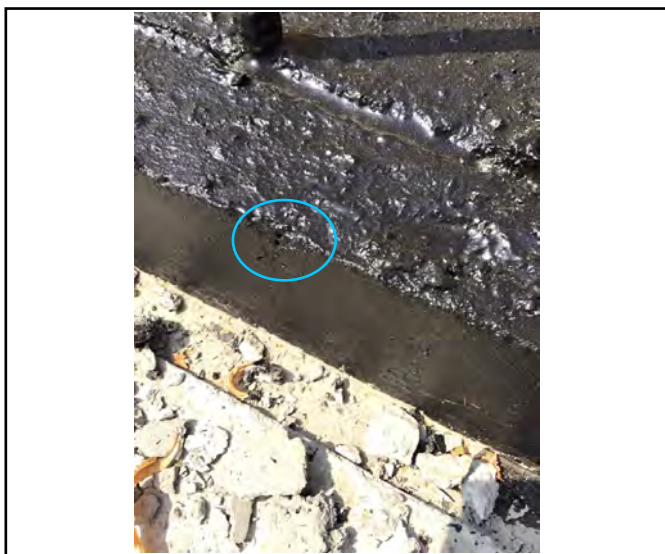
Pinholes found

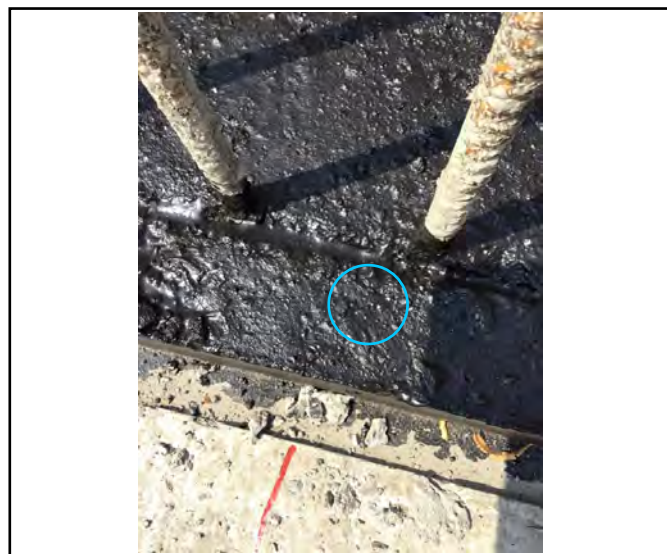
Pinholes found

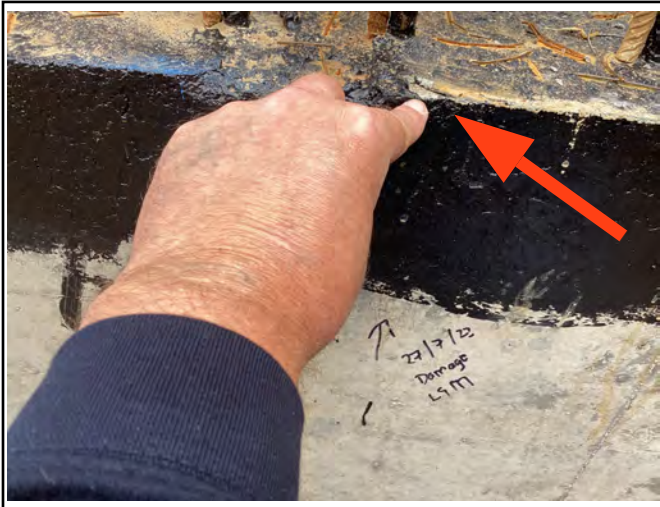
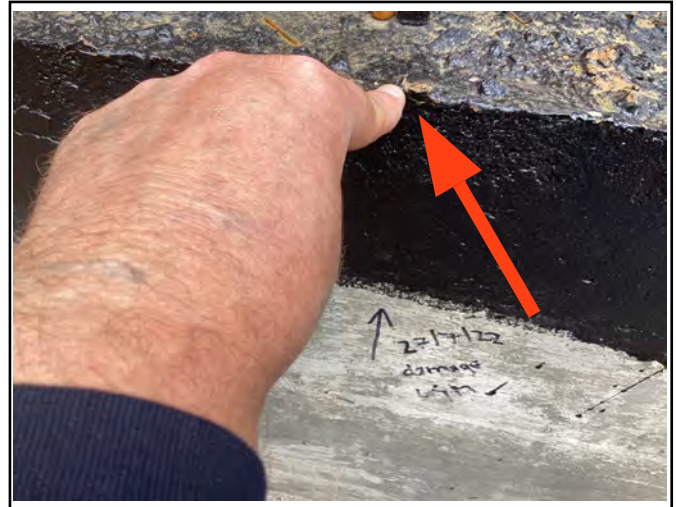
NOTES: Damage to Liquid Gas Membrane

Photos showing where follow on trades had inadvertently damaged the previously applied Liquid Gas Membrane (Report 001)

These areas were remediated during this verification visit and can be seen in the additional reports section this report. A further check will be completed at the next verification visit.

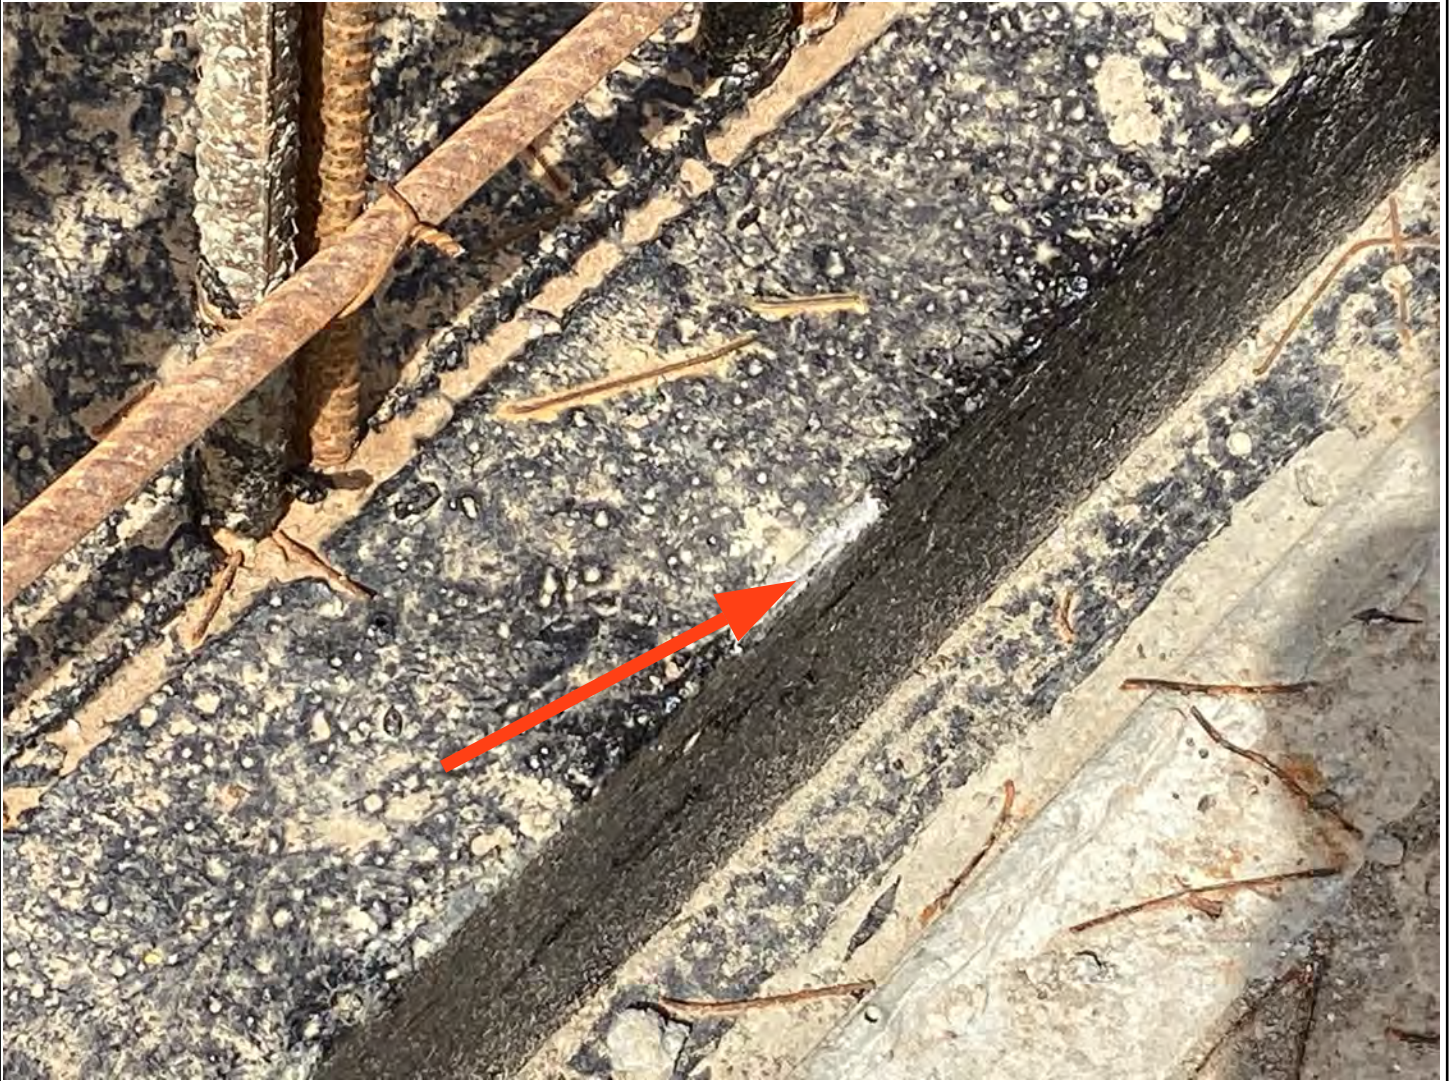
Overview of a further area of damage to the previously applied Liquid Gas Membrane and again this was in the process of being remediated during this verification visit but checked once again during the next visit.

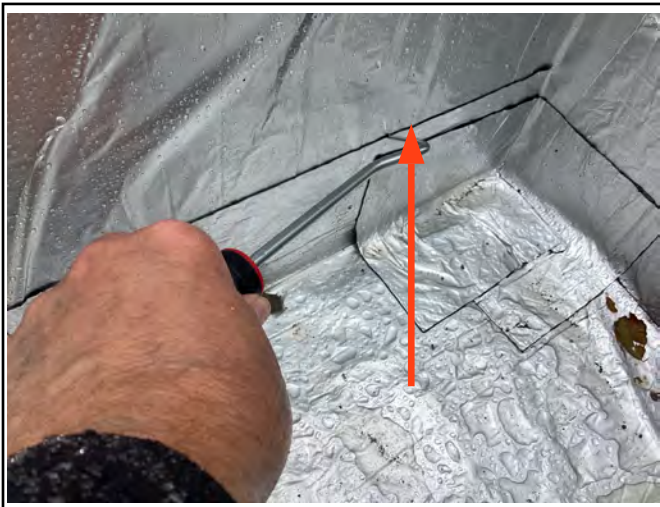
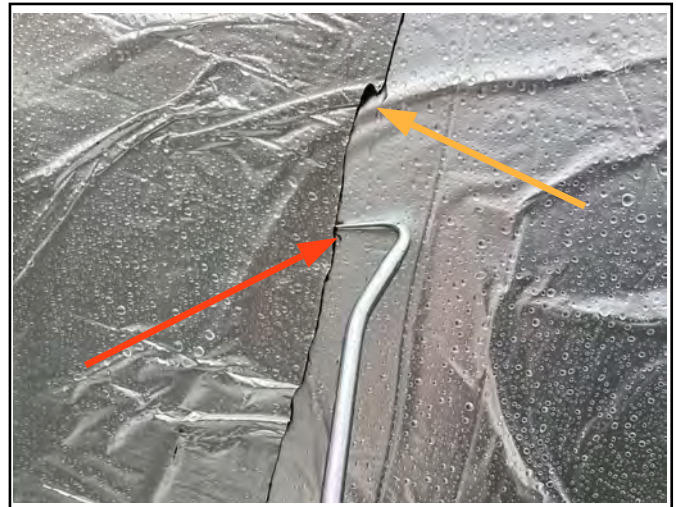
Photos showing the Mechanical Stress Point Test being undertaken as indicated with the red arrows. All available lap joints were checked ensuring there were fully sealed.

There were a couple of areas where there was creasing to the Visqueen Gas Resistant Self-Adhesive Membrane during application. The crease indicated with the yellow arrow was a potential capillary leak but upon further investigation, there was no risk of ground gas entering at this point. The crease was pressed flat during this visit.

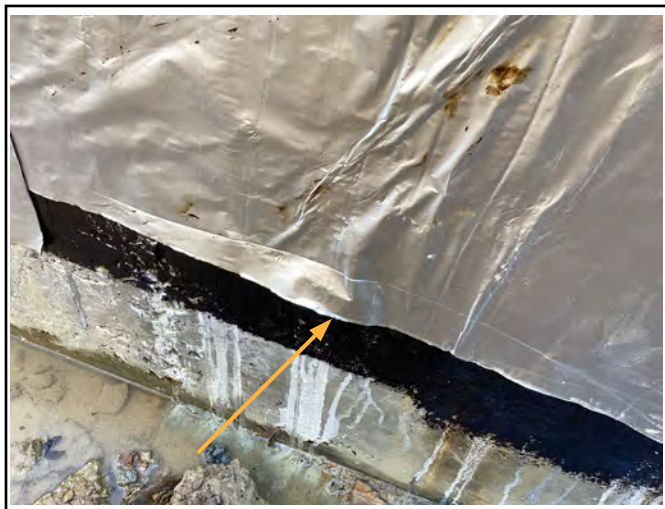
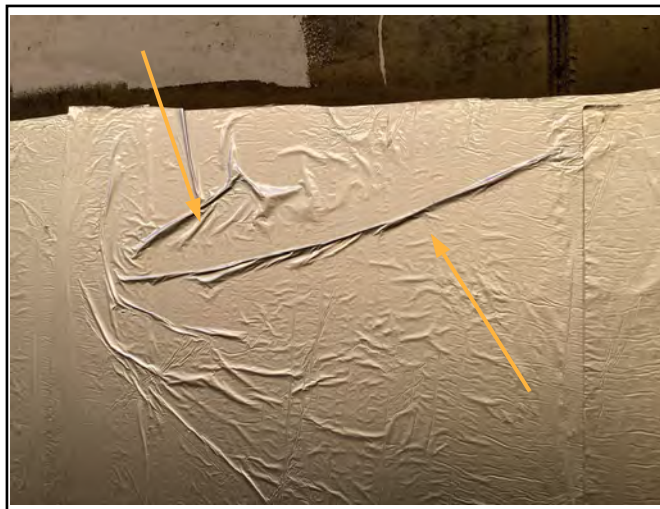
There were a couple of areas where there was creasing to the Visqueen Gas Resistant Self-Adhesive Membrane during application. The crease indicated with the yellow arrow was a potential capillary leak but upon further investigation, there was no risk

of ground gas entering at this point. The crease was pressed flat during this visit.

Shanco were informed that more care should be taken when installing the Gas

properly as these areas are susceptible to damage.

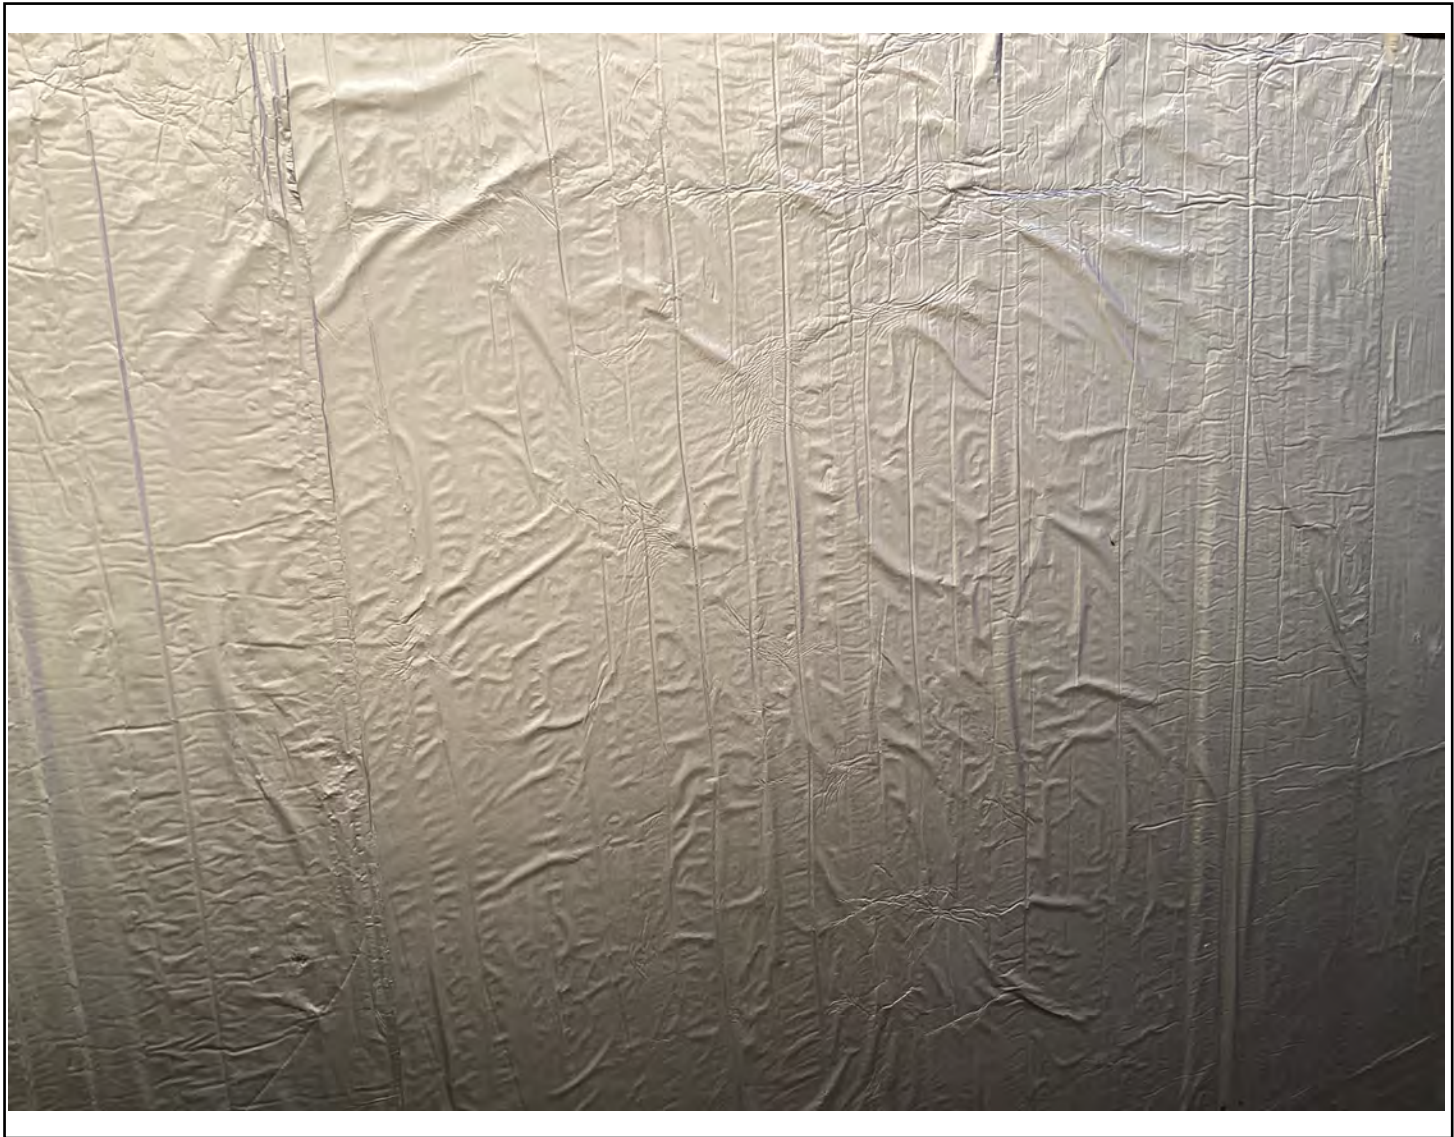
Overview of an area of the applied Visqueen Gas Resistant Self Adhesive Membrane adhered to the Retaining Wall. Note the various creases which are a possible source of puncture from follow on trades. The creases are to be avoided where possible.

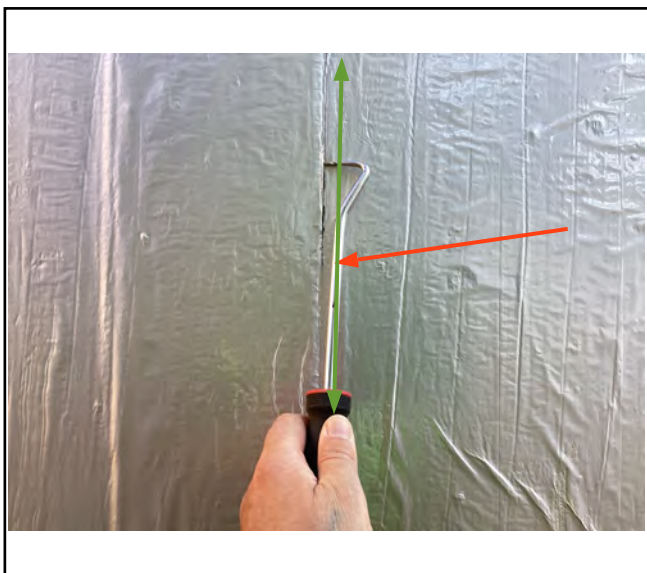
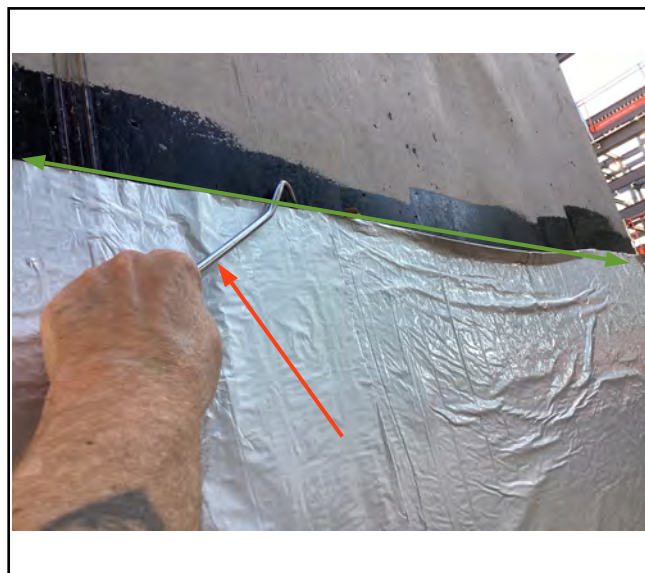
The Visqueen Gas Resistant Self Adhesive Membrane must be lapped a minimum of 100mm. The lap joints were both measured to determine the lap widths and also checked for potential capillary leaks. All lap joints were a minimum of 100mm wide

and following the completion of the Mechanical Point Stress Test (red arrow) along along the edges of the lap joints ( green arrow), no faults were identified during verification.

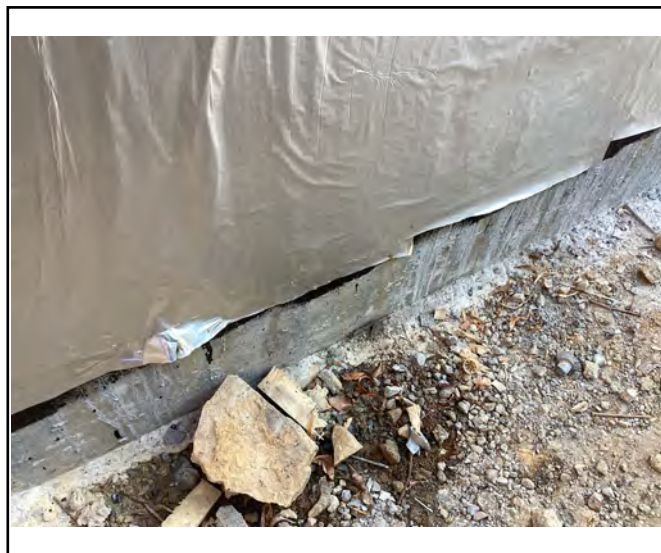
Loose edges of GRSAM remediated  
during verification visit

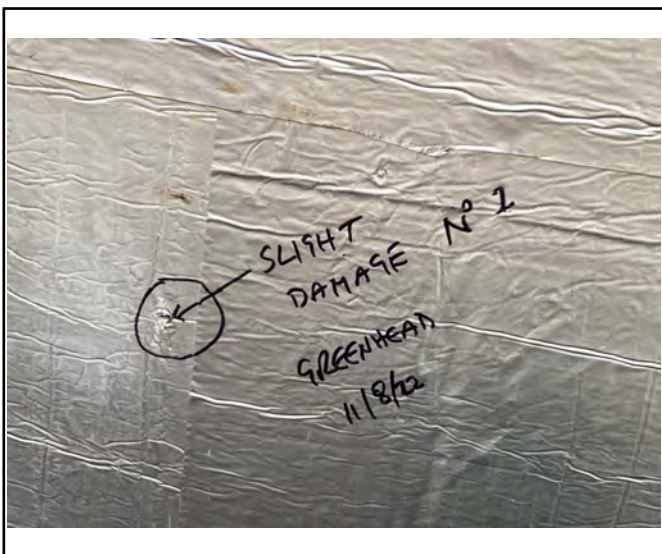
Small area of damage (1) to GRSAM  
requiring remediation

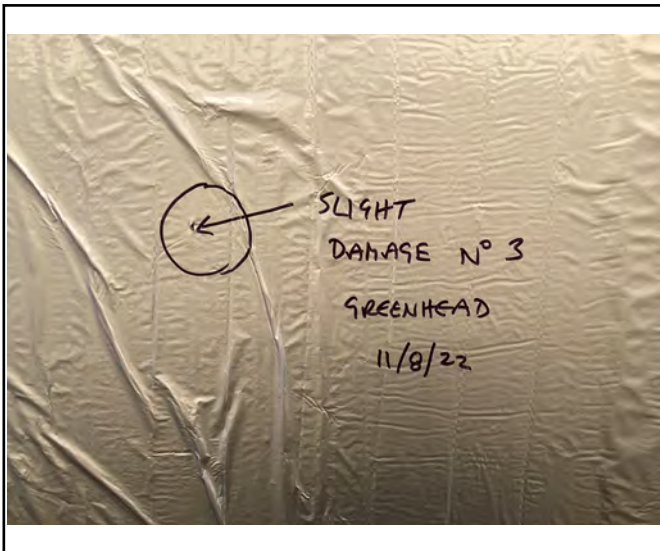
Small area of damage (3) to GRSAM

requiring remediation

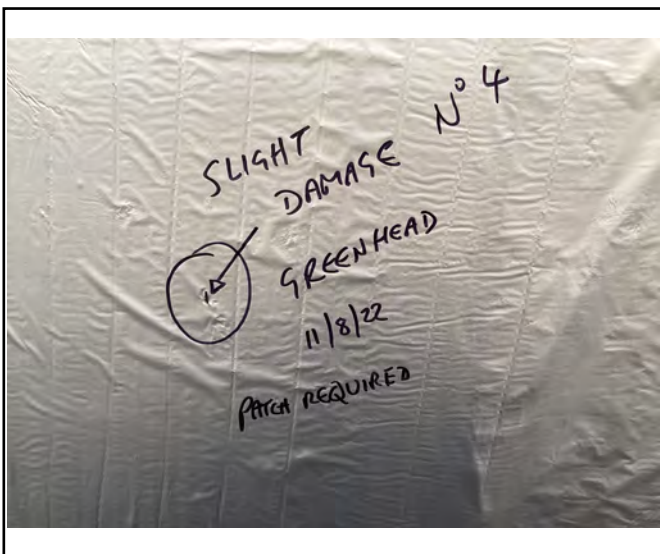
Small area of damage (4) to GRSAM

requiring remediation

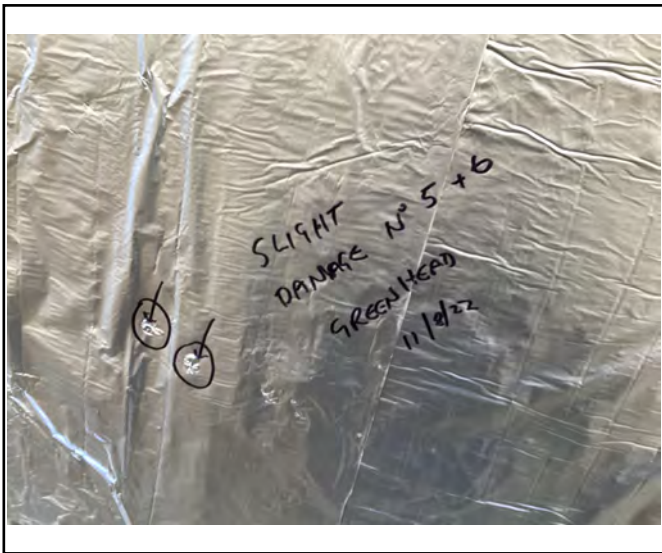
Small area of damage (5 & 6) to

GRSAM requiring remediation

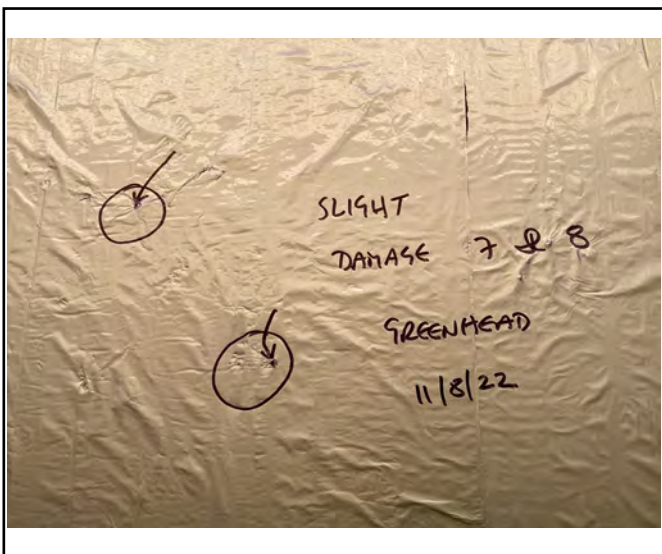
Small area of damage (7 & 8) to

GRSAM requiring remediation

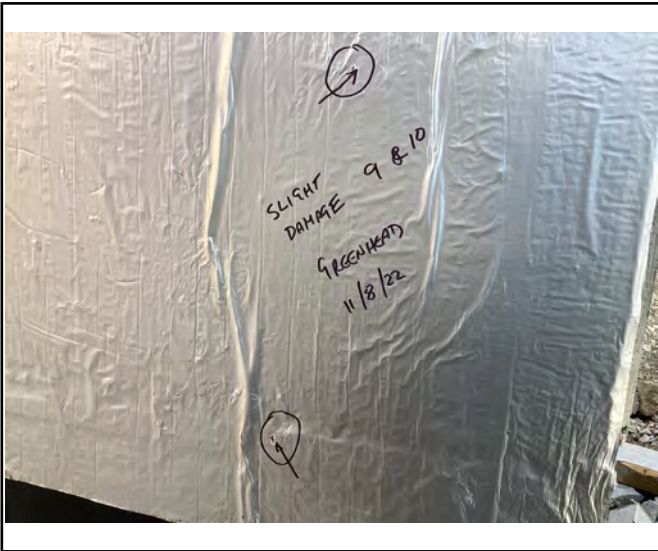
Small area of damage (9 & 10) to

GRSAM requiring remediation

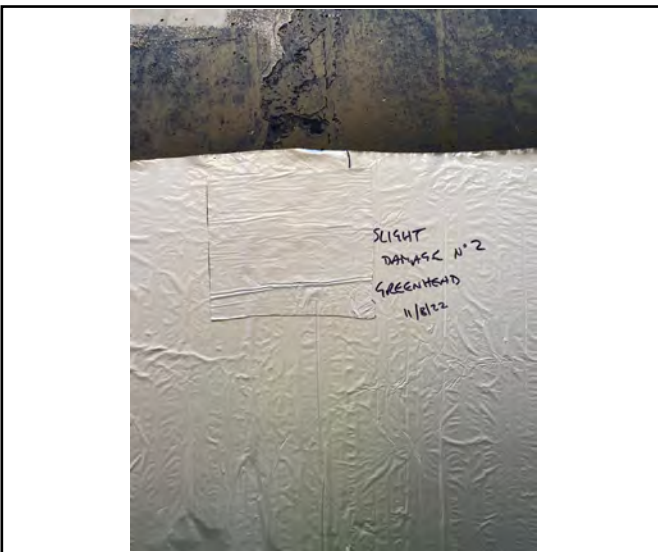
Small area of damage (2) to GRSAM

remediated and fully sealed.

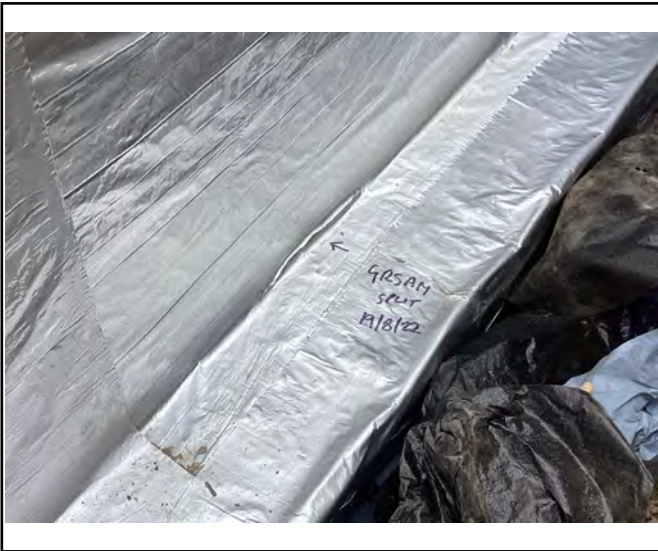
Area of damage (1) where the

GRSAM has split requiring a repair
