GEOSHIELD Verification Report

PROJECT REFERENCE: GEO102848

REPORT NUMBER: 010 REPORT DATE: 22/09/2022

PROJECT: Galiford Try Building

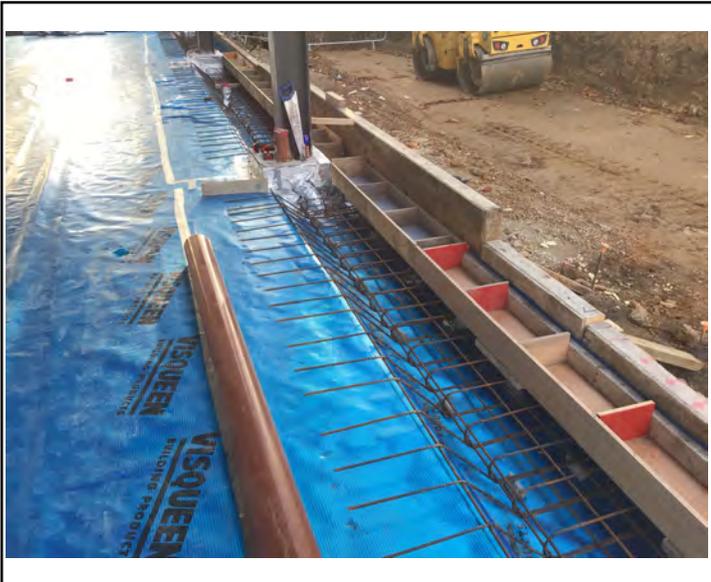
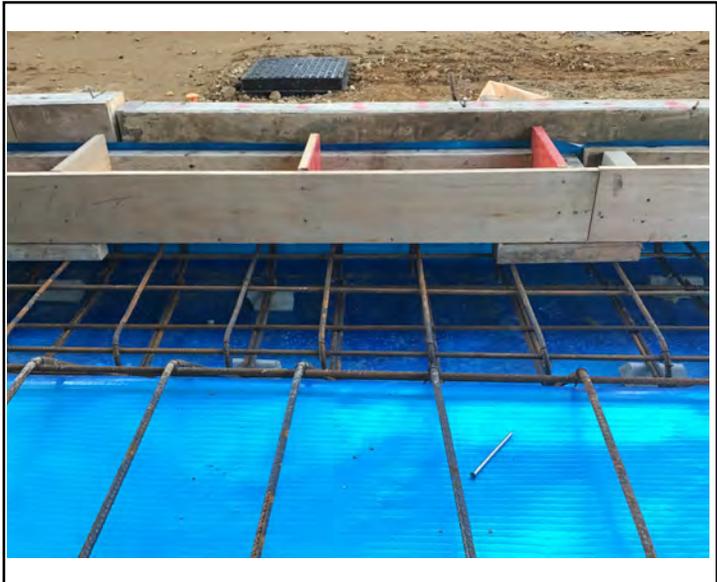
RESTRICTIONS AND LIMITATIONS: Steel work had started to be installed

This restricts our ability to verify the Visqueen GB under the installed steel

Images above show installed steel work and ply shuttering

These areas can still be visually inspected for punctures, however the seams

Cannot be exposed as easily

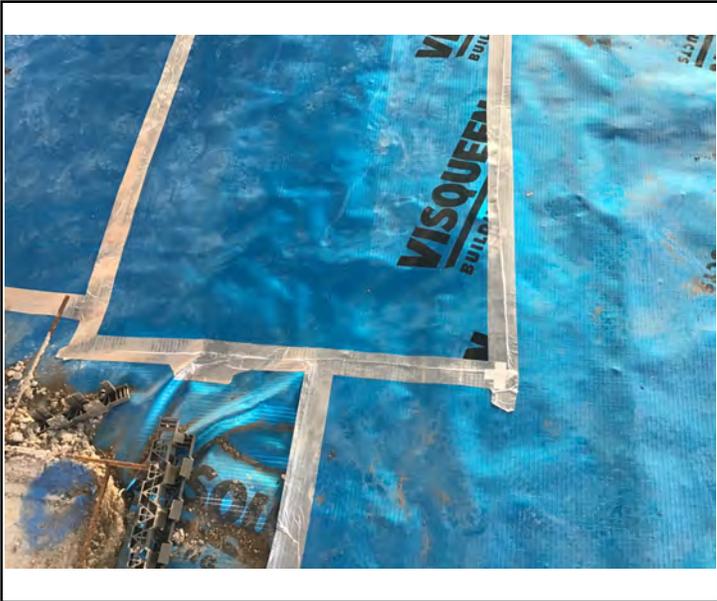
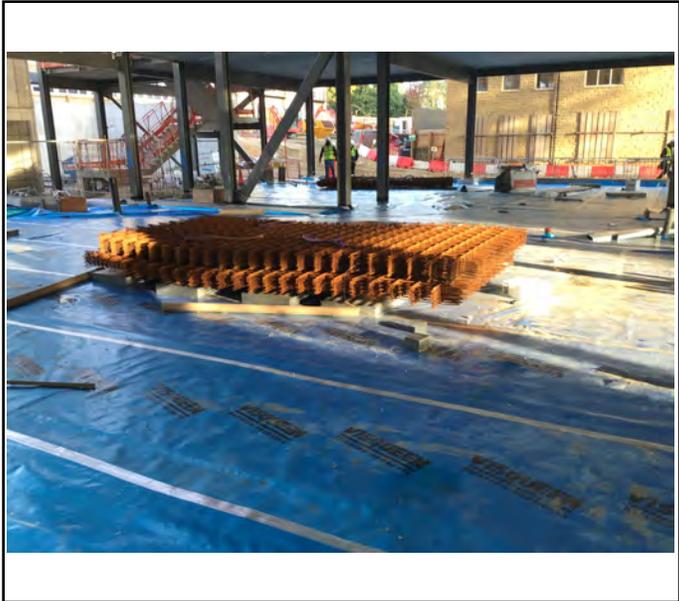
The foil taped seams restrict the ability to verify the adherence of the butyl tape

Materials stored on top of the Visqueen GB membrane limit the available areas

For inspection

The steel has however been stored on top of insulation to protect the membrane

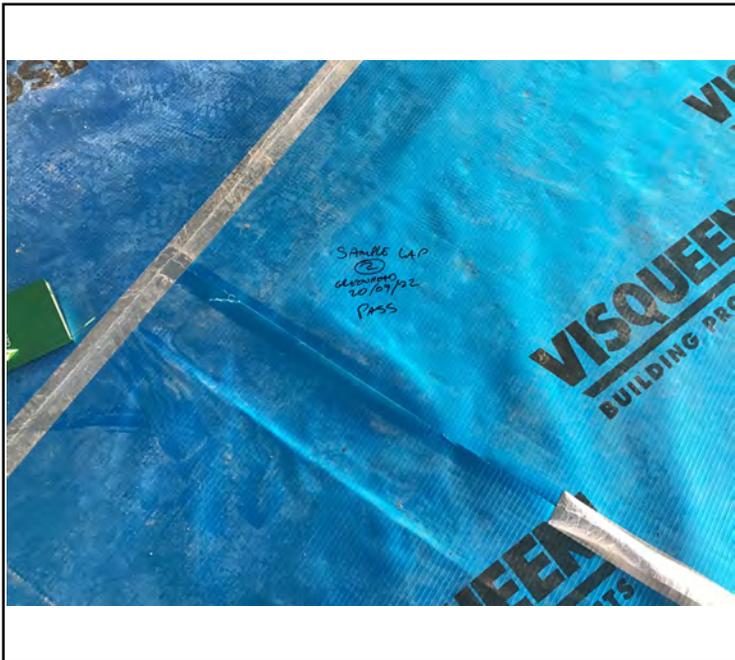
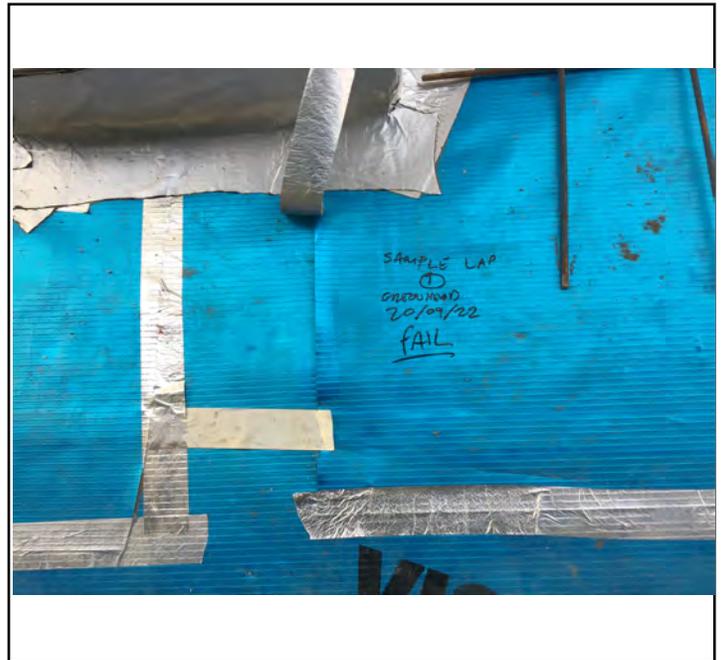
As the seams had been protected using the foil tape various sections were exposed

This was followed by a Mechanical Point Stress Test (MPST) to check that the Visqueen

Double sided Butyl tape had adhered correctly to form a bonded seam

The images above show two areas where the MPST had been undertaken.

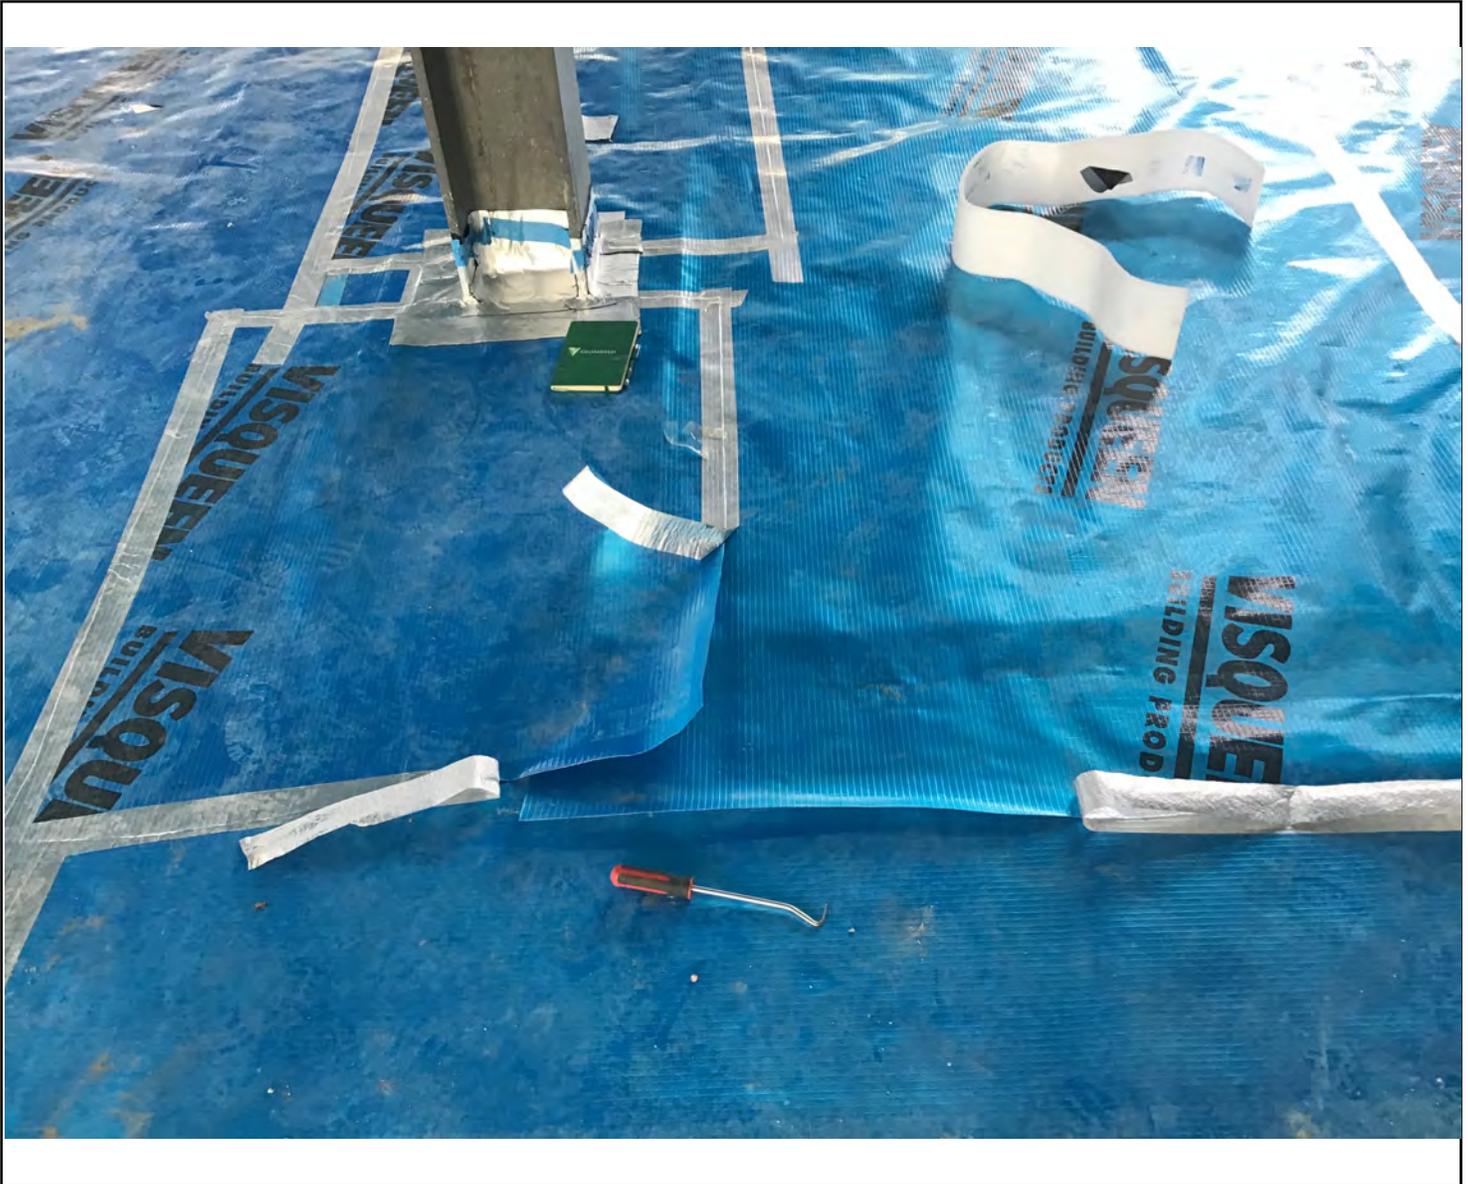
Another image of exposed seams to conduct an MPST

In total 9 seams were exposed for inspection with 6 of them requiring remediation

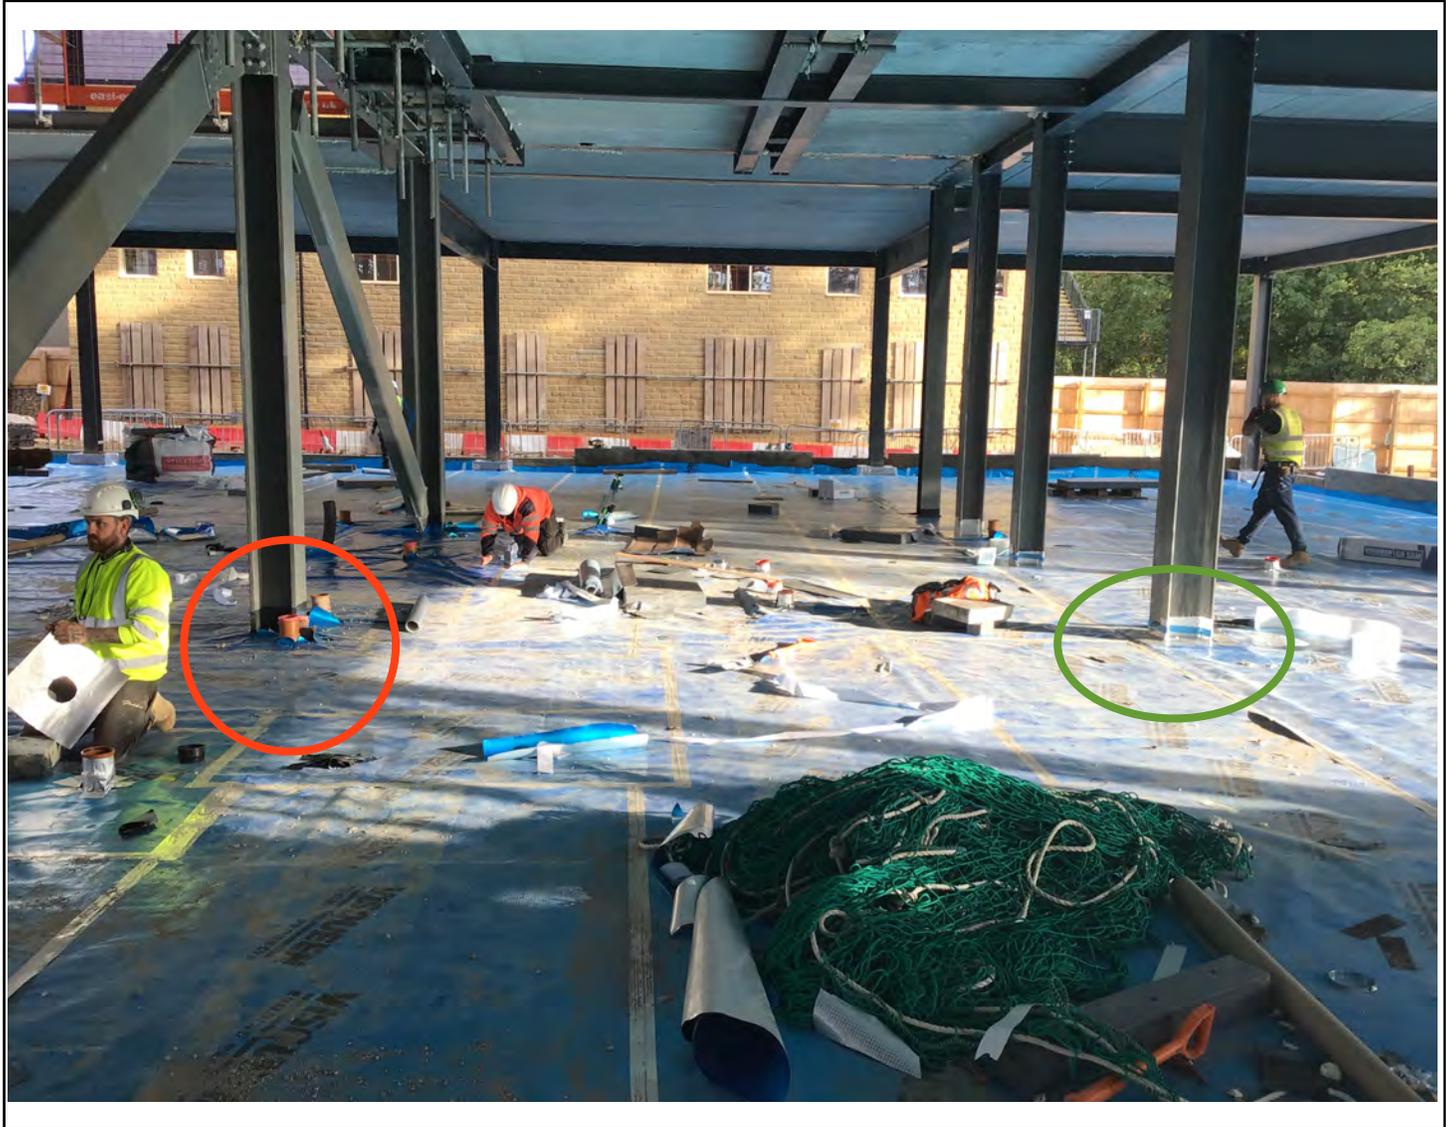
Overview of site with completed and incomplete Stanchion / pipe penetrations

The completed stanchion is circled in green while the incomplete penetration is

In red

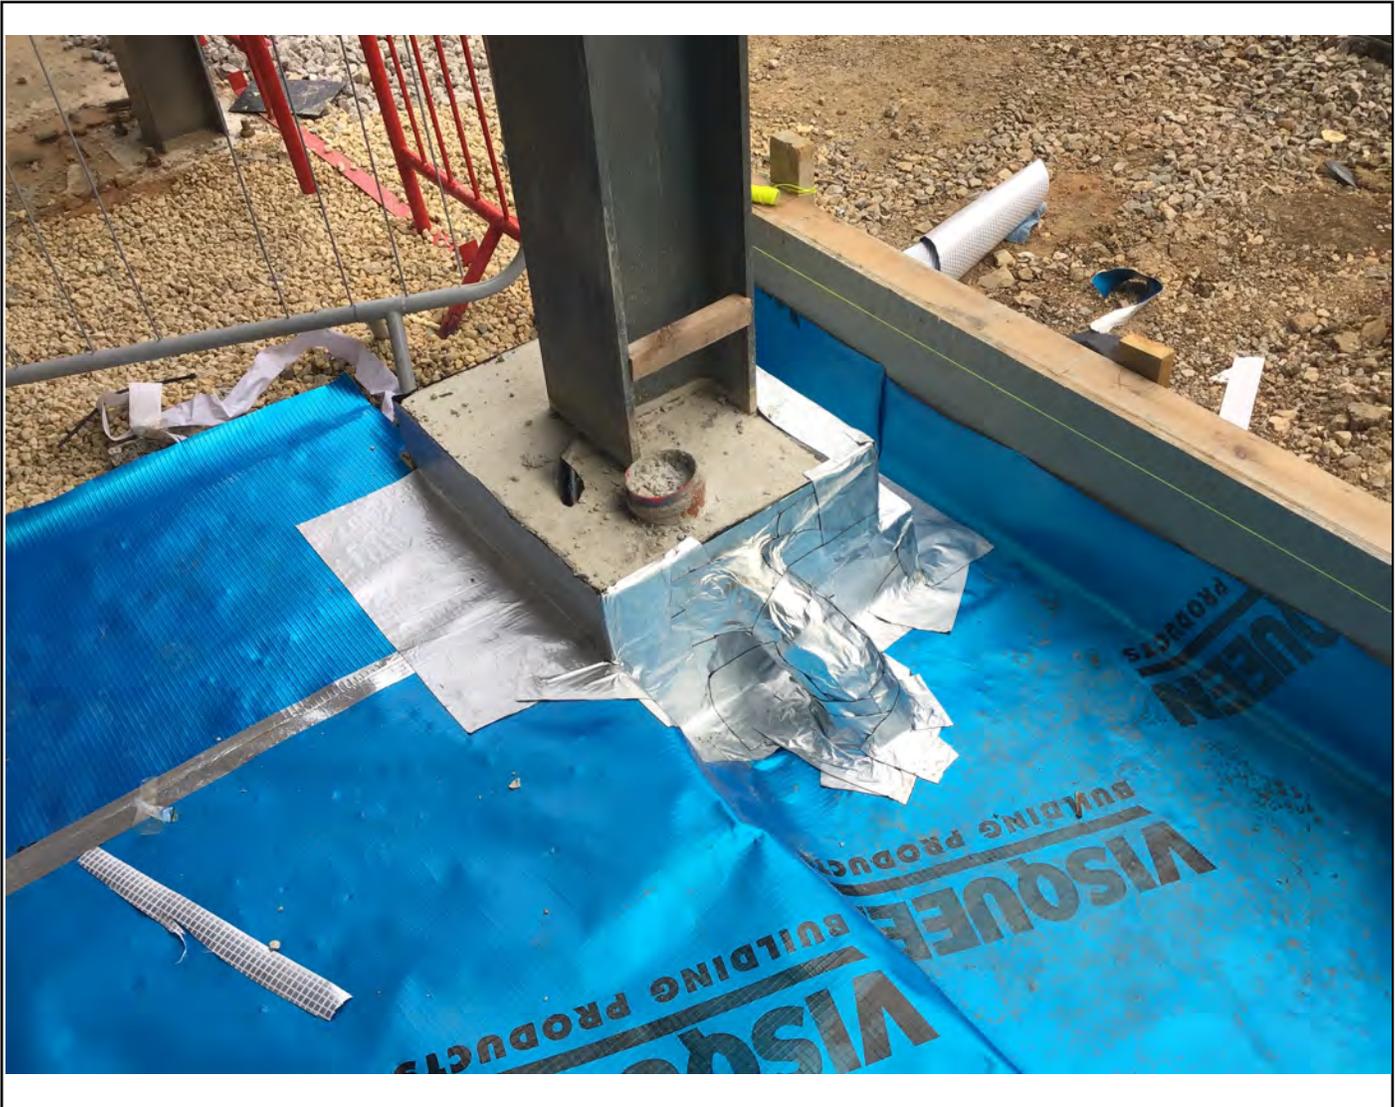
An overview of the sealed stanchion base.

These have been sealed according to the design detail

In accordance with BS8485:2019

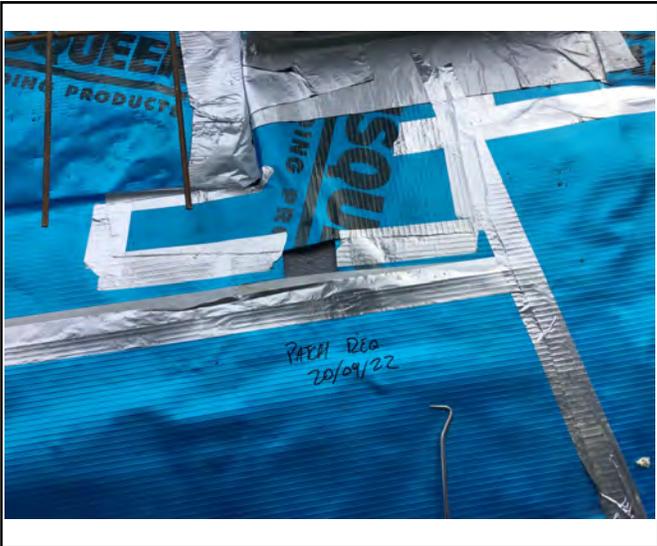
Remediation required

Missing membrane

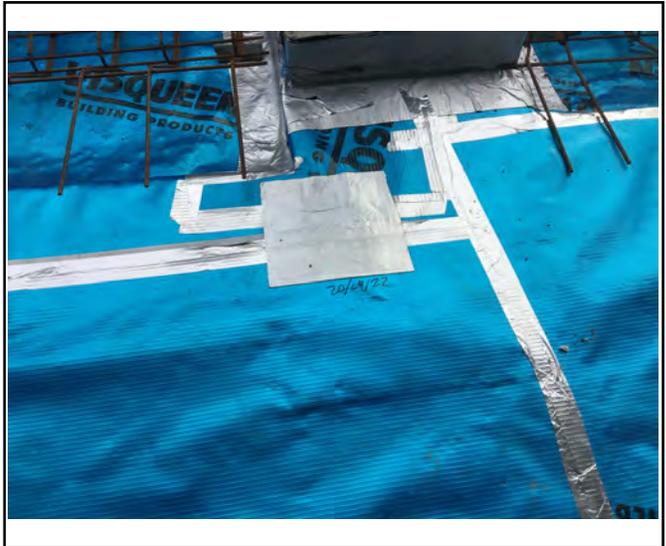
GRSAM patch

Remediation complete

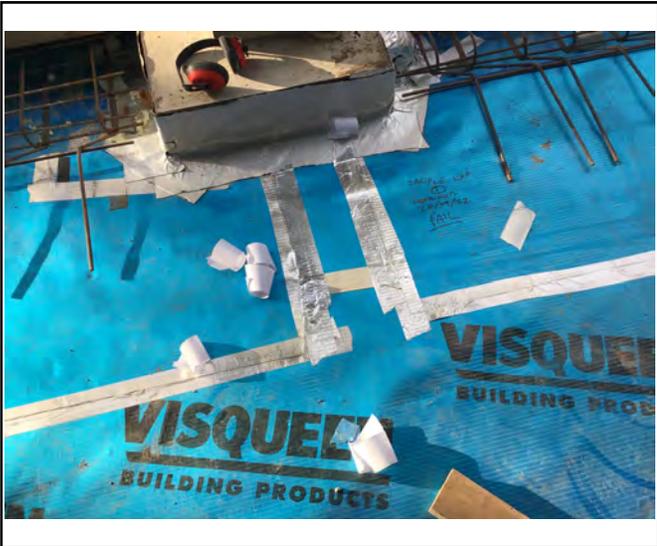
Seam missing butyl tape

Completed during visit

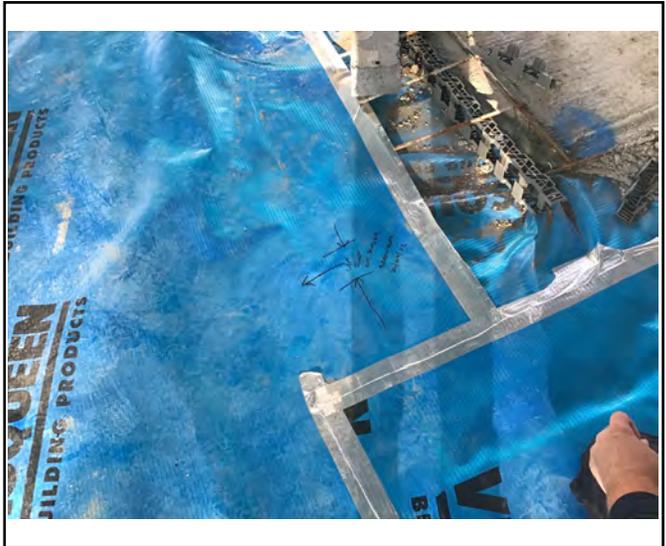
Seam with previously poured concrete

Remediation plan drawn up

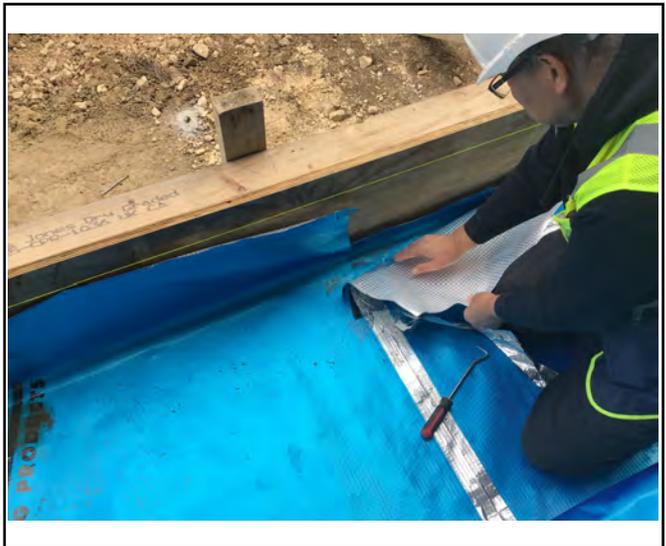
Perimeter detail missing

Butyl tape

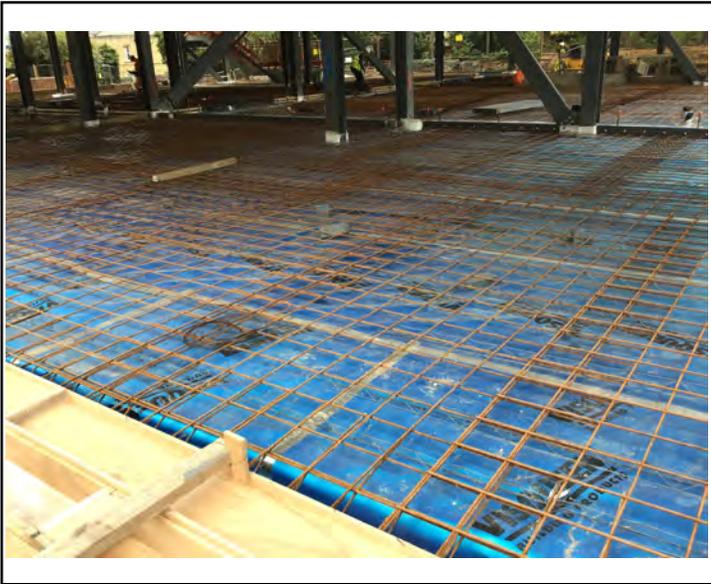
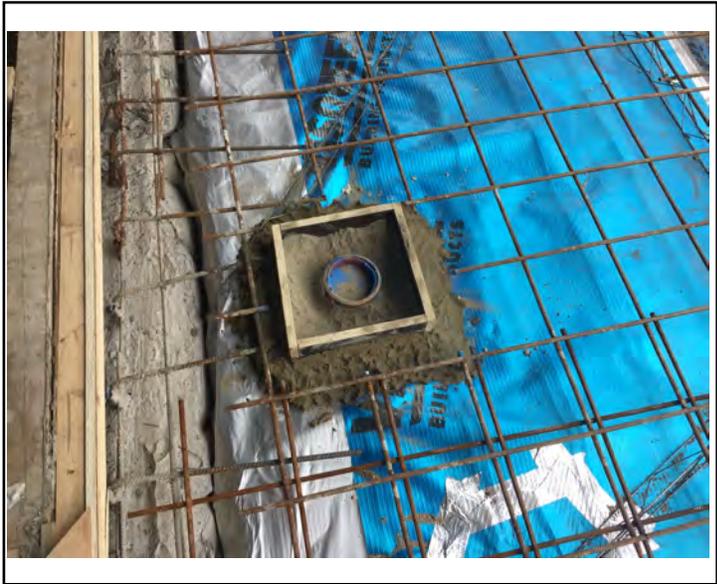
RESTRICTIONS AND LIMITATIONS: Steel reinforcing bar has been laid

Across the whole site in line with the inspection plan, however this limits the scope

Of testing in seams and penetrations.

The image on the right shows a pipe penetration shuttered and filled,

This limits the ability to check all the GRSAM has adhered correctly

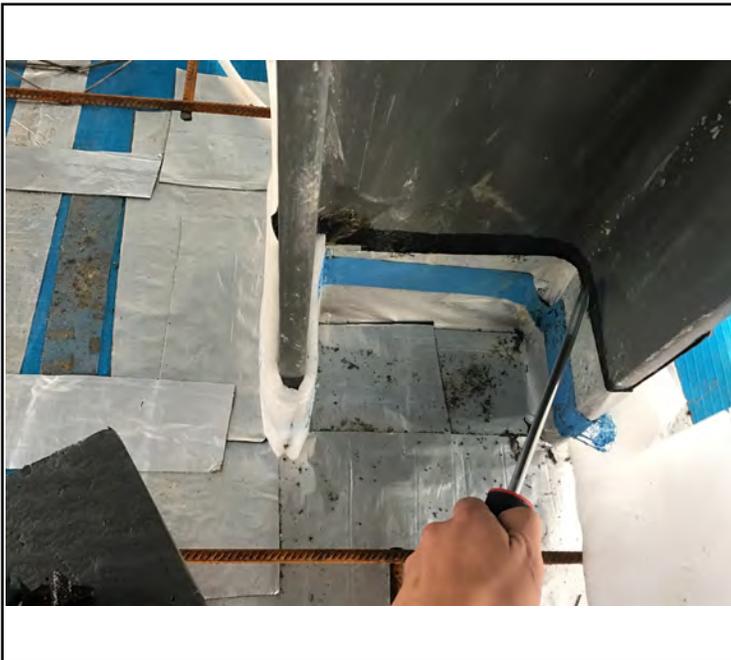
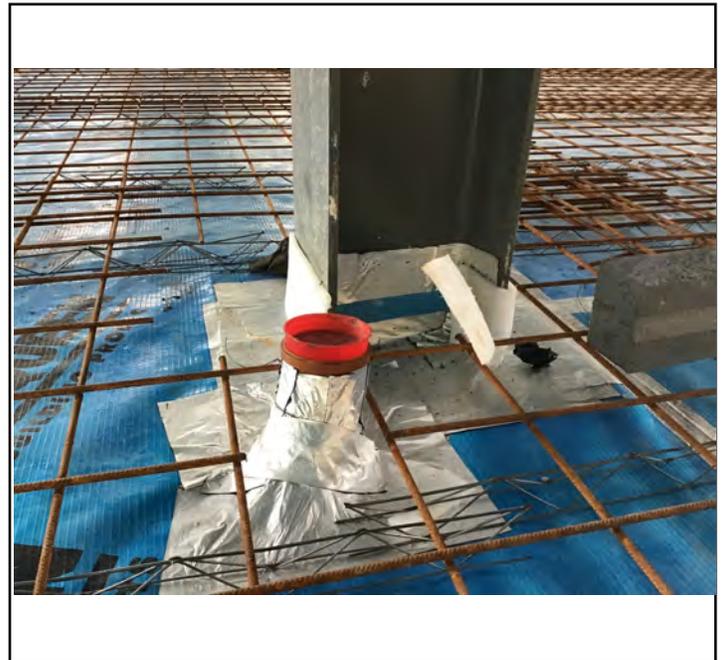
To the concrete being poured. The stanchions have been sealed using visqueen Gas

Resistant self adhesive membrane (GRSAM)

The images above show the stanchion seal being subject to a mechanical point stress

Test (MPST) and a stanchion in close proximity to a pipe penetration

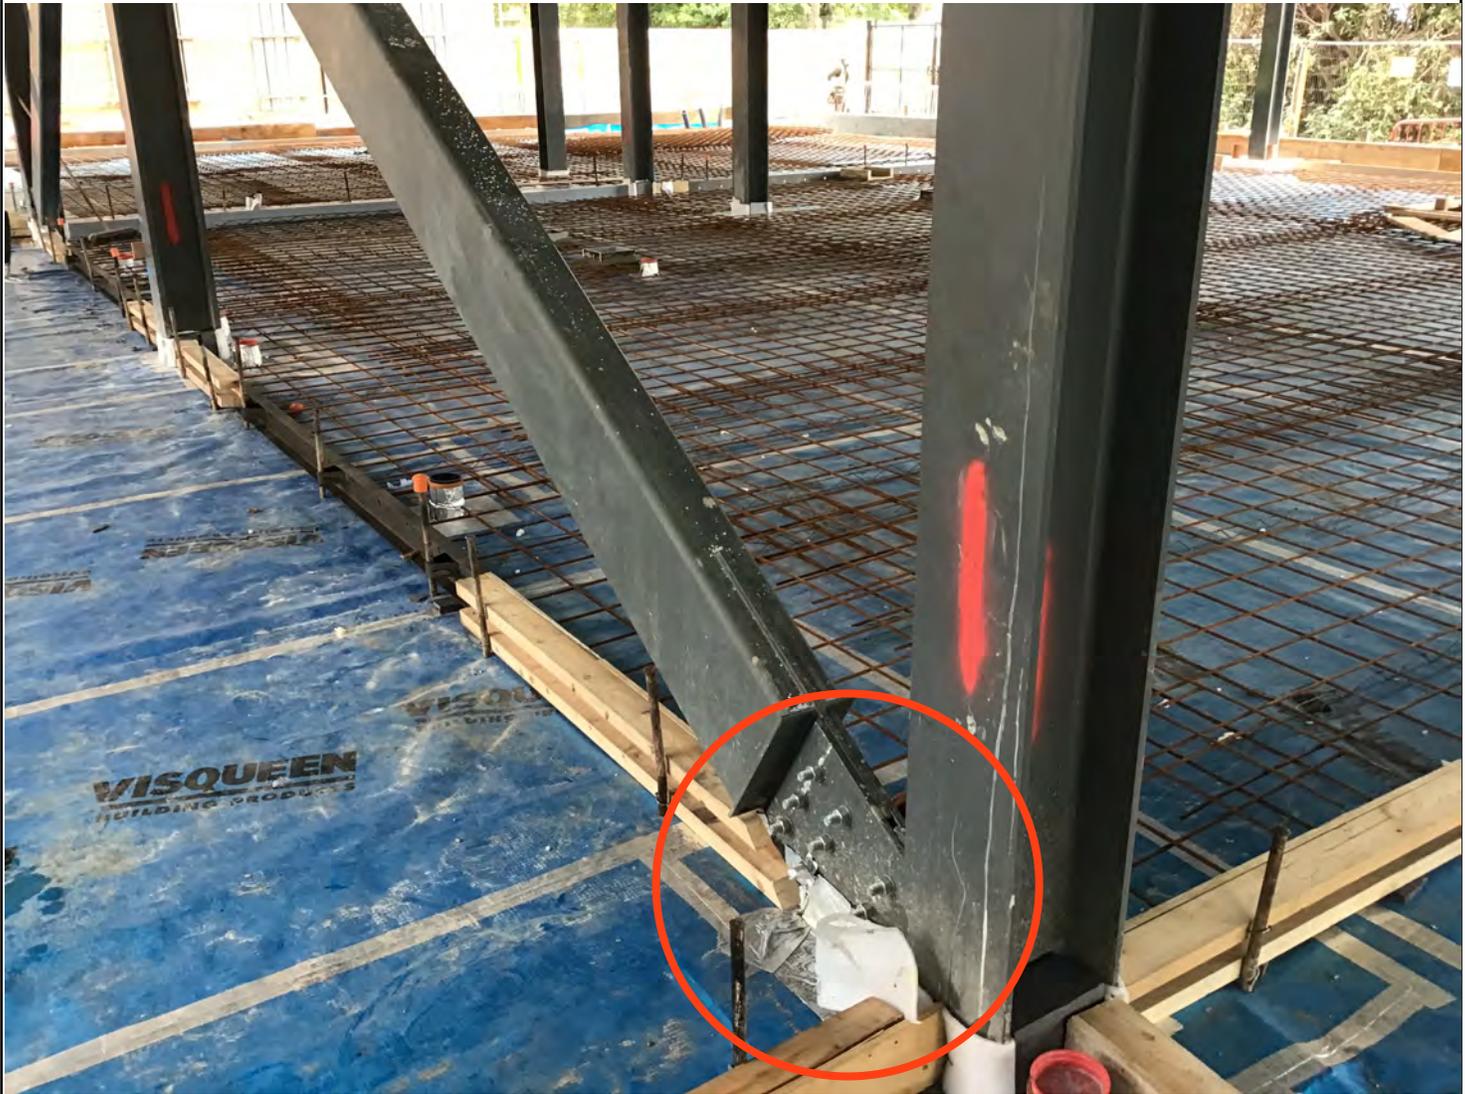
The stanchions had been prepared for concrete pour using foam blocks and sheeting

The stanchion highlighted by the red circle has had the GRSAM exposed to check

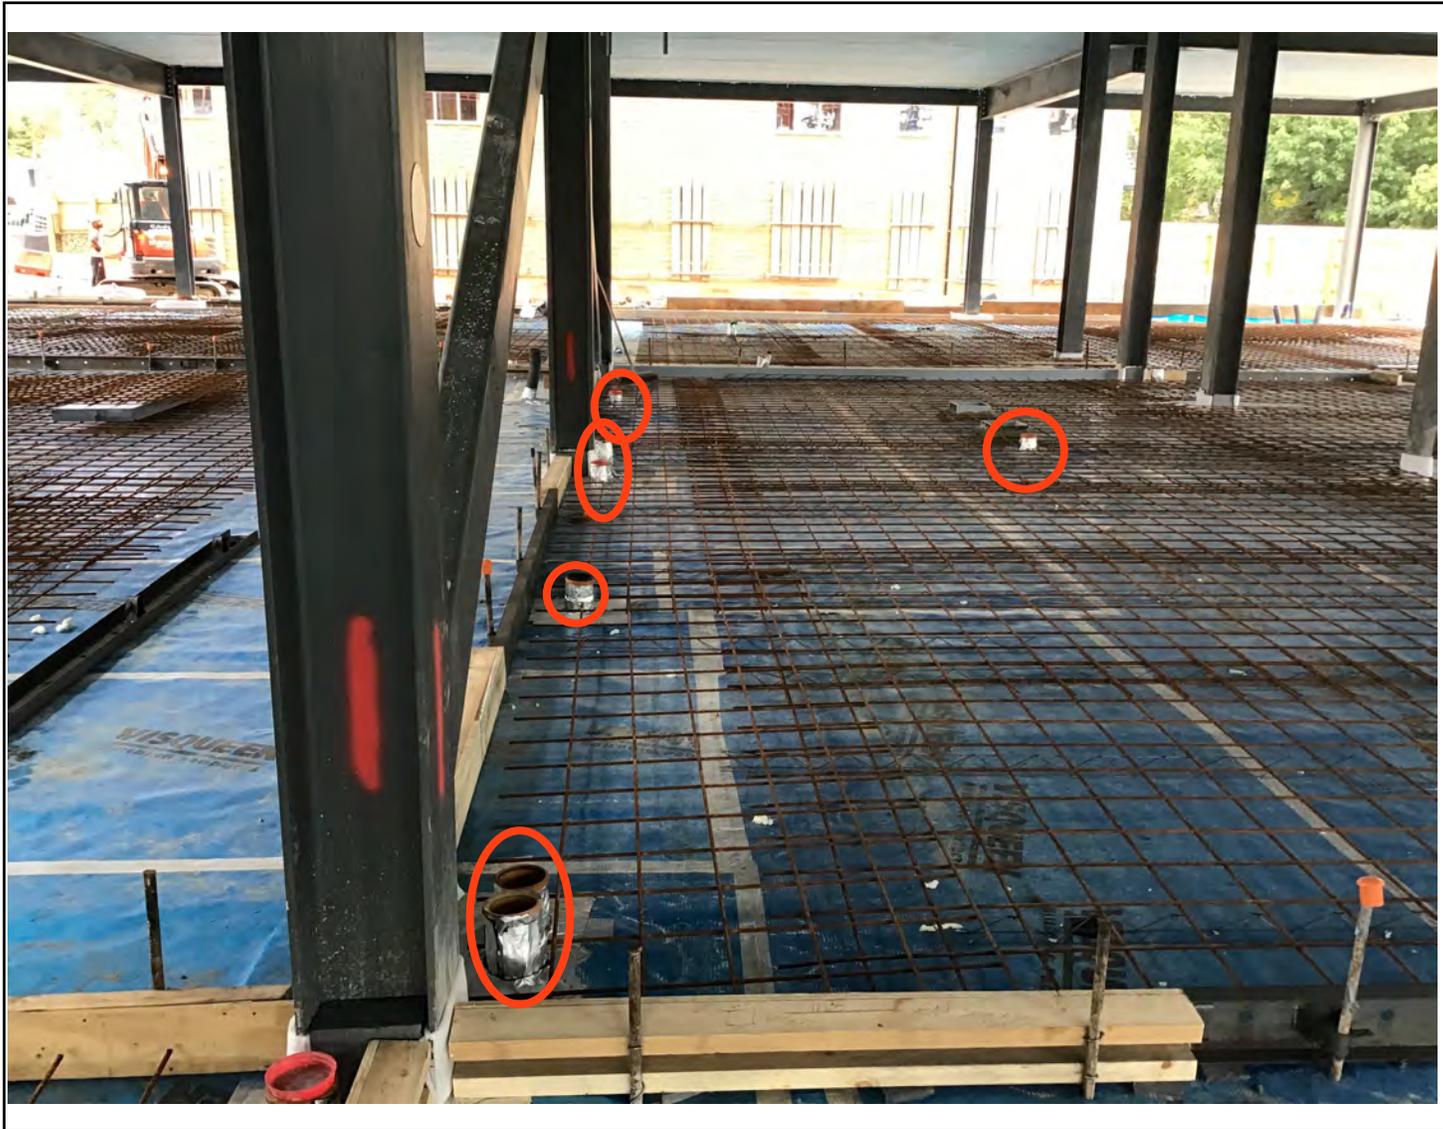
The above image shows the locations of multiple pipe penetrations (red circles)

All pipe penetrations were sealed correctly

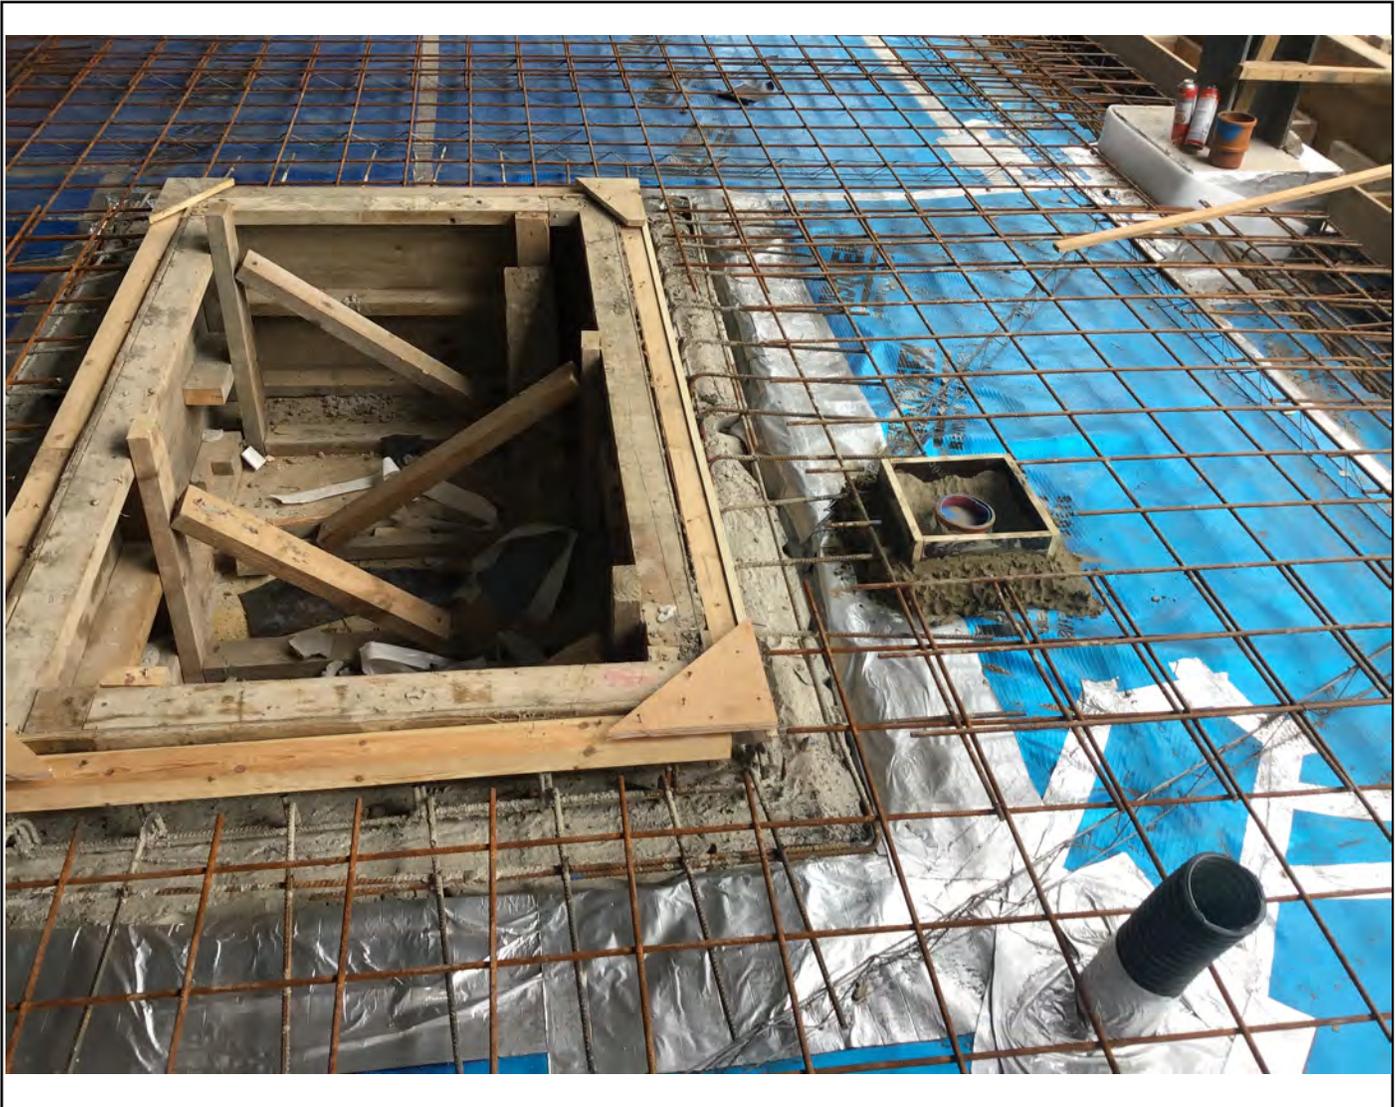
The second concrete area requiring GRSAM

The above image shows a significant lap of GRSAM applied to the remediation

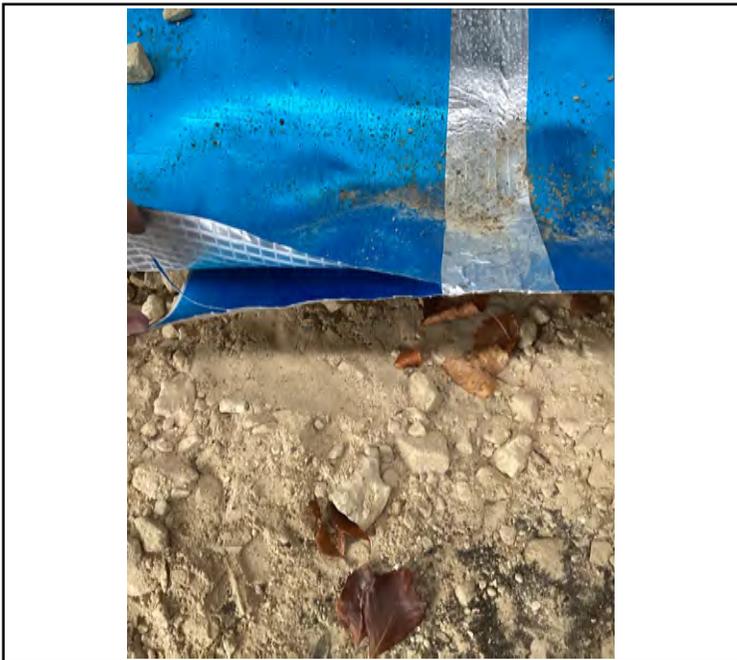
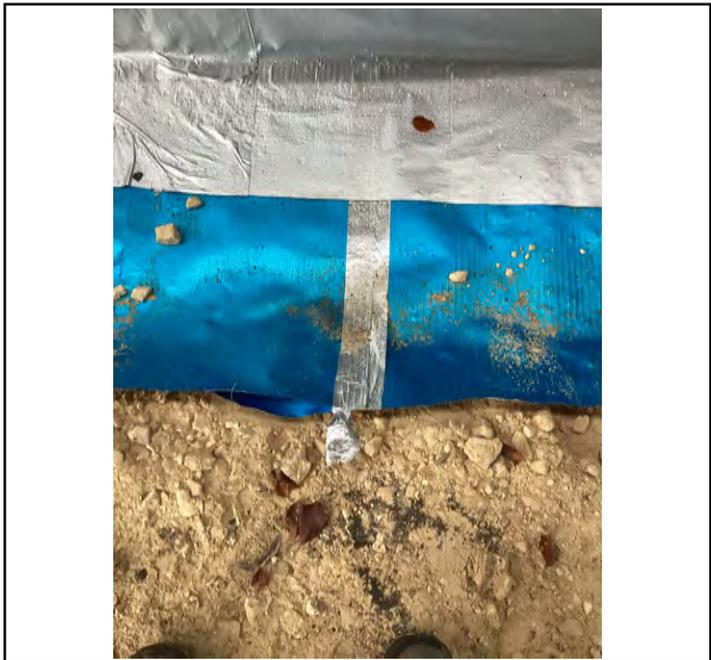
NOTES: Installation of Visqueen gas barrier and GRSAM to the internal perimeter. The first photograph below shows where the installers have lapped the membrane by 150mm, achieving a strong seal. The membrane has been adhered to the load-bearing wall using the Visqueen GRSAM. The membrane has been sealed

using double sided butyl tape, as well as foil tape to achieve a secure seal. This can be

seen on the second photograph above.

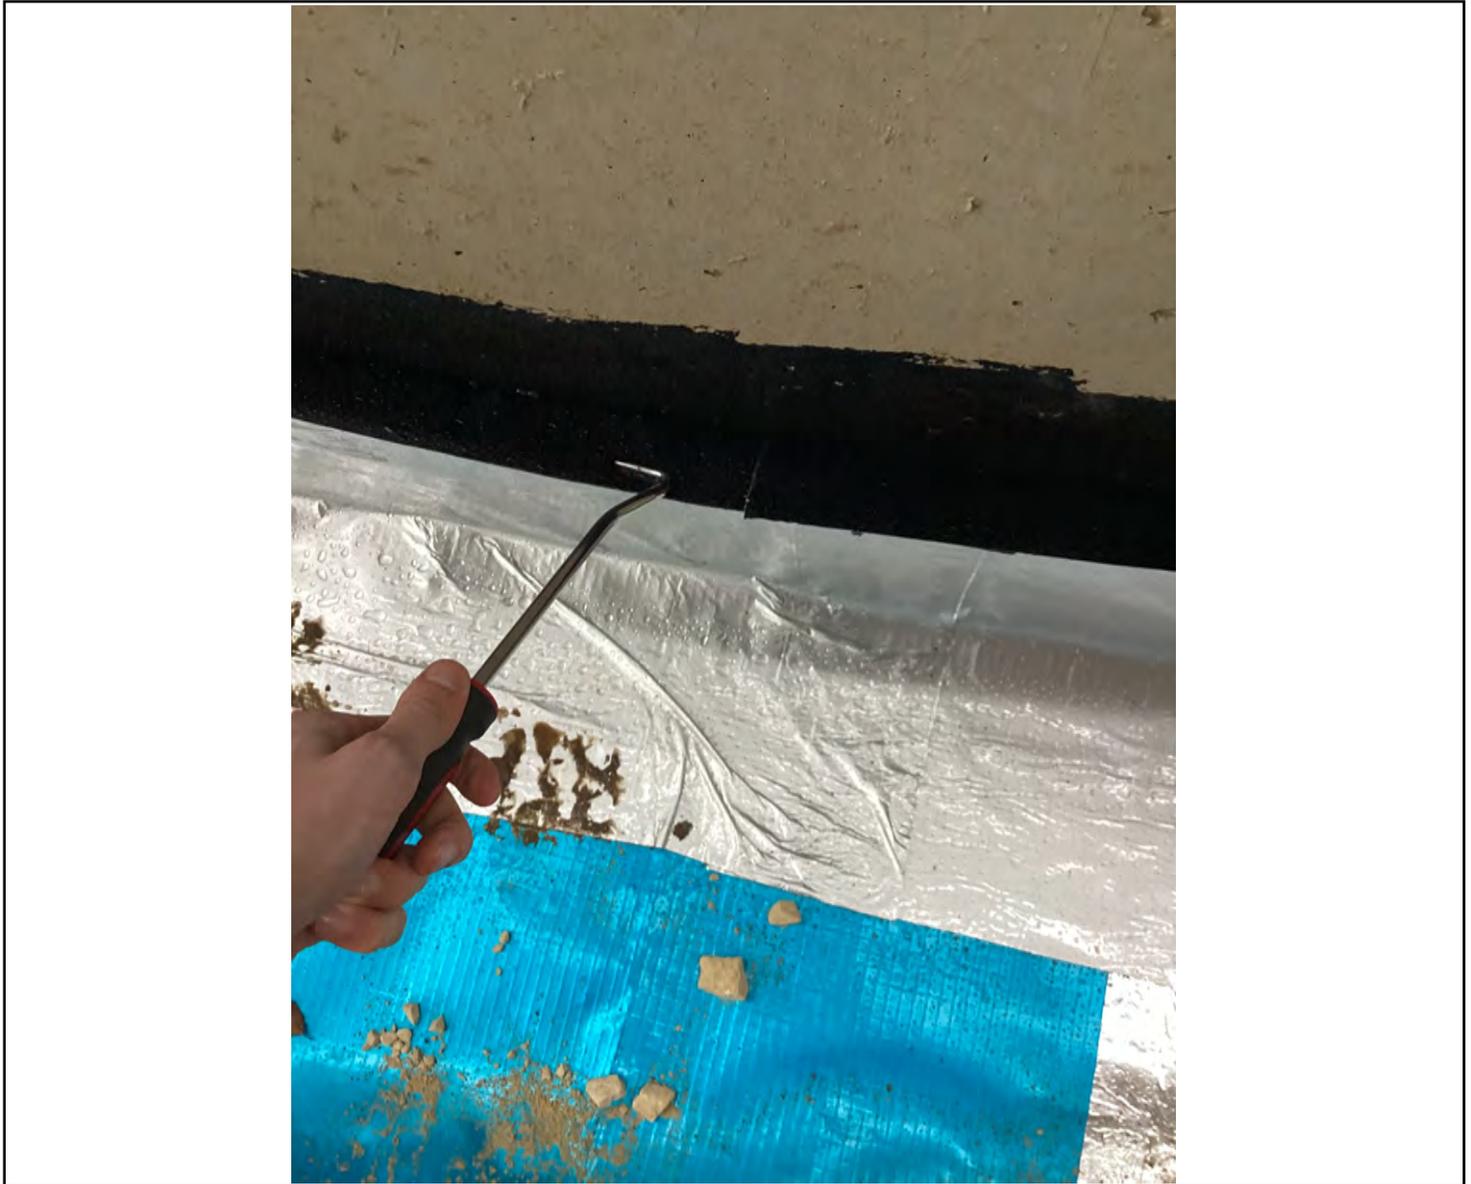
The photograph above shows where a pick and probe test has been completed to the

Visqueen GRSAM. Some faults were found along the wall where the GRSAM was loose.

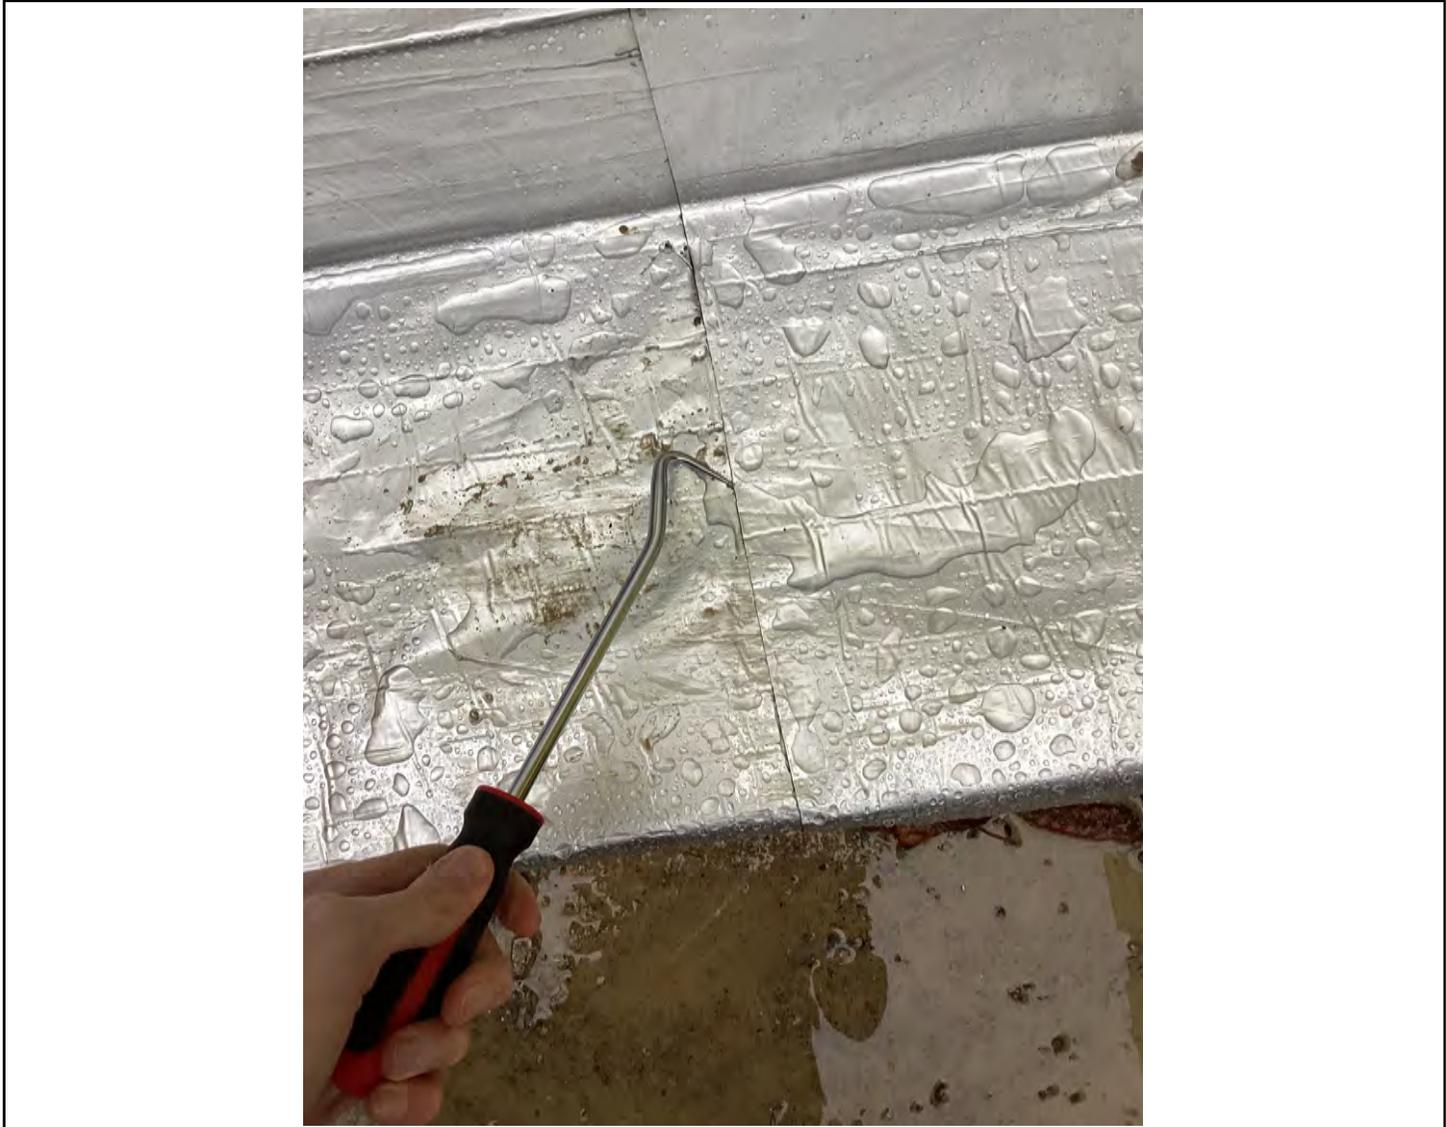
The photograph above shows a pick and probe test being completed to the perimeter details. The GRSAM has been installed with a strong and consistent seal, where few faults were found on the inspected areas.

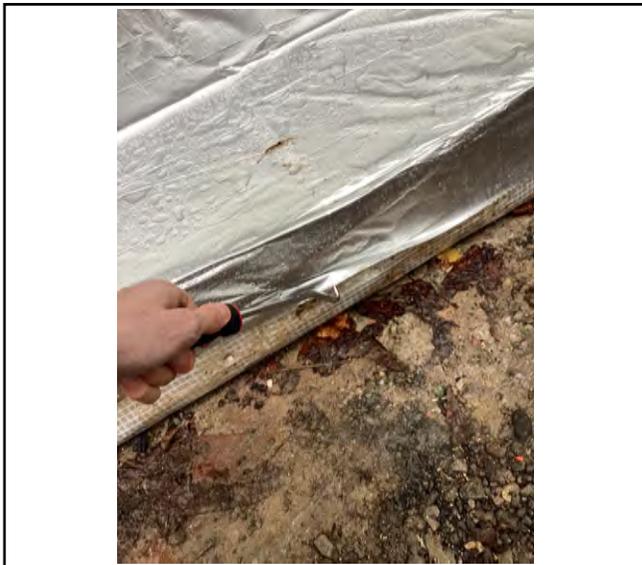
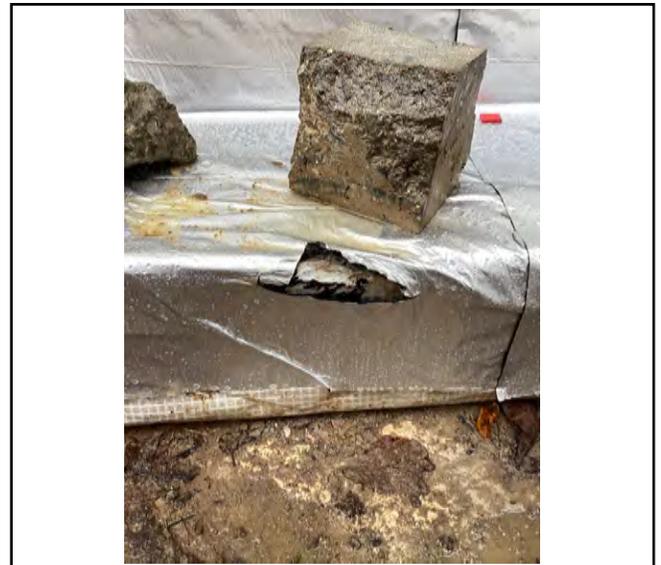
The first photograph bellow shows where a fault has been found on a perimeter detail of the installation. As illustrated by the pick, some of the GRSAM is loose and not correctly adhered. This needs to be rectified by applying more heat (using the hot ...

... air leister) to achieve a seal. The second photograph above shows where the

Visqueen GRSAM has been damaged. To rectify this fault another patch of the GRSAM must be applied to create a seal. The faults found on site were not rectified during the inspection, so they must be re-visited upon the next visit.
