GEOSHIELD Verification Report

PROJECT REFERENCE: GEO102848

REPORT NUMBER: 010 REPORT DATE: 22/09/2022

PROJECT: Galiford Try Building

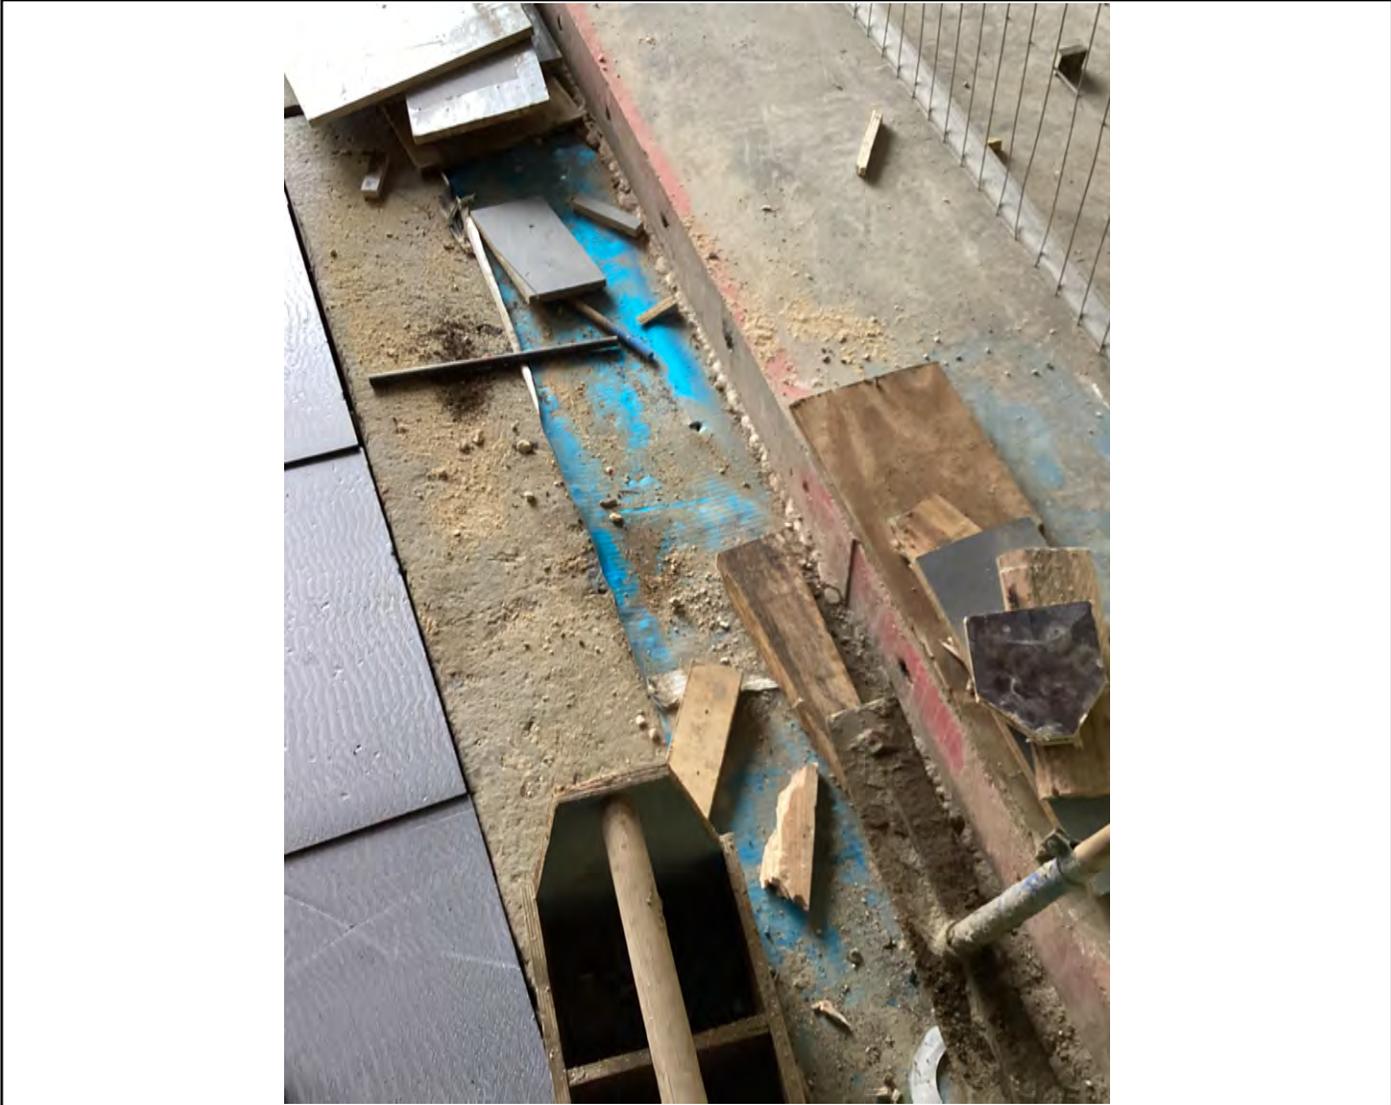
The photograph above shows part of the Visqueen gas barrier that has been

damaged. This was not an area which needed to be inspected and verified on this

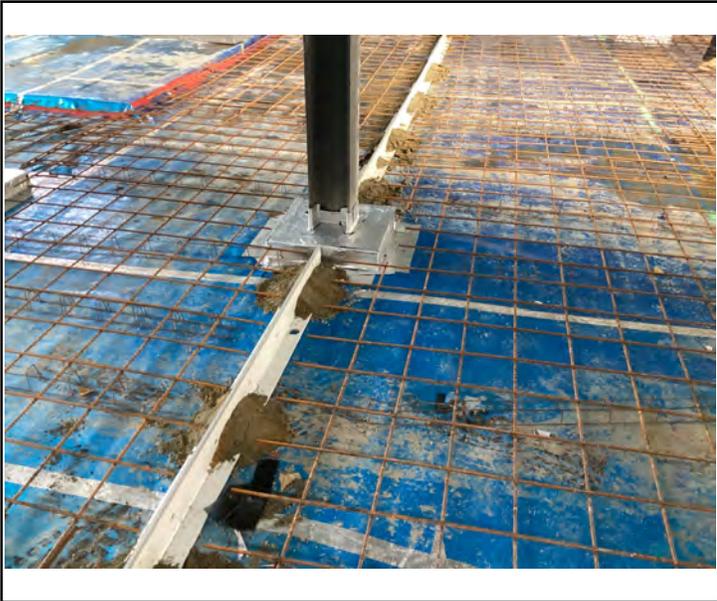
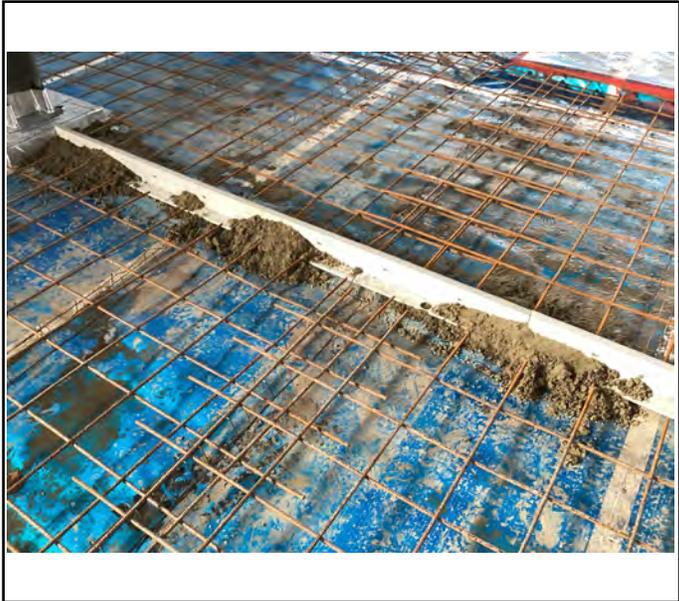
Membrane as there were areas where both the concrete had been placed plus the

actual screed rail.

The image shows the extent of one of the two screed rails.

The image on the right shows a close up of both the screed rail and the

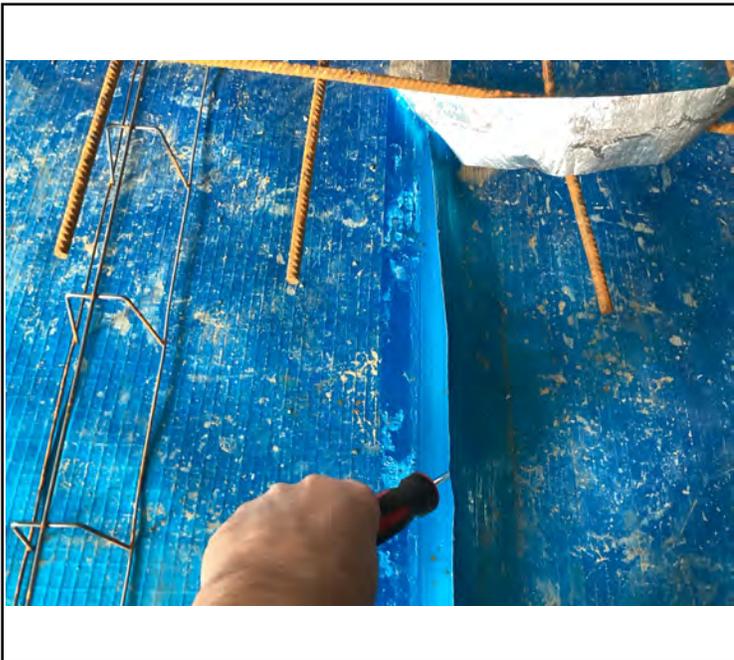
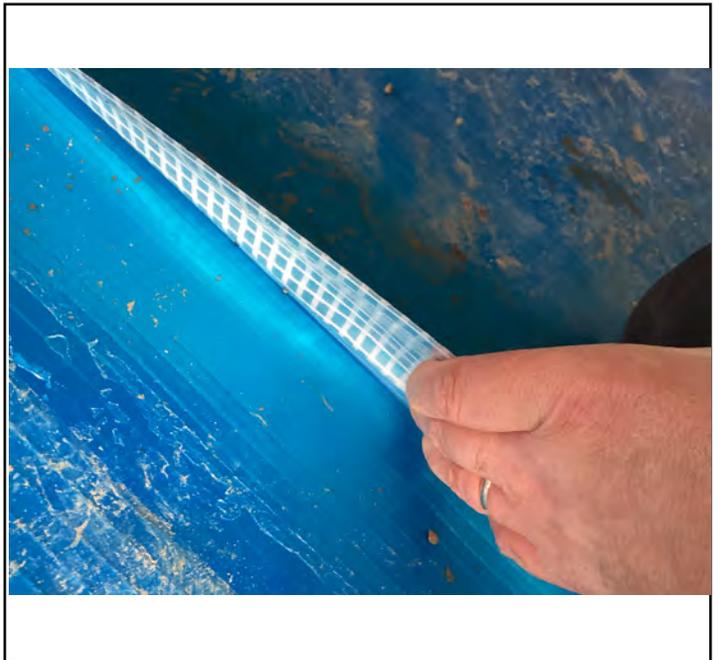
provides an ideal bearing from any potential damage from underneath. The Visqueen

Gas Barrier lap joints have been sealed using a combination of both Visqueen Double

Sided Butyl Tape and Visqueen Foil Lap Tape. The images show one of four sampled

lap joints checking visually and confirmed by undertaking Mechanical Point Stress Test.

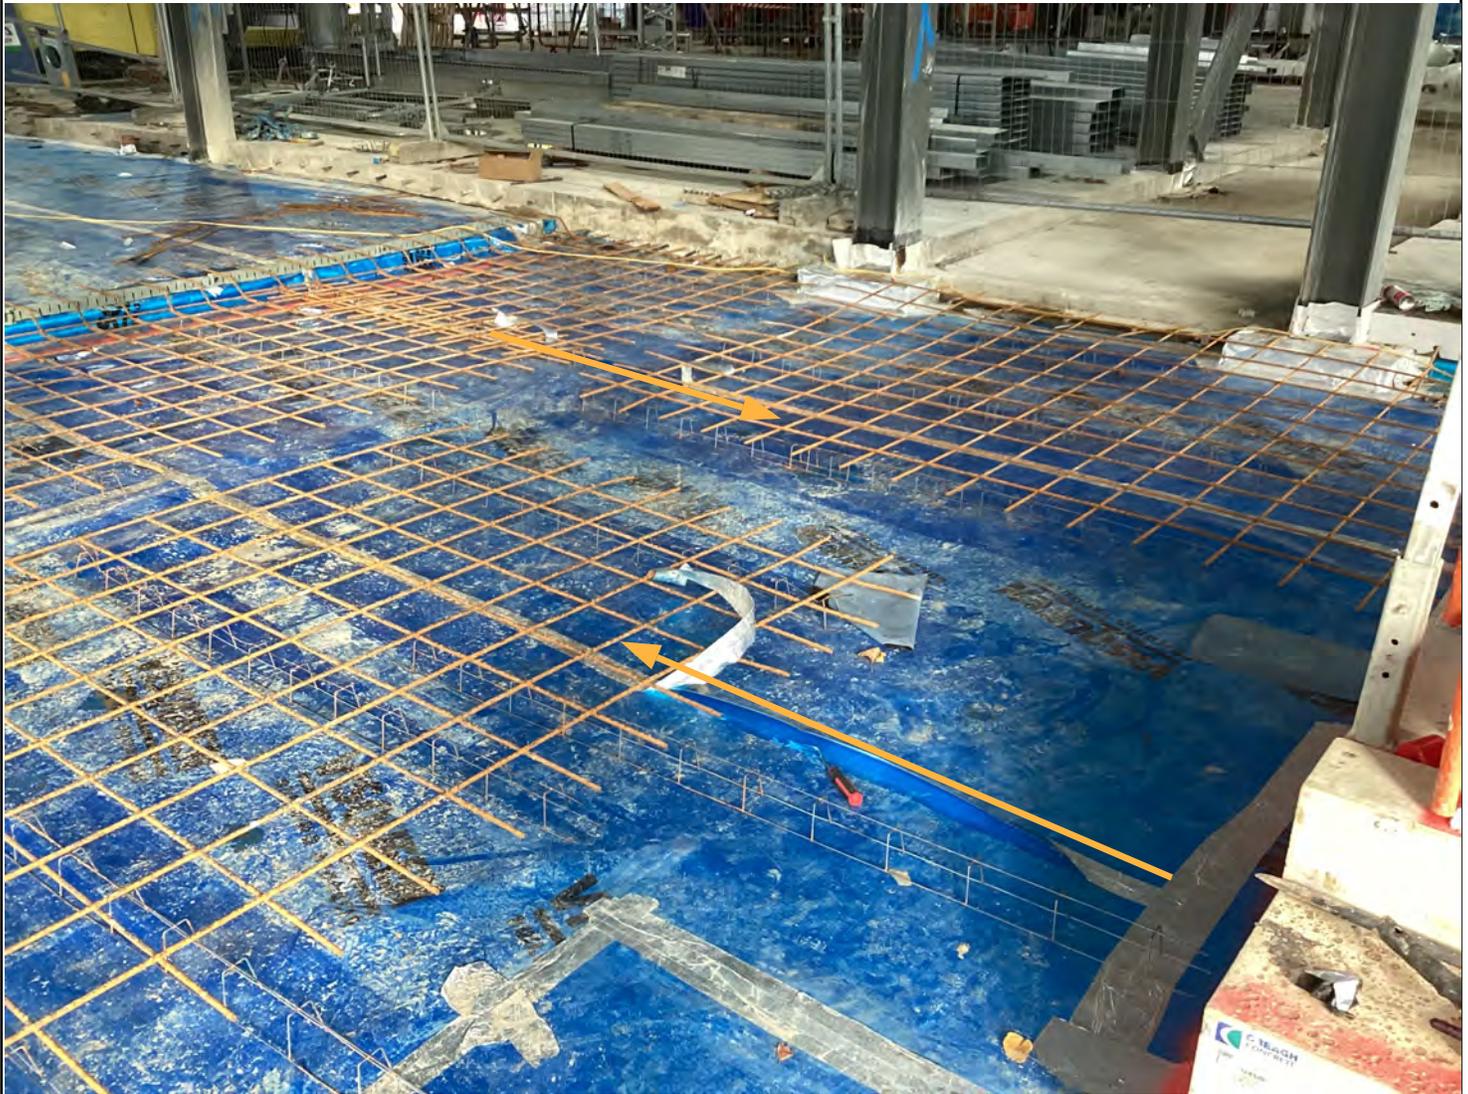
The overview image is showing where two of the four sampled Visqueen Gas Barrier lap joints. The four sampled lap joints proved to have been correctly sealed using a strip of Visqueen Double Sided Butyl Tape. The Mechanical Point Stress Test confirmed a securely bonded seal in all four sampled lap joints.

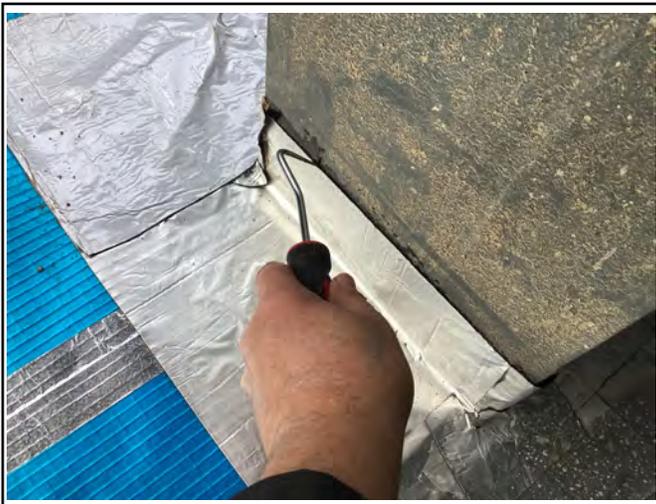
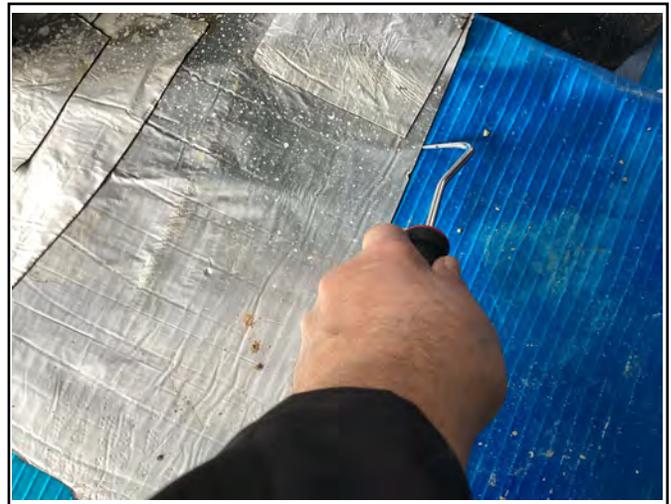
The various stanchions have all been sealed using strips of Visqueen Gas Resistant Self Adhesive Membrane. The image on the left shows the Mechanical Point Stress Test being undertaken along the edges of the Visqueen GRSAM and throughout the

test, the Visqueen GRSAM had been fully sealed to the stanchion.

The image on the right shows the Mechanical Point Stress Test being undertaken along the edges of the Visqueen GRSAM so as to ensure there was a complete seal with the Visqueen Gas Barrier. There were no issues identified throughout the verification and noted that the application of heat helped improve adhesion.

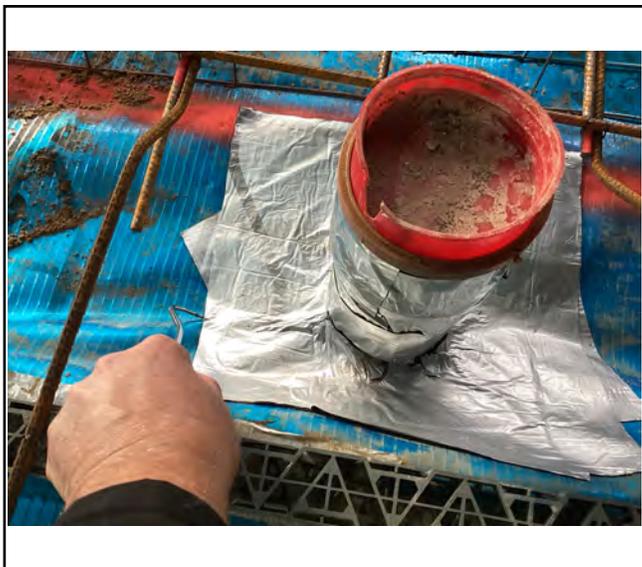
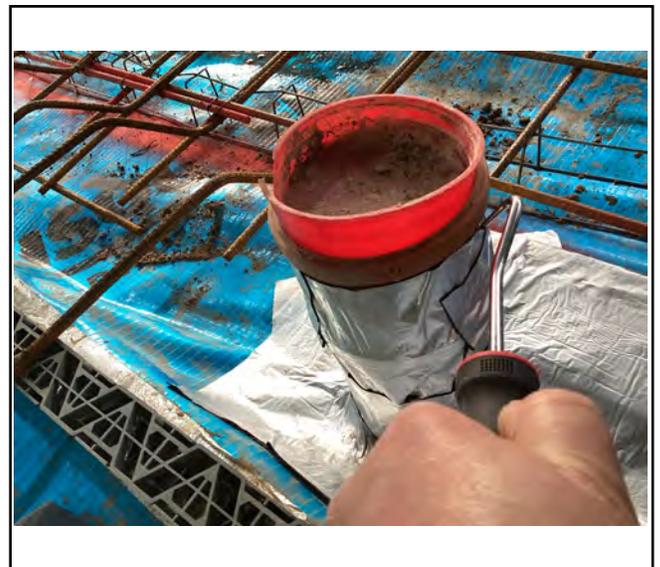
The pipe penetration had been fully sealed using strips of Visqueen Gas Resistant Self Adhesive Membrane. The installation was aided by the introduction of heat which had been applied whilst installing the various strips of Visqueen GRSAM.

The images show the Mechanical Point Stress Test being undertaken along the edges of the Visqueen GRSAM . A full seal was achieved with both the pipe penetration but also the Visqueen Gas Barrier too.

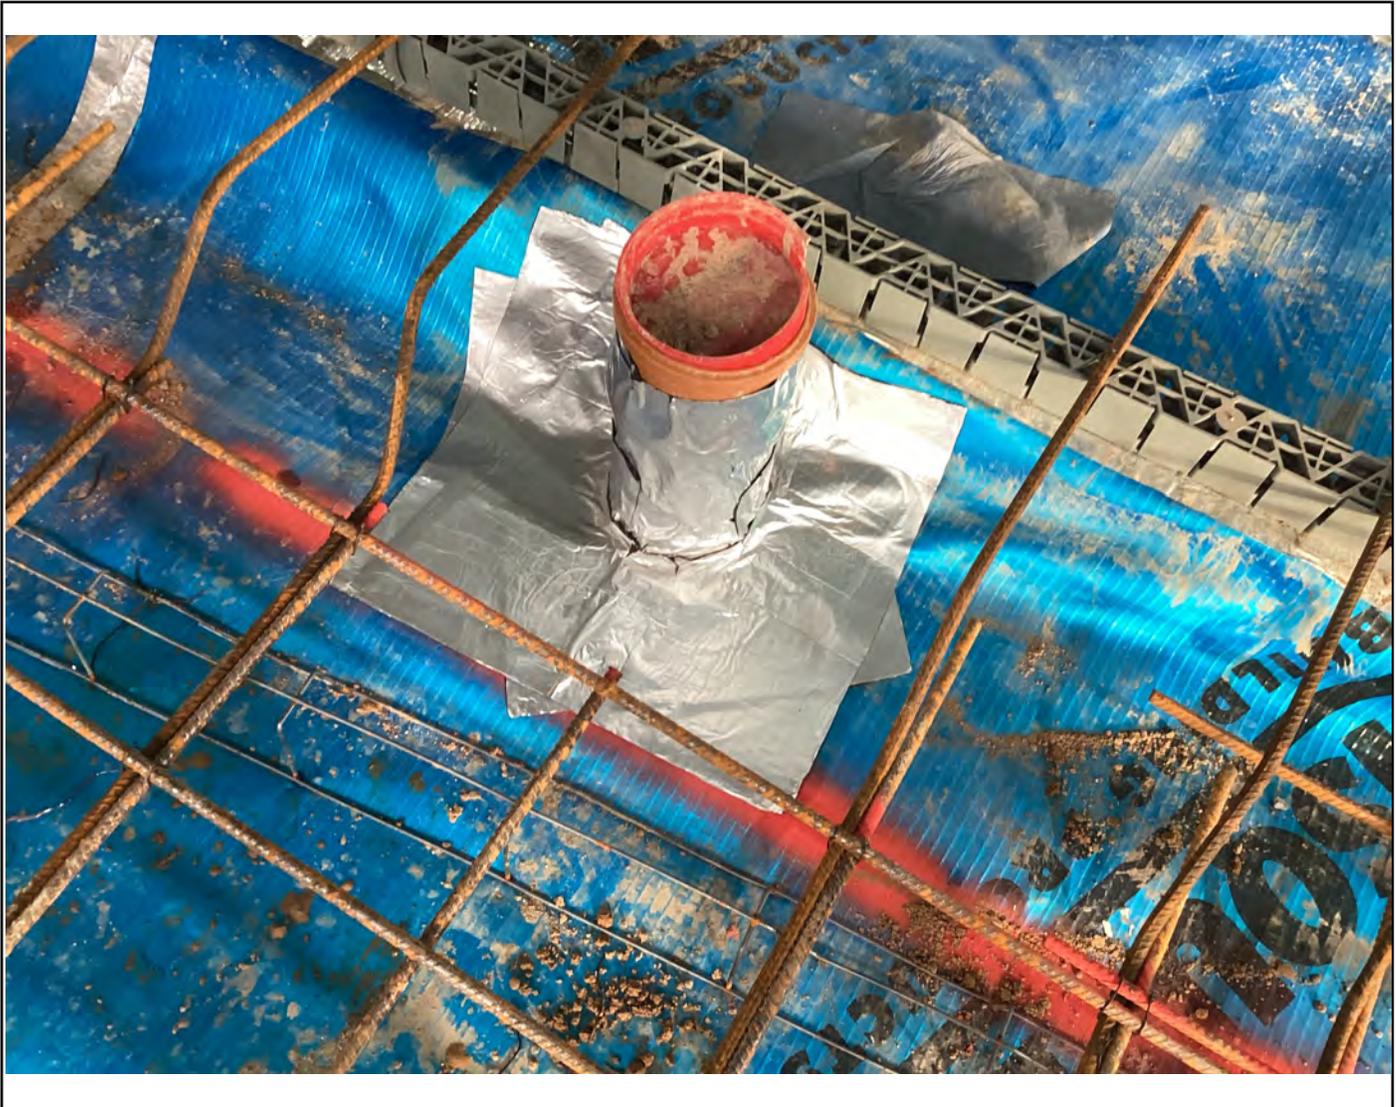
The image shows the pipe penetration which was subjected to verification.

The Mechanical Point Stress Test confirmed there were no issues although

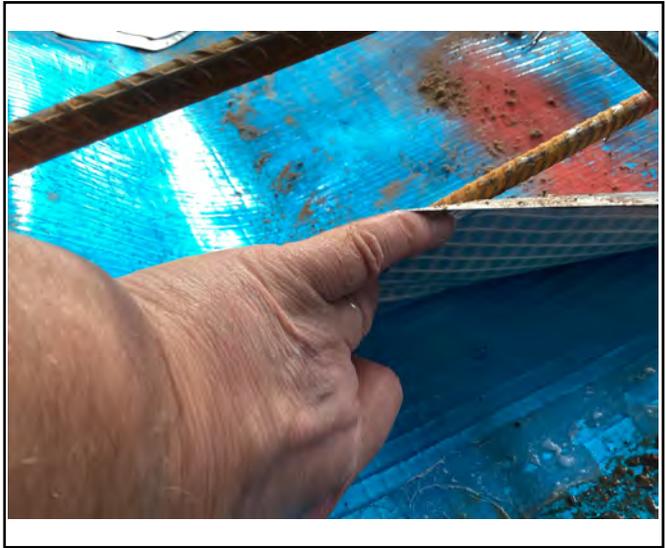
Visual of Double Sided Butyl Tape

seen during third lap joint sample

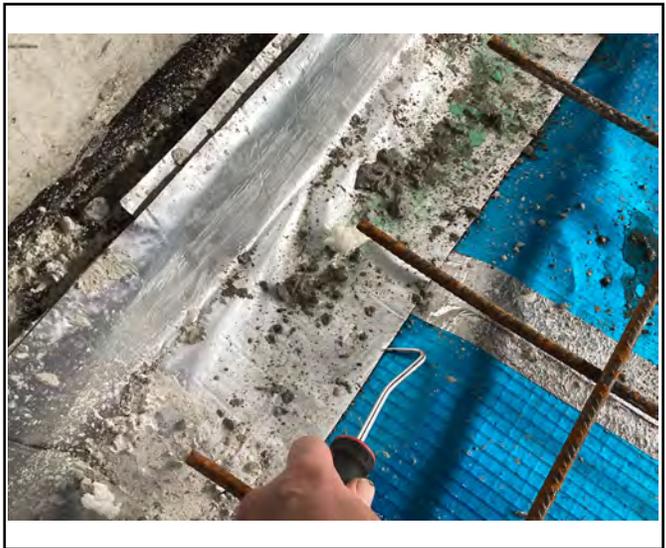
Mechanical Point Stress Test to

GRSAM detail to lift pit detail

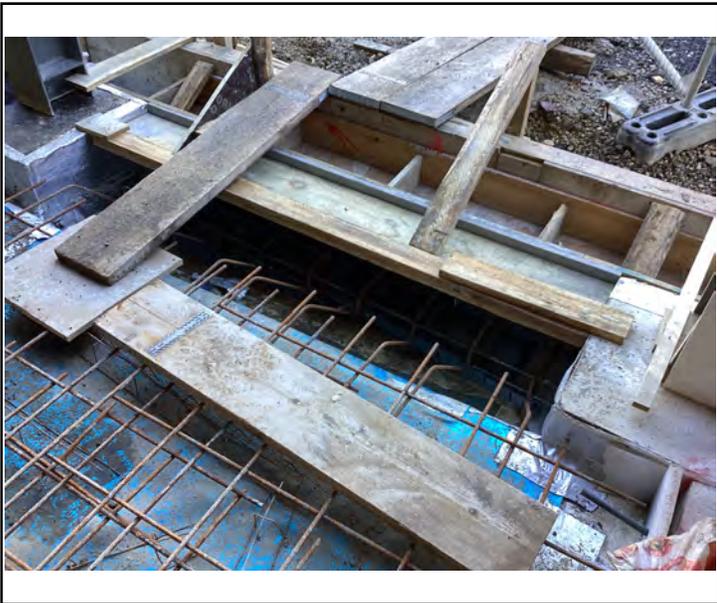
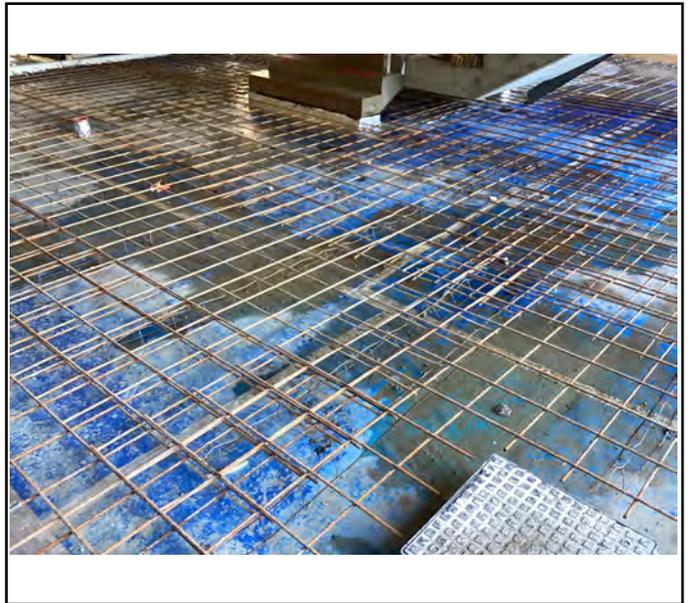
The perimeter areas restricted verification as there was no access to the installed

Visqueen Gas Barrier and associated lap joints.

The image on the right shows a typical area within the verification area where a

layer of steel reinforcement had already been placed upon the installed Visqueen

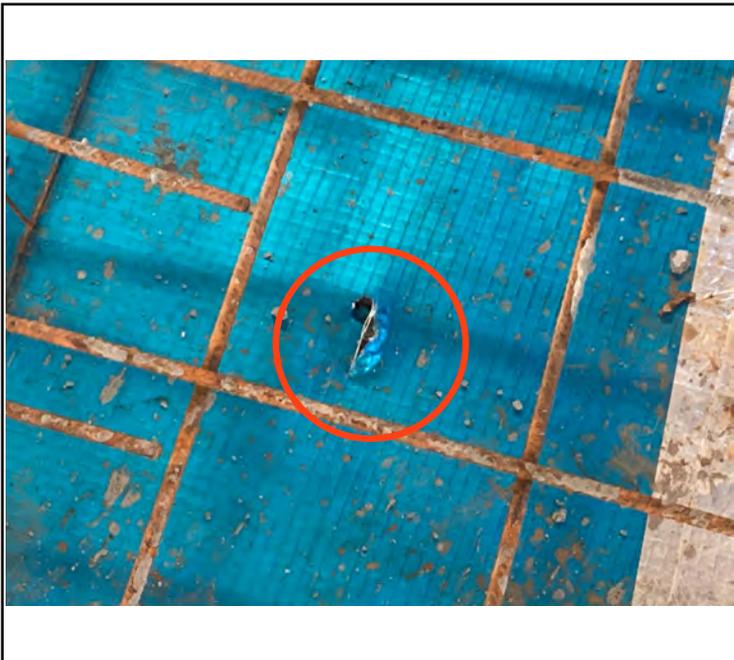
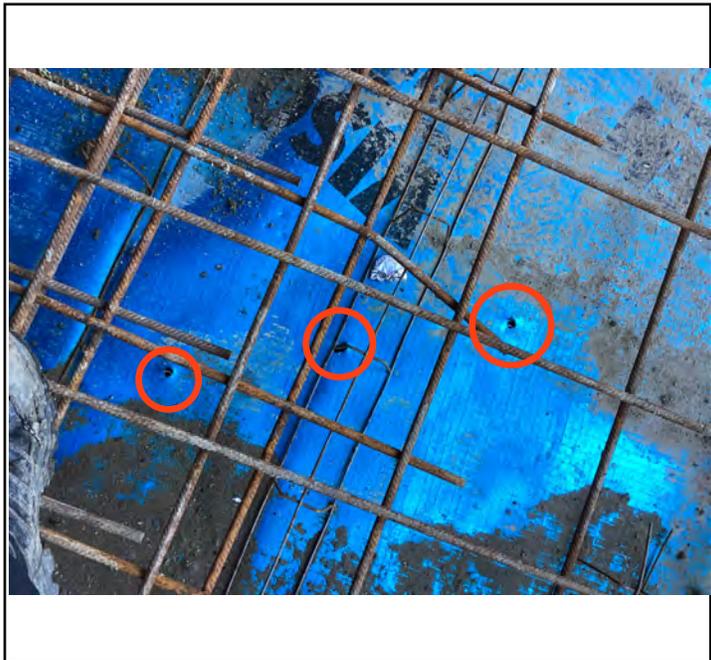
NOTES: Visqueen Gas Barrier Installation-Punctures

The Visqueen Gas Barrier has been installed upon a layer of insulation (substrate) which provides an ideal bearing from any potential damage from underneath. The area was however visually. The images show (red circles) punctures which are likely to have been

caused during the placement of steel reinforcement. These punctures were remediated

during the verification visit and recorded in 'additional photos section' this report.

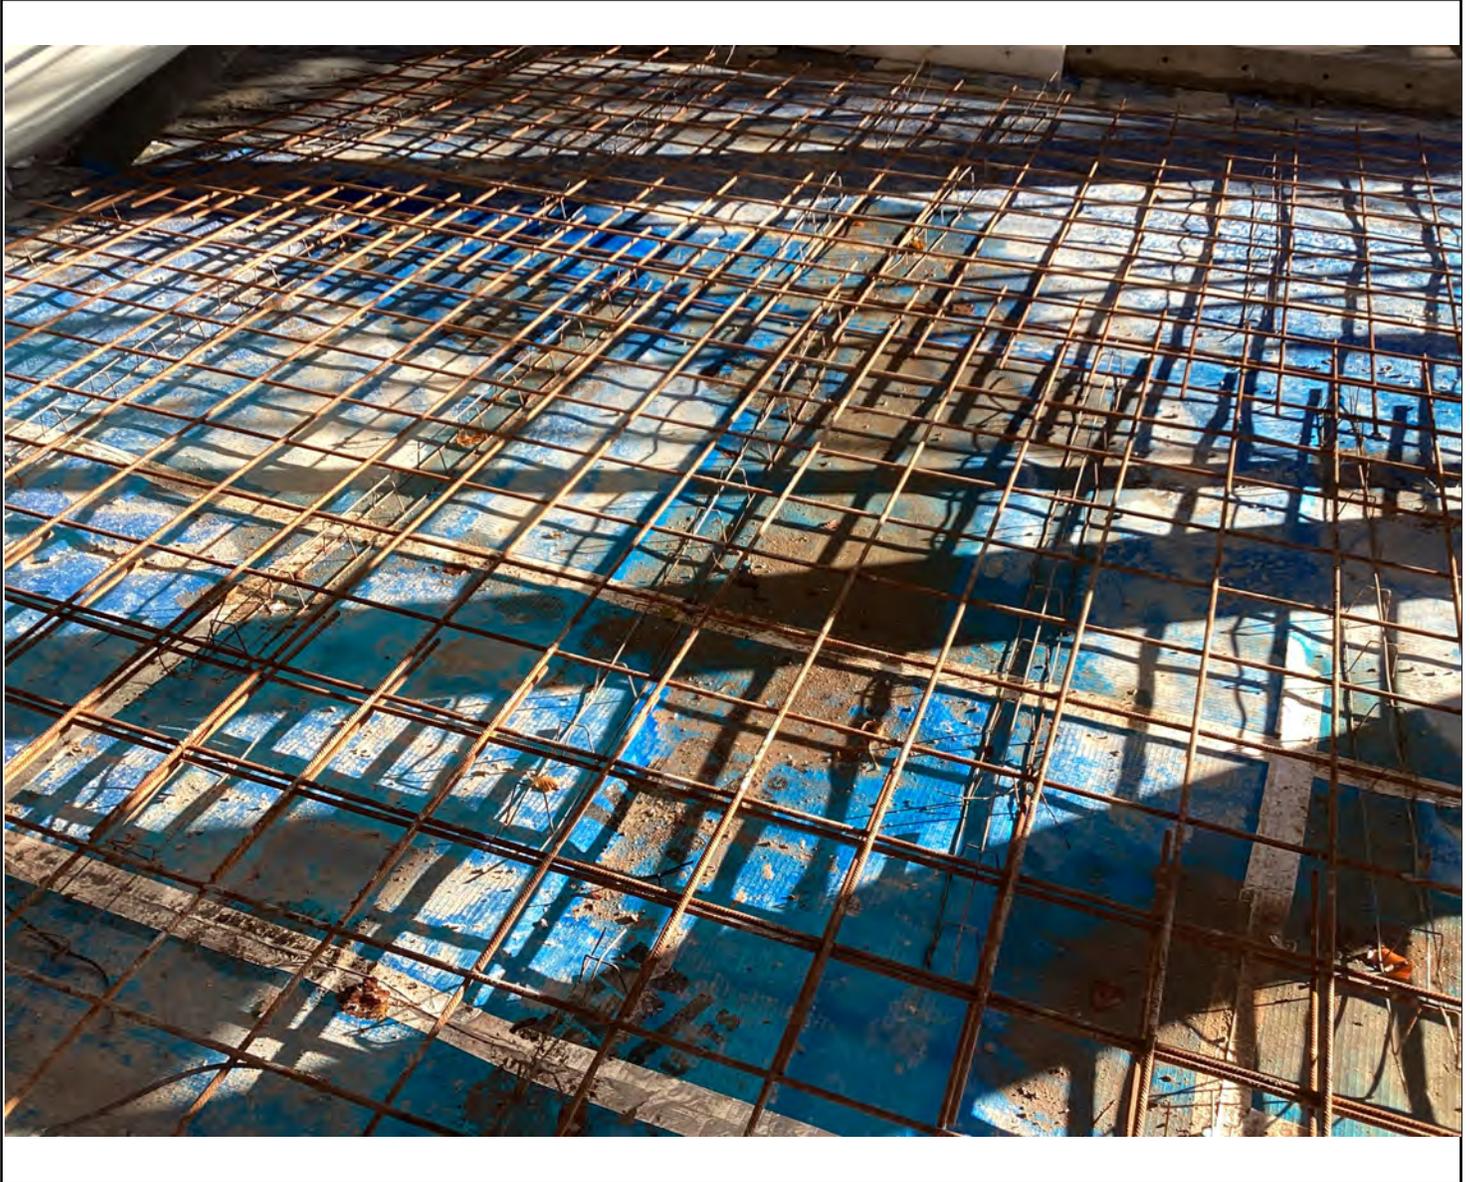
Overview image showing a typical area where a thorough although limited inspection

was undertaken. There was particular attention to areas where the steel 'high chairs'

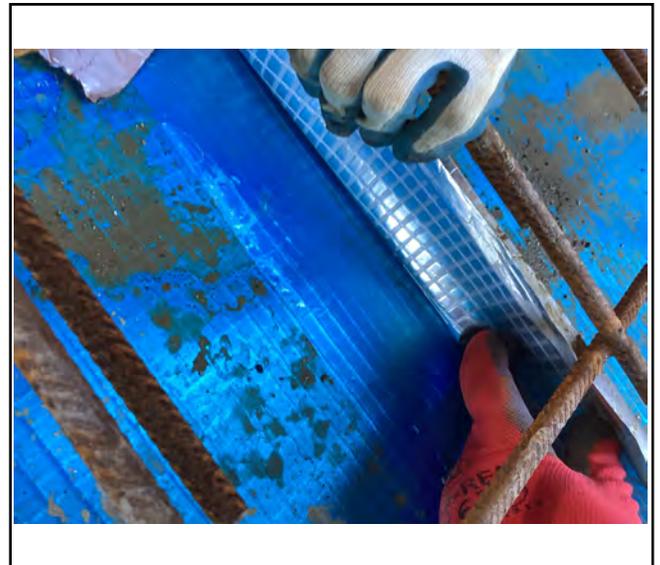
The Visqueen Gas Barrier had been installed upon a layer of insulation and effectively providing a suitable substrate. The lap joints were dual sealed combining the

Visqueen Double Sided Butyl Tape (main seal) and the Visqueen Foil Lap Tape which

protects the lap. A Visqueen lap joint was sampled where as seen in the first image,

the Visqueen Foil Lap Tape was peeled back before completing the Mechanical

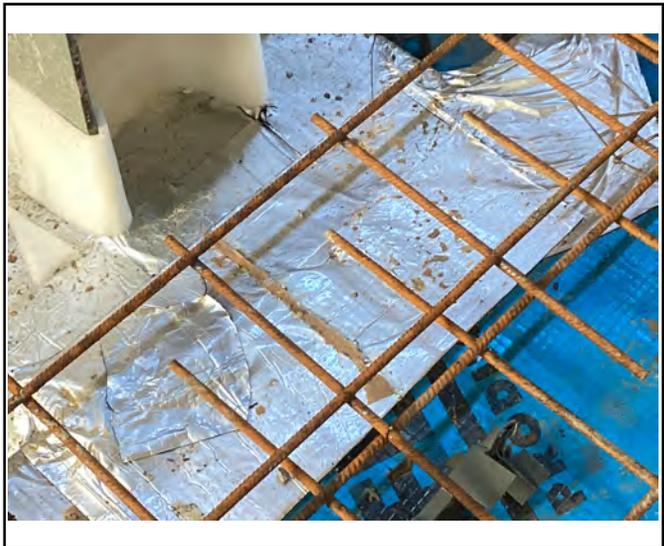
Potential damage to GRSAM was

evaded by supporting reinforcement

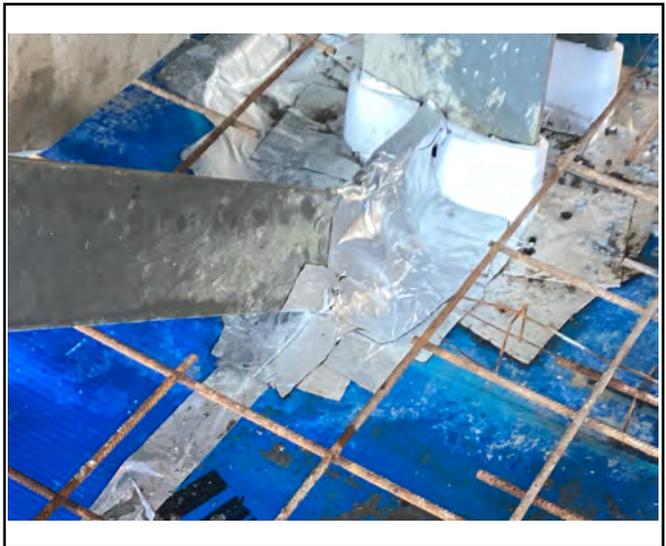
Remediation to steel cross bracing

completed observed by Geoshield
