## **Condition Survey, Blue Hills Farm – Planning Application 2022/91047 - Condition 10**

# BLUE HILLS FARM

Highway Dilapidation Survey

Thursday, 10 August 2023

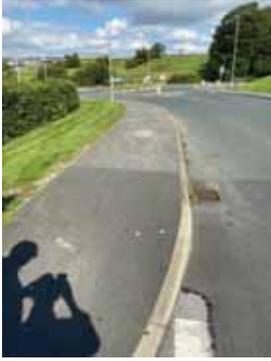
**ISSUE 1**

Patch to wearing course

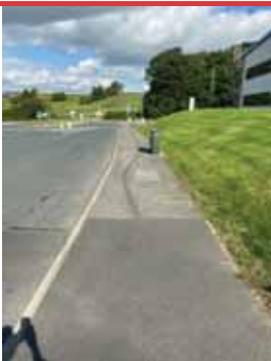
**ISSUE 3**

Patch to wearing course

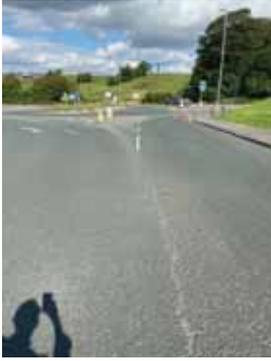
**ISSUE 5**

Wearing course friable

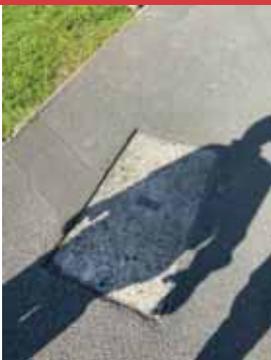
**ISSUE 16**

Telecoms lid has sunk

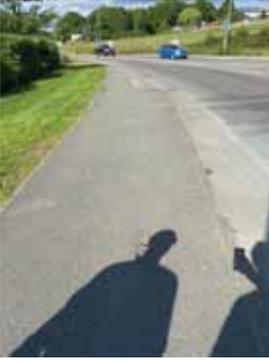
**ISSUE 17**

Wearing course intact

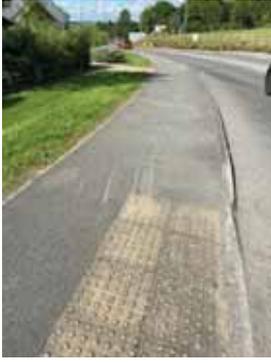
**ISSUE 21**

Scars in wearing course

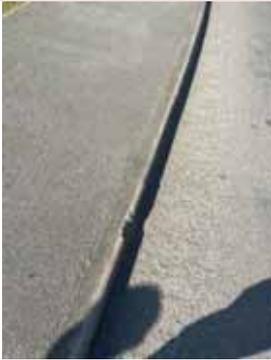
**ISSUE 22**

Damage to kerb

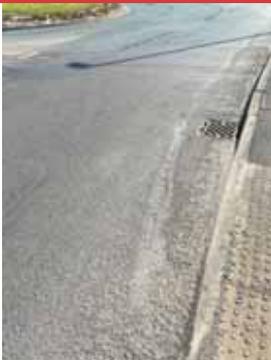
**ISSUE 23**

Wearing course friable

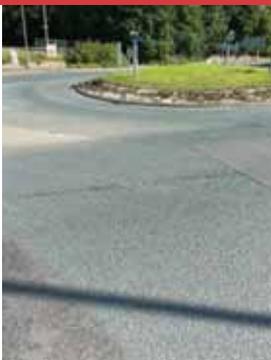
**ISSUE 24**

Friable joints in wearing course

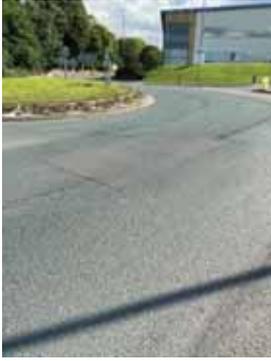
**ISSUE 25**

Friable joints in wearing course

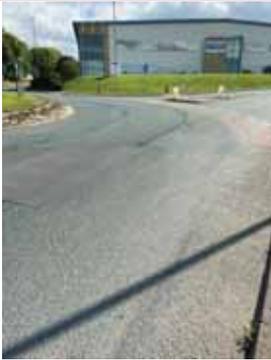
**ISSUE 26**

Wearing course friable / patchy

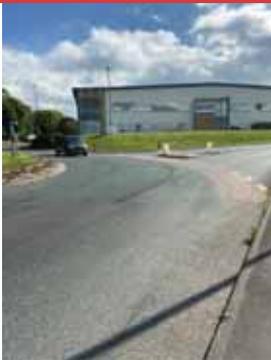
**ISSUE 27**

Wearing course friable / patchy

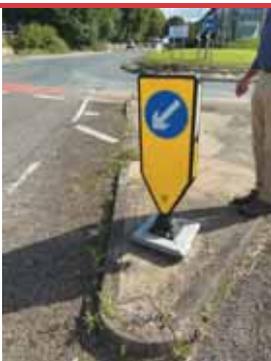
**ISSUE 32**

Wearing course friable

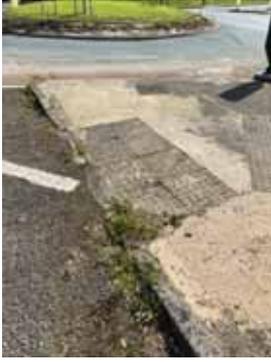
**ISSUE 33**

Wearing course friable

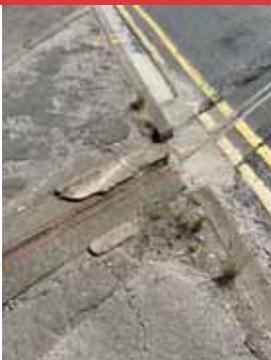
**ISSUE 127**

Wearing course friable / pothole

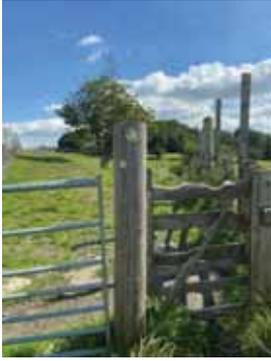
**ISSUE 12**

Pathway broken up / friable
