155 Penistone Road  
Kirkburton  
HUDDERSFIELD  
West Yorkshire  
HD8 0RB

**INSURANCE CLAIM**

**CONCERNING SUSPECTED SUBSIDENCE**

**ENGINEERING APPRAISAL REPORT**

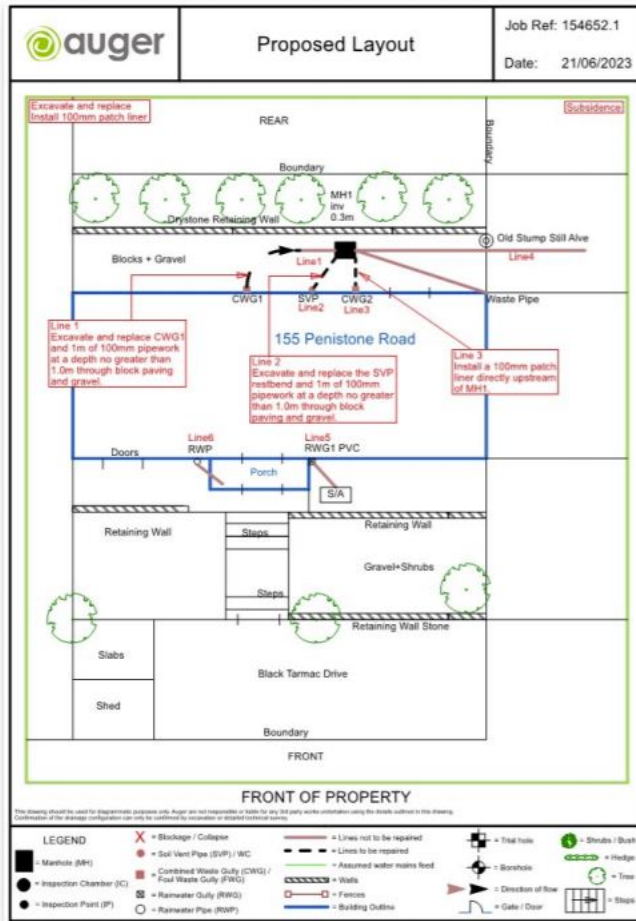
A survey of the drains noted damage to lines 1, 2 and 3 to the rear.

We will also arrange repairs to the damaged drains at the rear.

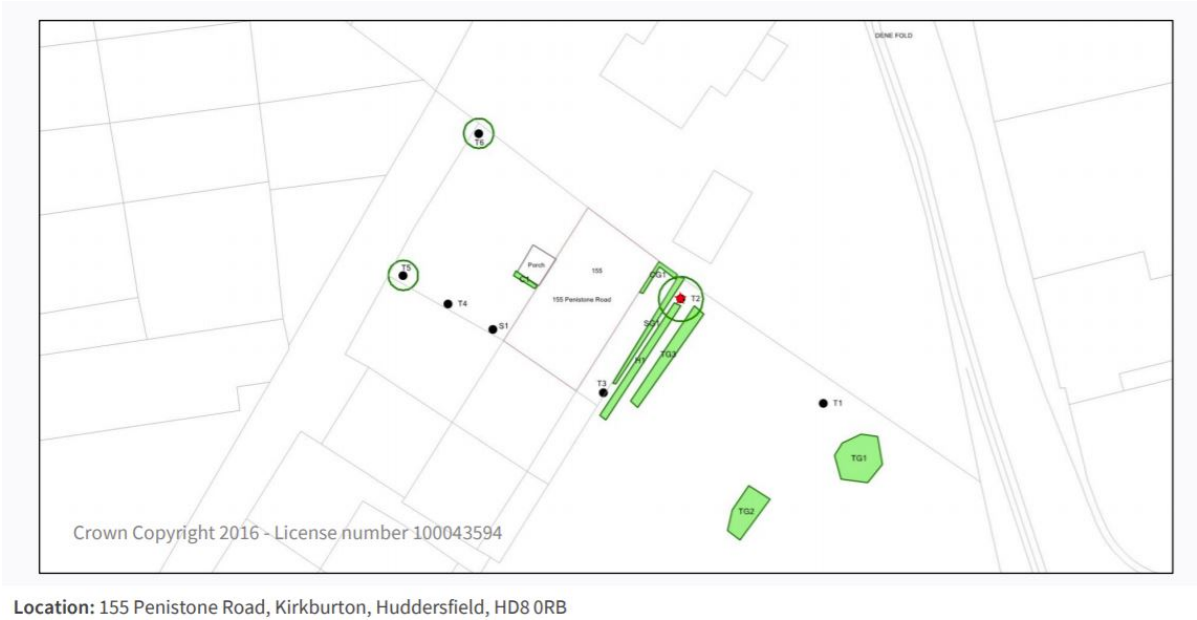
Kirklees Council has confirmed that none of the implicated vegetation is subject to a Tree Preservation Order. There are Conservation Area controls.

Our mitigation team will liaise with the Third Party to fell the Holly.
