# Bat Scoping Survey to

47 North Cross Road

Fixby

26<sup>th</sup> February 2024

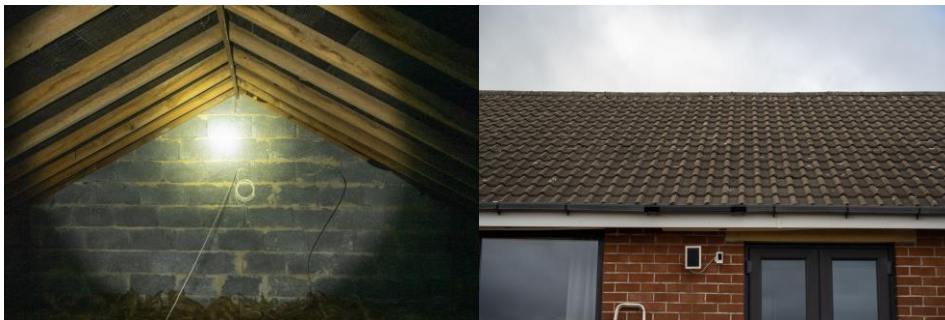
The site comprises a small, detached brick-built bungalow with a Marley modern tile to the roof. These tiles are tightly interlocking and prevent access by bats. All roof tiles are present and there are no missing or slipped tiles and all ridge tiles are present without any signs of failed mortar. Internally, the roof is lined with traditional materials and there is no light ingress along the ridge. There were no signs of use by bats inside the loft and both internal gables were closely inspected. There were no scattered droppings or discarded prey remains. There was nothing to suggest the roof has been used by bats.

Photo 1: internal and external roof detail

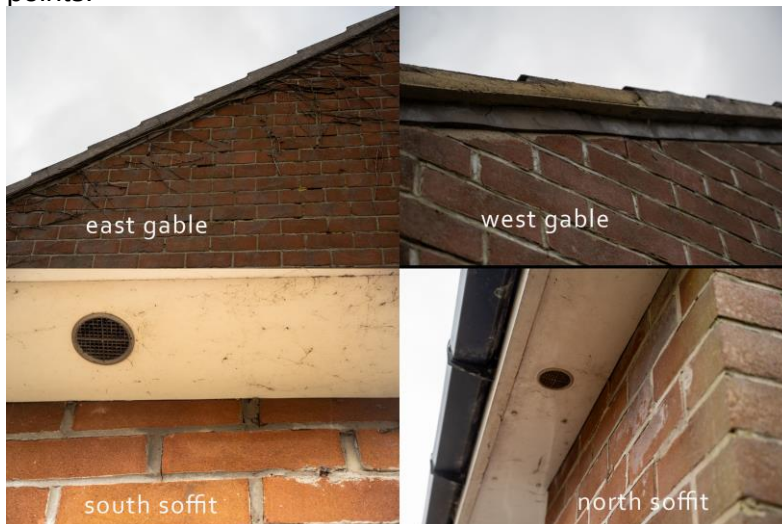
The dry verge on the east elevation is sound and has no failed mortar and it is unlikely that bats would be able to access the verge. The west elevation verge has a flashing that sits between the tiles and the wall and is flat and without gaps. The deep UPVC soffits that run the length of the north and south elevations are fitted tightly to the walls and do not offer any potential access points.

Photo 2: Gable wall and soffit details

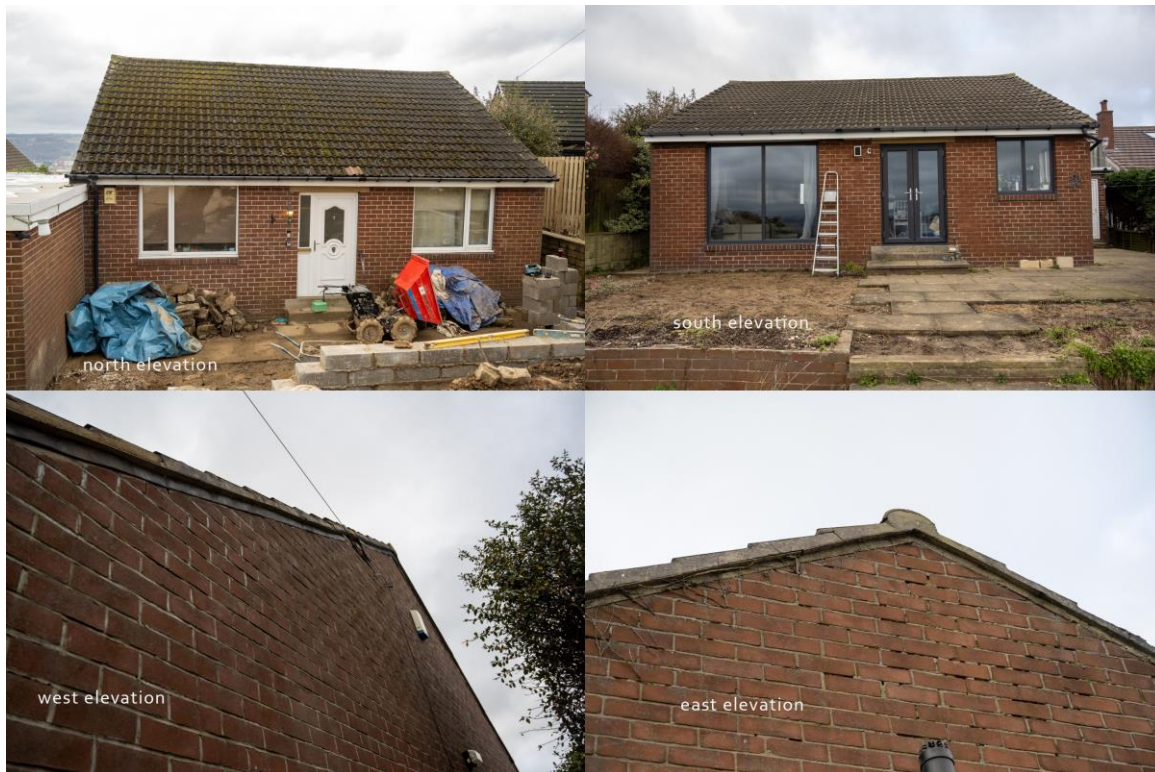
The brick walls have a standard cavity but there are no open joints, structural cracks or gaps that would allow access. The windows and doors are all UPVC and do not offer any potential access points.

Photo 3: General view of the building
