## 5. BRICK STREET

## 6. QUARRY ROAD

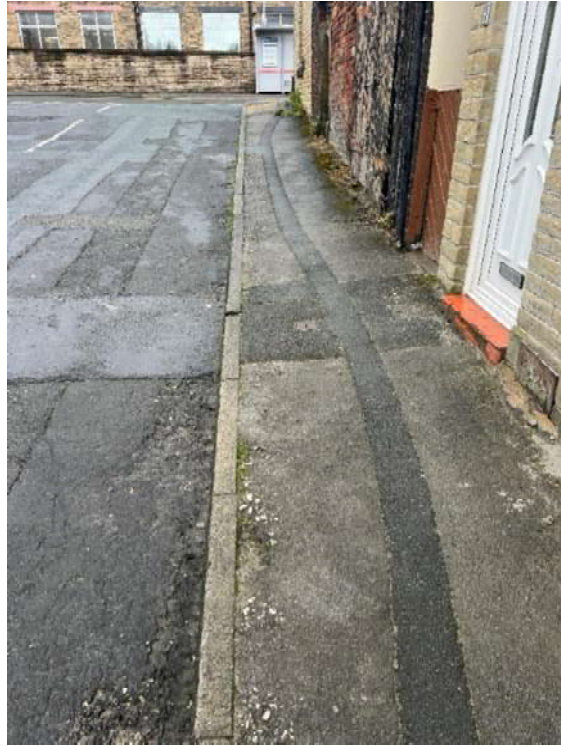
Photo 9 – Footway and carriageway severely fatigued along kerb line and visible trench scars in footway and carriageway.

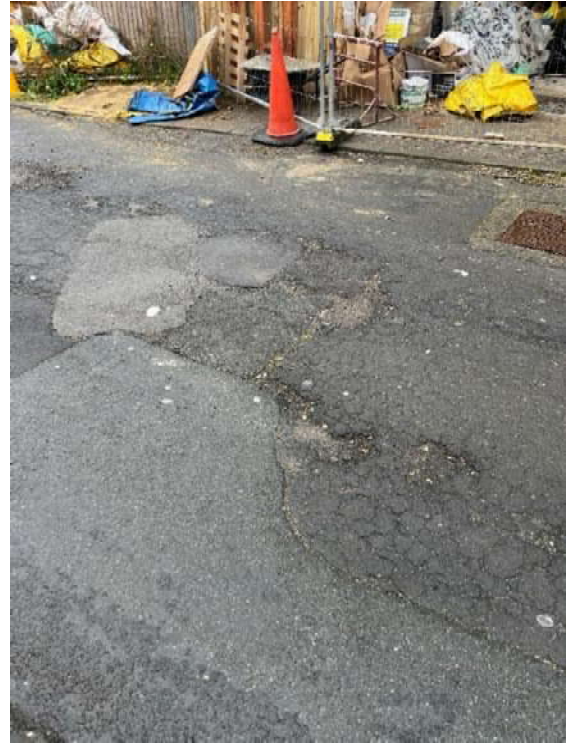
Photo 10 – Carriageway has deteriorated severely

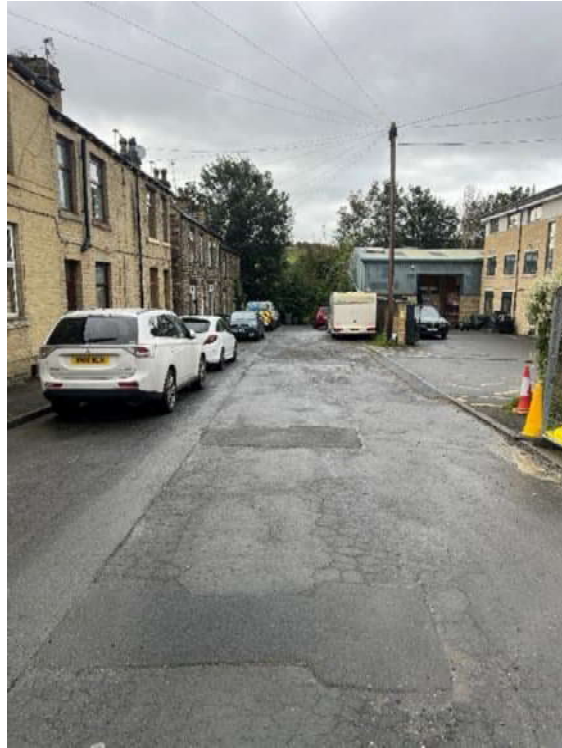
Photo 11 – Carriageway surfacing is fatigued and visible trench scars

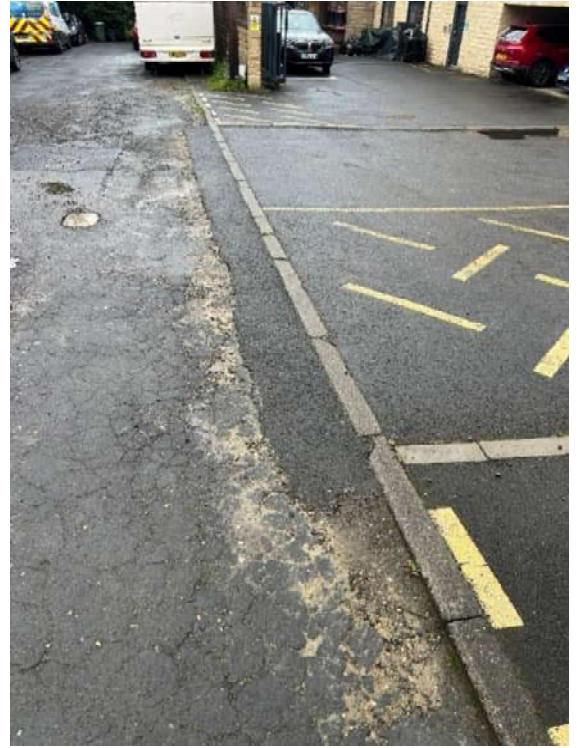
Photo 12 – Ramp has been installed for access

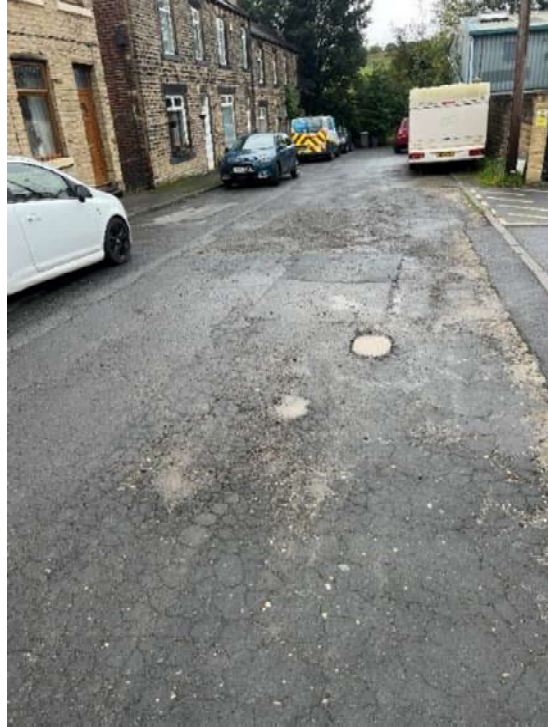
Photo 13 – Deterioration of carriageway, causing pot holes, pooling of water.

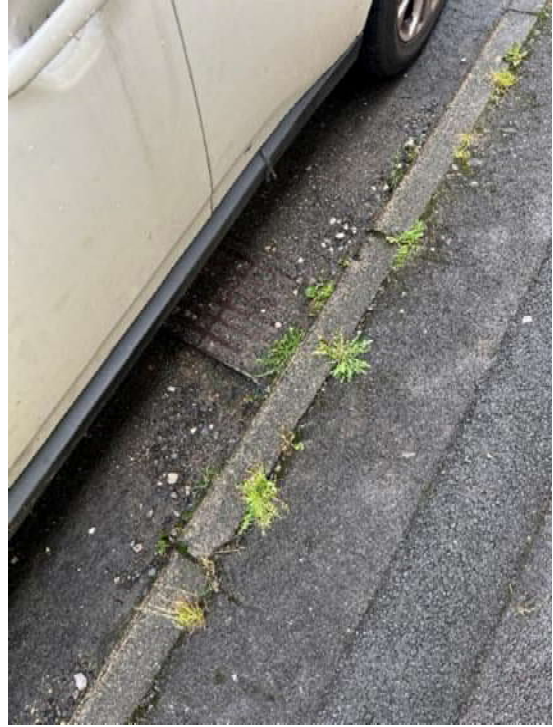
Photo 14 – Gully blocked

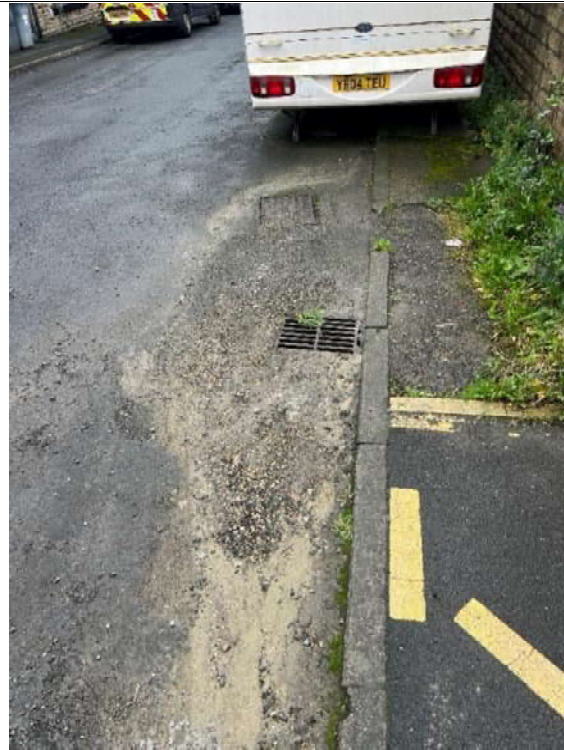
Photo 15 – Deposits around gully and cover. Gully is not blocked. Kerbing is cracked and damaged. Carriageway surface is fatigued.

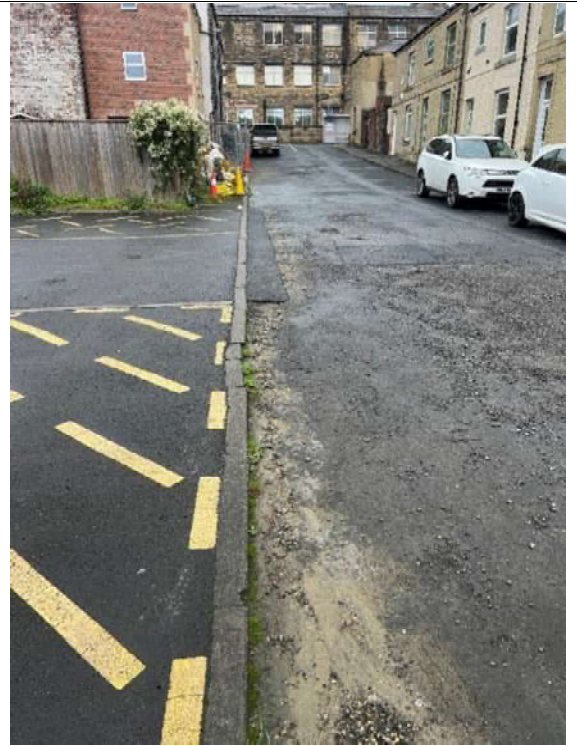
Photo 16 – Kerbing is out of place

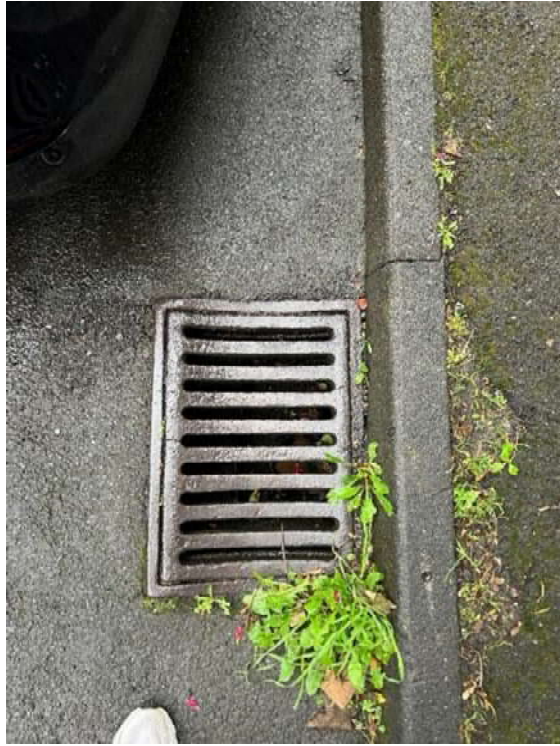
Photo 17 – Gully at bottom of Taylor Street  
clear

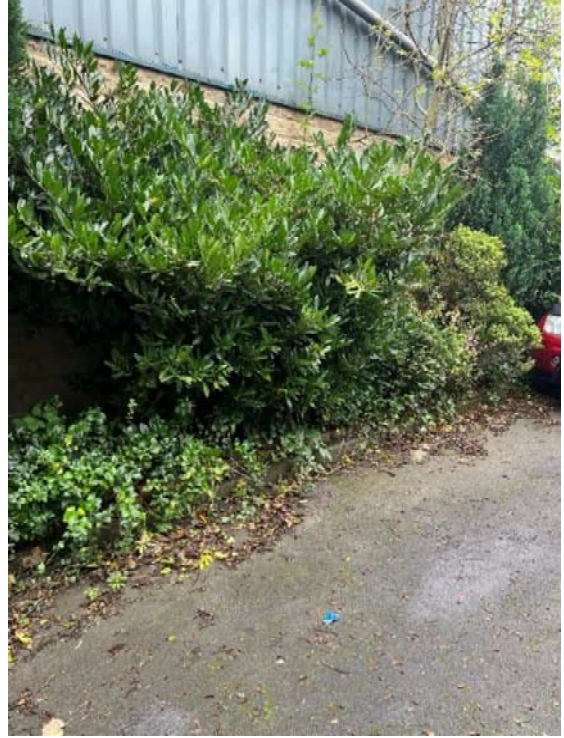
Photo 18 – Overgrown vegetation

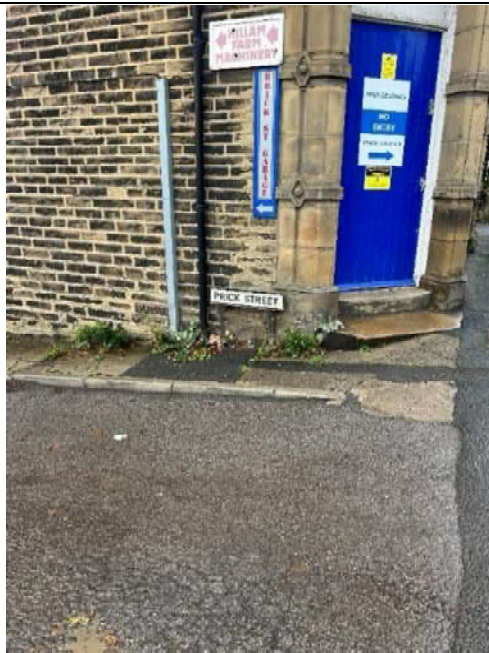
Photo 1 – Street name plate damaged, vegetation overgrown, footway surface cracked, visible trench lines and change in surfacing.

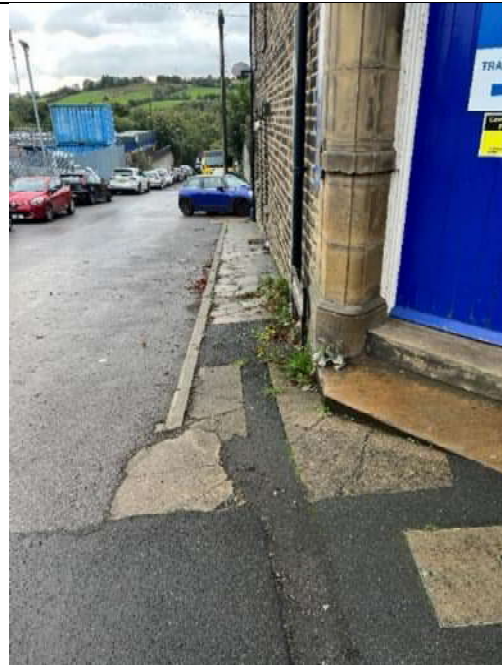
Photo 2 – Footway severely fatigued, visible trench lines

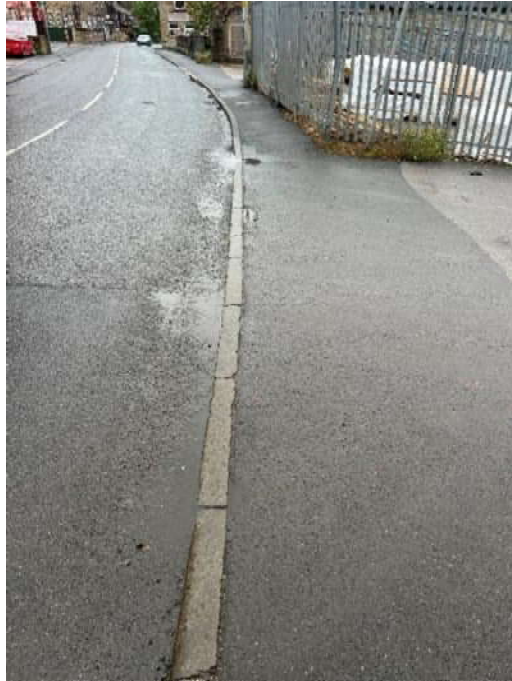
Photo 3 – kerbing not level and cracked, surfacing is fatigued and is pooling of water at far end of junction with Westgate

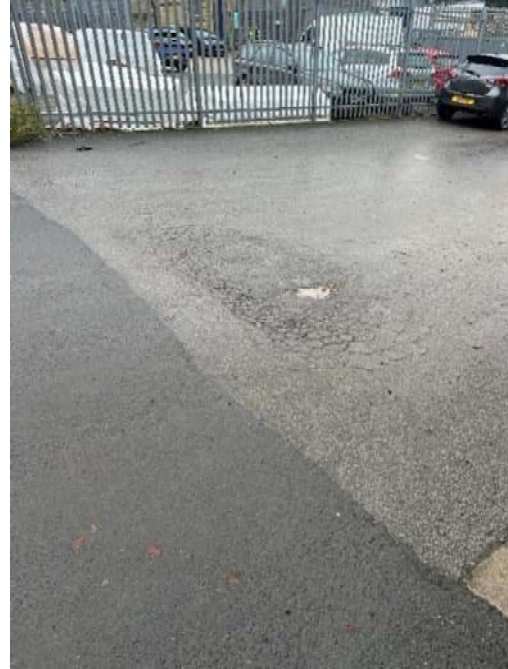
Photo 4 – Fatigued surface with water pooling in centre

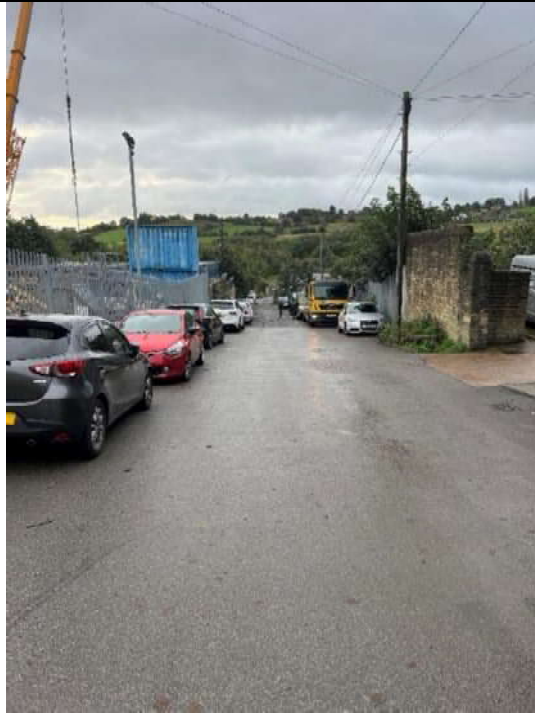
Photo 6 – General wear of edging

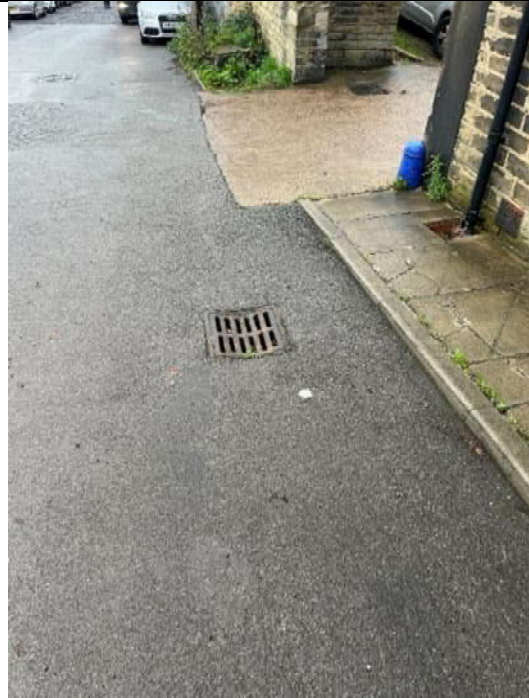
Photo 7 – General wear of carriageway

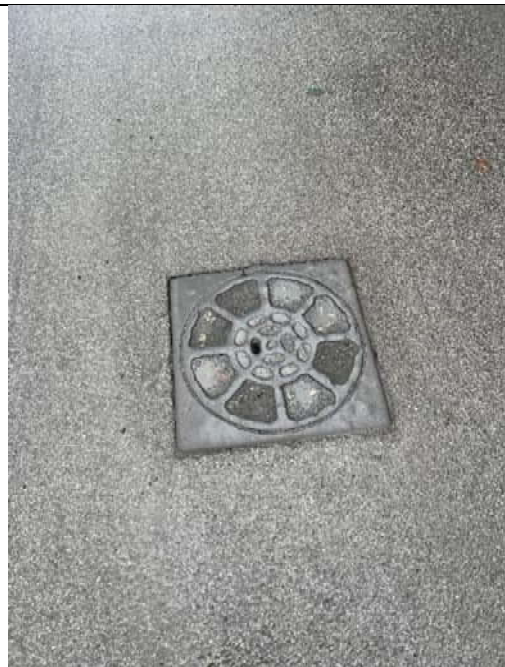
Photo 9 – Fatiguing of surface of carriageway

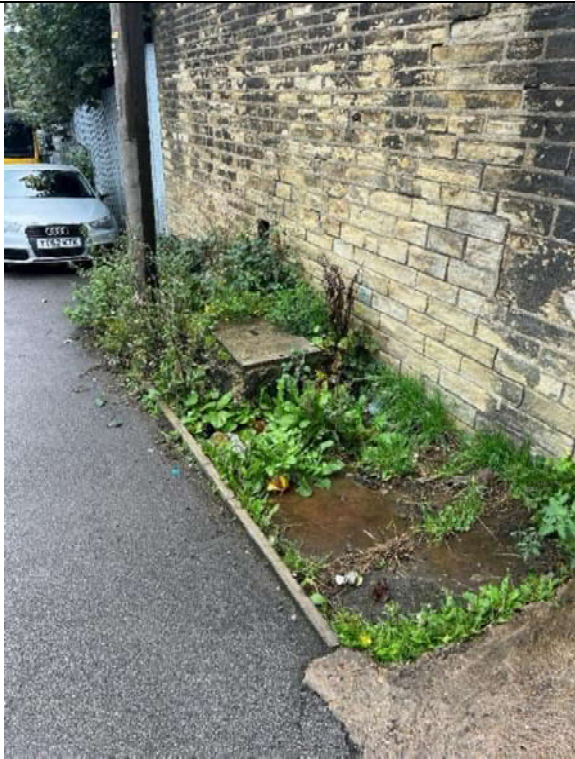
Photo 10 – General wear of cover

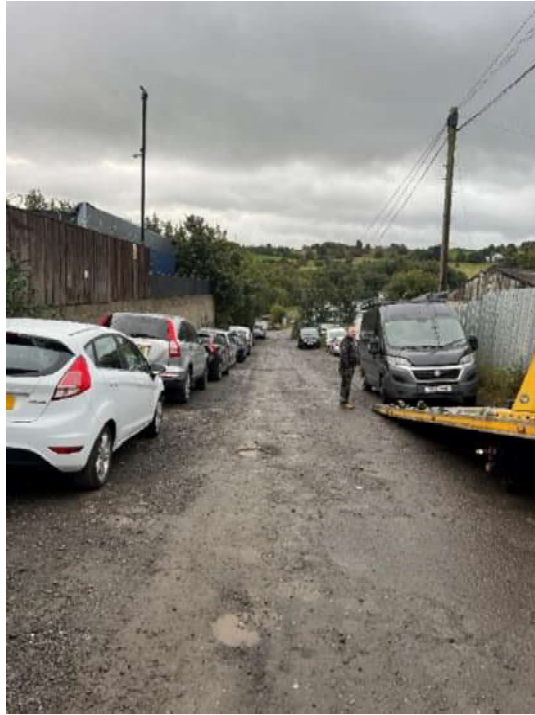
Photo 13 – Severely deteriorated surfacing, pitting and pooling of water.

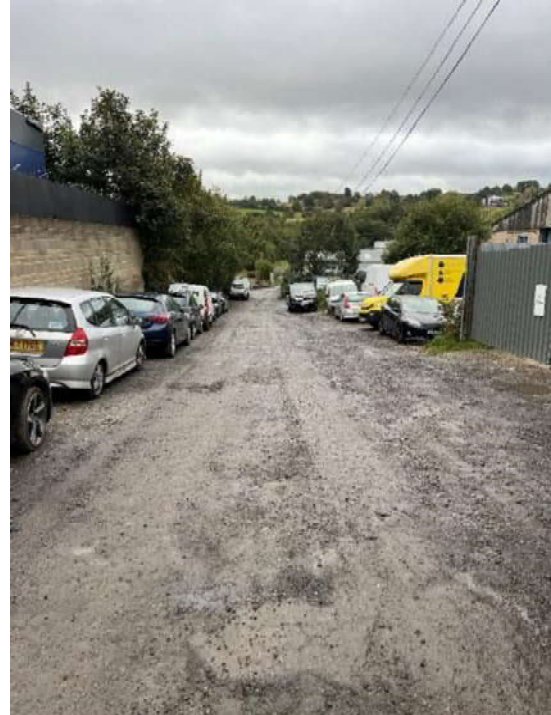
Photo 14 – Severely deteriorated surface, pooling of water in some areas.

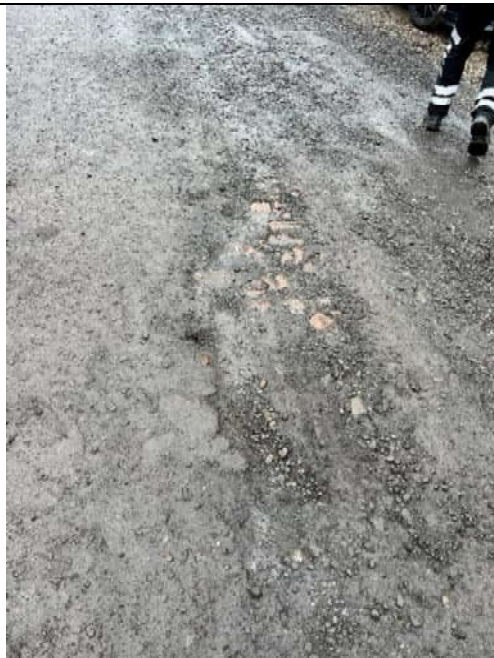
Photo 15 – Brick under surface exposed

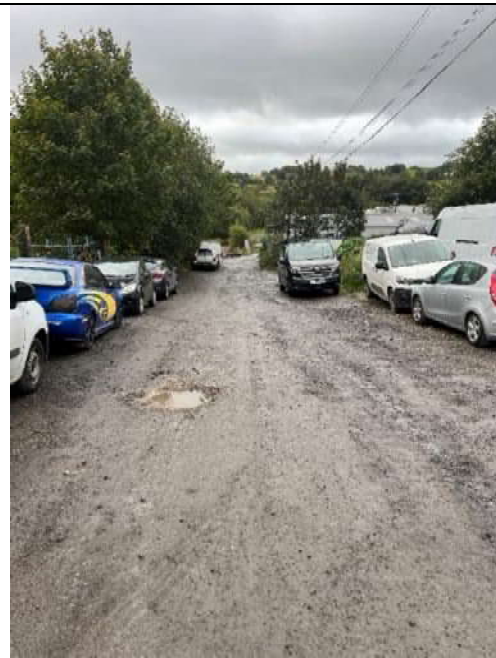
Photo 16 – Pooling of water in pot hole on surface, Severely deteriorated surface.

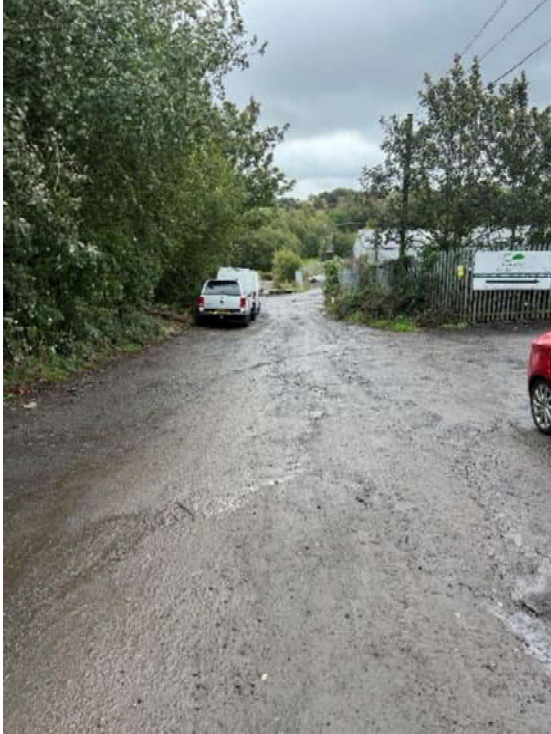
Photo 17 – Severely deteriorated carriageway surfacing

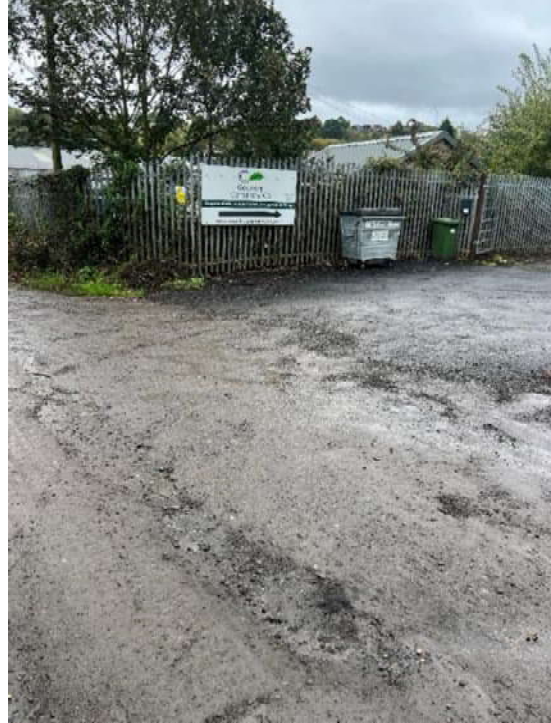
Photo 18 – Severely deteriorated carriageway surfacing

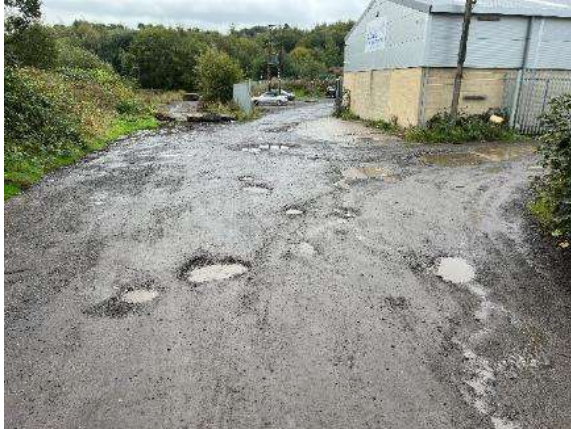
Photo 19 – Severe pot holes at bottom of street, with pooling of water.

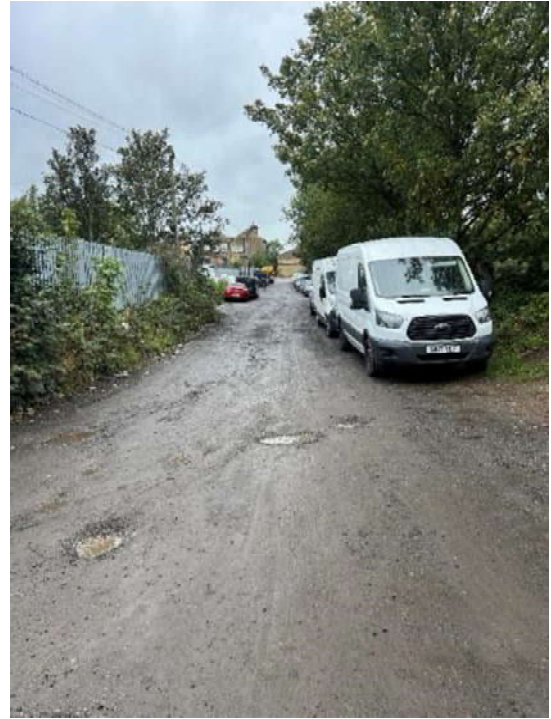
Photo 20 – Severe pot holes at bottom of street, with pooling of water.

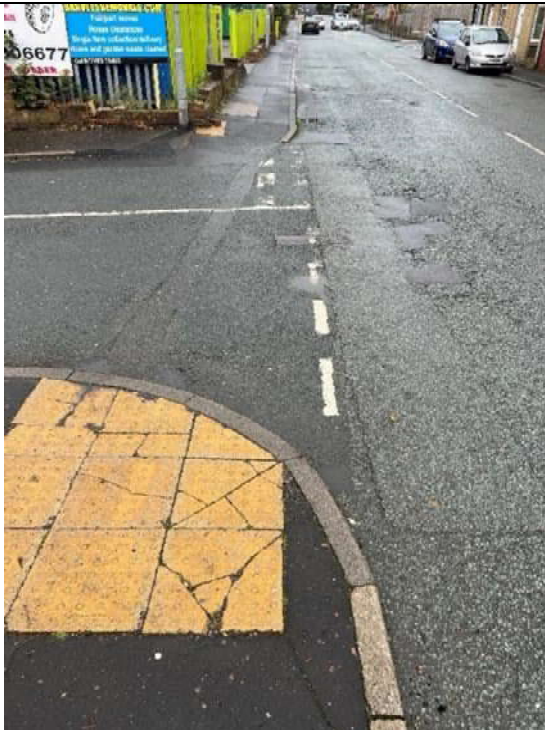
Photo 1 – Trench scars across the junction, junction markings worn, tactiles cracked

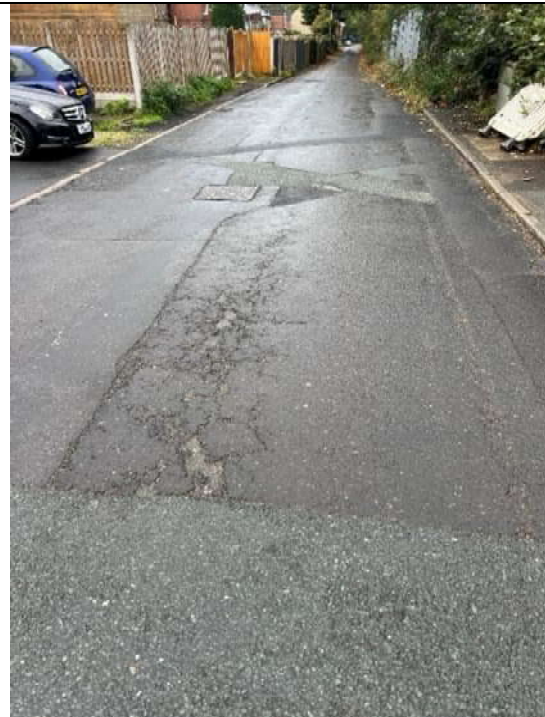
Photo 2 – Deterioration of carriageway surface, clear trench scars throughout the street

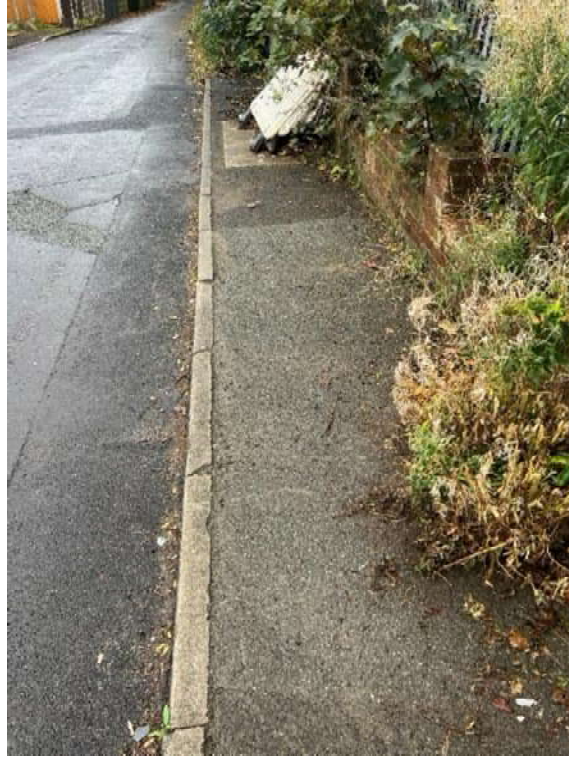
Photo 3 – Kerbing is chipped

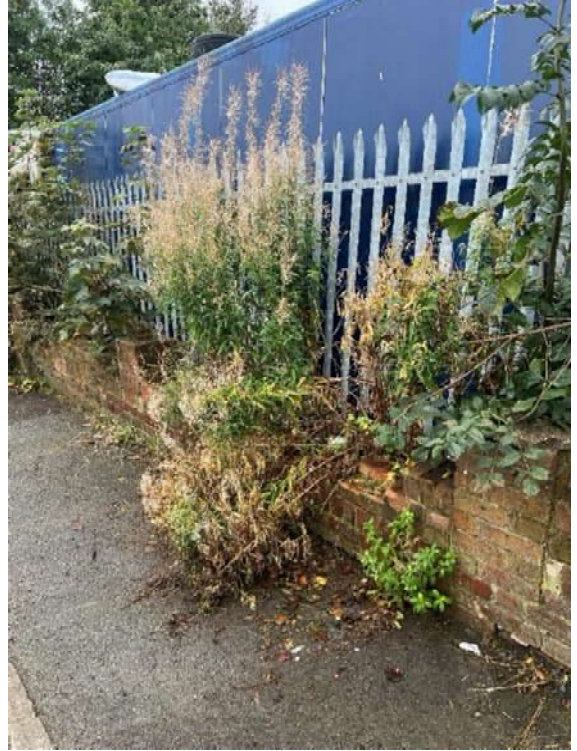
Photo 4 – Damaged brick work, over grown vegetation

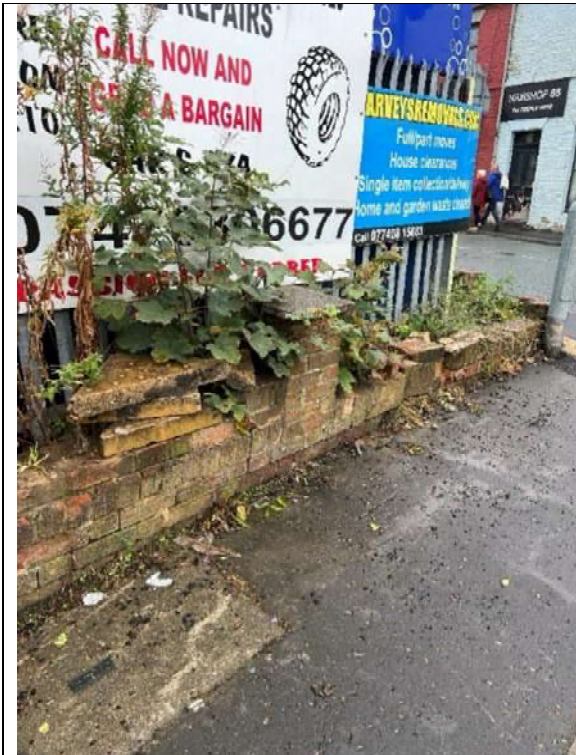
Photo 5 – Damaged brick work, overgrown vegetation

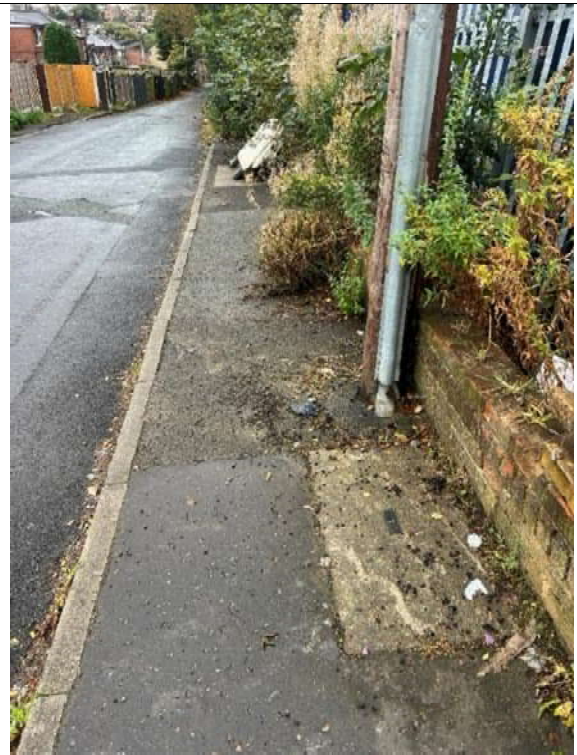
Photo 6 – Debris deposits on footway, scars on footway surfacing. Cover is in an acceptable condition. Kerbing is in acceptable condition.

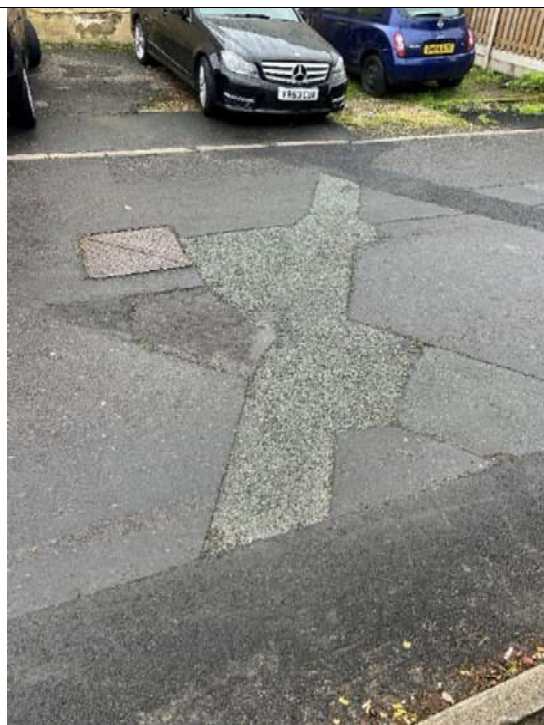
Photo 7 – Trench scars on carriageway surfacing. Iron works in acceptable condition. Debris deposits on kerbside. Kerbing on opposite side of road damaged and out of place.

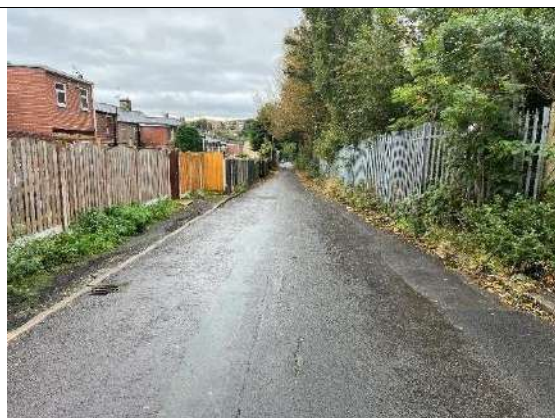
Photo 8 – Trench scars on surfacing full length of carriageway. General wear of carriageway.

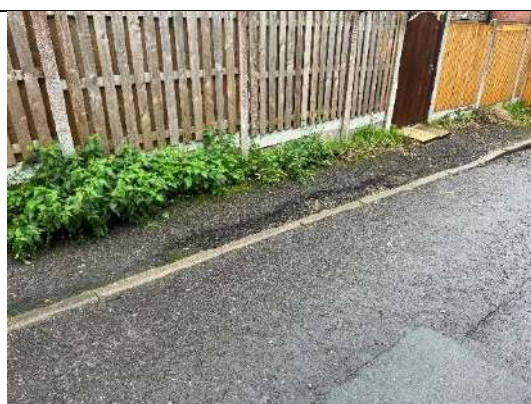
Photo 9 - Severely deteriorated footway surfacing, overgrown vegetation.

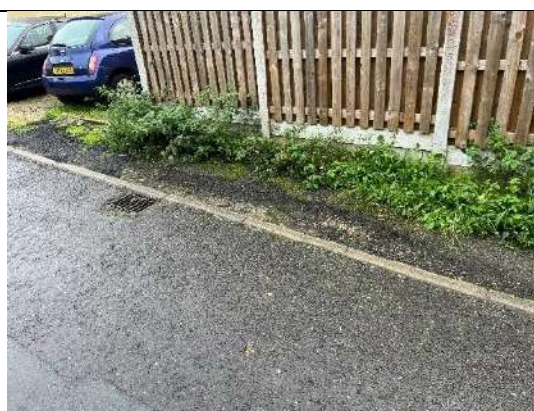
Photo 10 – Severely deteriorated footway surfacing, overgrown vegetation.

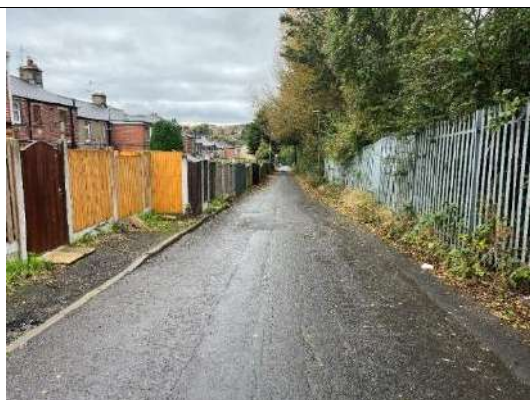
Photo 11 – Trench scars for length of carriageway, overgrown vegetation on edges of footway and carriageway. Leaf deposits on both sides of carriageway.

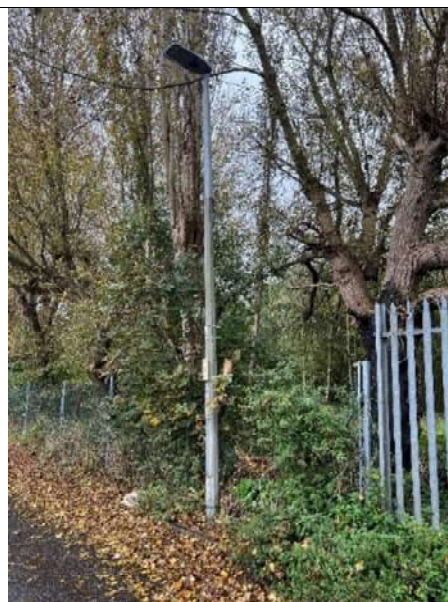
Photo 12 – Lighting column is slanted

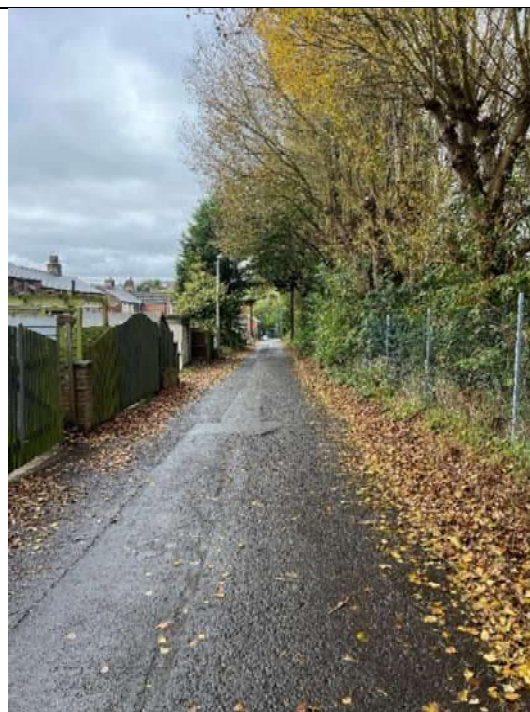
Photo 13 – Trench scars and deterioration of carriageway surfacing, leaf deposits on either side of carriageway.

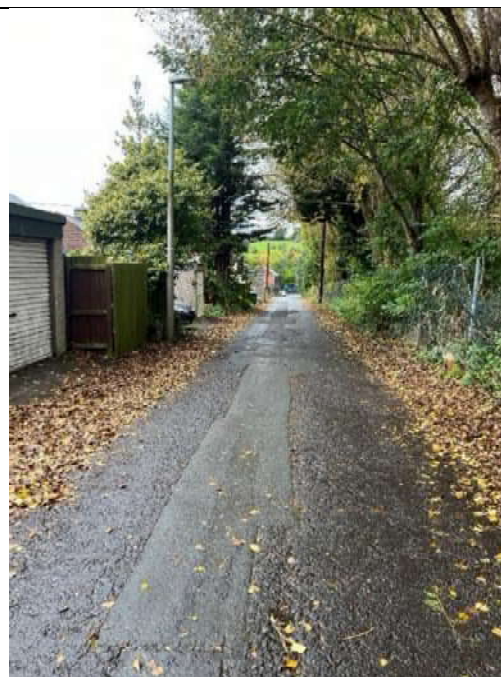
Photo 14 – Trench scars and deterioration of carriageway surfacing, leaf deposits on either side of carriageway.

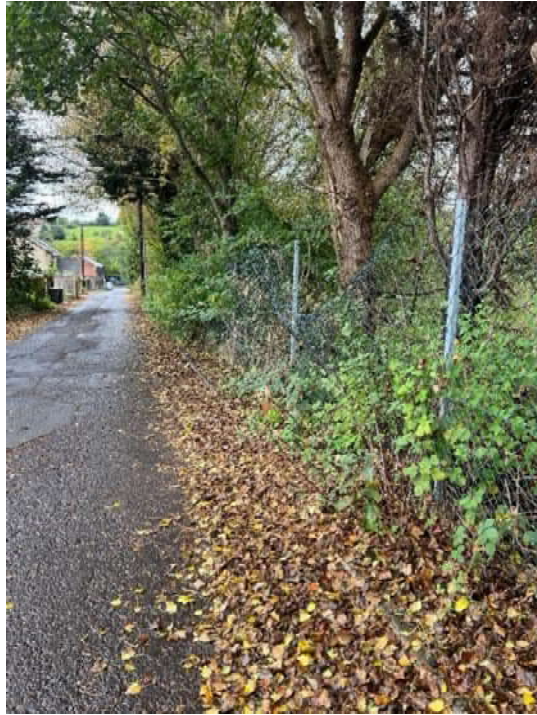
Photo 15 – Damaged fence coming on to highway.

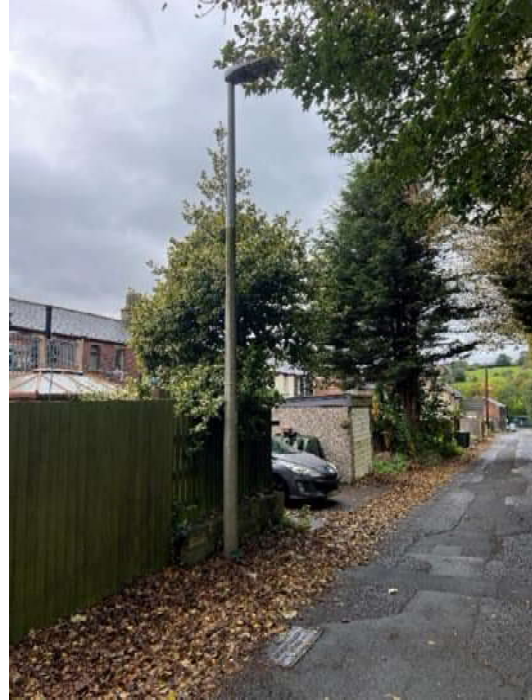
Photo 16 – Lighting column in acceptable condition
