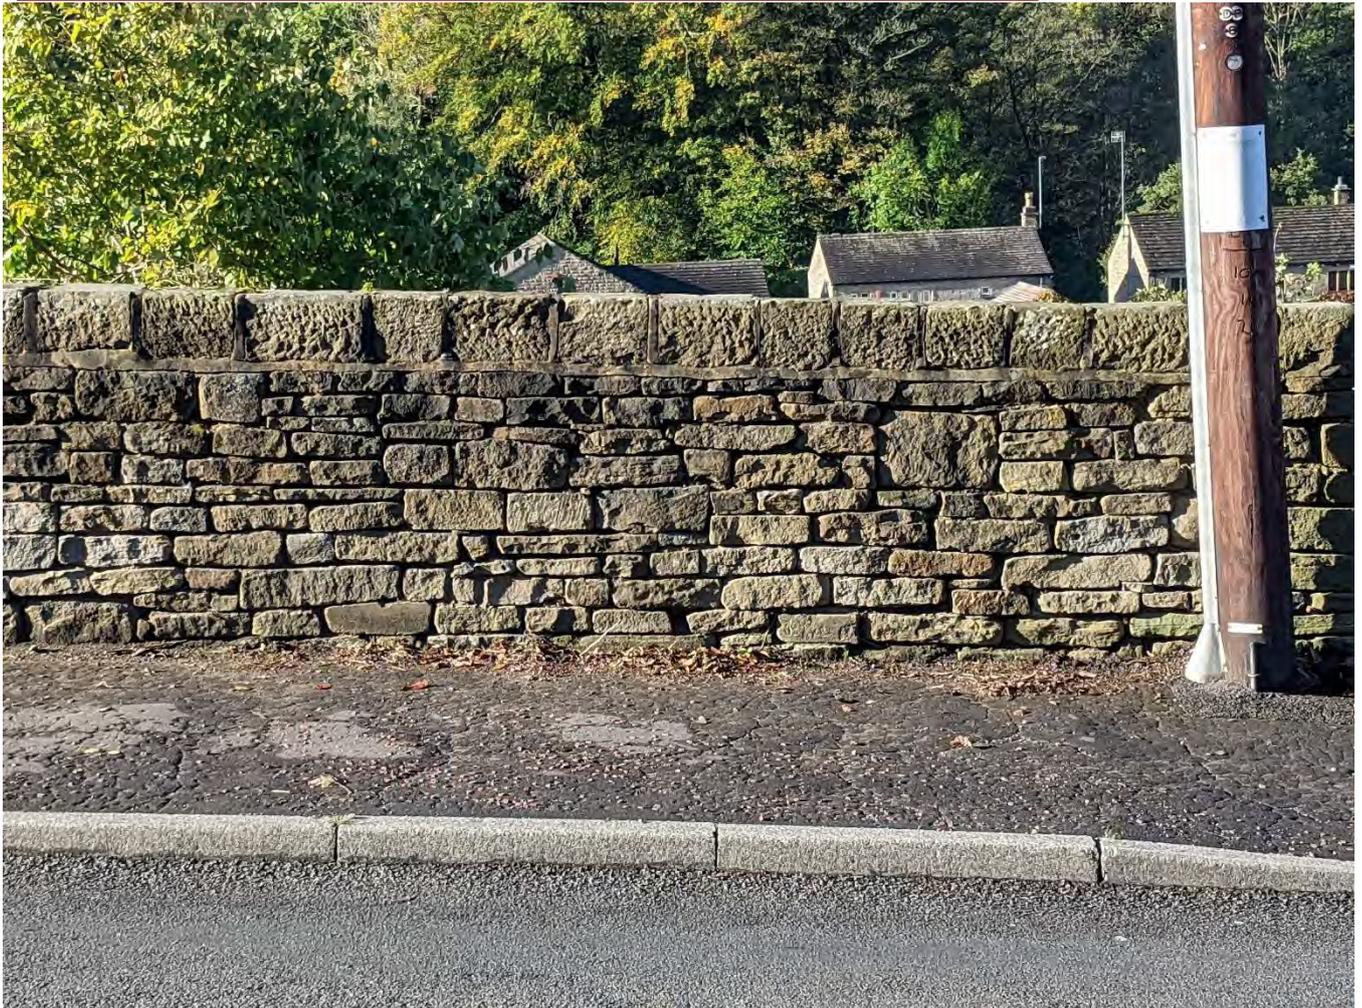
OK

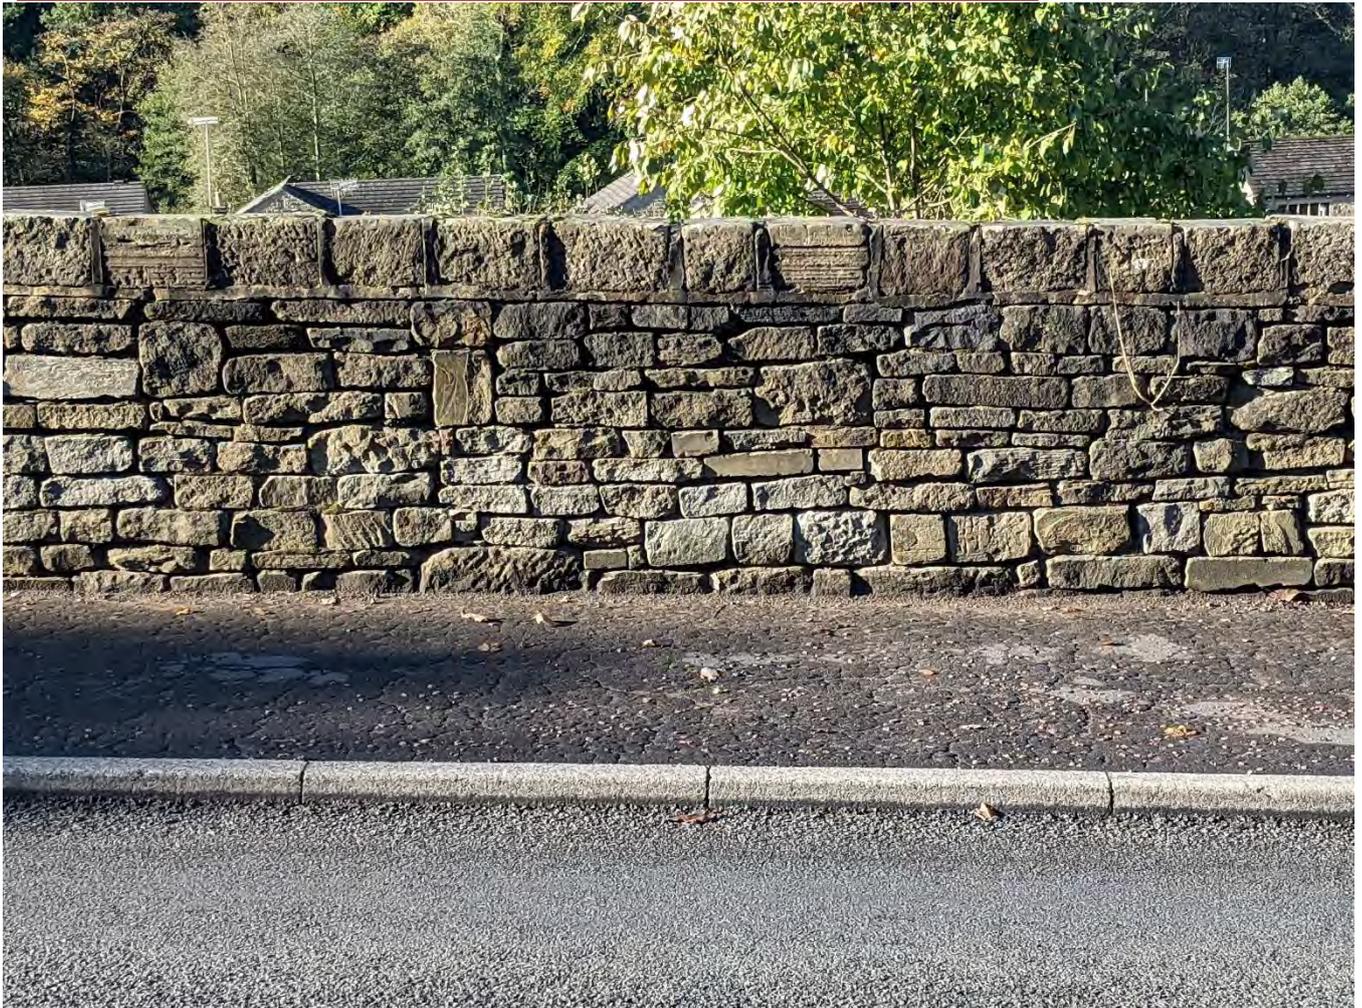
OK

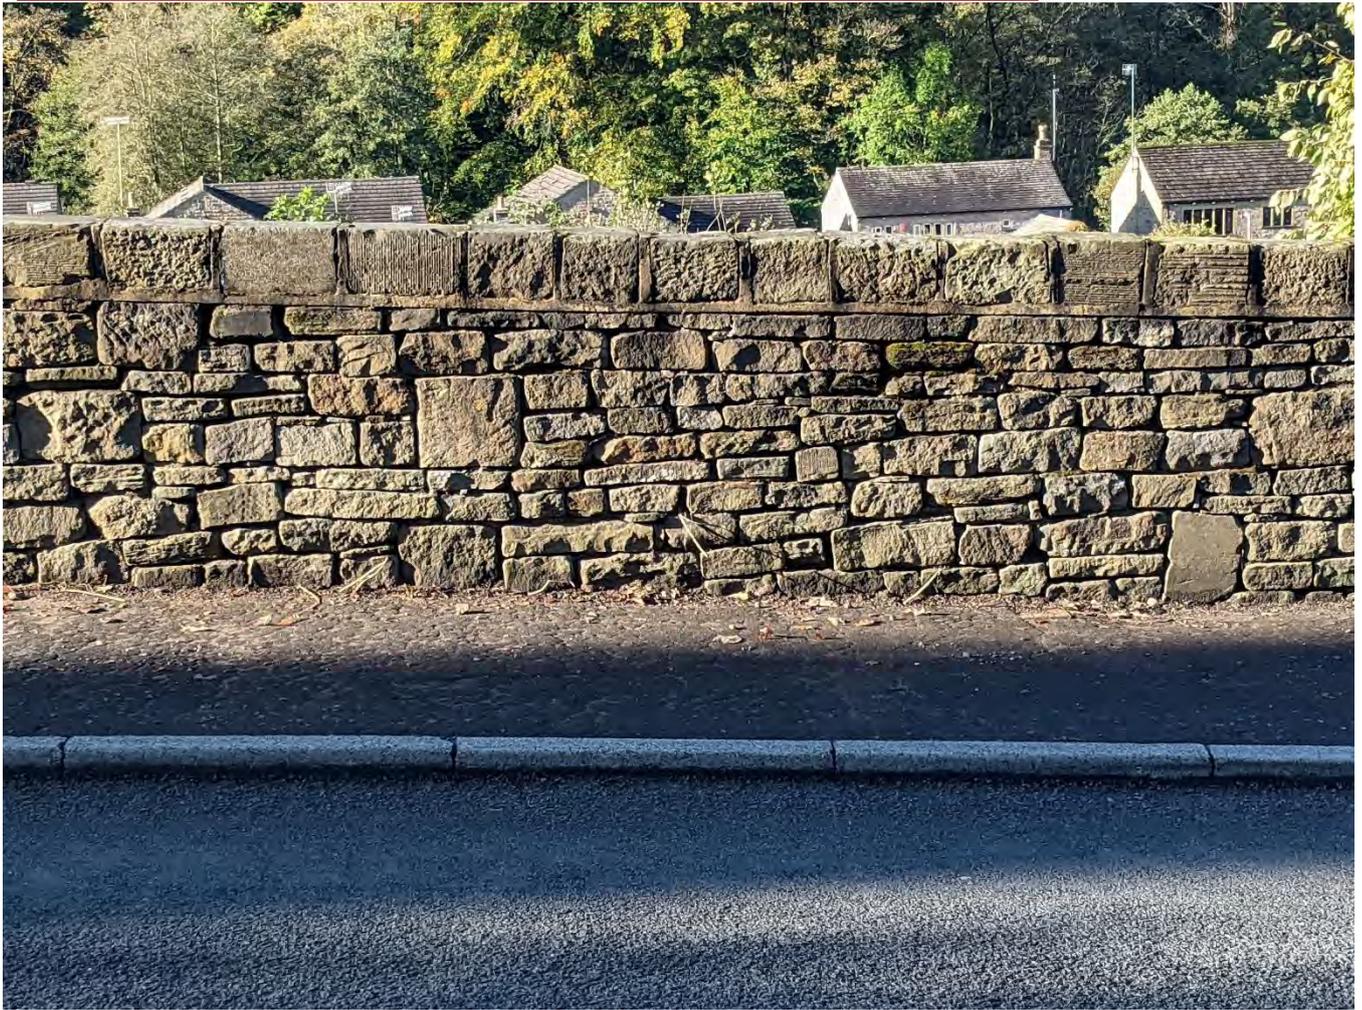
OK

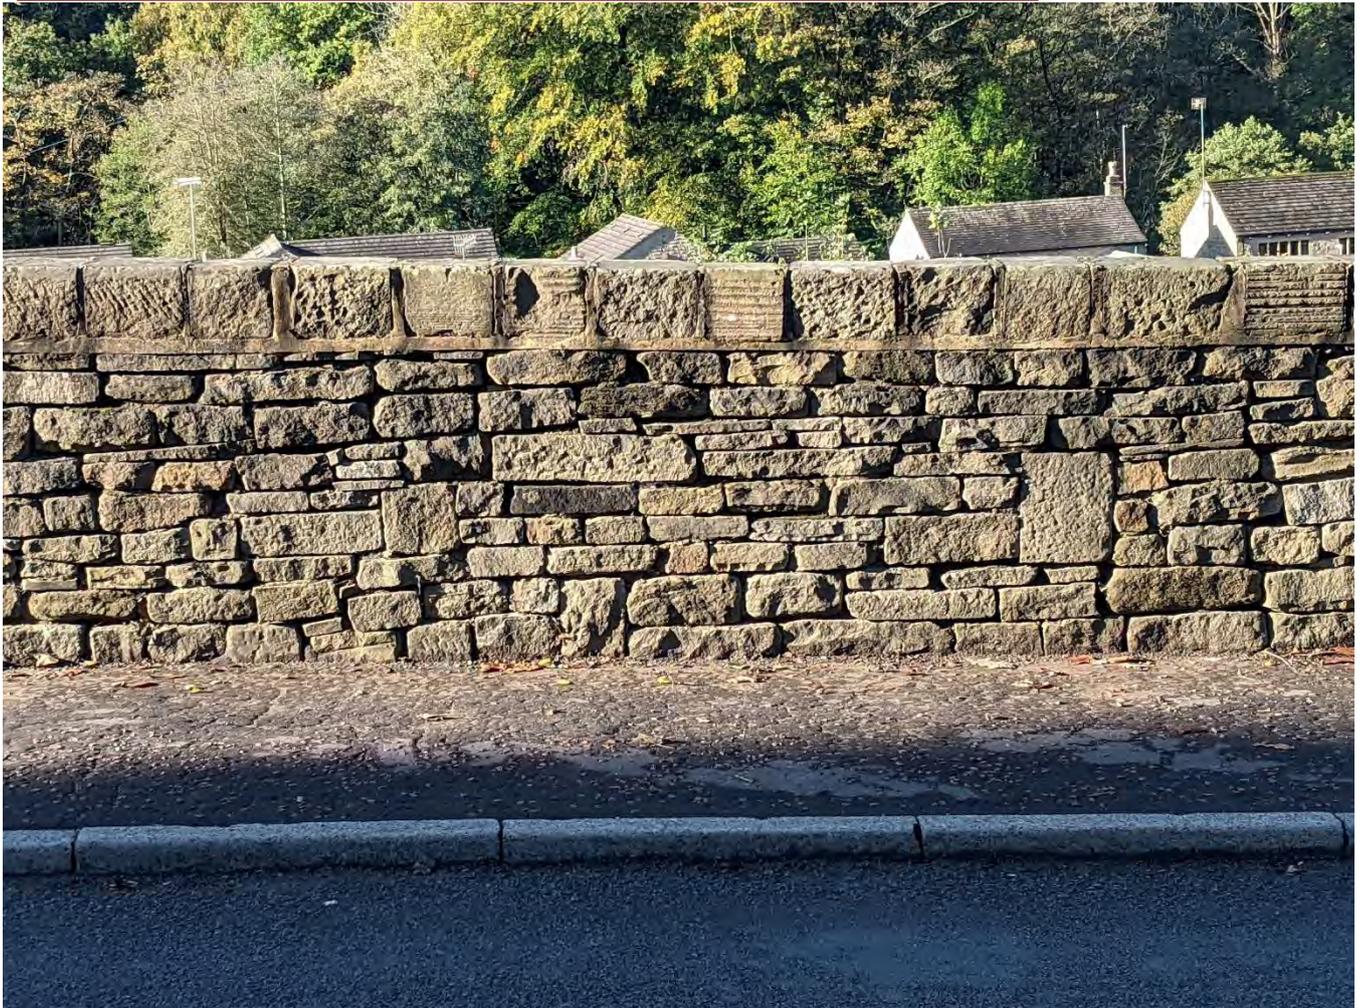
OK

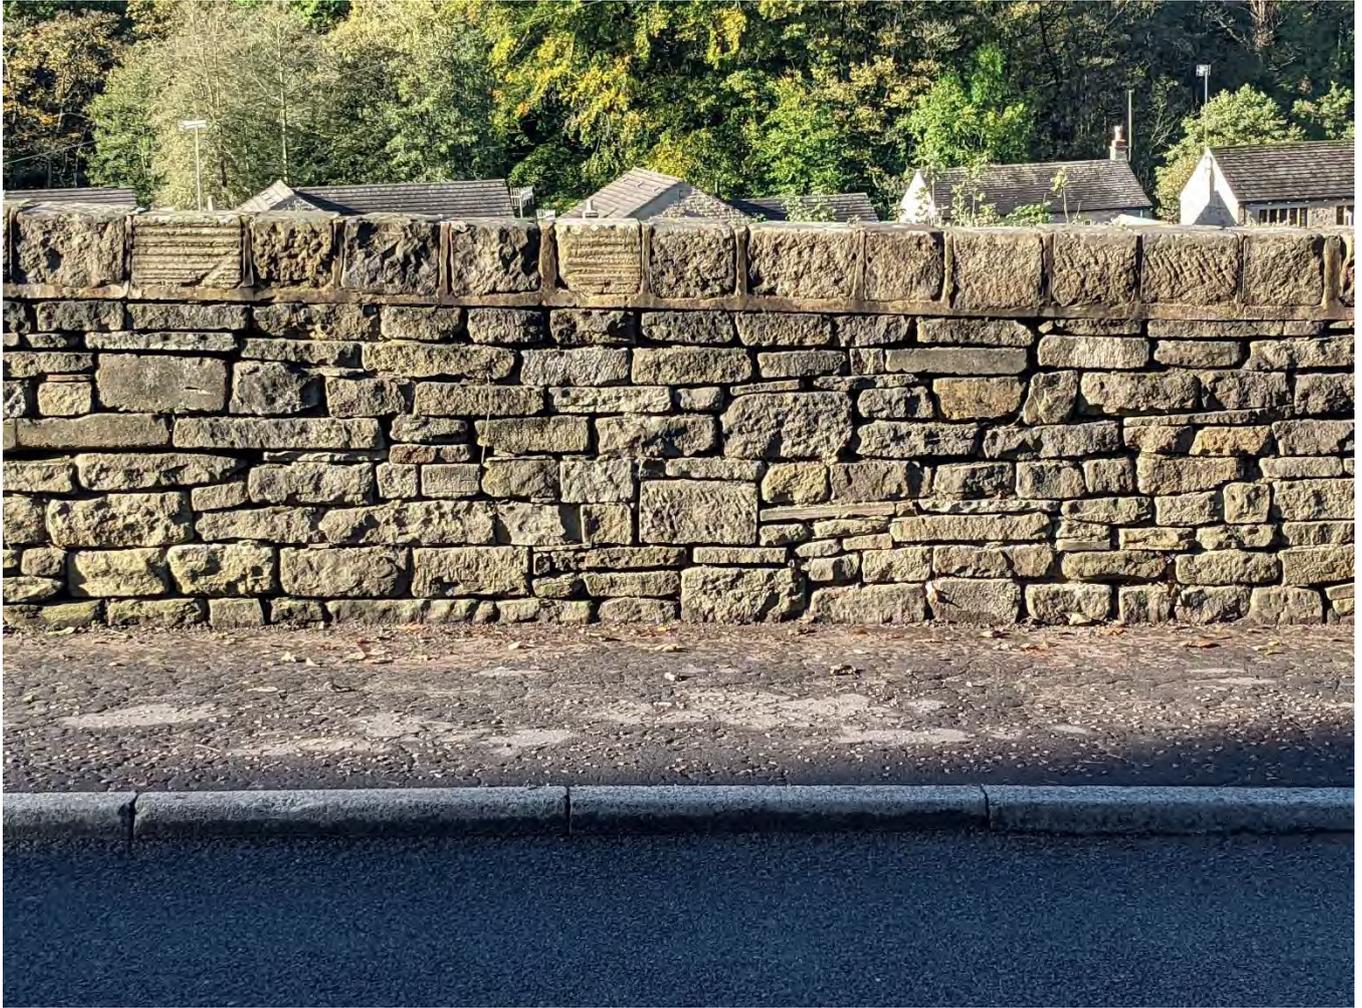
OK

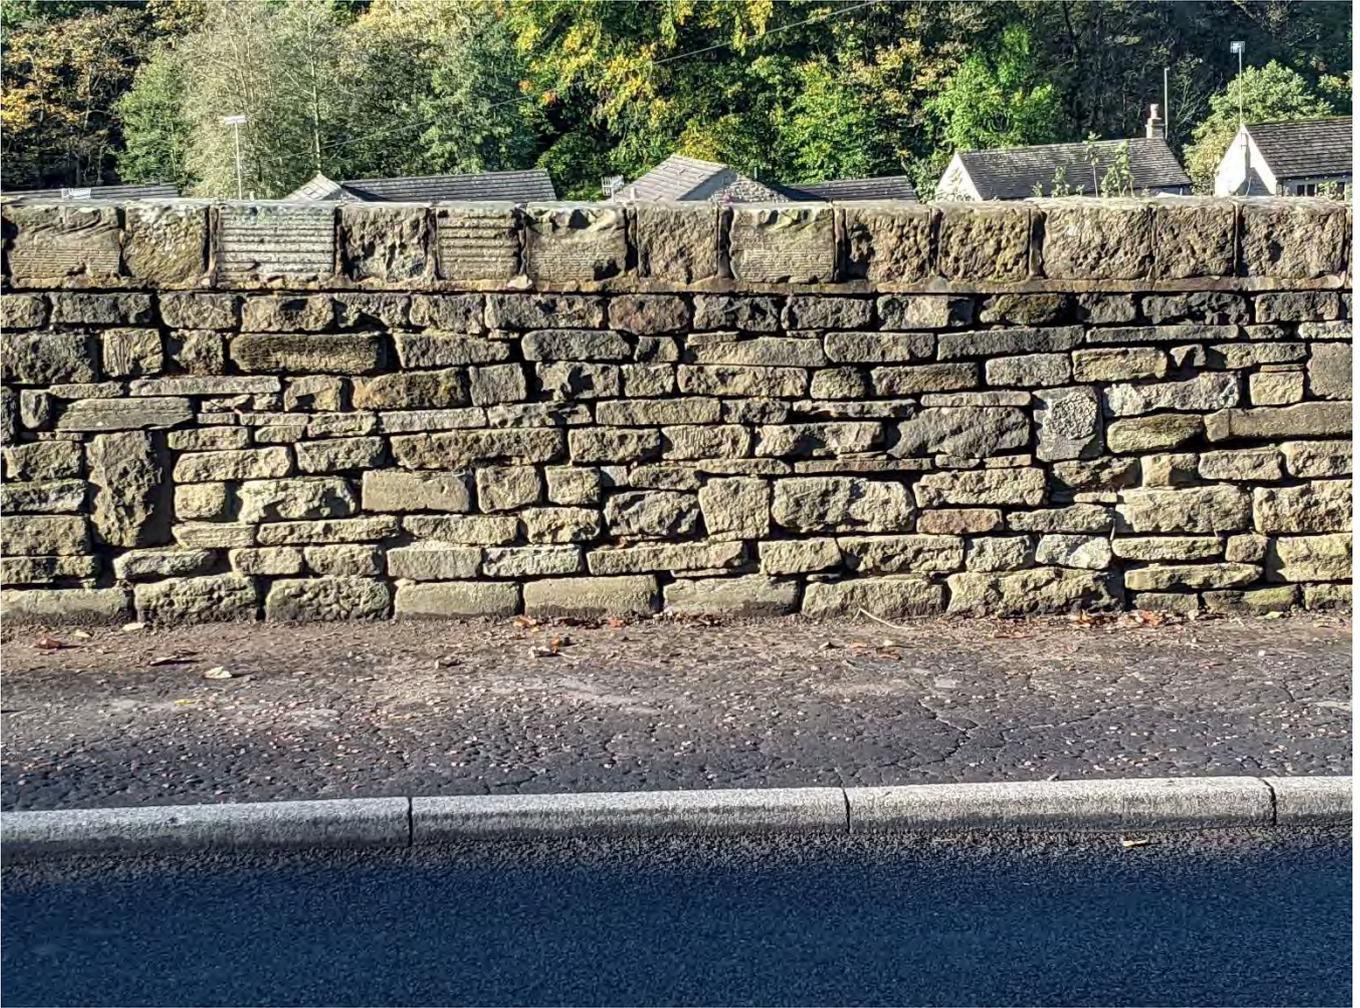
OK

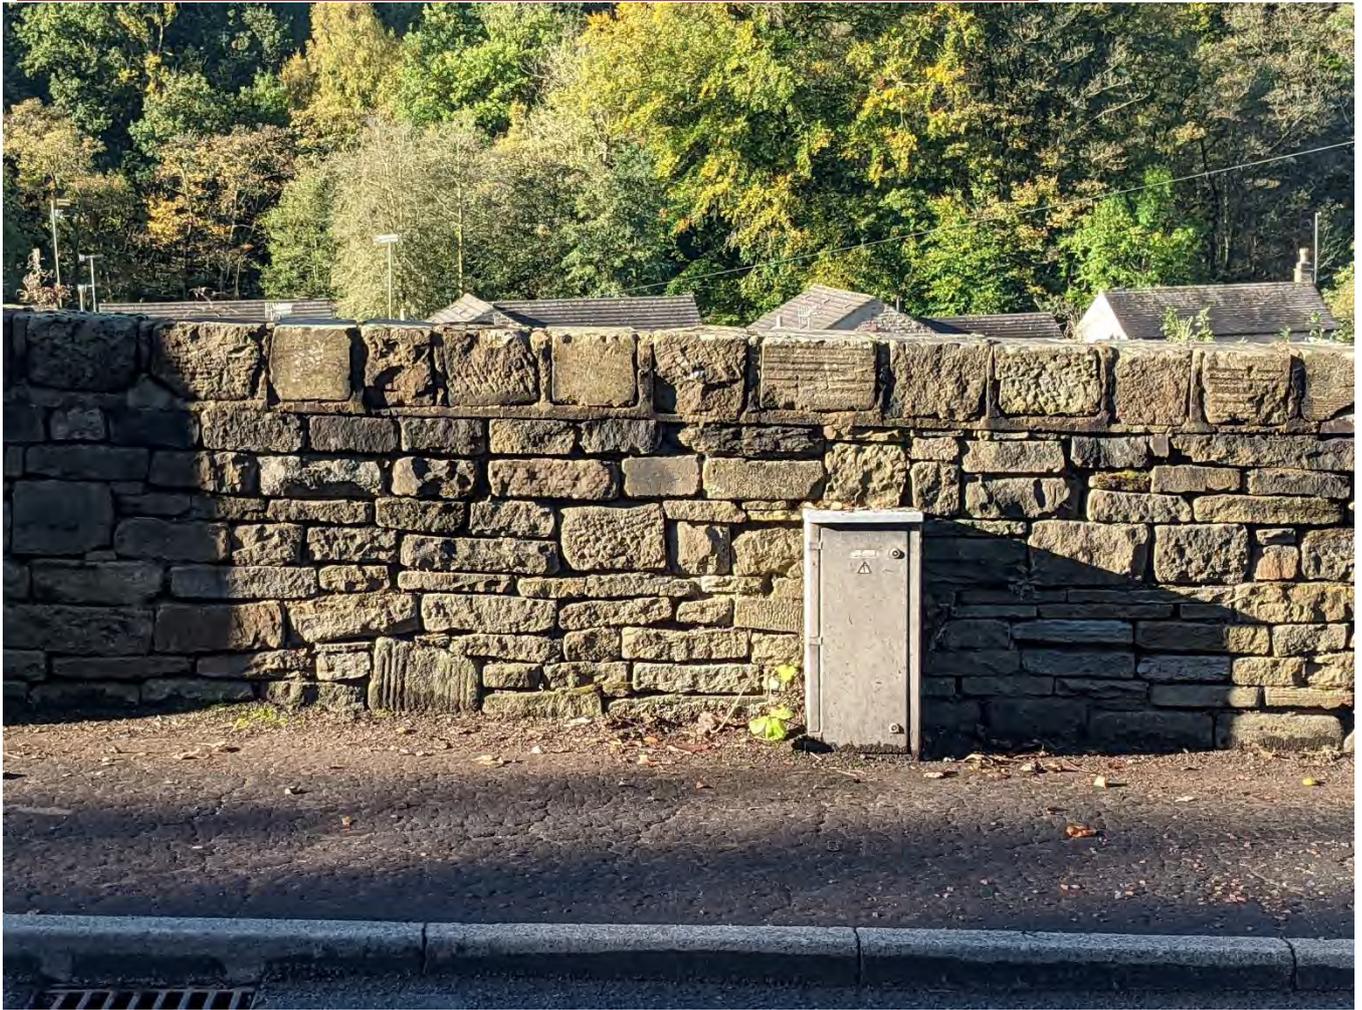
OK

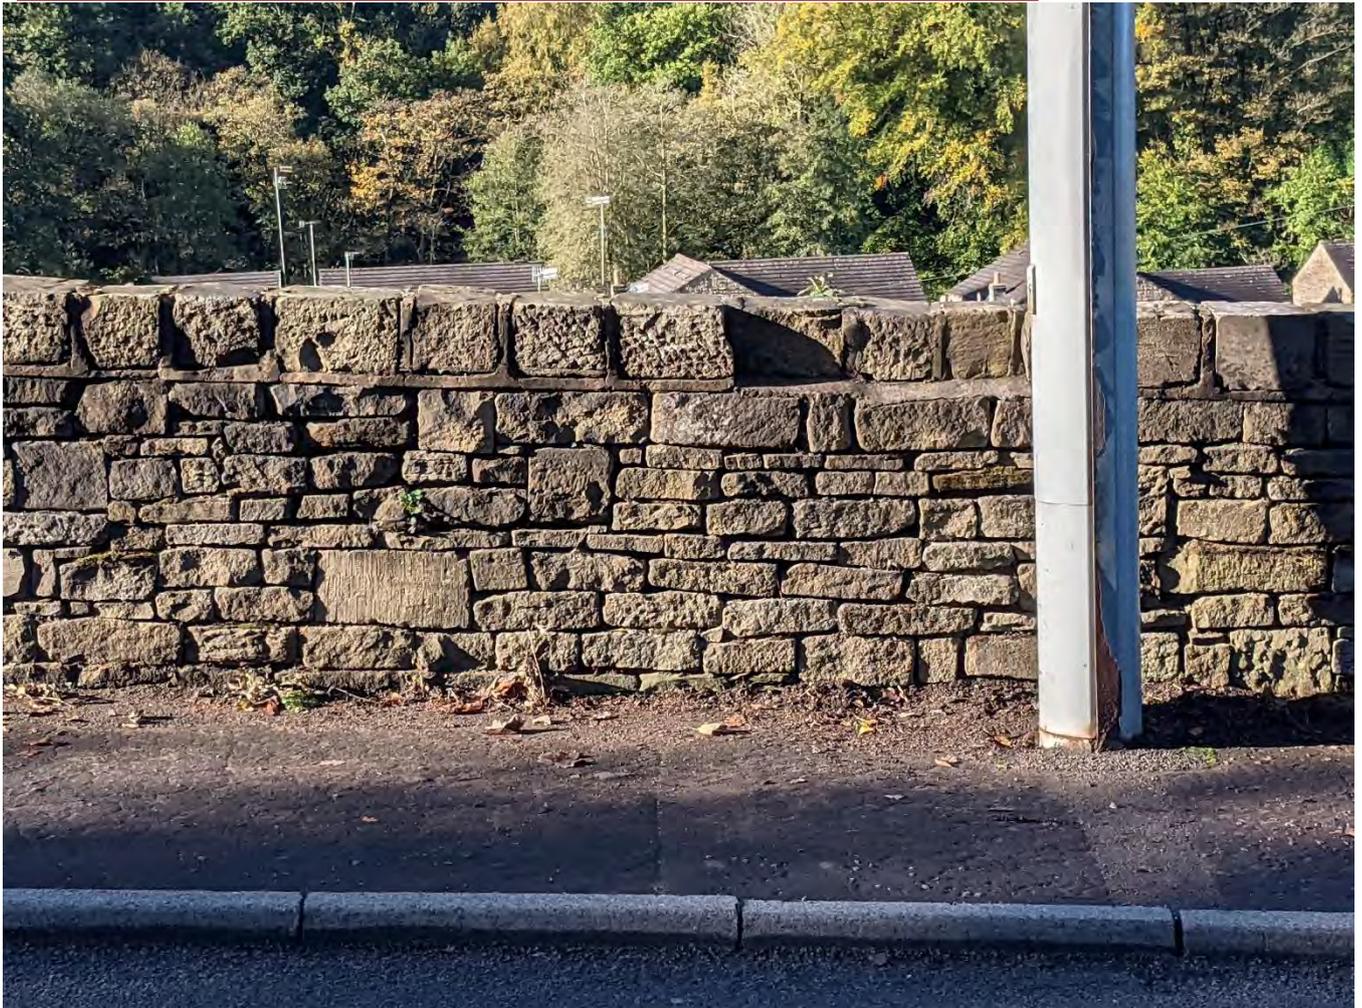
Odd detail in the capping stones adjacent to the post. Three capping stones have been mortared in a set back position. Appears OK.

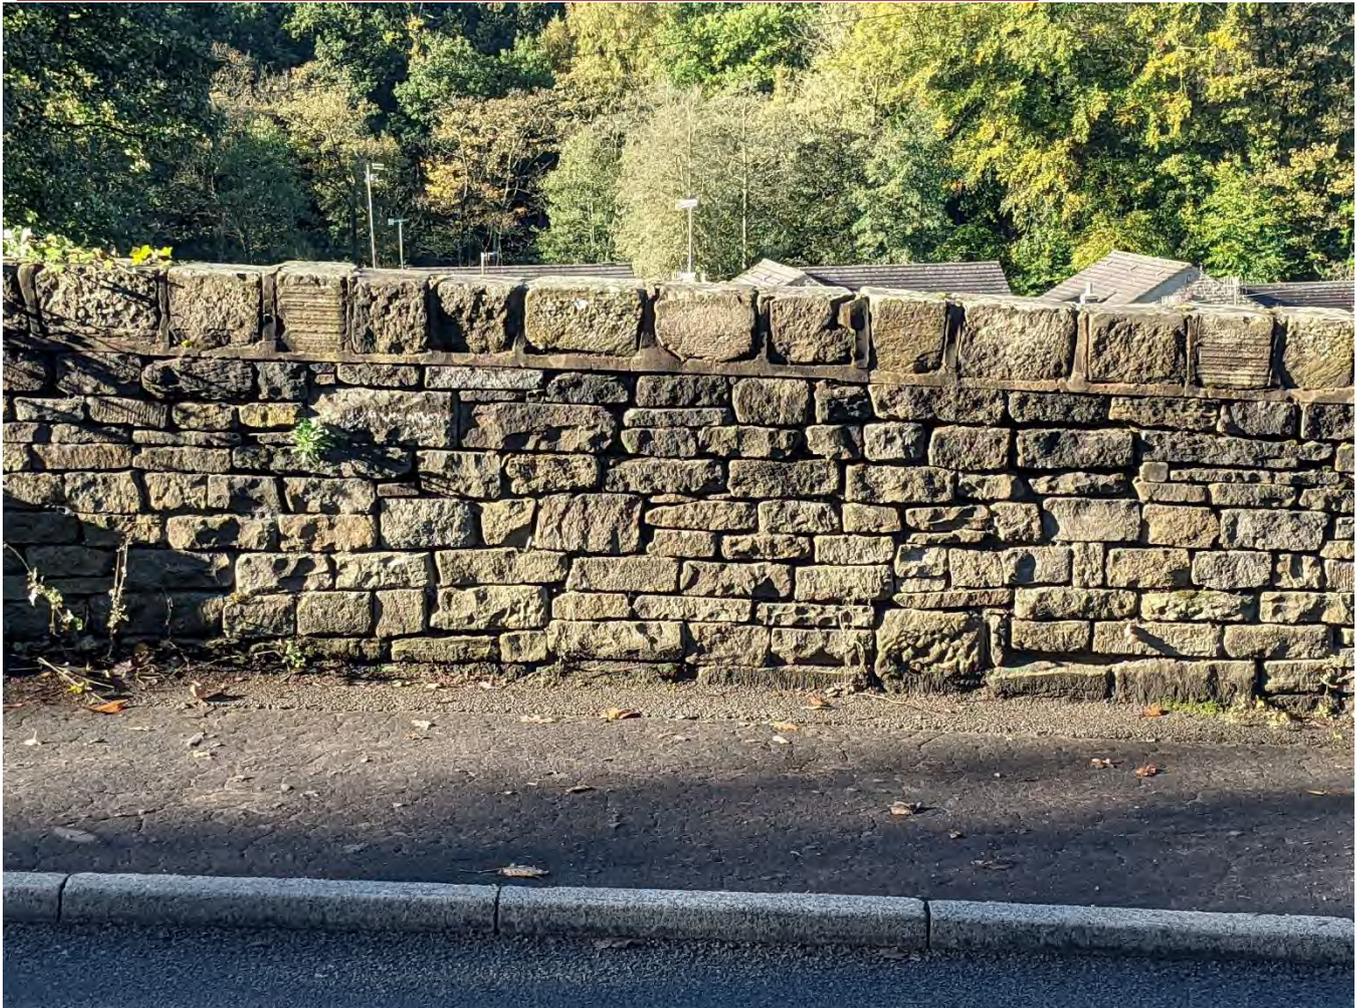
OK

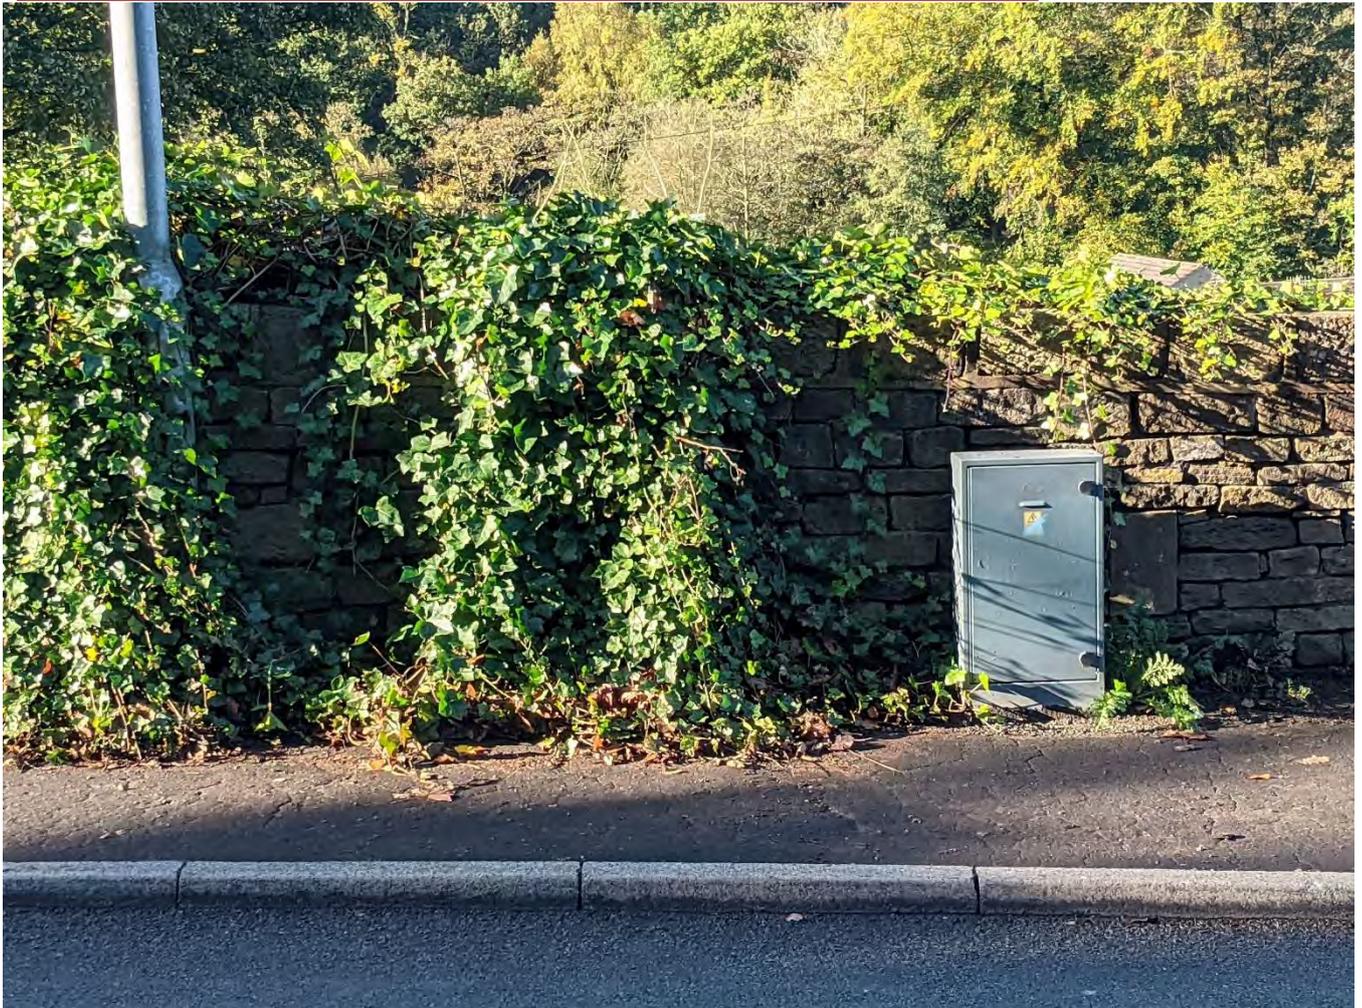
OK

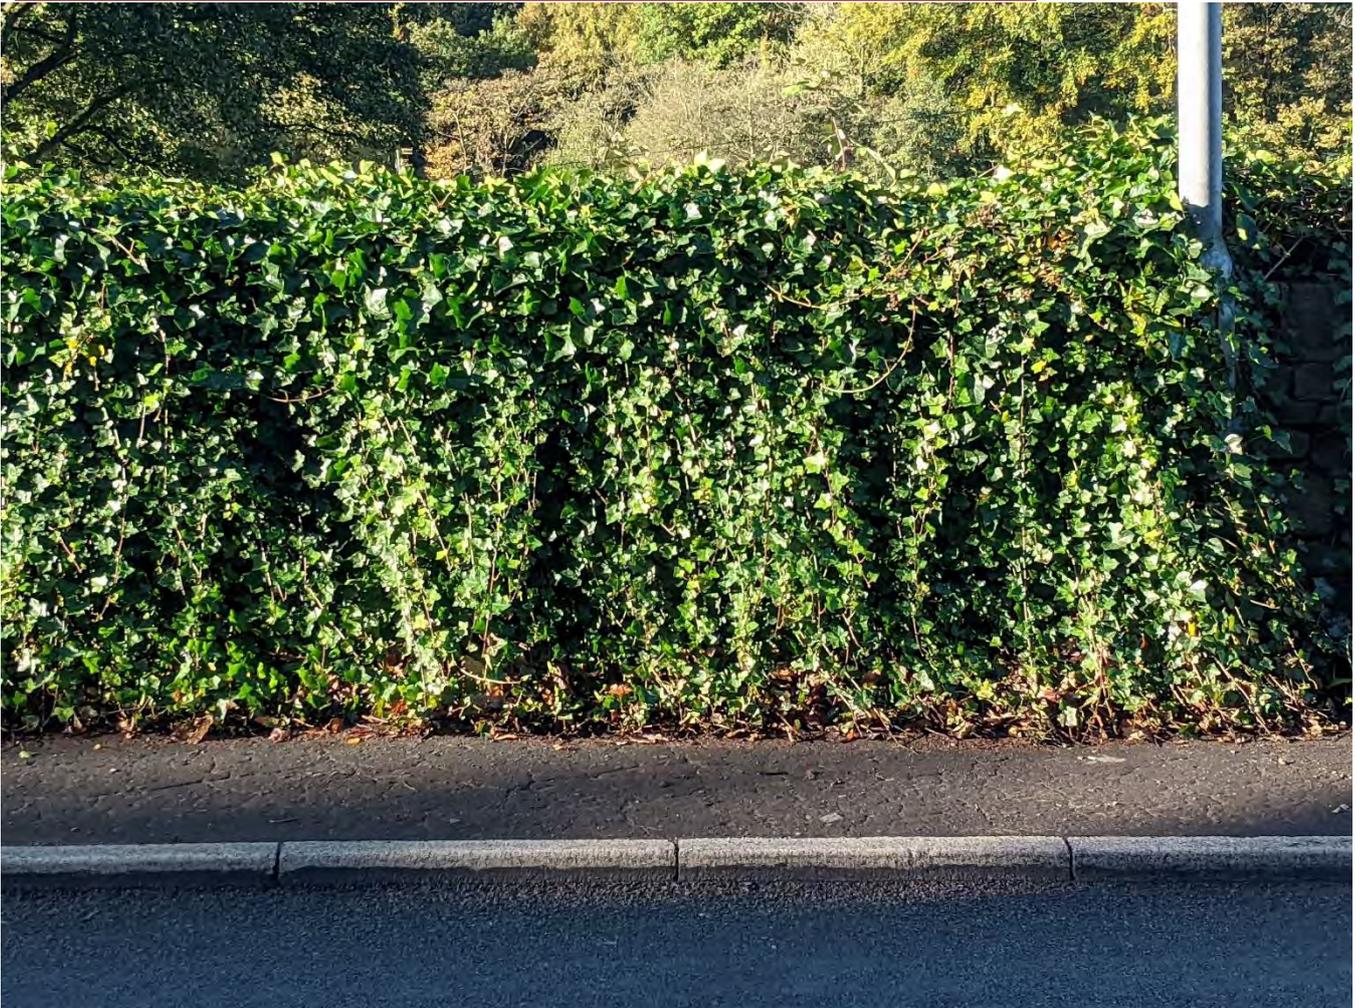
Unknown

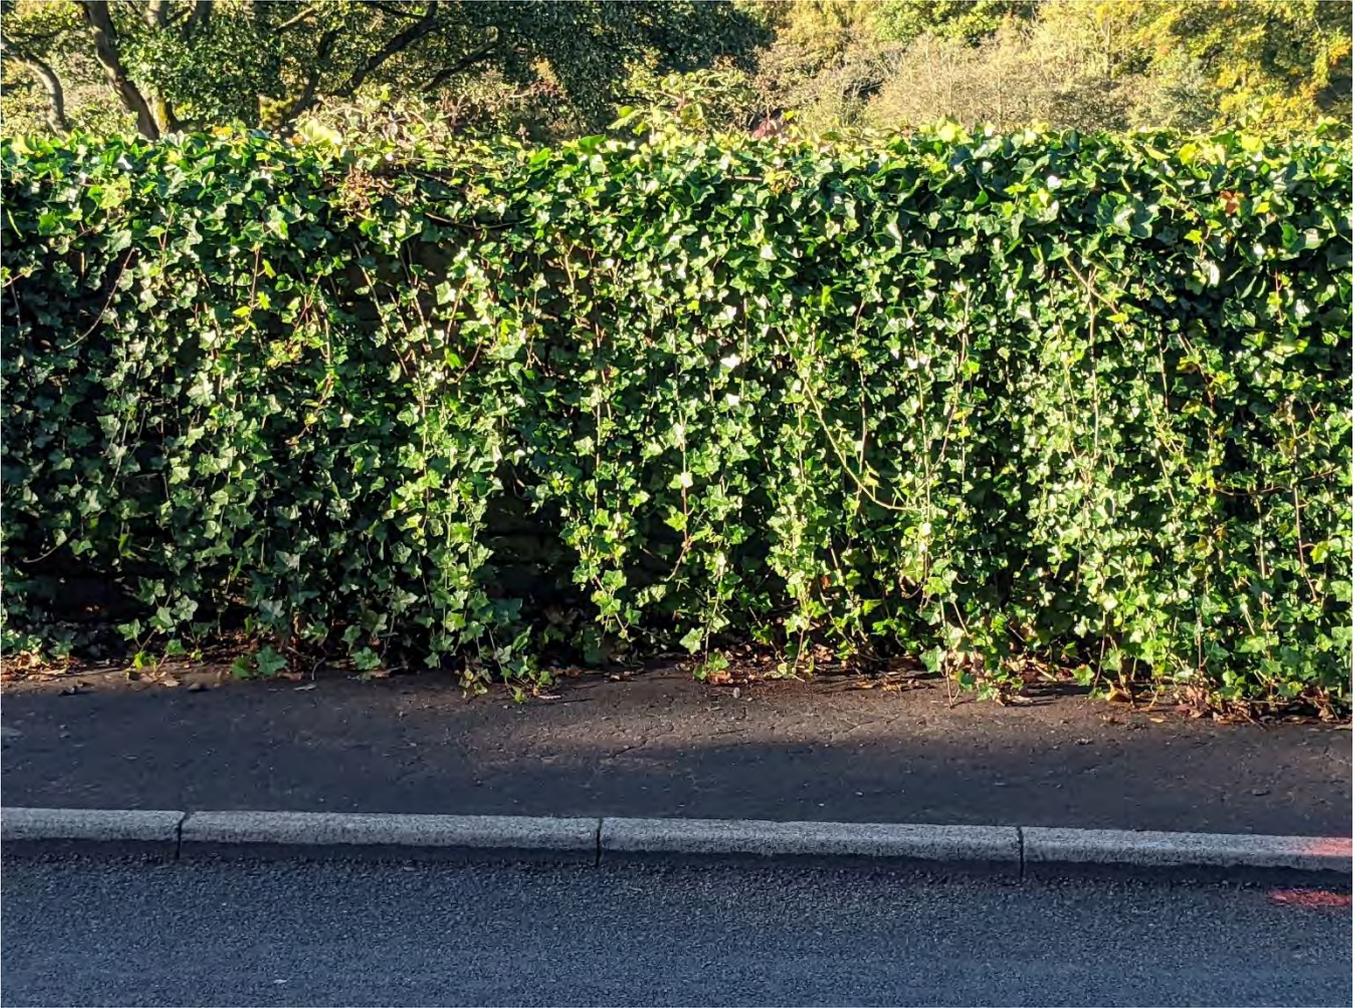
Unknown
