Arboricultural Consultancy for AXA Insurance

Insured	Mr Robert Benyon joint PH Mrs Janet Benyon	Address	Greentrees, Prospect Lane, Birkenshaw, Bradford, BD11 2EL		
Client	Subsidence Management Services	Contact	Stephen Rutherford	Claim No.	IFS-AXA-SUB-22-0104686
ES Ref	SA-252157	Consultant	Nigel Chopping	Contact No.	0330 380 1036
Report Date	29/03/2023

Scope of Report: To survey the property and determine significant vegetation contributing to subsidence damage, make recommendation for remedial action and assess initial mitigation and recovery prospects. The survey does not make an assessment for decay or hazard evaluation.

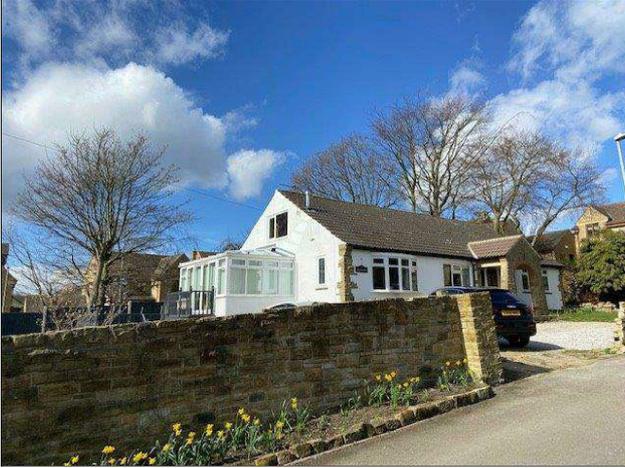
With due regards to species profile, size and proximity, T2 (Beech (Common)), T3 (Beech (Common)) and T4 (Oak) are considered the dominant features proximate to the focal area(s) of movement and accordingly, where vegetation is confirmed as being causal, we have identified them as the primary cause of the current subsidence damage.

View towards T2 T3 and T4 from public highway

Consequently, we have advocated the complete removal of T2 (Beech (Common)), T3 (Beech (Common)) and T4 (Oak) as it will offer the most certain arboricultural solution likely to restore long-term stability.

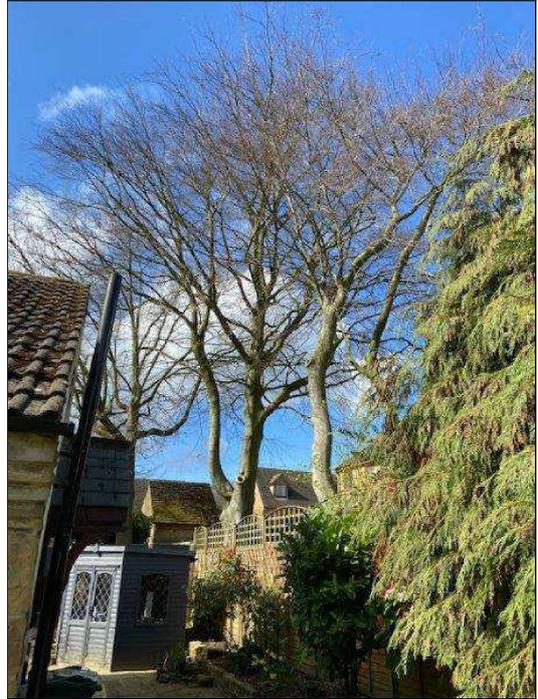
T2 and T3

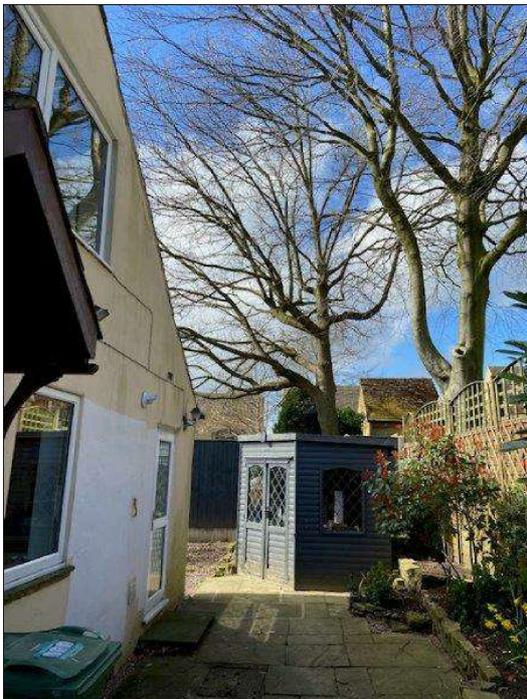
T3 and T4

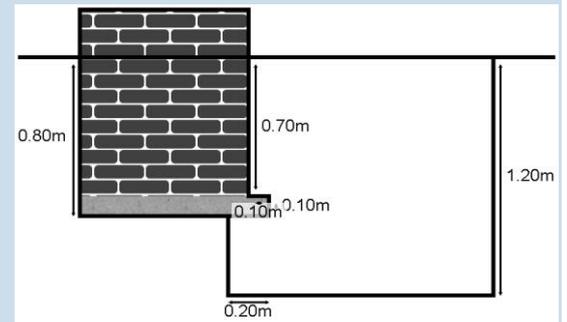
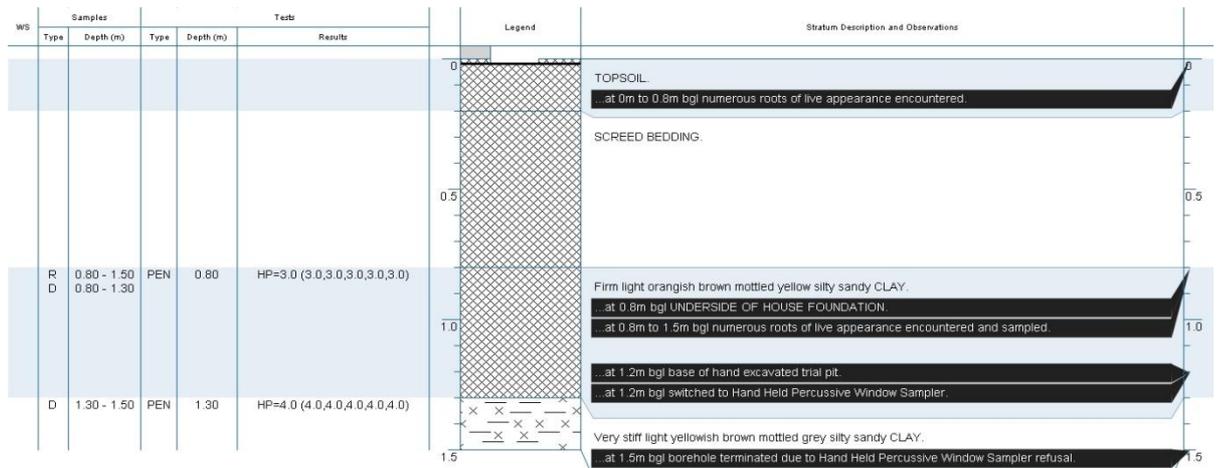
TP/BH1 Foundation Detail and Borehole Log

House foundation comprised of brick wall to 700mm bgl, bearing on concrete to 800mm bgl, with a total projection of 100mm from the elevation. Underside of foundation (USF) was exposed to 200mm back from the face of the foundation and probed 200mm back from the face of the foundation.

-- End of borehole at 1.50m --
 PEN = Hand Penetrometer (kg/sq cm). Groundwater strikes not encountered. Roots encountered to 1.5m bgl. Trial pit excavated to 1.20m bgl. Borehole completed by mech window sampler.

At 0m to 0.8m bgl numerous roots of live appearance encountered in TP/BH1.

At 0.8m to 1.5m bgl numerous roots of live appearance encountered and sampled in TP/BH1.
