**Project Name:** HAIGH HUDDLESTON & ASSOCIATES - Manchester Road  
Slaithwaite

**Project Description:** Investigation

**Project Date:** 15/02/2024

**Inspection Standard:** MSCC5 Sewers & Drainage GB (SRM5 Scoring)

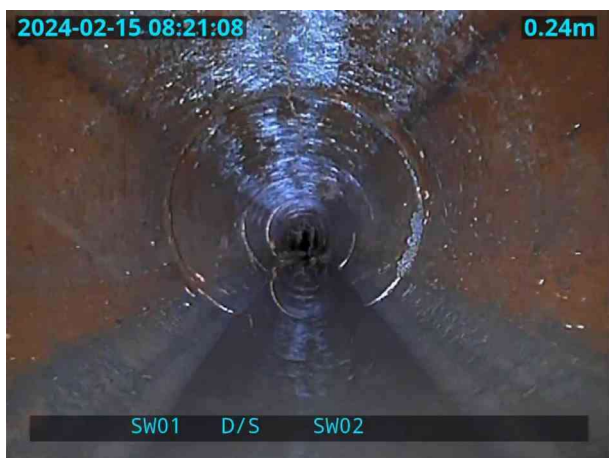
| Scale: 1:137 | Position [m] | Code | Observation | MPEG | Photo | Grade |
|---|---|---|---|---|---|---|
| | 0.24 | FL | Fracture, longitudinal at 12 o'clock | 00:00:15 | 002.jpg | 3 / 2 |

002.jpg, 00:00:15, 0.24 m  
Fracture, longitudinal at 12 o'clock

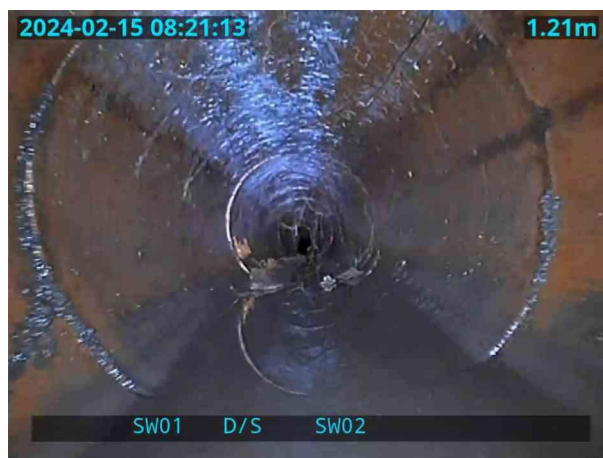
| Scale: 1:137 | Position [m] | Code | Observation | MPEG | Photo | Grade |
|---|---|---|---|---|---|---|
| | 1.21 | S01 | Roots, fine at joint, start | 00:00:20 | 003.jpg | |

003.jpg, 00:00:20, 1.21 m  
Roots, fine at joint, start

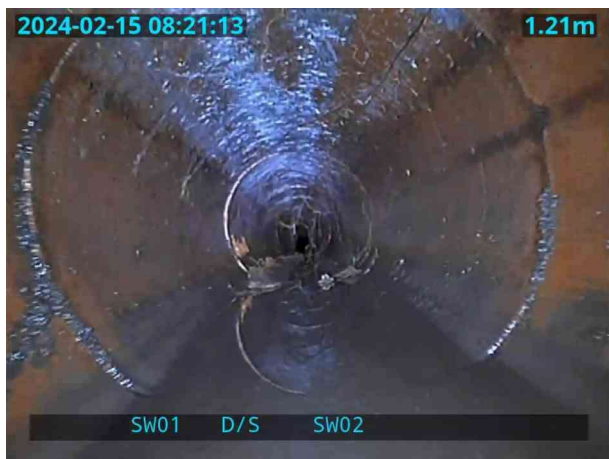
| Scale: 1:137 | Position [m] | Code | Observation | MPEG | Photo | Grade |
|---|---|---|---|---|---|---|
| | 1.21 | FL | Fracture, longitudinal at 1 o'clock | 00:00:20 | 004.jpg | 3 / 2 |

004.jpg, 00:00:20, 1.21 m  
Fracture, longitudinal at 1 o'clock

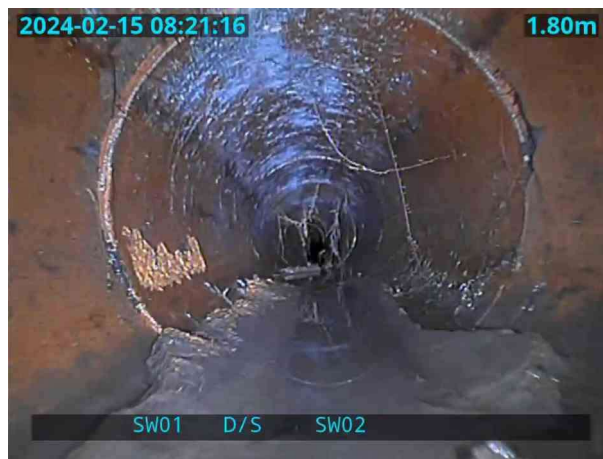
| Scale: 1:137 | Position [m] | Code | Observation | MPEG | Photo | Grade |
|---|---|---|---|---|---|---|
| | 1.80 | DES | Settled deposits, fine, 10% cross-sectional area loss | 00:00:23 | 006.jpg | 3 |

006.jpg, 00:00:23, 1.80 m  
Settled deposits, fine, 10% cross-sectional area loss

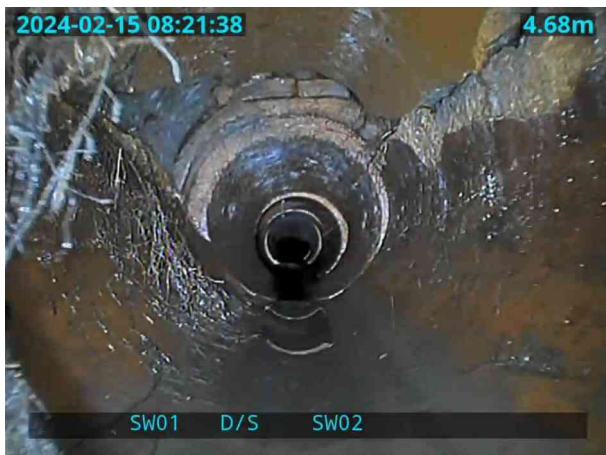
| Scale: 1:137 | Position [m] | Code | Observation | MPEG | Photo | Grade |
|---|---|---|---|---|---|---|
| | 4.68 | RPR | Point repair, pipe replaced from 10 o'clock to 2 o'clock: Top half replaced | 00:00:45 | 005.jpg | |

005.jpg, 00:00:45, 4.68 m  
Point repair, pipe replaced from 10 o'clock to 2 o'clock, Top half replaced

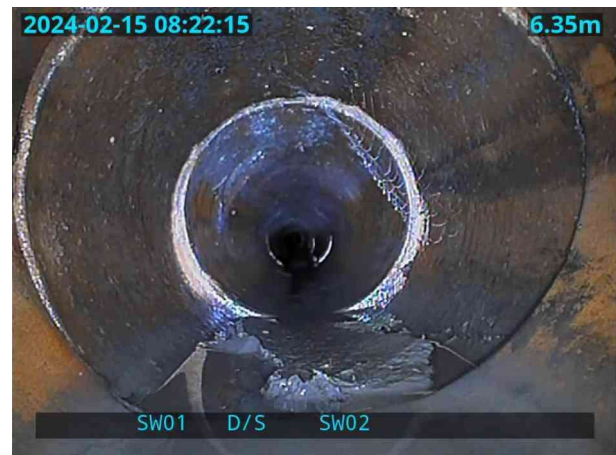
| Scale: 1:137 | Position [m] | Code | Observation | MPEG | Photo | Grade |
|---|---|---|---|---|---|---|
| | 6.35 | DES | Settled deposits, fine, 5% cross-sectional area loss | 00:01:22 | 007.jpg | 3 |

007.jpg, 00:01:22, 6.35 m  
Settled deposits, fine, 5% cross-sectional area loss

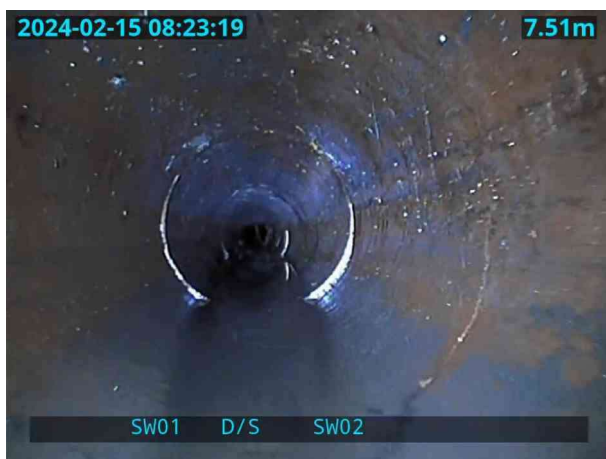
| Scale: 1:137 | Position [m] | Code | Observation | MPEG | Photo | Grade |
|---|---|---|---|---|---|---|
| | 7.51 | FC | Fracture, circumferential from 2 o'clock to 6 o'clock | 00:01:38 | 008.jpg | 3 / 2 |

008.jpg, 00:01:38, 7.51 m  
Fracture, circumferential from 2 o'clock to 6 o'clock

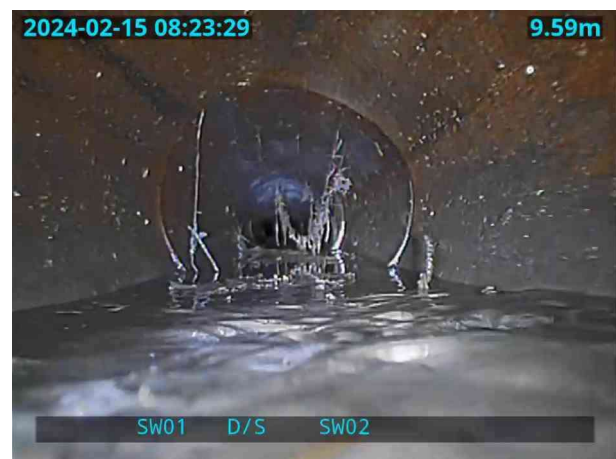
009.jpg, 00:01:49, 9.59 m  
Settled deposits, fine, 20% cross-sectional area loss, start Under water level

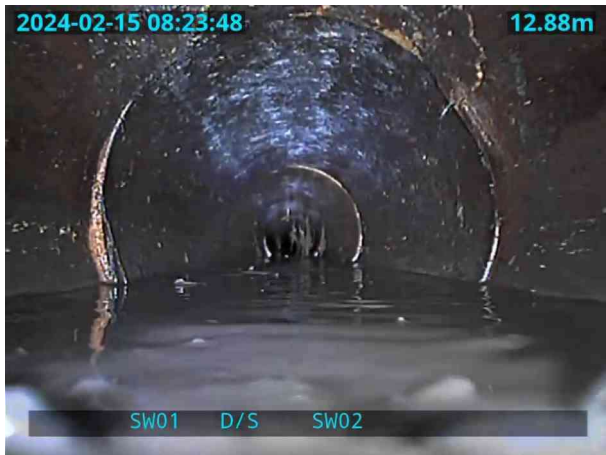
| Scale: | 1:137 | Position [m] | Code | Observation | MPEG | Photo | Grade |
|---|---|---|---|---|---|---|---|
| | | 12.88 | FCJ | Fracture, circumferential at joint from 11 o'clock to 2 o'clock | 00:02:07 | 010.jpg | 3 / 2 |

010.jpg, 00:02:07, 12.88 m  
Fracture, circumferential at joint from 11 o'clock to 2 o'clock

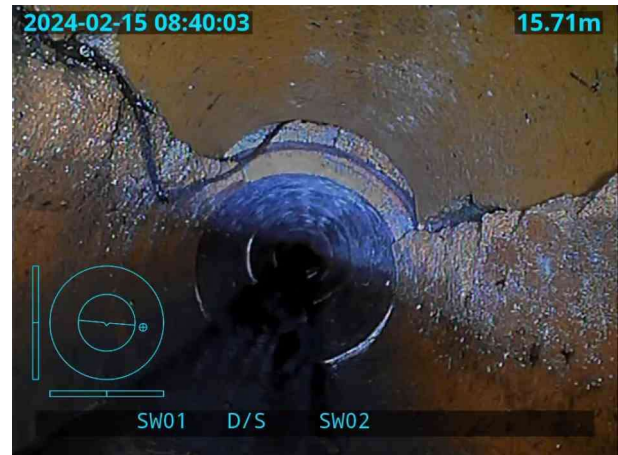
| Scale: | 1:137 | Position [m] | Code | Observation | MPEG | Photo | Grade |
|---|---|---|---|---|---|---|---|
| | | 15.43 | RPR | Point repair, pipe replaced from 10 o'clock to 2 o'clock: Top section replaced | 00:03:53 | 012.jpg | |

012.jpg, 00:03:53, 15.43 m  
Point repair, pipe replaced from 10 o'clock to 2 o'clock, Top section replaced

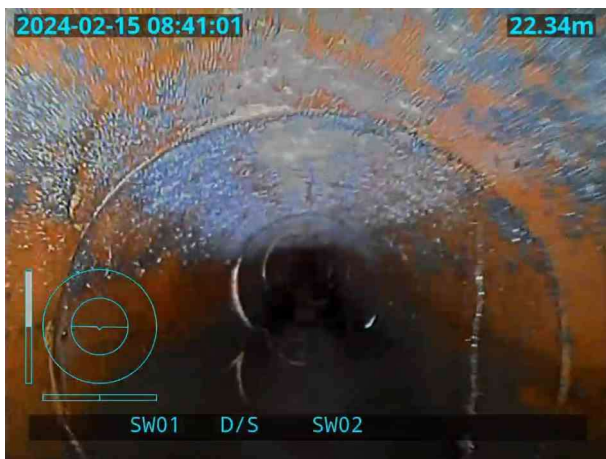
| Scale: | 1:137 | Position [m] | Code | Observation | MPEG | Photo | Grade |
|---|---|---|---|---|---|---|---|
| | | 22.34 | CCJ | Crack, circumferential at joint from 10 o'clock to 1 o'clock | 00:04:54 | 014.jpg | 2 / 2 |

014.jpg, 00:04:54, 22.34 m  
Crack, circumferential at joint from 10 o'clock to 1 o'clock

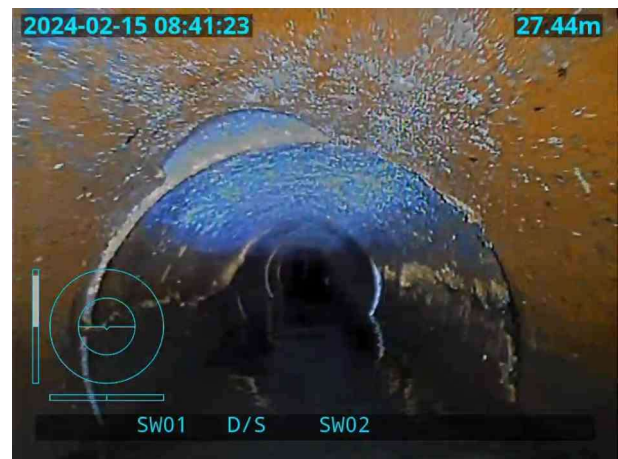
| Section | PLR | Grade | Description |
|---|---|---|---|
| 1 | SW01X | 4 | Broken pipe at joint from 11 o'clock to 12 o'clock |

| Scale: | 1:137 | Position [m] | Code | Observation | MPEG | Photo | Grade |
|---|---|---|---|---|---|---|---|
| | | 27.44 | BJ | Broken pipe at joint from 11 o'clock to 12 o'clock | 00:05:16 | 013.jpg | 4 |

013.jpg, 00:05:16, 27.44 m  
Broken pipe at joint from 11 o'clock to 12 o'clock

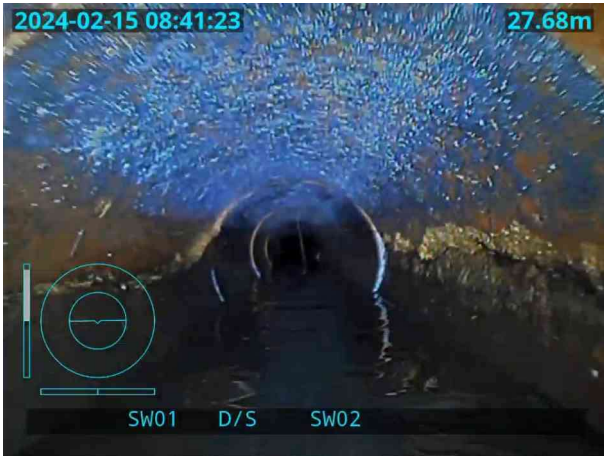
| Scale: | 1:137 | Position [m] | Code | Observation | MPEG | Photo | Grade |
|---|---|---|---|---|---|---|---|
| | | 27.68 | RPR | Point repair, pipe replaced from 9 o'clock to 3 o'clock: Top half replaced | 00:05:16 | 015.jpg | |

015.jpg, 00:05:16, 27.68 m  
Point repair, pipe replaced from 9 o'clock to 3 o'clock, Top half replaced

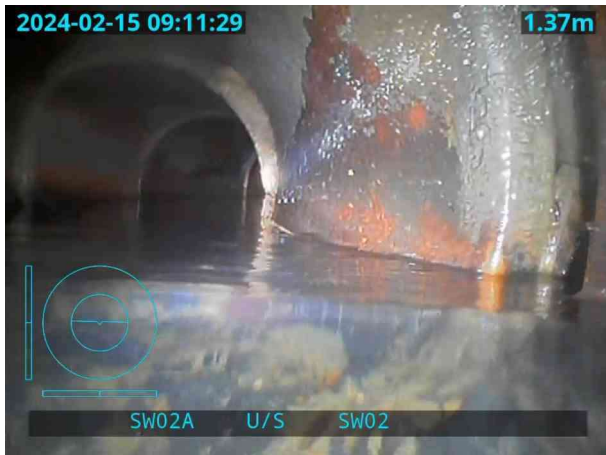
016.jpg, 00:00:18, 1.37 m  
Open joint, medium

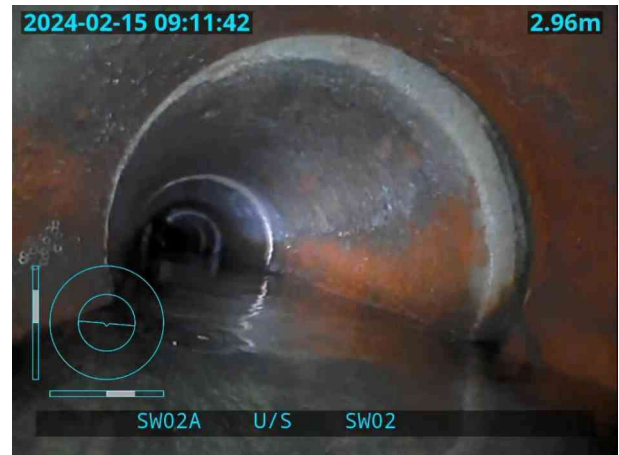
| Section | PLR | Grade | Description |
|---|---|---|---|
| 2 | SW02X | 3 | Joint displaced, medium |

017.jpg, 00:00:31, 2.96 m  
Joint displaced, medium

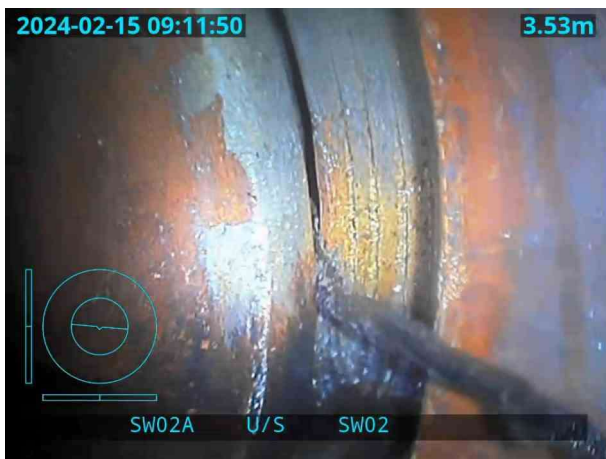
018.jpg, 00:00:39, 3.53 m  
Roots, fine at joint

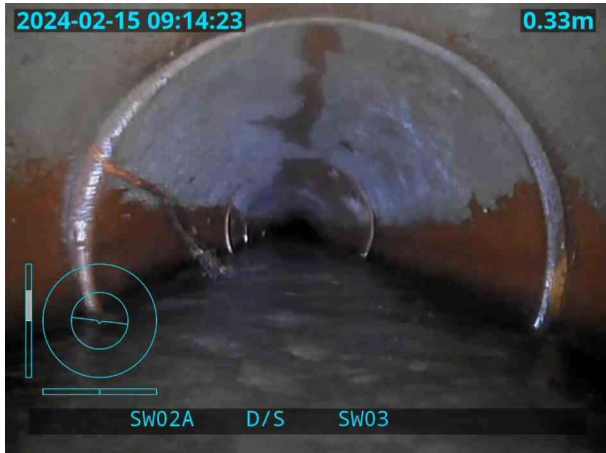
019.jpg, 00:00:12, 0.33 m  
Roots, fine at joint

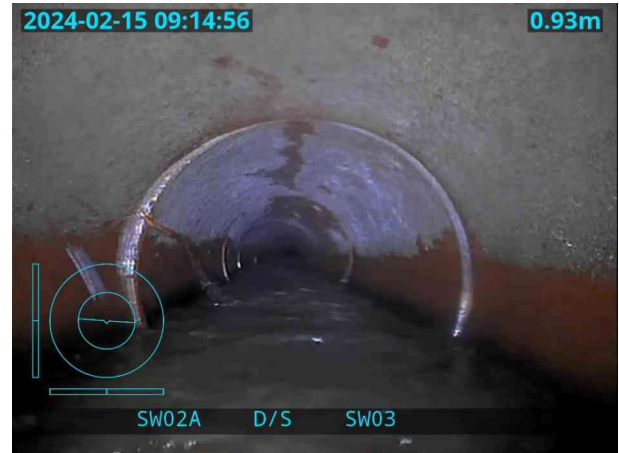
| Section | PLR | Grade | Description |
|---|---|---|---|
| 3 | SW02AX | 5 | Other obstacles, other object in invert from 4 o'clock to 8 o'clock, 20% cross-sectional area loss |

020.jpg, 00:00:44, 0.93 m  
Survey abandoned, Due to obstruction under water level, poss debris

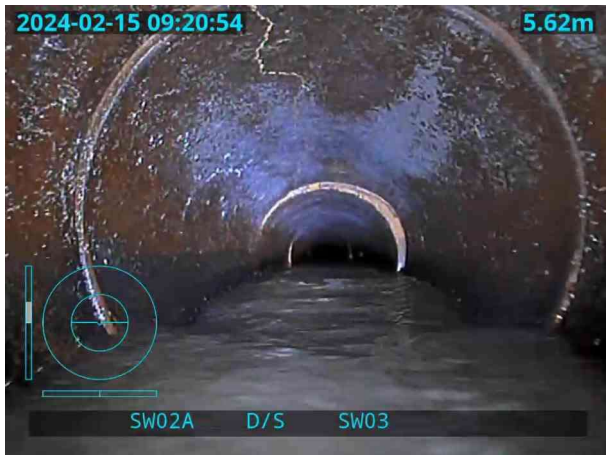
| Scale: | 1:188 | Position [m] | Code | Observation | MPEG | Photo | Grade |
|---|---|---|---|---|---|---|---|
| | | | CLJ | Crack, longitudinal at joint at 12 o'clock | 00:00:29 | 021.jpg | 2 / 2 |

021.jpg, 00:00:29, 5.62 m  
Crack, longitudinal at joint at 12 o'clock

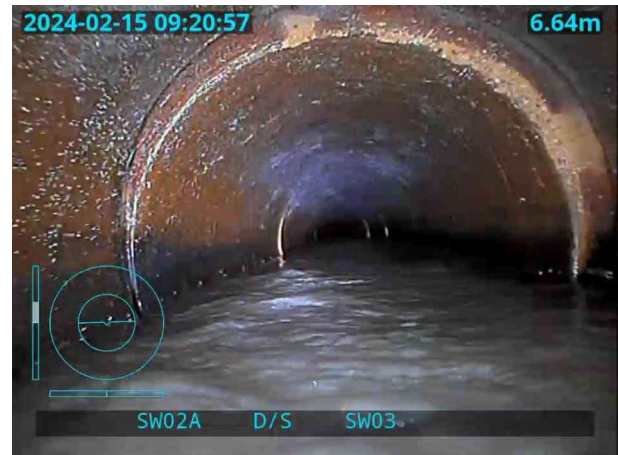
022.jpg, 00:00:33, 6.64 m  
Joint displaced, medium

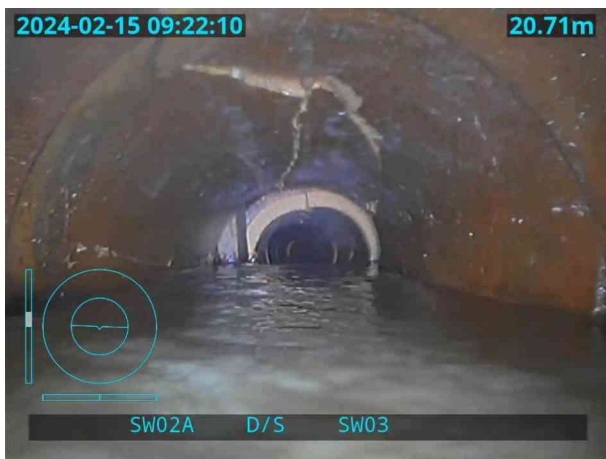
| Scale: | 1:188 | Position [m] | Code | Observation | MPEG | Photo | Grade |
|---|---|---|---|---|---|---|---|
| | | | FL | Fracture, longitudinal at 9 o'clock | 00:01:45 | 023.jpg | 3 / 2 |

023.jpg, 00:01:45, 20.71 m  
Fracture, longitudinal at 9 o'clock

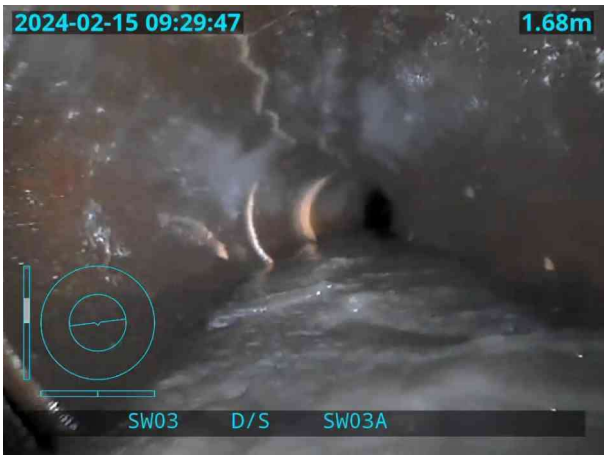
| Scale: 1:233 | Position [m] | Code | Observation | MPEG | Photo | Grade |
|---|---|---|---|---|---|---|
| | 1.68 | FL | Fracture, longitudinal at 12 o'clock | 00:00:16 | 024.jpg | 3 / 2 |

024.jpg, 00:00:16, 1.68 m  
Fracture, longitudinal at 12 o'clock

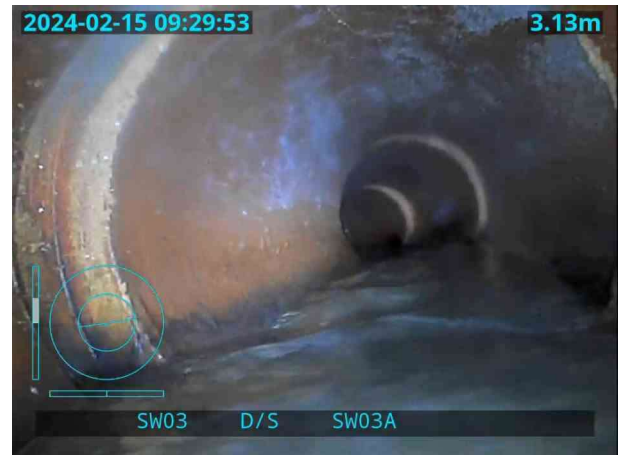
025.jpg, 00:00:22, 3.13 m  
Open joint, large

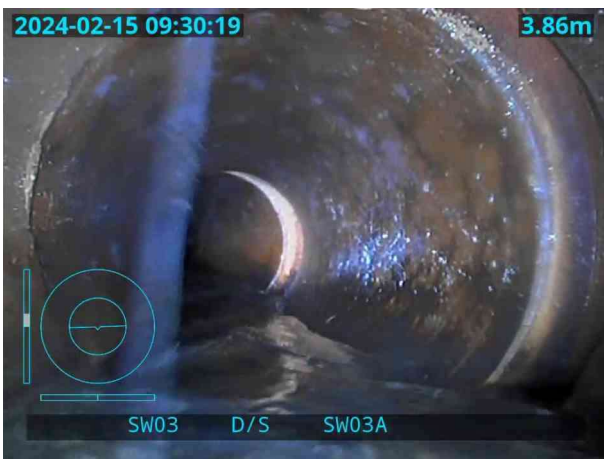
026.jpg, 00:00:48, 3.86 m  
Open joint, large

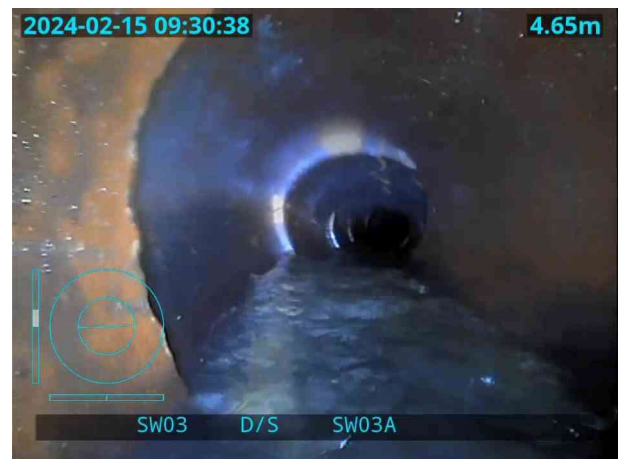
027.jpg, 00:01:07, 4.65 m  
Open joint, large

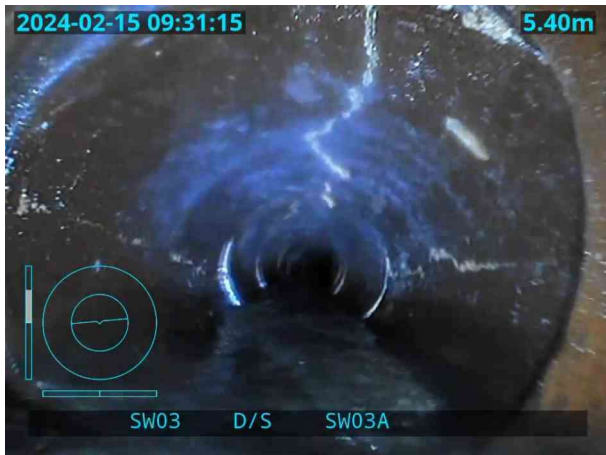
| Scale: 1:233 | Position [m] | Code | Observation | MPEG | Photo | Grade |
|---|---|---|---|---|---|---|
| | 5.40 | FL | Fracture, longitudinal at 9 o'clock | 00:01:44 | 028.jpg | 3 / 2 |

028.jpg, 00:01:44, 5.40 m  
Fracture, longitudinal at 9 o'clock

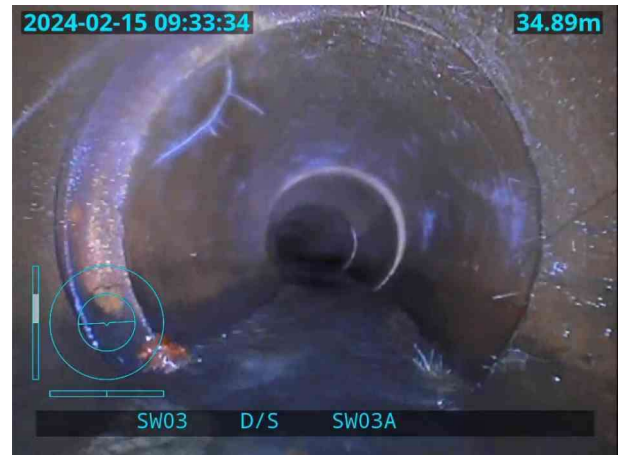
029.jpg, 00:04:03, 34.89 m  
Open joint, medium

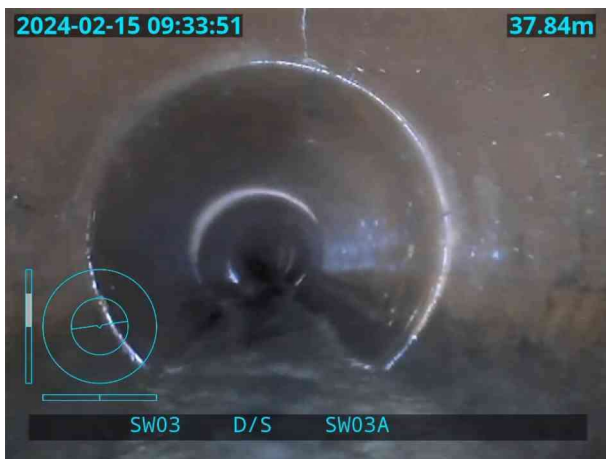
| Scale: | 1:233 | Position [m] | Code | Observation | MPEG | Photo | Grade |
|---|---|---|---|---|---|---|---|
| | | 37.84 | CL | Crack, longitudinal at 12 o'clock | 00:04:20 | 030.jpg | 2 / 2 |

030.jpg, 00:04:20, 37.84 m  
Crack, longitudinal at 12 o'clock

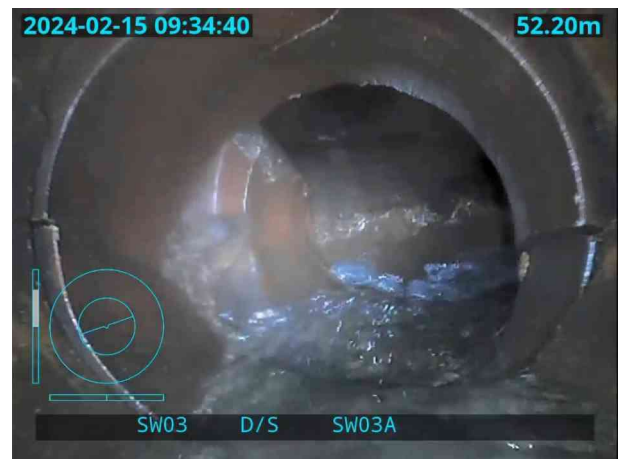
| Scale: | 1:233 | Position [m] | Code | Observation | MPEG | Photo | Grade |
|---|---|---|---|---|---|---|---|
| | | 52.20 | FL | Fracture, longitudinal at 9 o'clock | 00:05:09 | 031.jpg | 3 / 2 |

031.jpg, 00:05:09, 52.20 m  
Fracture, longitudinal at 9 o'clock
