CCTV Survey Report

FSI Ref: 27006
Issue Date: August 2023

Risk Address: 52 Crowlees Road
Mirfield
West Yorkshire
WF14 9JE

DRAINAGE SURVEY

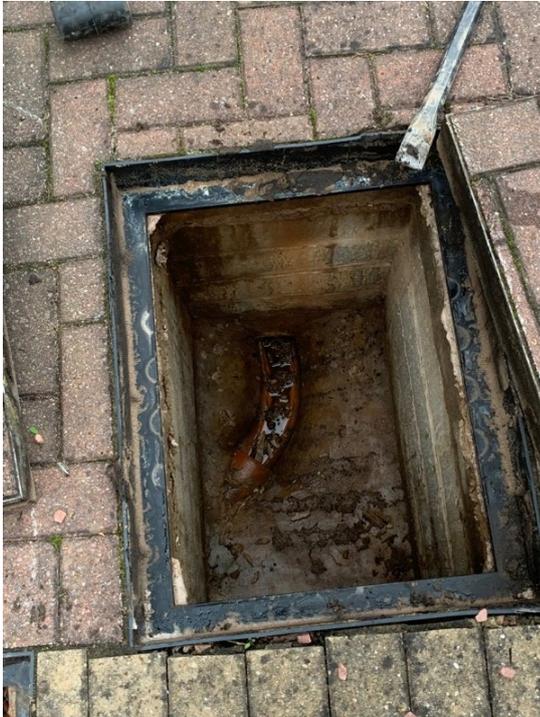
MH2 not in use as it took on front WC that has now been removed.

Photo 1 (MH2 not in use)

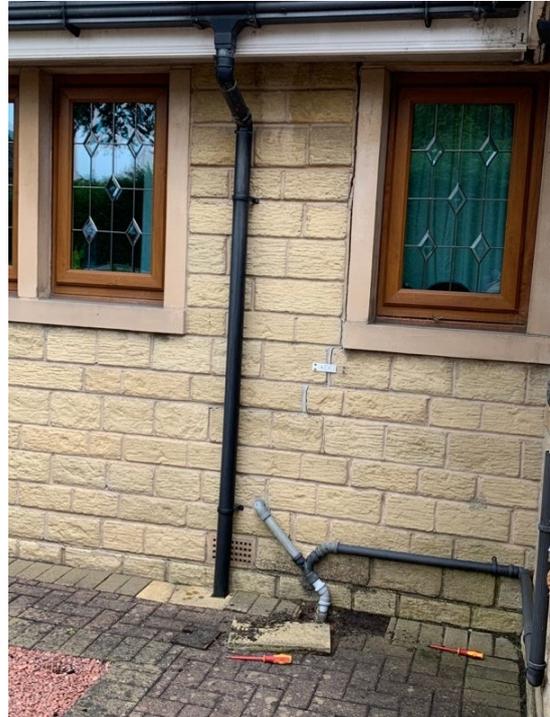
Photo 2 (FWG1 not in use)
