# Arboricultural Appraisal Report

## Subsidence Damage Investigation at:

52 Crowlees Road  
Mirfield  
WF14 9JE

| MWA REF: | SUB230831-14081 |

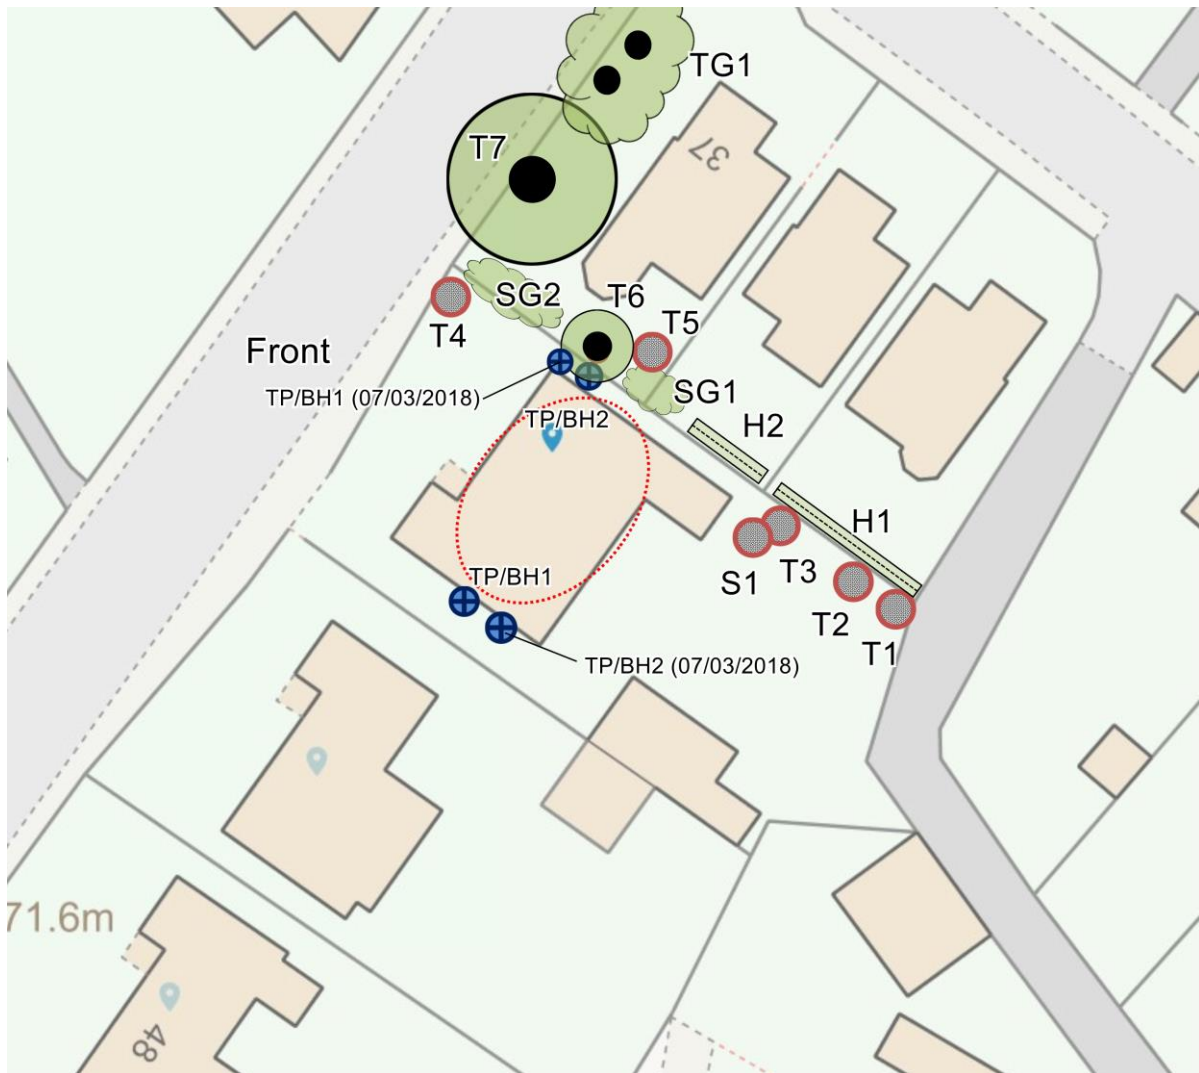
## Site Plan

Approximate areas of damage

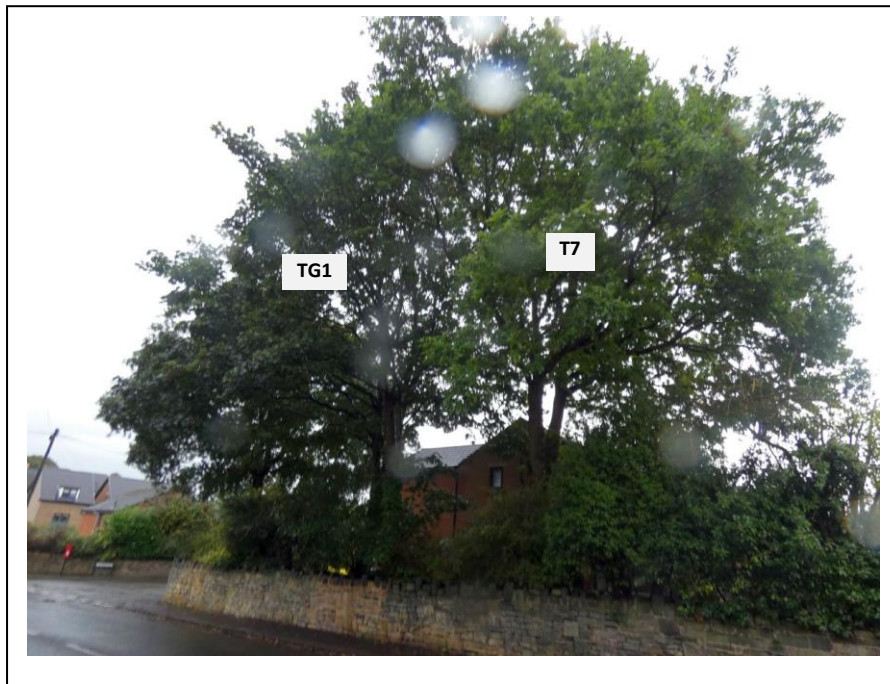
| Tree No. | Species | Ht (m) | Dia (mm) | Crown Spread (m) | Dist. to building (m) | Age Classification | Ownership |
|---|---|---|---|---|---|---|---|
| T7 | Oak | 15 * | 650 Ms * | 14 | 11 | Older than Property | Third Party<br>37 Pinfold Lane<br>WF14 9HZ |
| Management history | | No significant recent management noted. Previously recommended for removal. | | | | | |

| Tree No. | Species | Ht (m) | Dia (mm) | Crown Spread (m) | Dist. to building (m) | Age Classification | Ownership |
|---|---|---|---|---|---|---|---|
| TG1 | Sycamore | 15 * | 350 * | 10 * | 16.5 | Younger than Property | Third Party<br>37 Pinfold Lane<br>WF14 9HZ |
| Management history | | Subject to past management/pruning. | | | | | |

View of T7 and TG1

| Tree No. | Species | Ht (m) | Dia (mm) | Crown Spread (m) | Dist. to building (m) | Age Classification | Ownership |
|---|---|---|---|---|---|---|---|
| Recommendation | | Remove (fell) to near ground level and treat stump to inhibit regrowth. | | | | | |

| Tree No. | Species | Ht (m) | Dia (mm) | Crown Spread (m) | Dist. to building (m) | Age Classification | Ownership |
|---|---|---|---|---|---|---|---|
| Recommendation | | Maintain broadly at no more than current dimensions by periodic pruning. | | | | | |

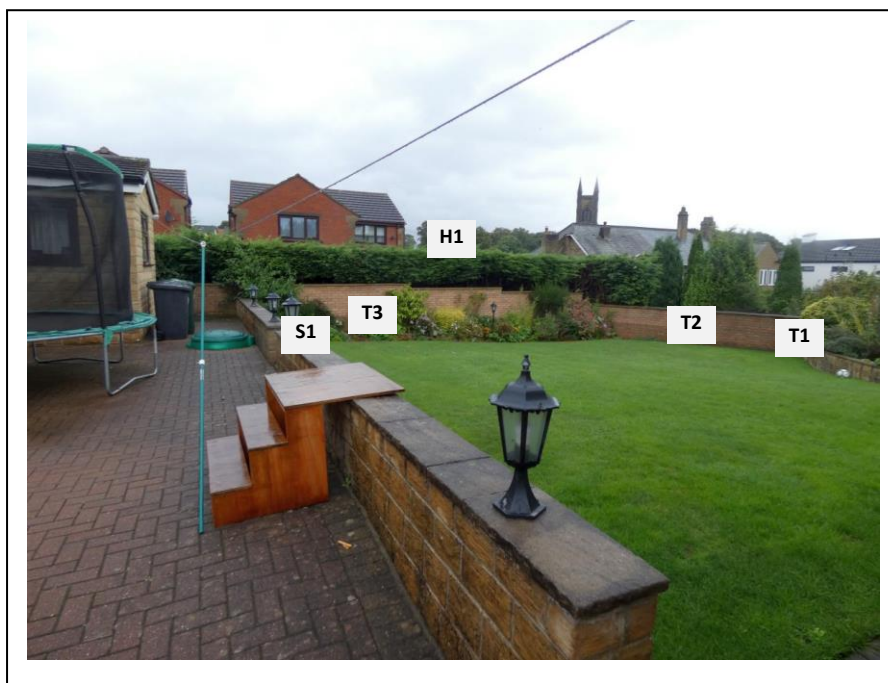
| Tree No. | Species | Ht (m) | Dia (mm) | Crown Spread (m) | Dist. to building (m) | Age Classification | Ownership |
|---|---|---|---|---|---|---|---|
| H1 | Leyland Cypress | 2 * | Ms | 1.5 | 3 | Younger than Property | Third Party<br>33 Pinfold Lane<br>WF14 9HZ |
| Management history | | Recently reduced/pruned. | | | | | |

View of H1 and the approx. locations of removed vegetation

| Tree No. | Species | Ht (m) | Dia (mm) | Crown Spread (m) | Dist. to building (m) | Age Classification | Ownership |
|---|---|---|---|---|---|---|---|
| Recommendation | | Maintain broadly at no more than current dimensions by periodic pruning. | | | | | |
