# **TECHNICAL REPORT ON A SUBSIDENCE CLAIM**

**Crawford Reference: SU1704565**

**52 Crowlees Road  
Mirfield  
West Yorkshire  
WF14 9JE**

## **SUBSIDENCE CLAIM**

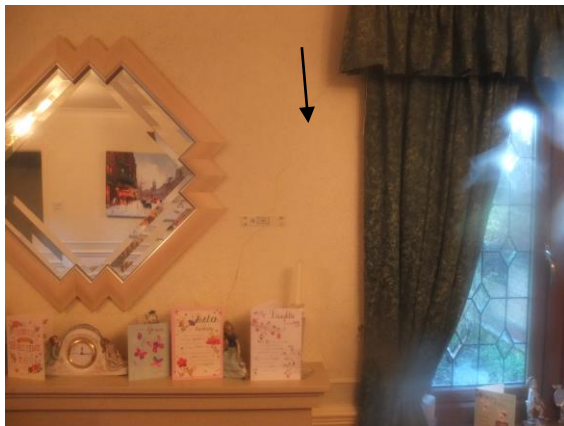
Internal crack to right of front left lounge chimney breast

Front left lounge - Cracking on wall plaster to front chimney breast, along coving line to right and above rear right internal door leading to hallway. Cracking less than 1mm wide.

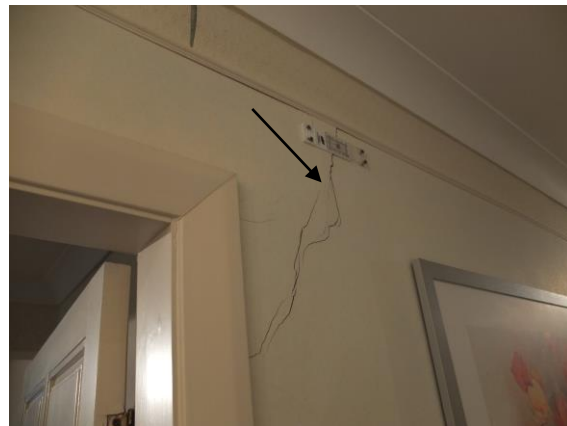
Internal cracking to rear wall of inner hallway to right of door leading to rear kitchen

Inner hallway - Cracking to wall / coving and ceiling to left hand side adjacent to internal front left lounge door. Cracking on rear facing internal wall to right of door leading to kitchen. Cracking to wall to right of entrance to front porch. Cracking up to 2mm wide.

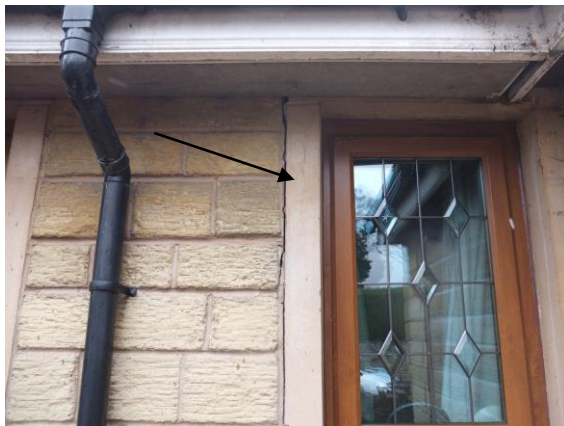
External cracking around concrete window reveal to left of front mid-section bedroom window

Front elevation - Vertical and stepped cracking around window reveal to front mid-section bedroom window and beneath front left lounge windows. Cracking up to 15mm wide.

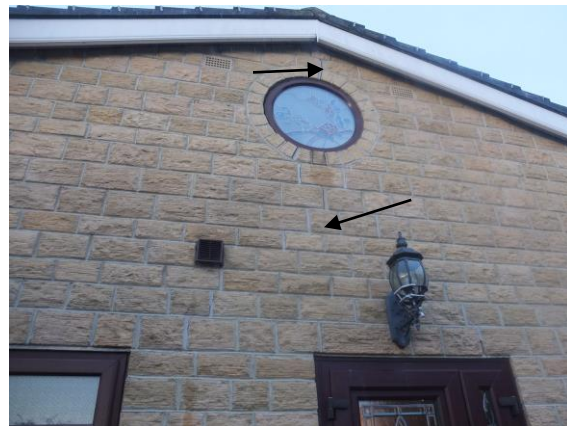
External cracking above rear kitchen door leading into high level roof

Rear elevation - Stepped and tapered cracking above rear kitchen door and rising up into high level roof line and around attic oculus window. Cracking up to 4mm wide.

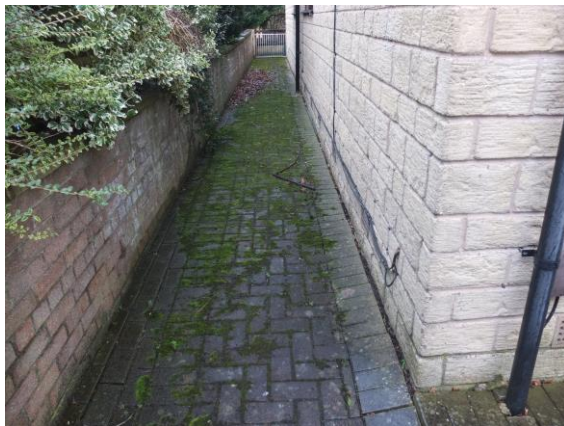
External movement to block paving to left of main property

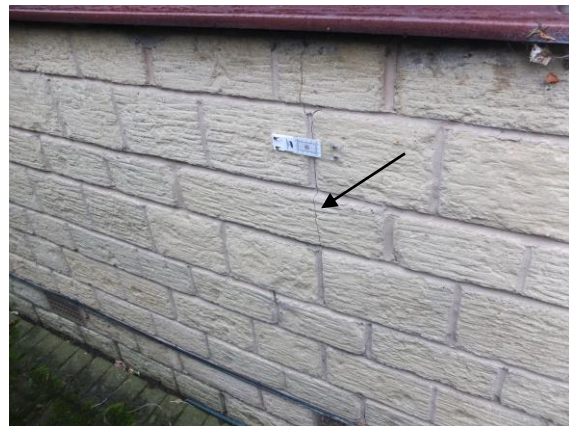
Left elevation - Vertical cracking beneath front left lounge window and beneath mid-section dining room window. Cracking generally non-tapered up to 2mm wide.

External crack beneath left mid-section dining room window

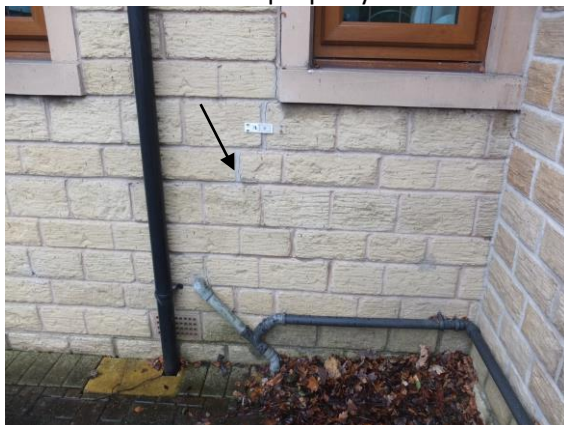
External cracking beneath front mid-section bedroom window

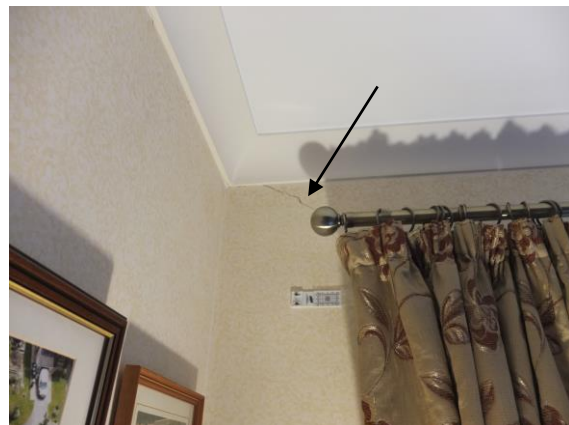
Left mid-section dining room - Cracking to wall plaster to front left corner and along ceiling line and wall to internal wall shared with front left lounge and rear kitchen. Cracking up to 1mm wide.

Internal crack to front left corner of rear mid-section dining room

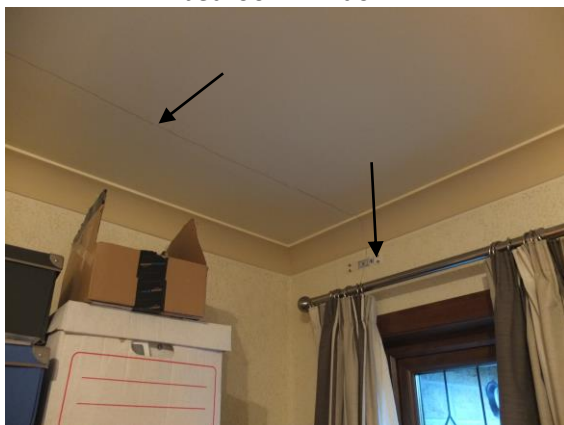
Front mid-section bedroom - Cracking on front and right walls and ceiling. Cracking up to 1mm wide.

Internal cracking to front right to front mid-bedroom

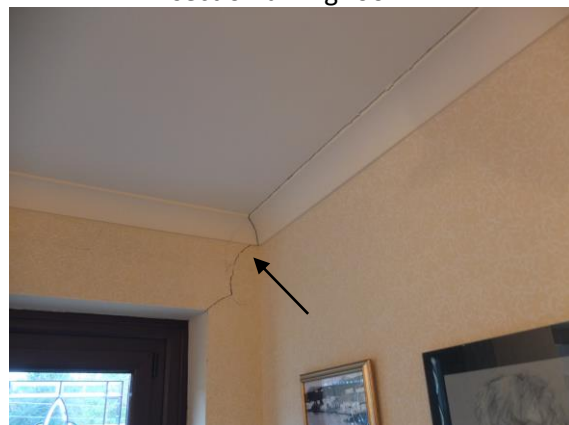
Rear kitchen - Cracking on right hand wall / coving and ceiling up to 2mm wide.

Internal cracking to right internal wall to rear kitchen

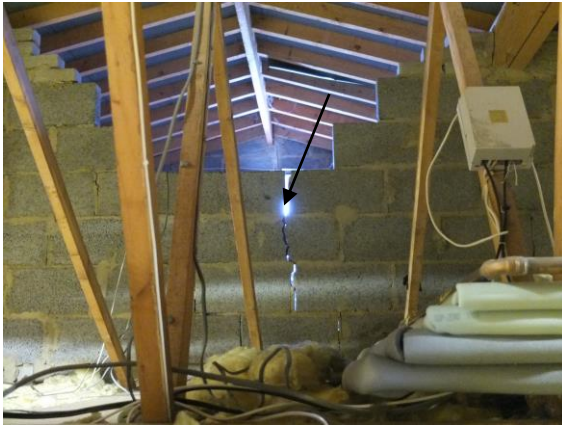
Attic - Tapered separation crack in dwarf block wall over rear wall to inner hallway up to 10mm wide.

Internal separation of blockwork in central area to attic space

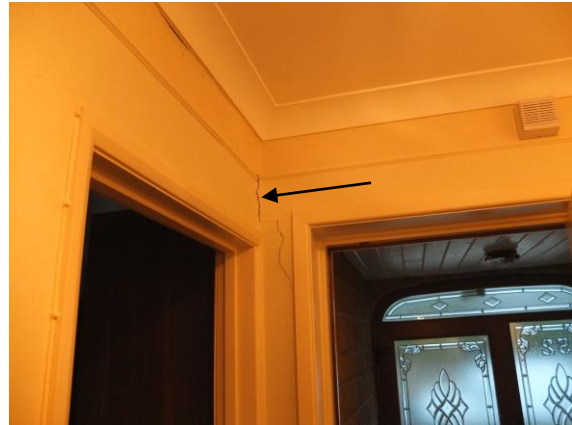
Internal crack to right of front entrance door leading to porch
