Kirklees Cultural Heart, Huddersfield

Huddersfield Library - Conservation of Artwork  
- Articulation in Motion Ceramic Panel 09-10

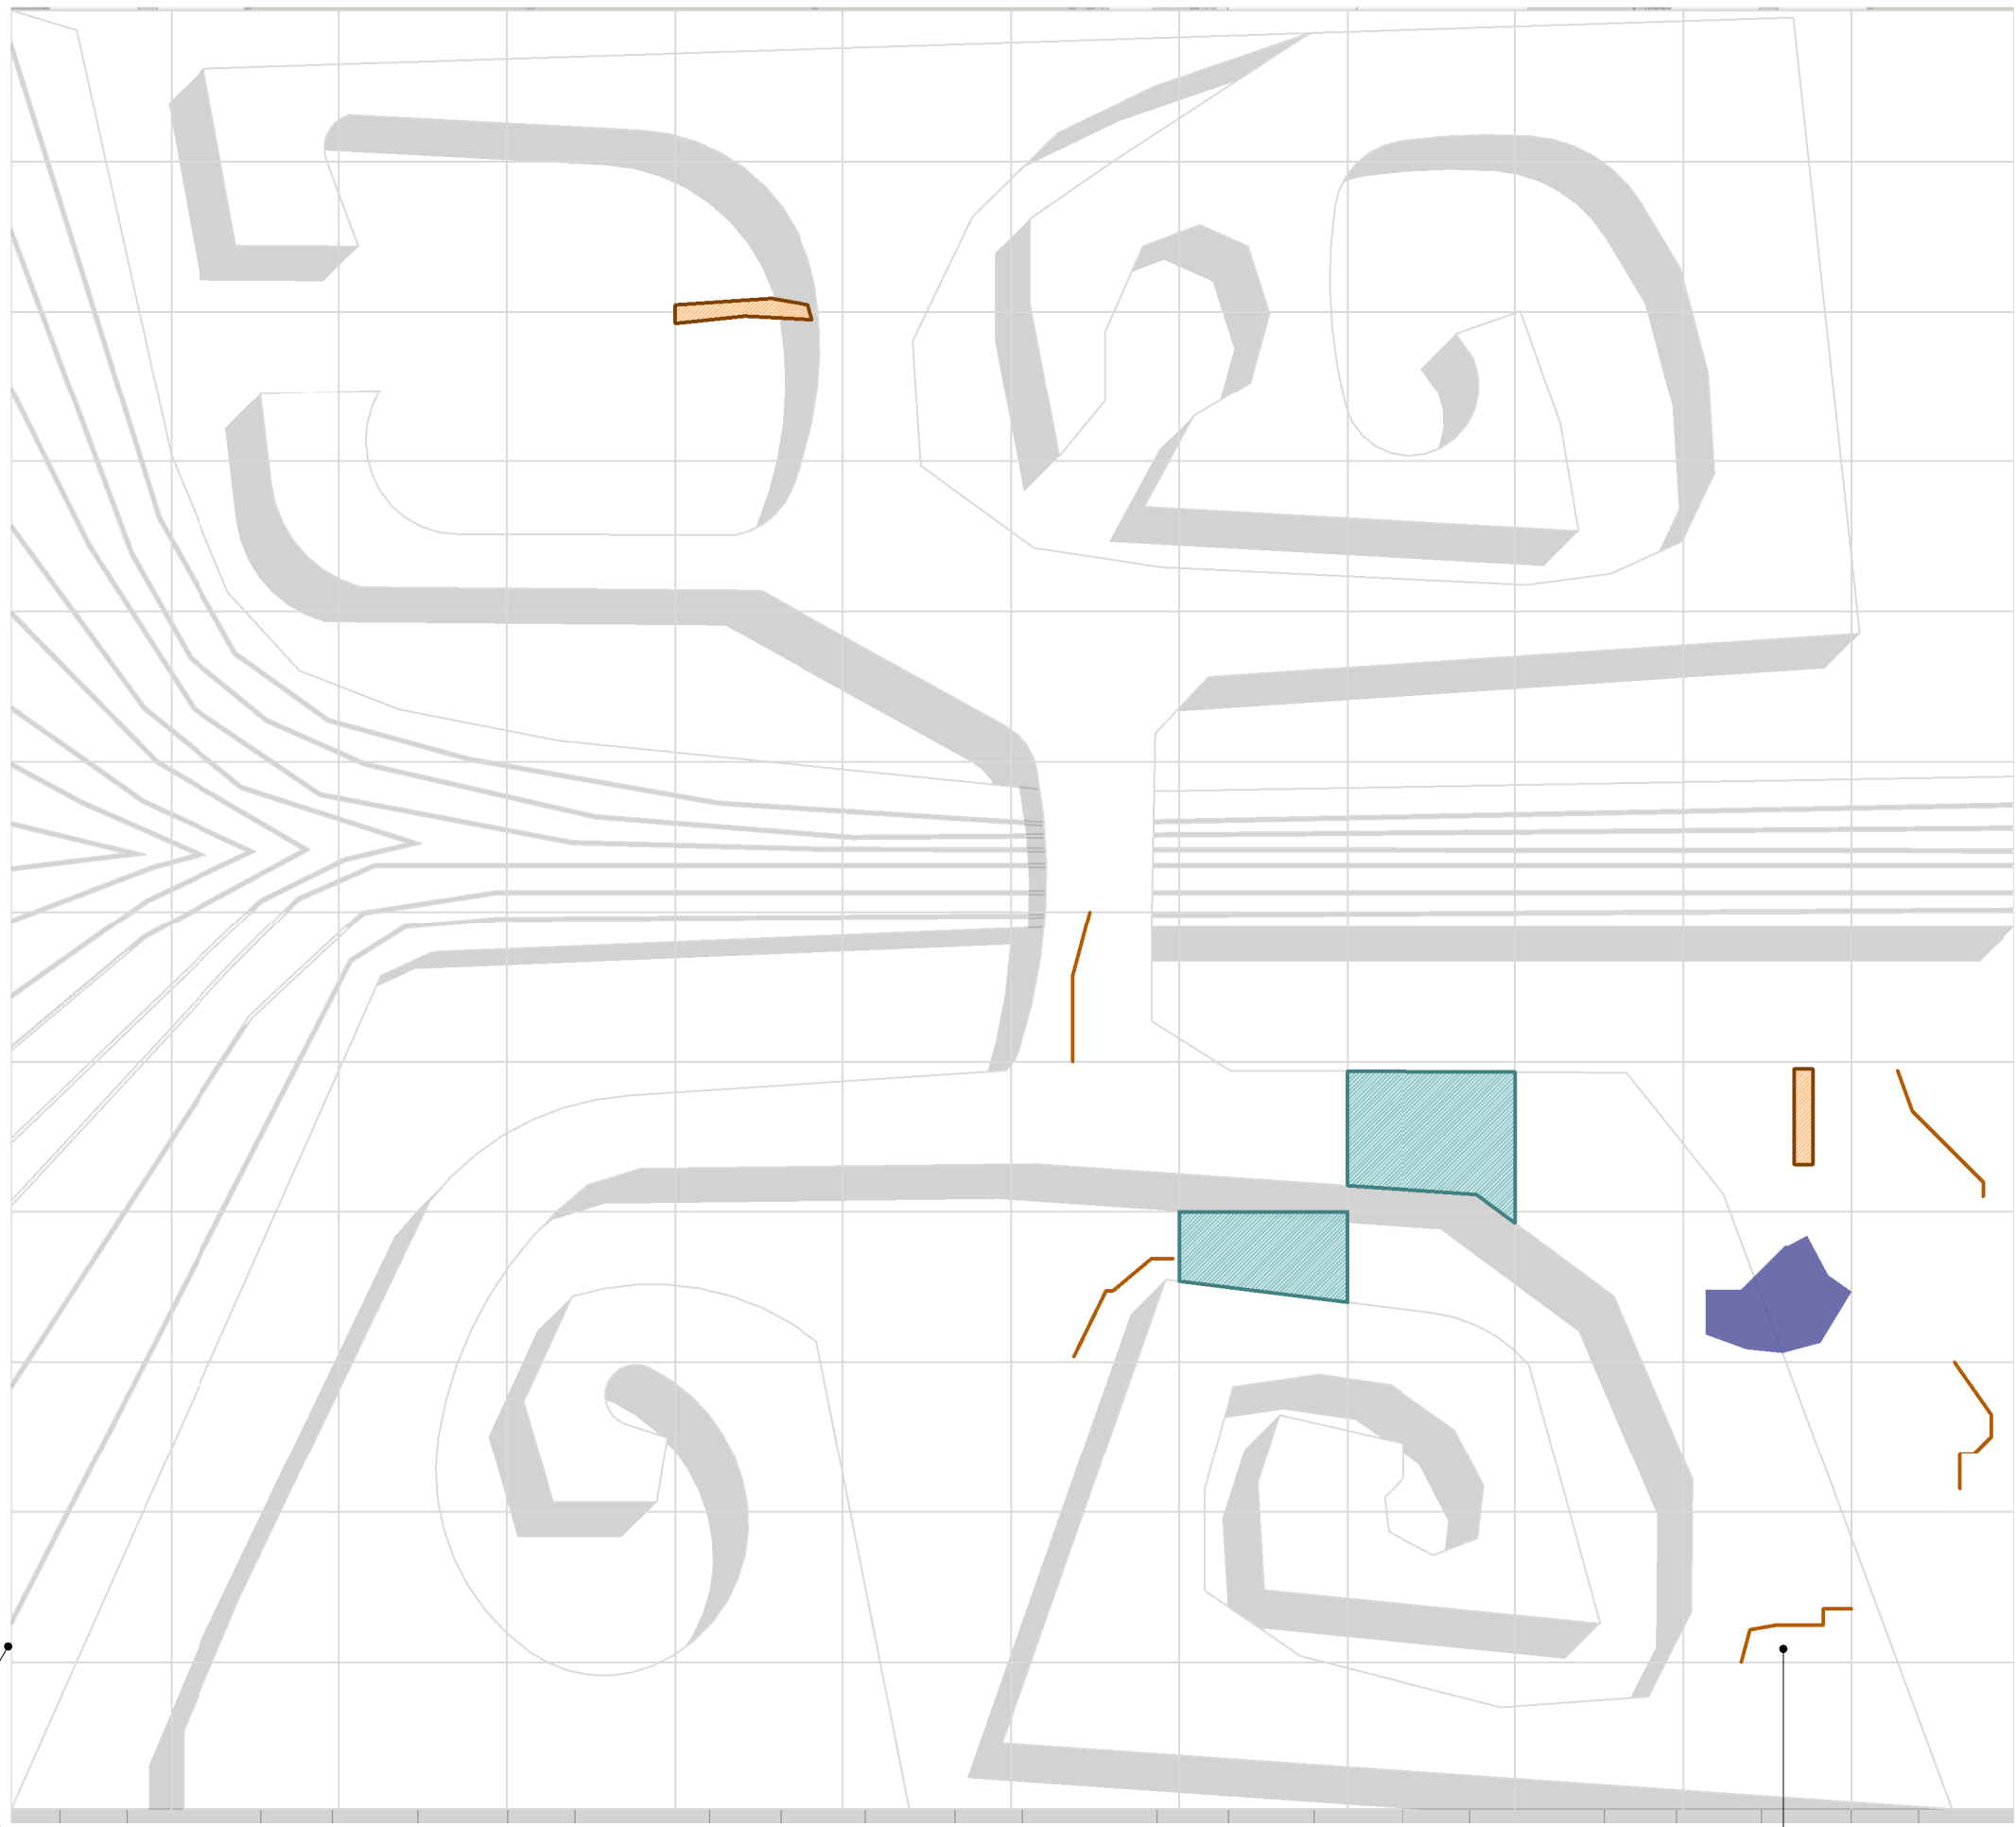
1 Main Elevation (East) - Ceramic Panel 09  
1 : 20

Visual inspection has confirmed that the ceramic panels are largely in good repair with damage present but in limited volumes. There are a variety of cracks with areas of repair from different times since 1969. Many areas of cracking appear to have occurred in firing. Other cracks or broken units have been reassembled with a dark mortar like that used to bed the units. These may be units that failed in the firing or later and have been reassembled for use. A few units appear to have been mortar repaired with the mortar mixed in an attempt to match the tone of the ceramic. Some degradation in panel 10 is indicative of changes in the mix of the clay and possible lower firing temperatures. The later fabrication of this panel could offer some explanation for the difference in its condition as it is thought the original kiln had been dismantled by the time panel 10 was sculpted.

- 50% repointing
- 100% doff / thermotech cleaning
- Localised mortar repairs
- 12 no. specialist replacement panels approx 480mm square
- Remediation of corroding fixings where damage has been caused to the ceramics
