PROJECT
 Kirklees Cultural Heart, Huddersfield

DRAWING TITLE
 Huddersfield Library - Conservation of Artwork - Articulation in Motion Ceramic Panel 03-04

IR430301 CTA ZZ XX DR A 074202 P02

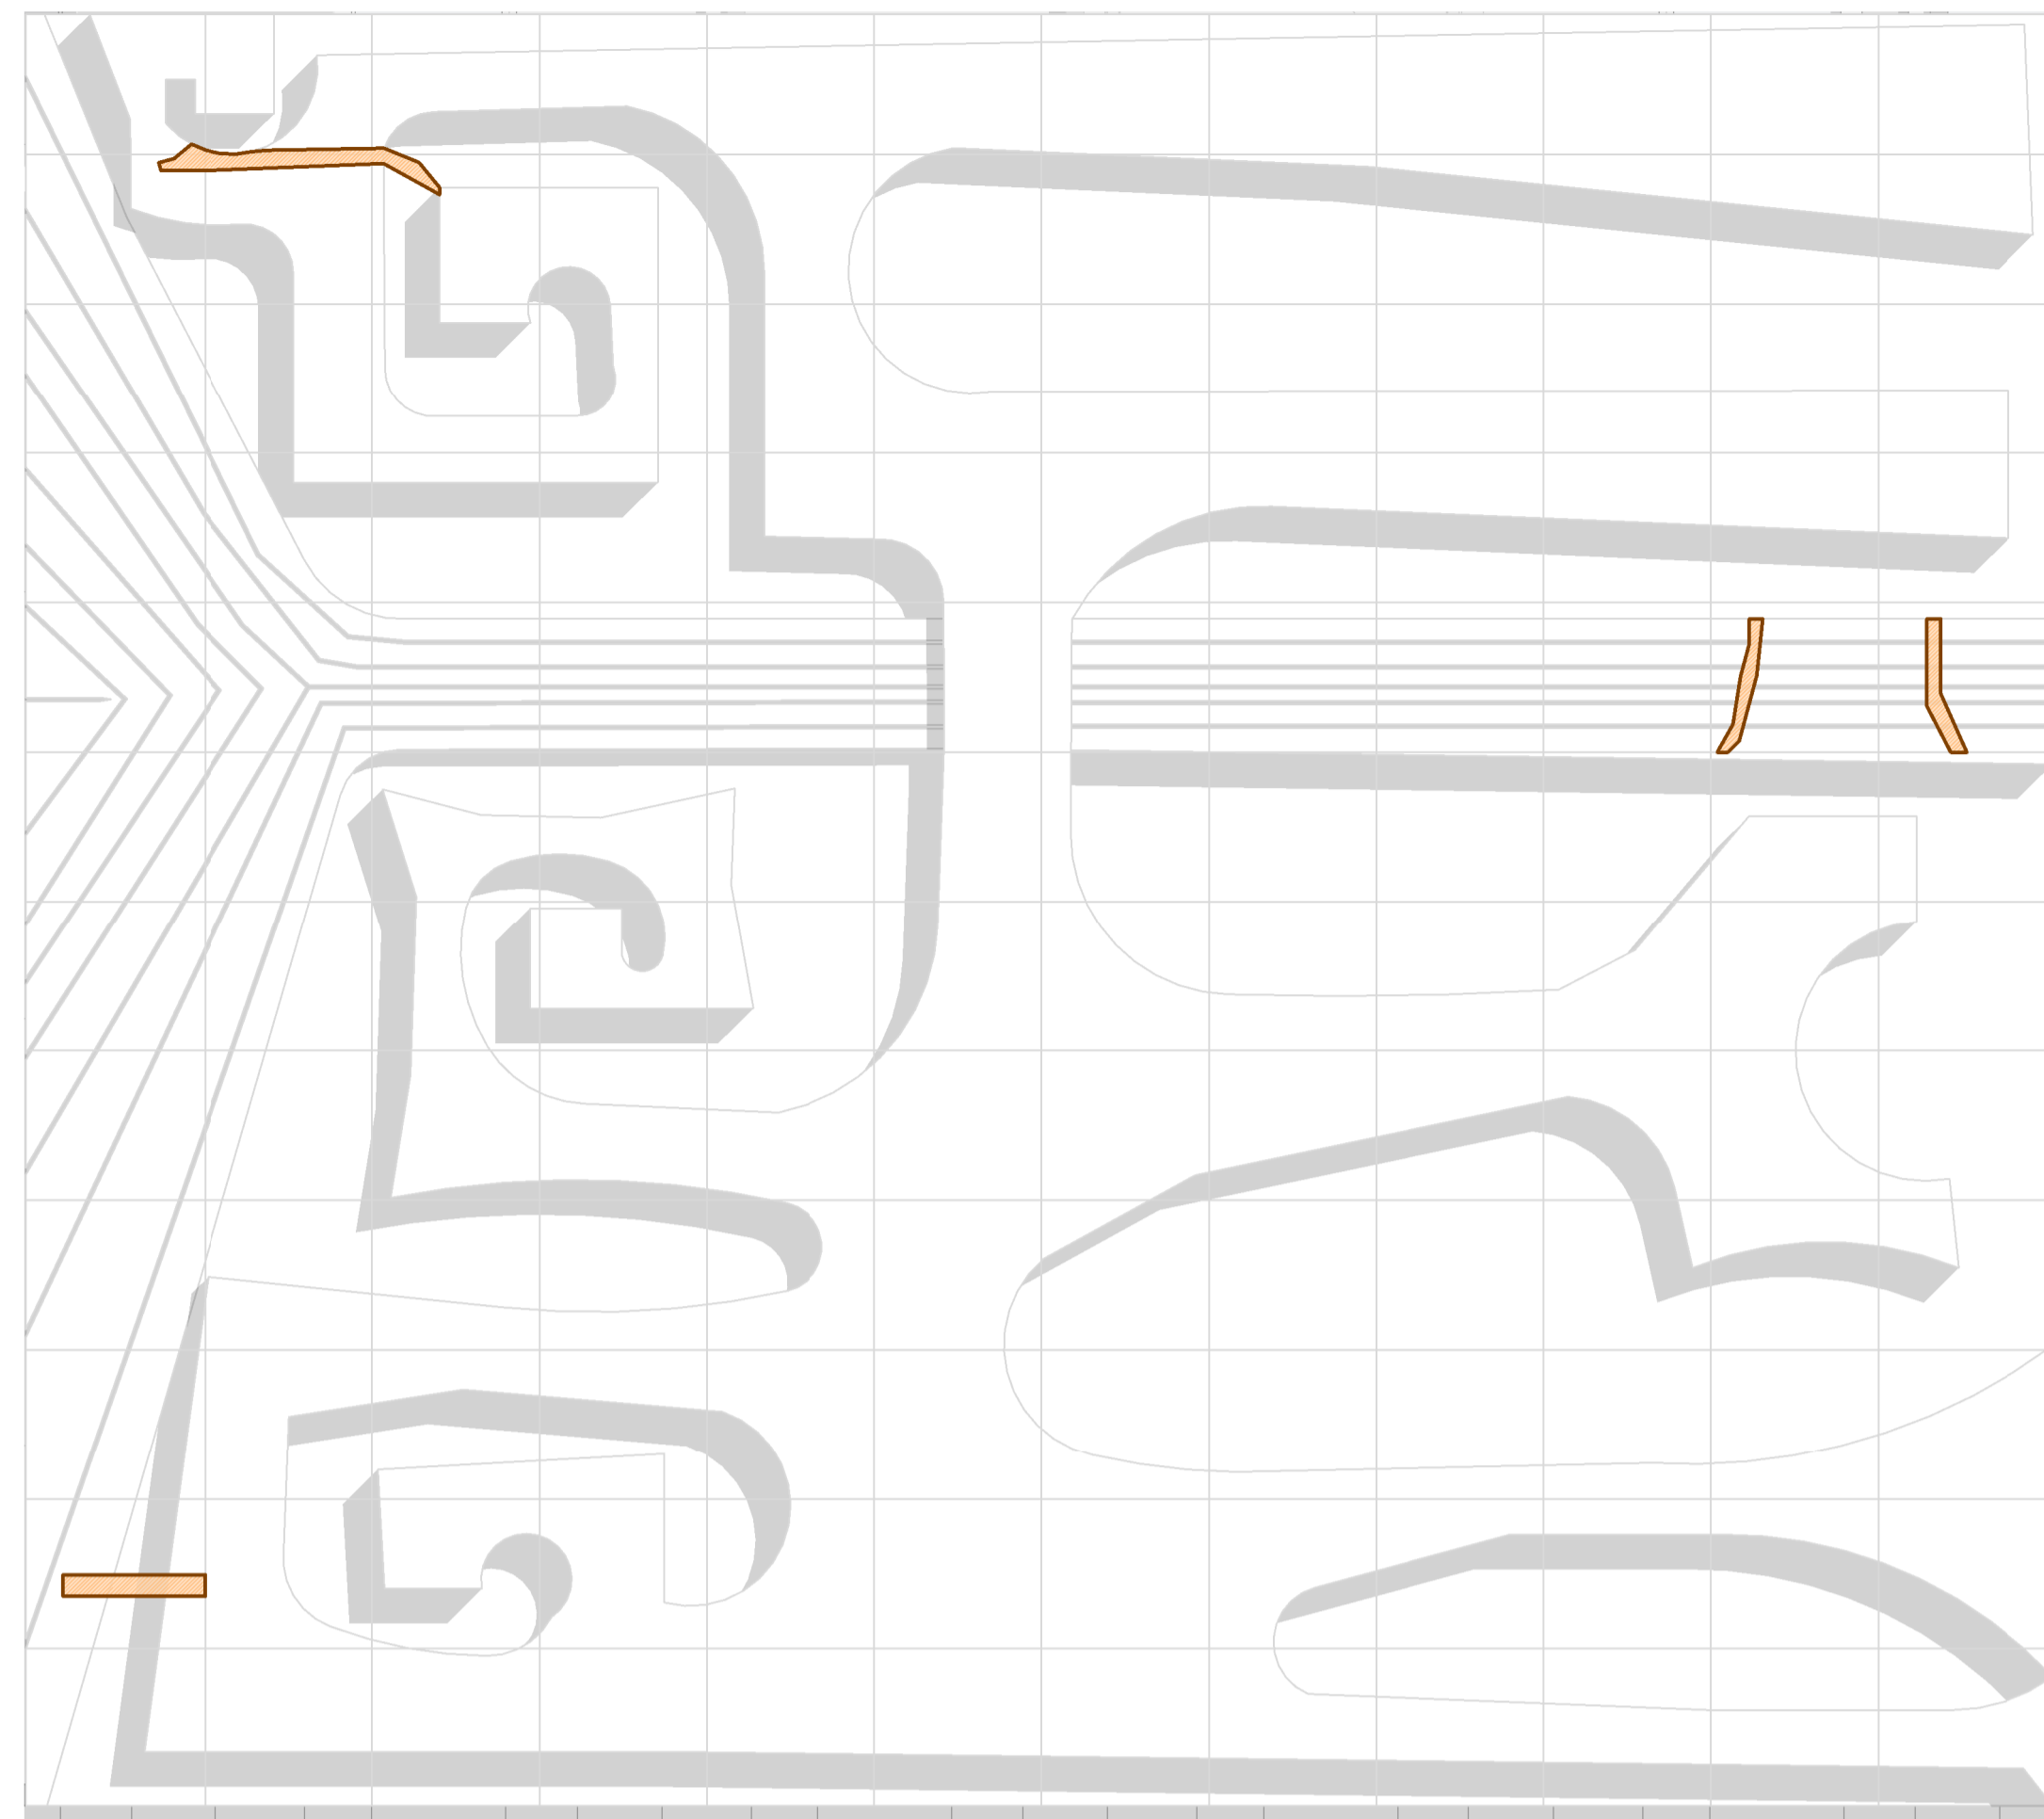
1 Main Elevation (East) - Ceramic Panel 03
1 : 20

Condition
 Visual inspection has confirmed that the ceramic panels are largely in good repair with damage present but in limited volumes. There are a variety of cracks with areas of repair from different times since 1969. Many areas of cracking appear to have occurred in firing. Other cracks or broken units have been reassembled with a dark mortar like that used to bed the units. These may be units that failed in the firing or later and have been reassembled for use. A few units appear to have been mortar repaired with the mortar mixed in an attempt to match the tone of the ceramic. Some degradation in panel 10 is indicative of changes in the mix of the clay and possible lower firing temperatures. The later fabrication of this panel could offer some explanation for the difference in its condition as it is thought the original kiln had been dismantled by the time panel 10 was sculpted.

Proposed Repairs
 - 50% repointing
 - 100% eff / thermotech cleaning
 - Localised mortar repairs
 - 12 no. specialist replacement panels approx 480mm square
 - Remediation of corroding fixings where damage has been caused to the ceramics
