## OUR CULTURAL HEART

# Existing Precast RC Plank/Slab Investigation Report

**Curtins Ref: 081801-CUR-00-XX-PR-S-00006**

Site Address: Queensgate Market, Princess St, Huddersfield HD1 2RS

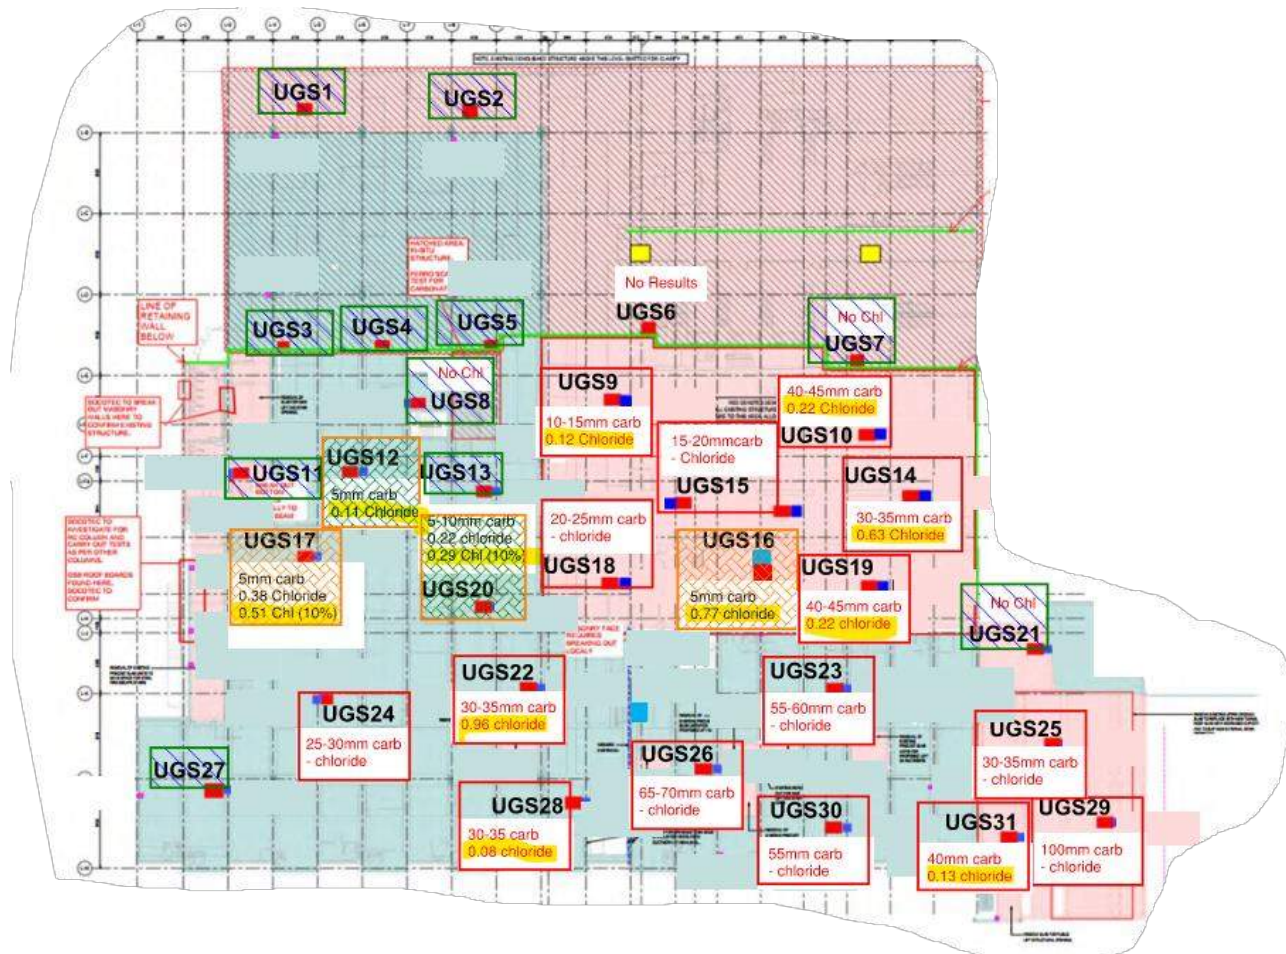
Figure 1: Upper Ground Floor Chloride Results

The chloride content results for the Upper Ground Floor and Level One indicate that several locations have chloride levels exceeding the 0.4% limit. These high levels of chloride do not show any clear pattern or correlation with the existing layout or exposure conditions, suggesting that the issue is widespread.

During site visual surveys many precast RC planks were found to show signs of water ingress. This suggests that during the service life of the structure, the floor build up above the precast

RC planks had failed causing the precast RC planks to be exposed to liquids applied to the floor finish. Cleaning products and chemicals containing chlorides are believed to have seeped through the floor finish in damaged/failed zones causing the high levels of chloride in certain areas.

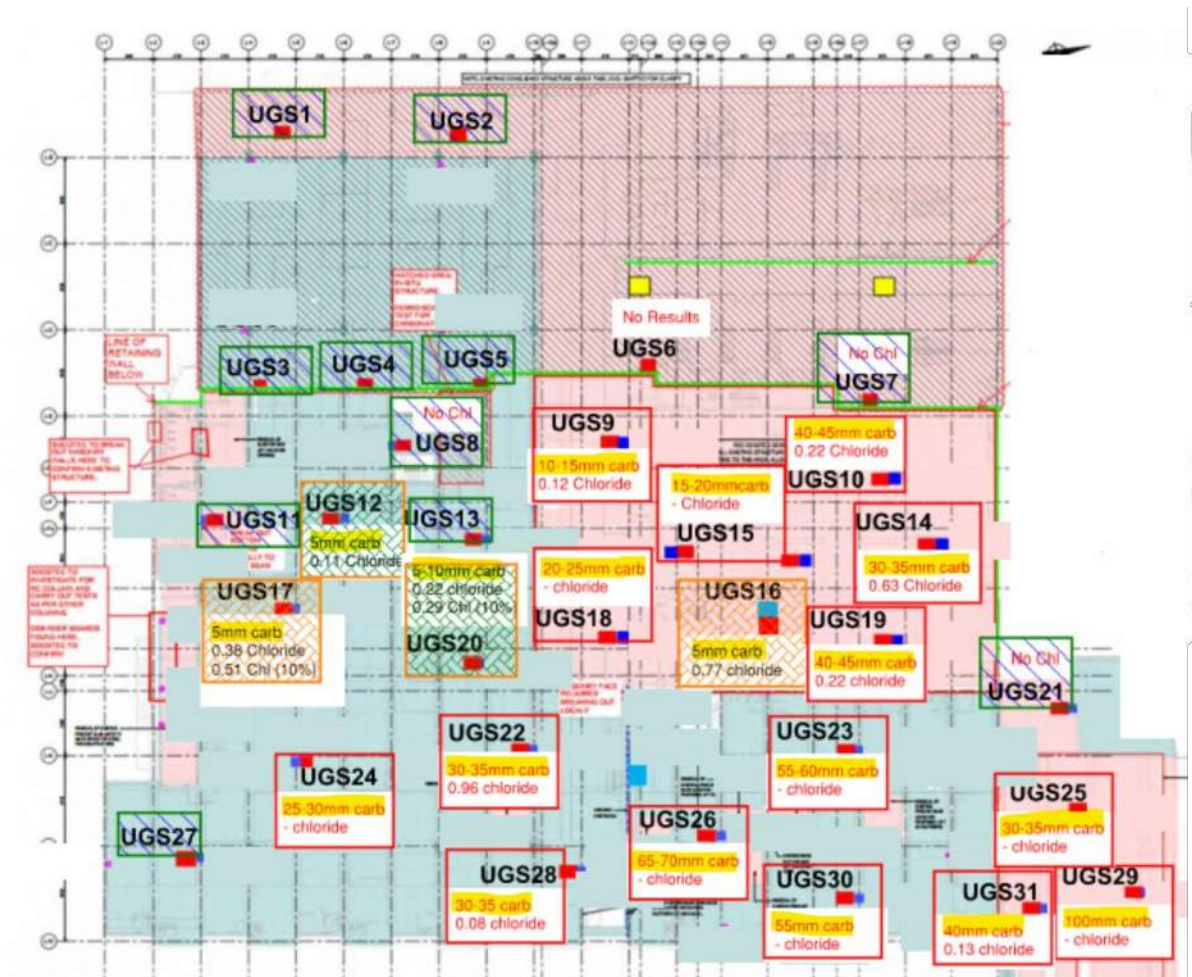
Figure 3: Upper Ground Floor Precast RC Planks Carbonation Results

The upper ground floor carbonation extent results indicate that in locations of vehicle access, where the exposed precast RC planks have been subjected to carbon fumes, carbonation has penetrated beyond cover levels. Results from the precast RC planks located over the proposed event space, currently the Piazza Shopping Centre, indicate high levels of carbonation. In contrast, precast RC planks located internally in the Queensgate Market space, north-west on the upper ground floor plan, show low levels of carbonation.

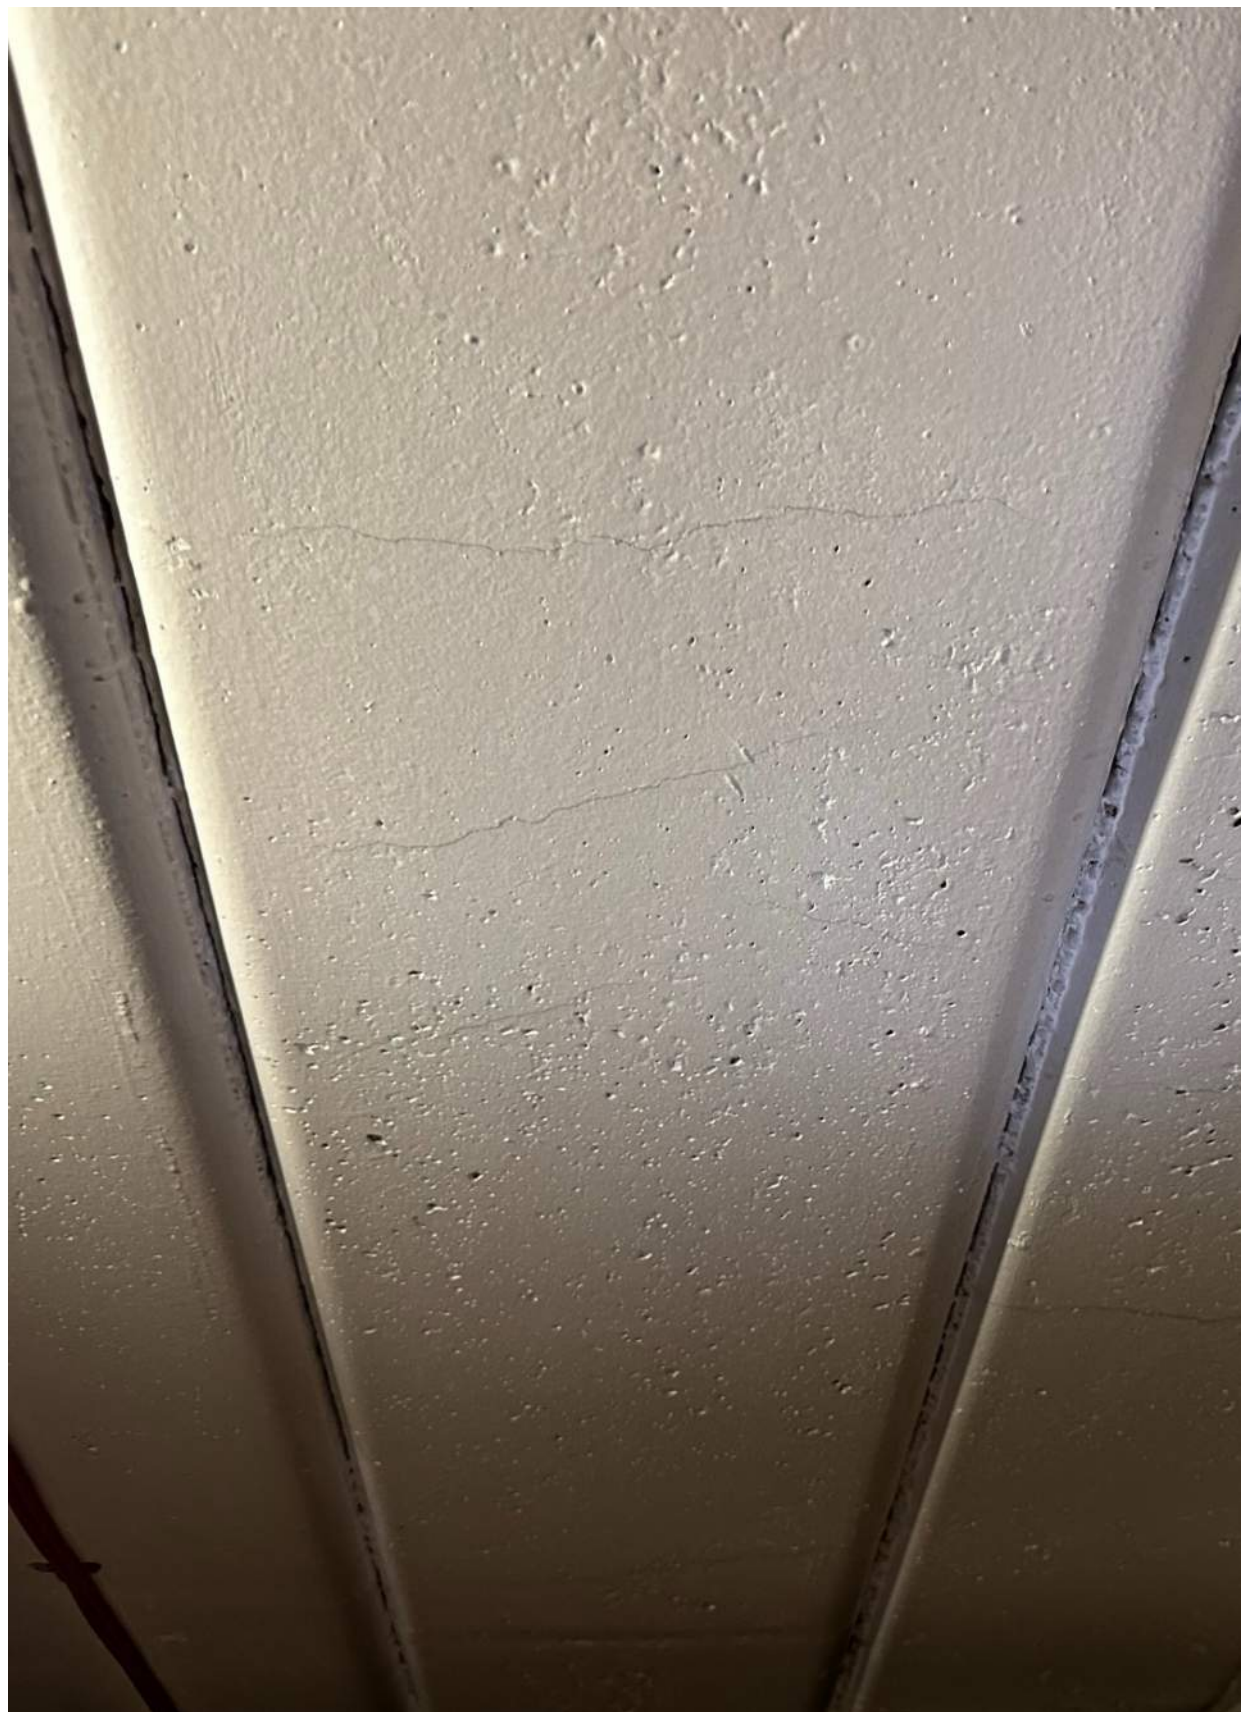
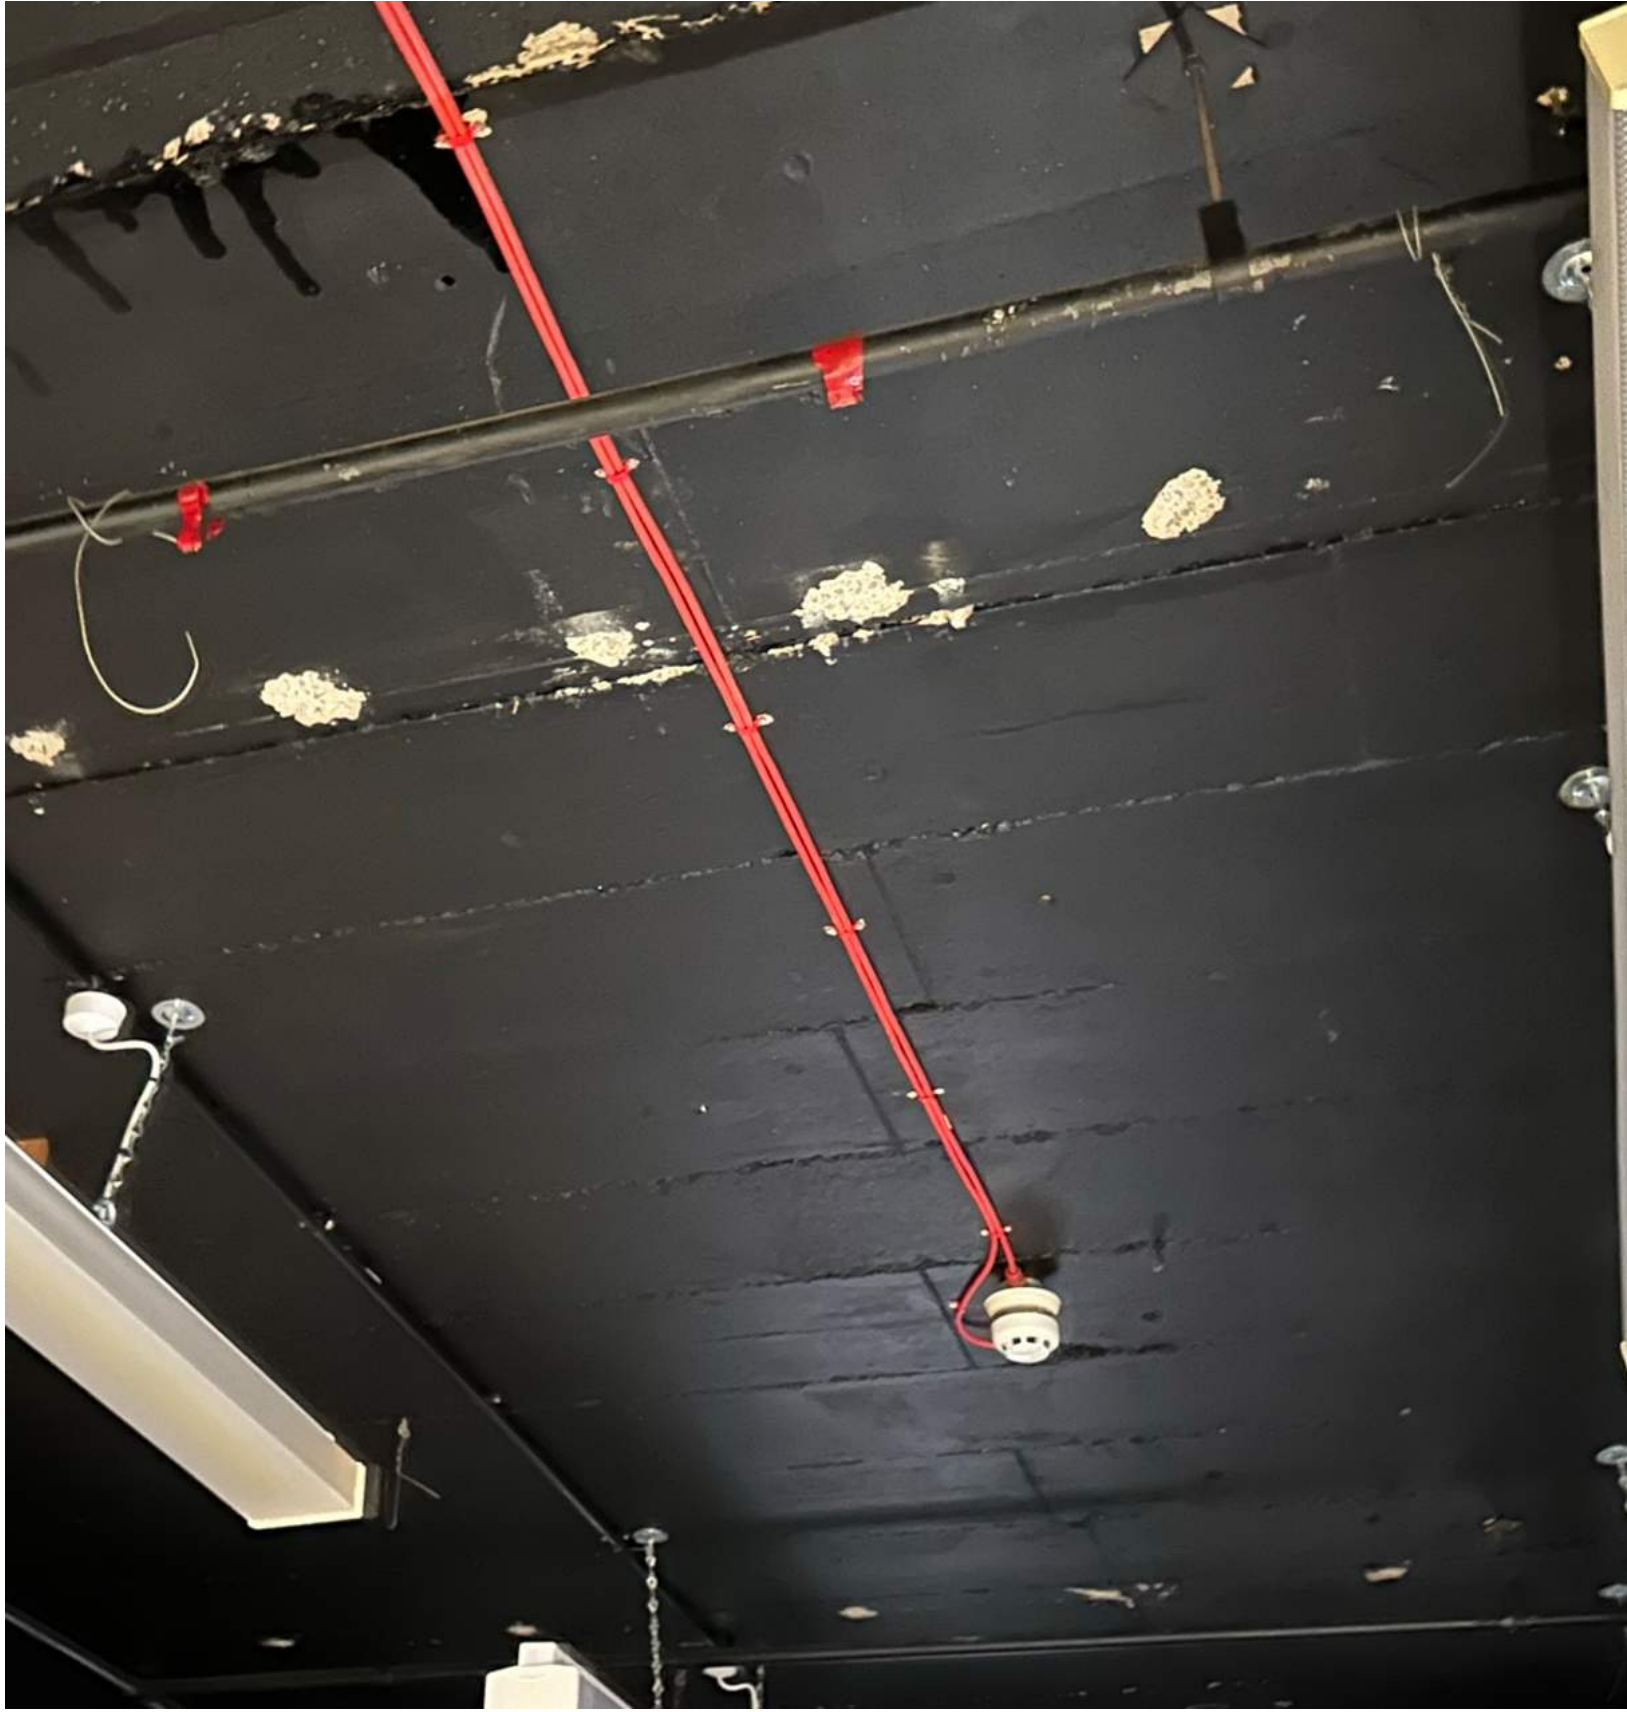
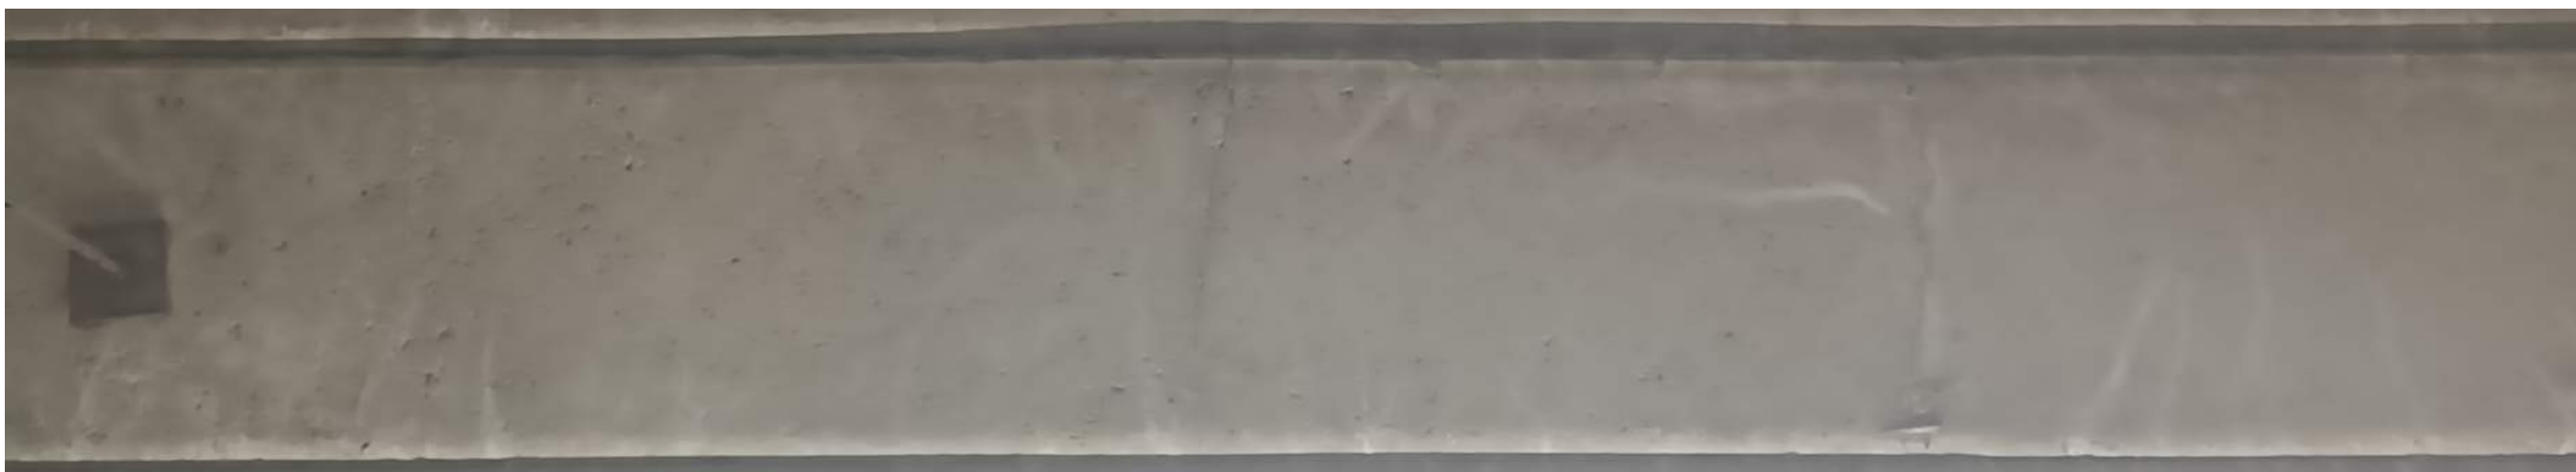
TYPE 1: VISUALLY  
IN GOOD  
CONDITION  
(SMALL BENDING  
CRACKS MAY BE  
PRESENT) -  
EXAMPLE:

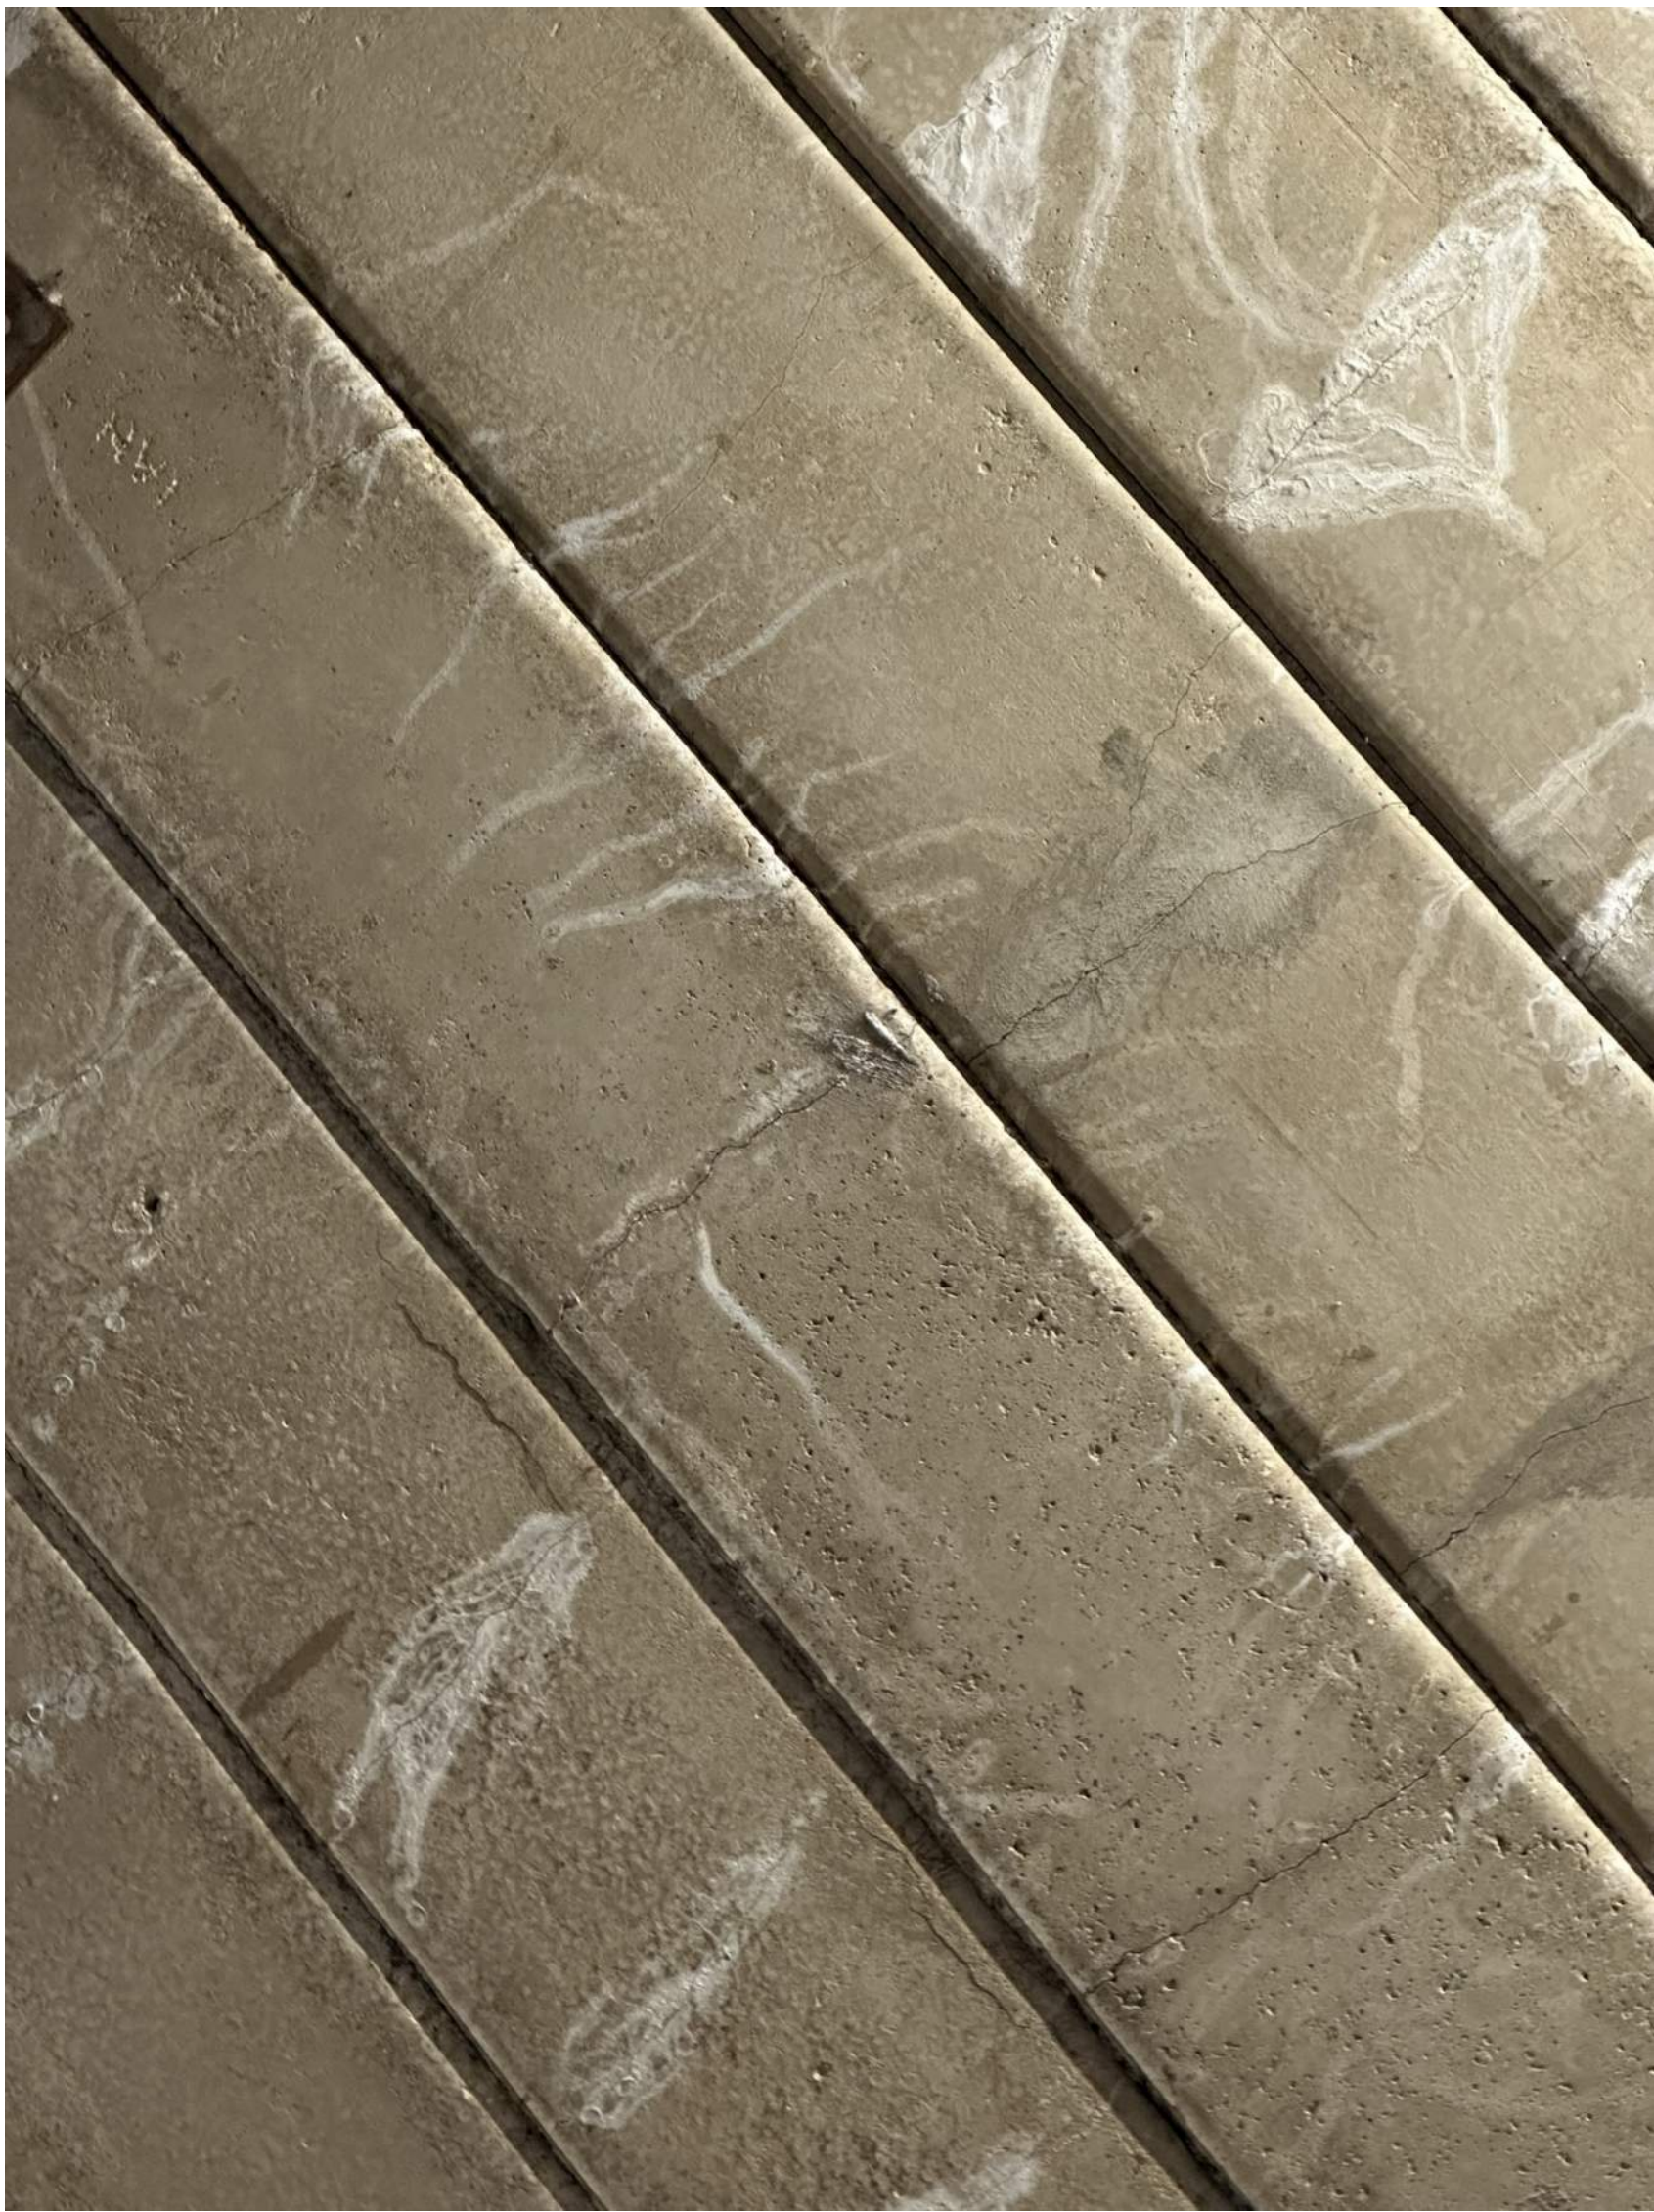
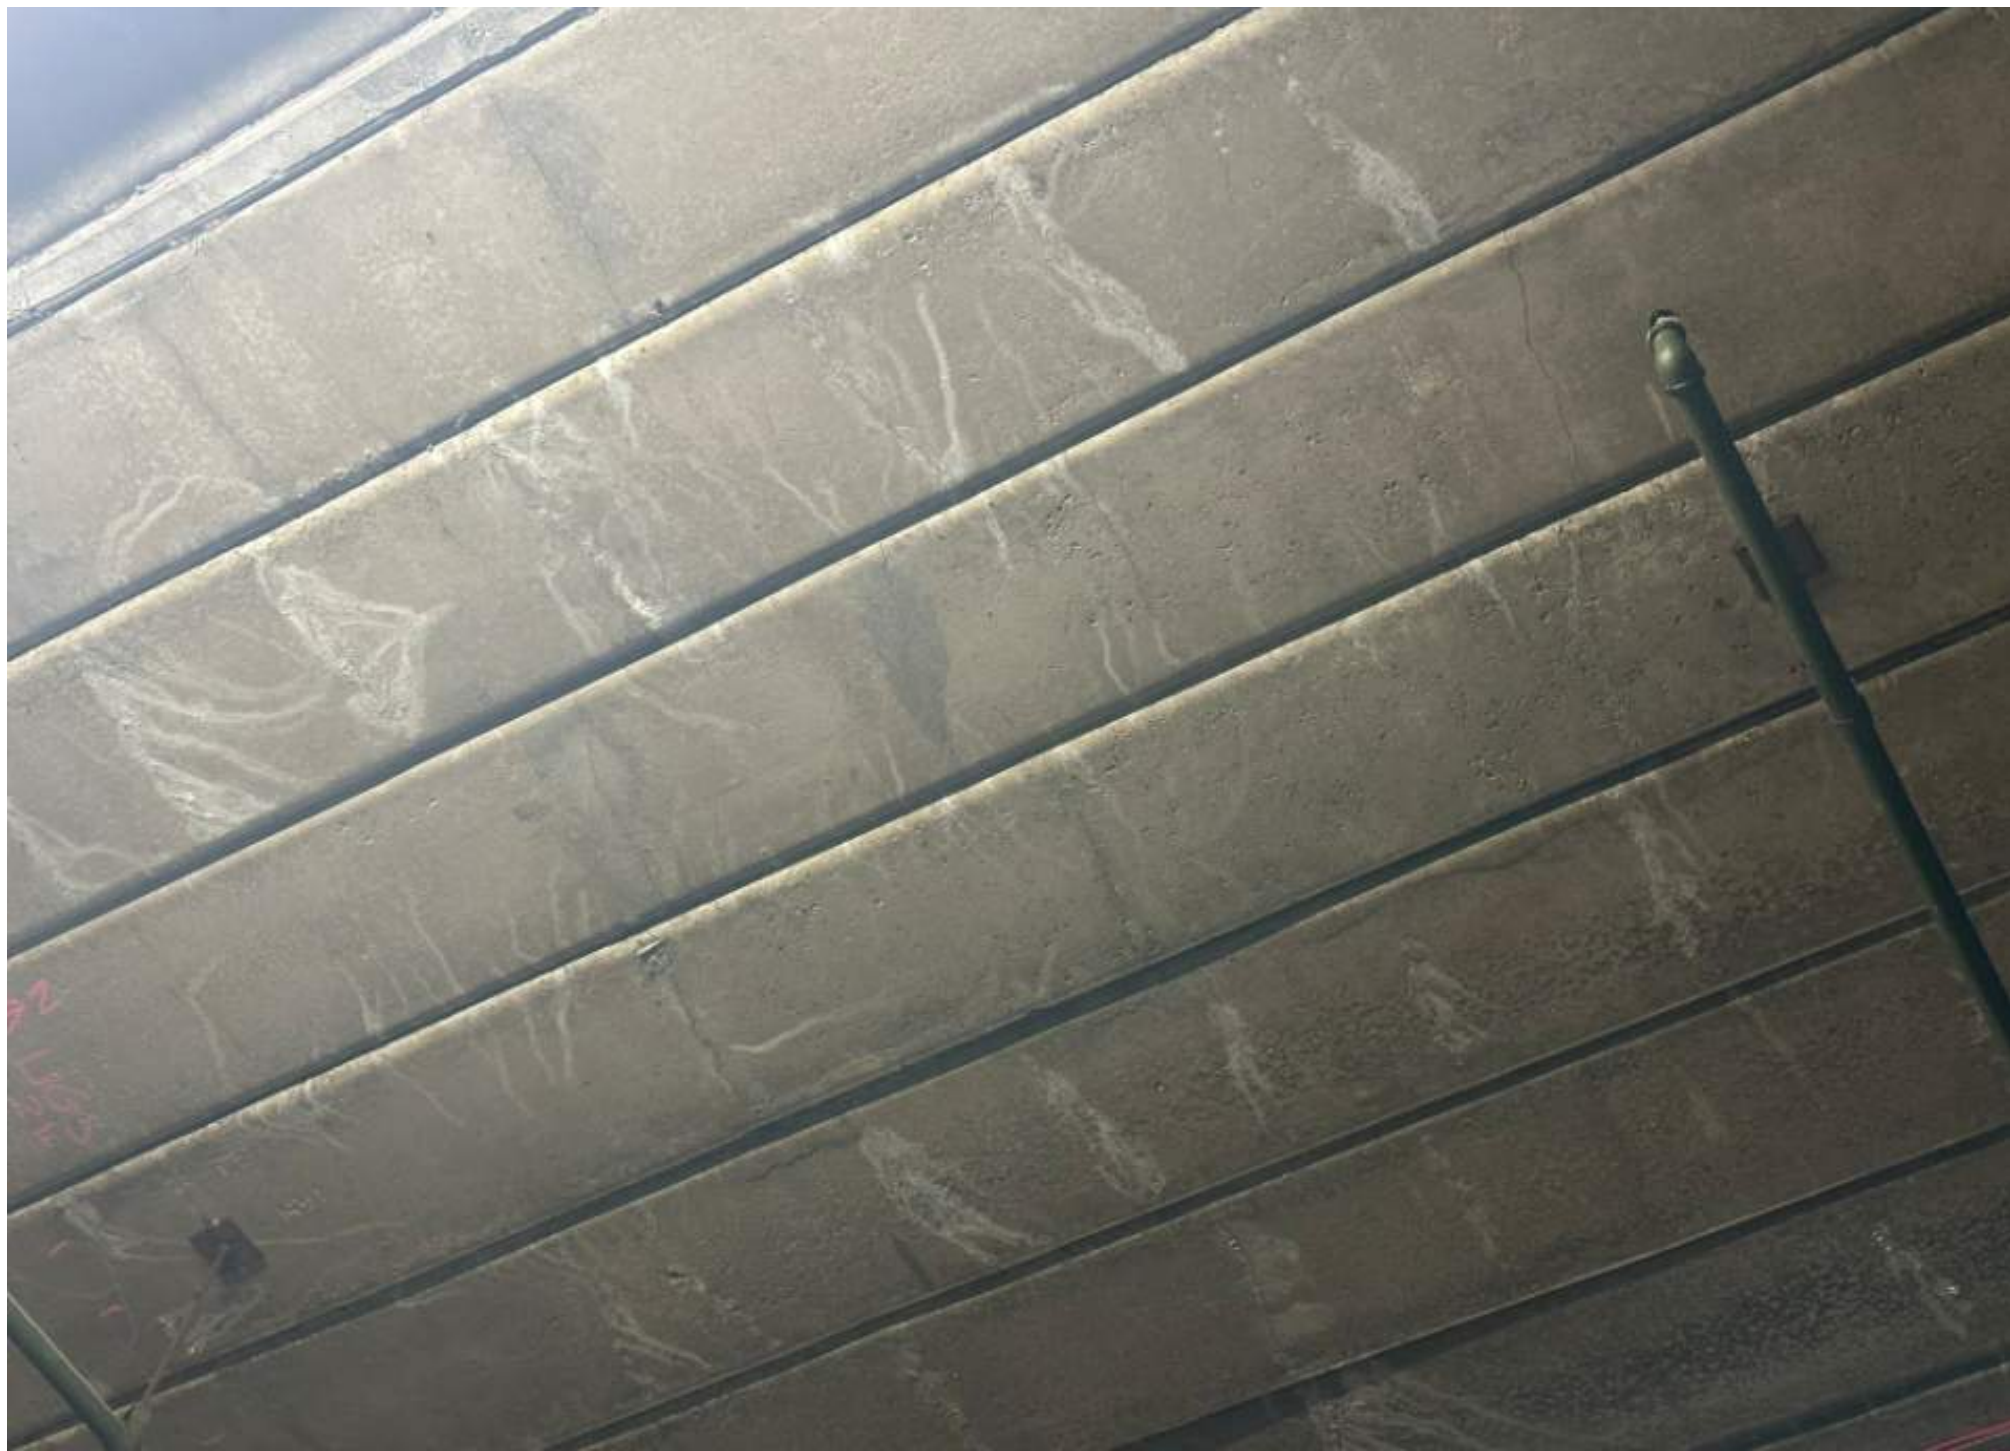
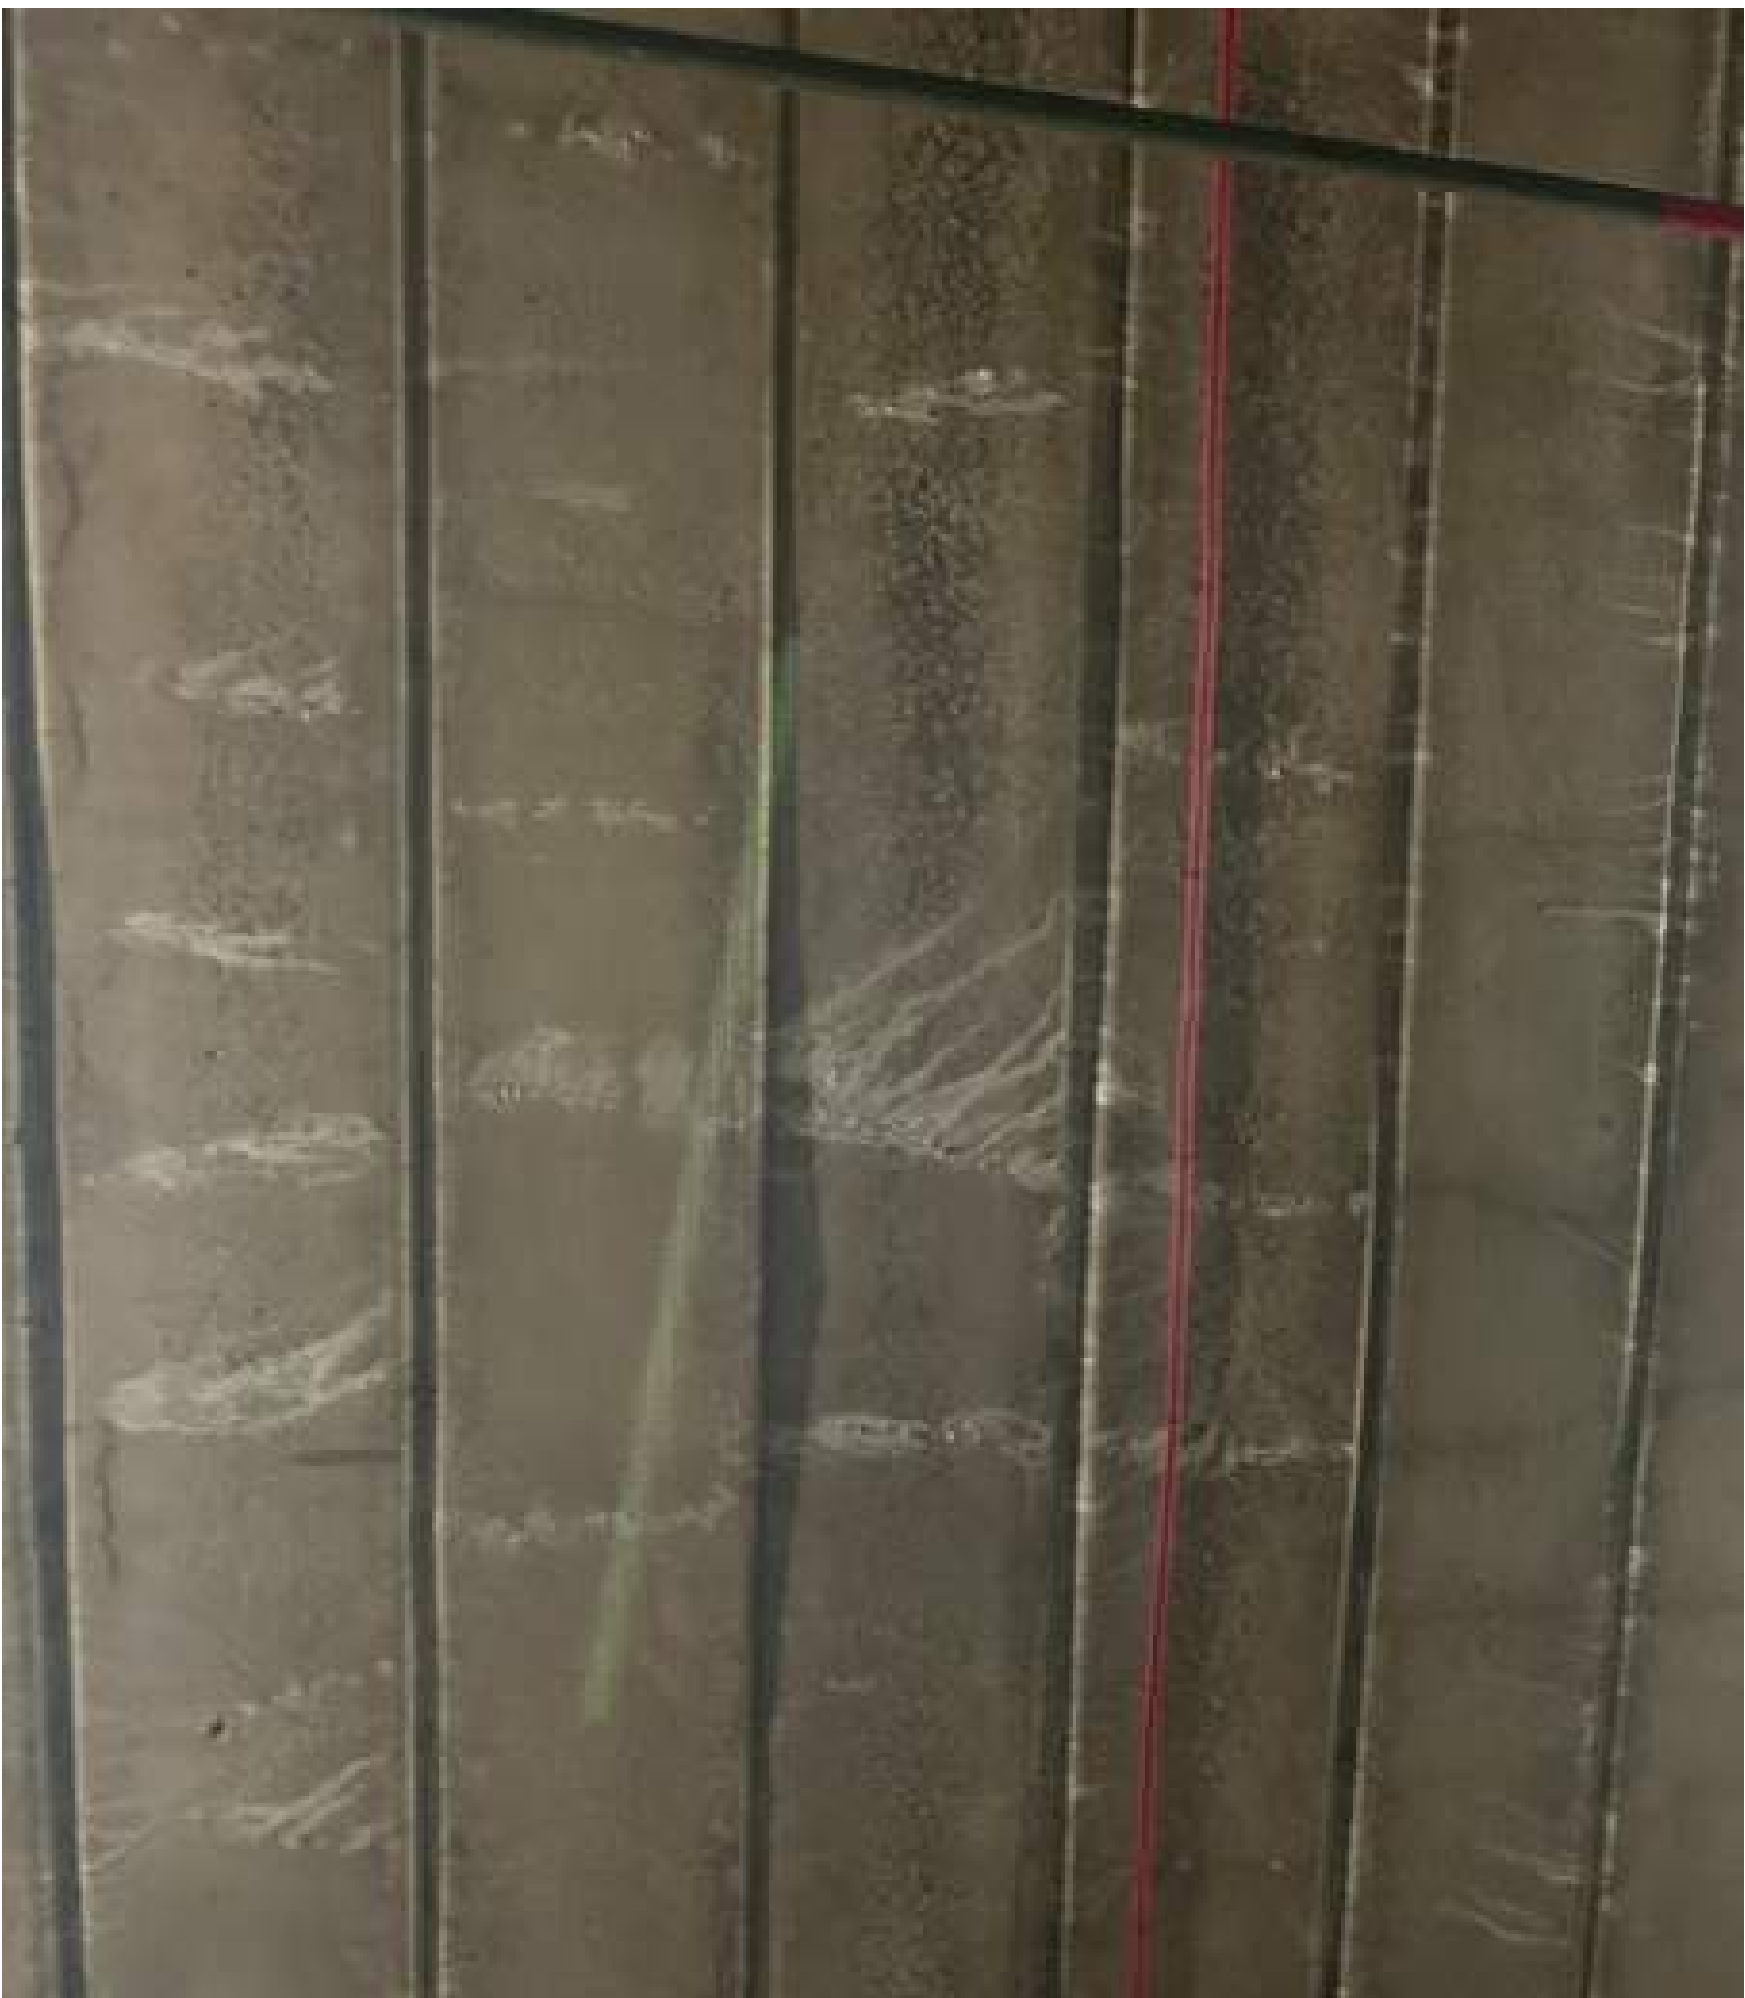
TYPE 2: MANY  
VISIBLE BENDING  
CRACKS (SIGNS OF  
WATER SEAPAGE  
MAY ALSO BE  
PRESENT AND/OR  
LARGE BENDING  
CRACKS) - EXAMPLE:
