## OUR CULTURAL HEART

# Existing Precast RC Plank/Slab Investigation Report

**Curtins Ref: 081801-CUR-00-XX-PR-S-00006**

Site Address: Queensgate Market, Princess St, Huddersfield HD1 2RS

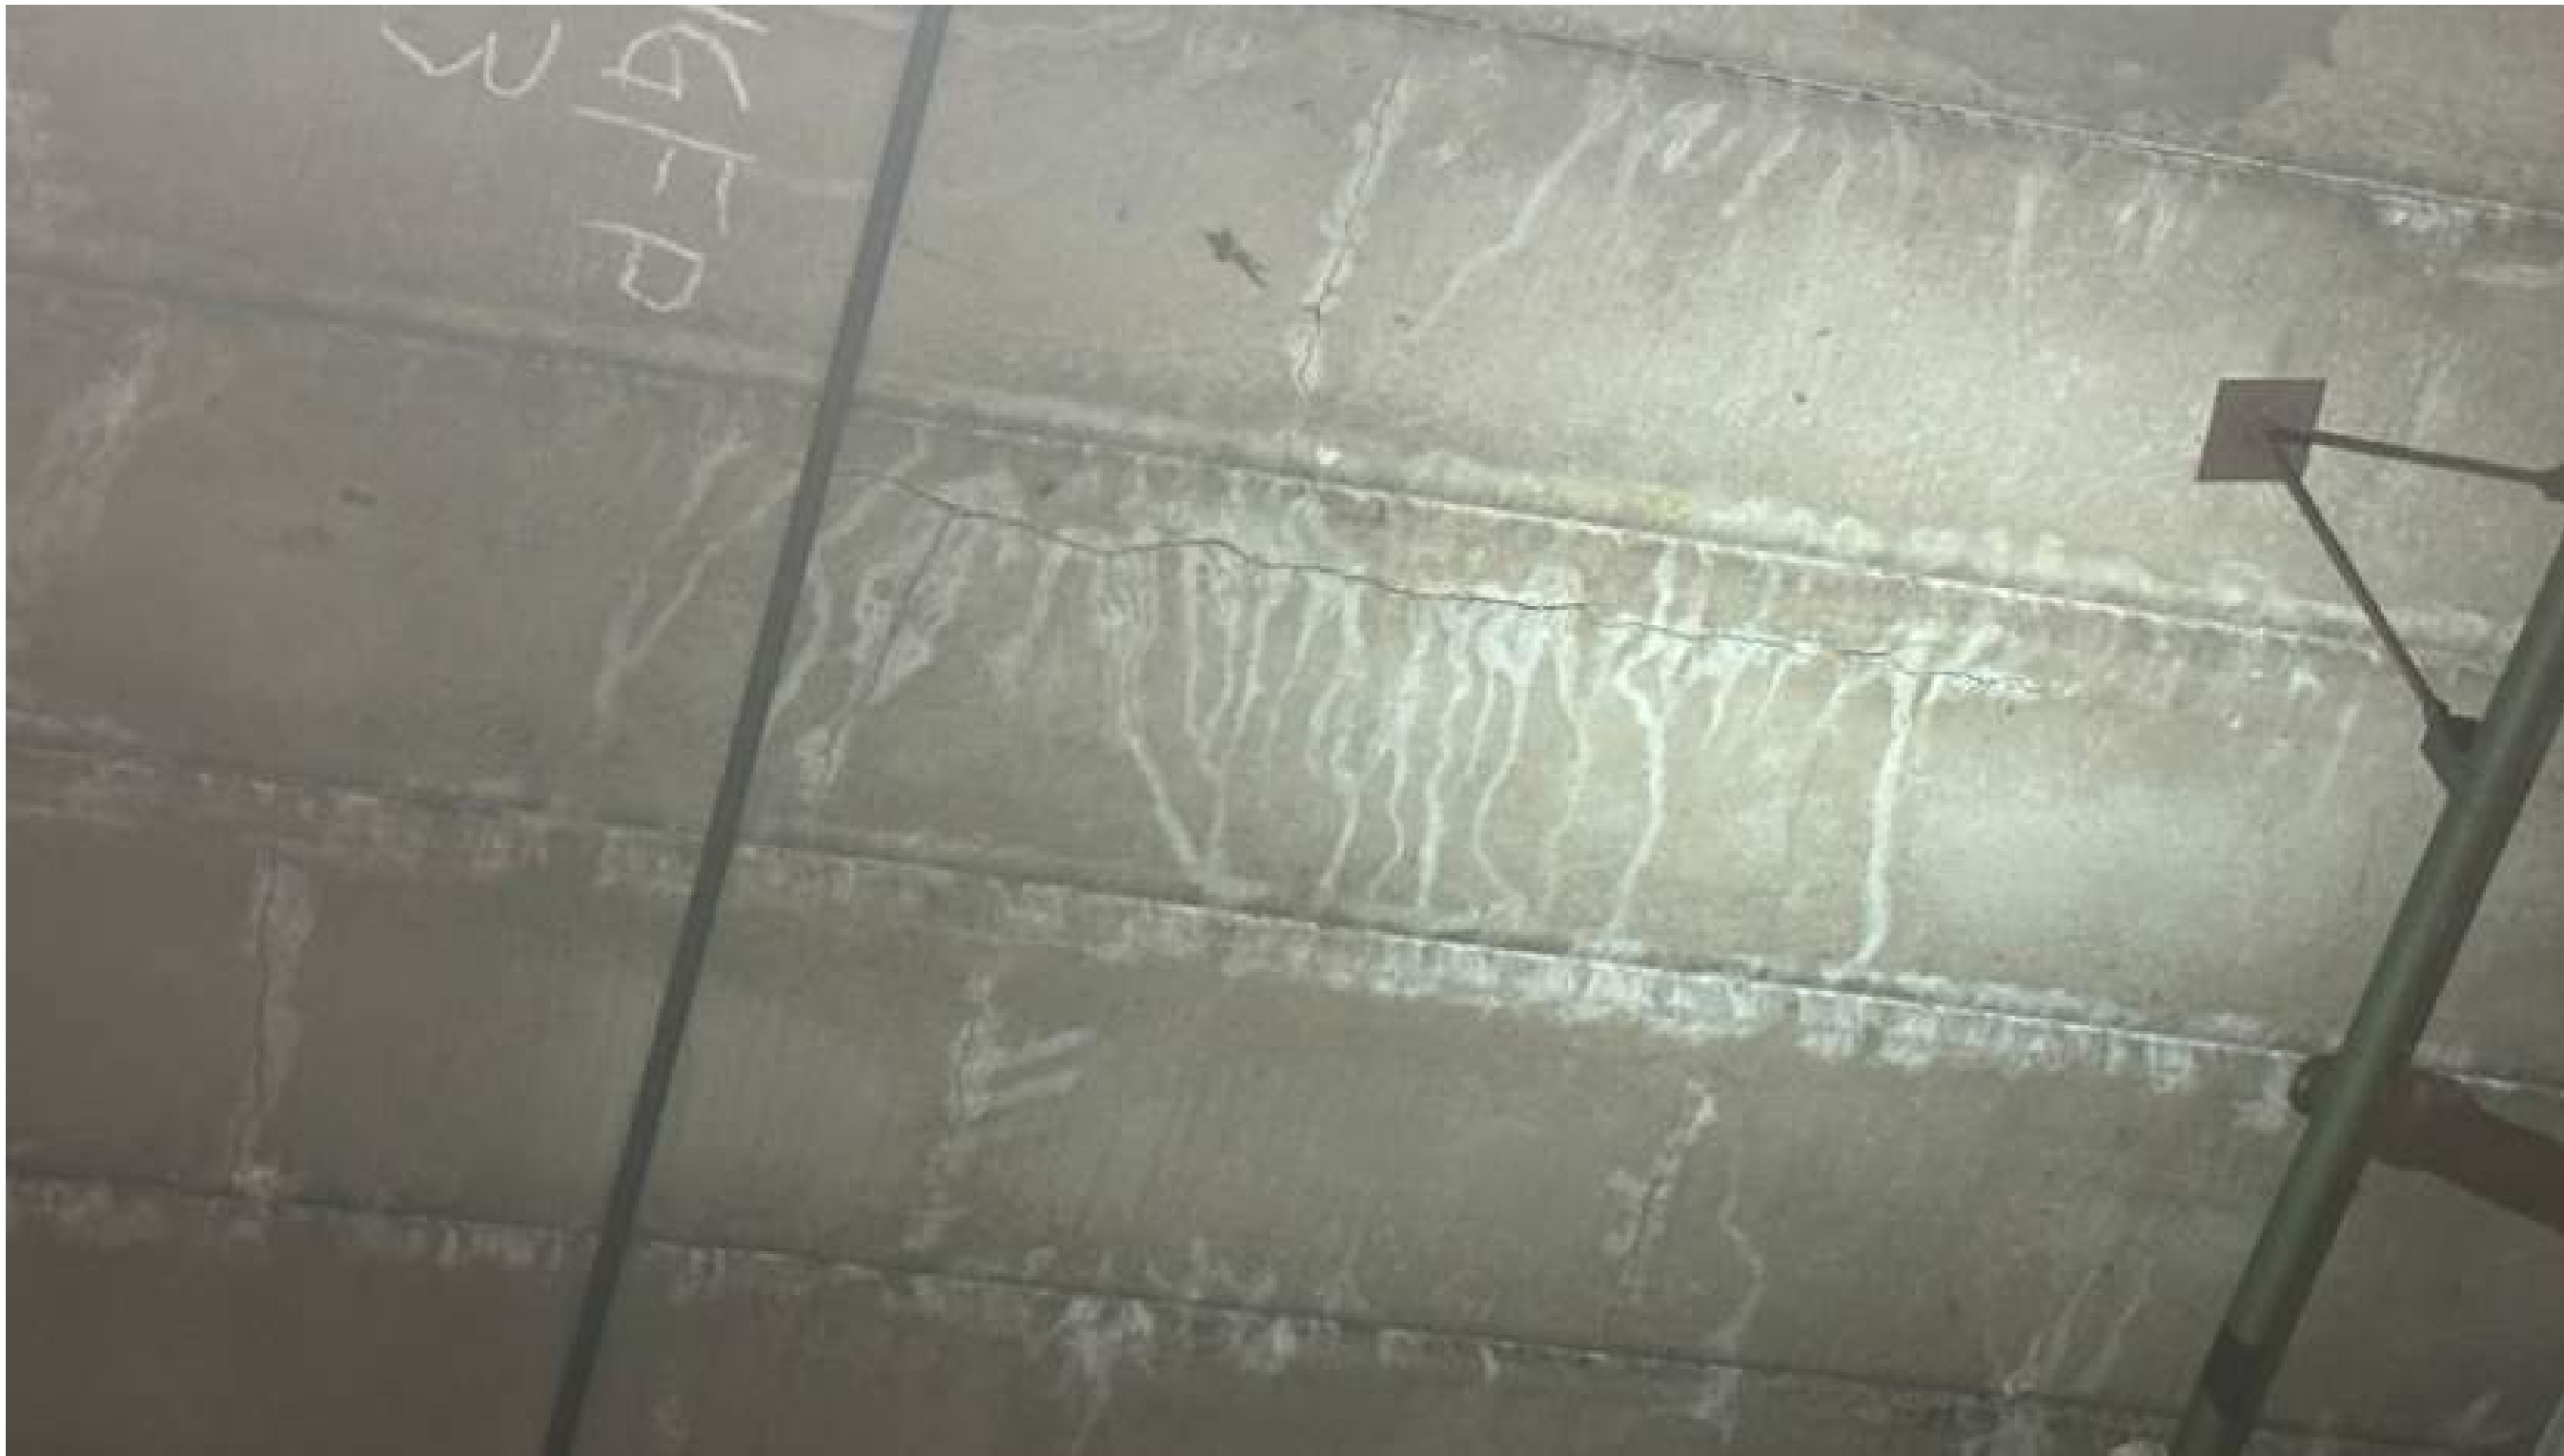
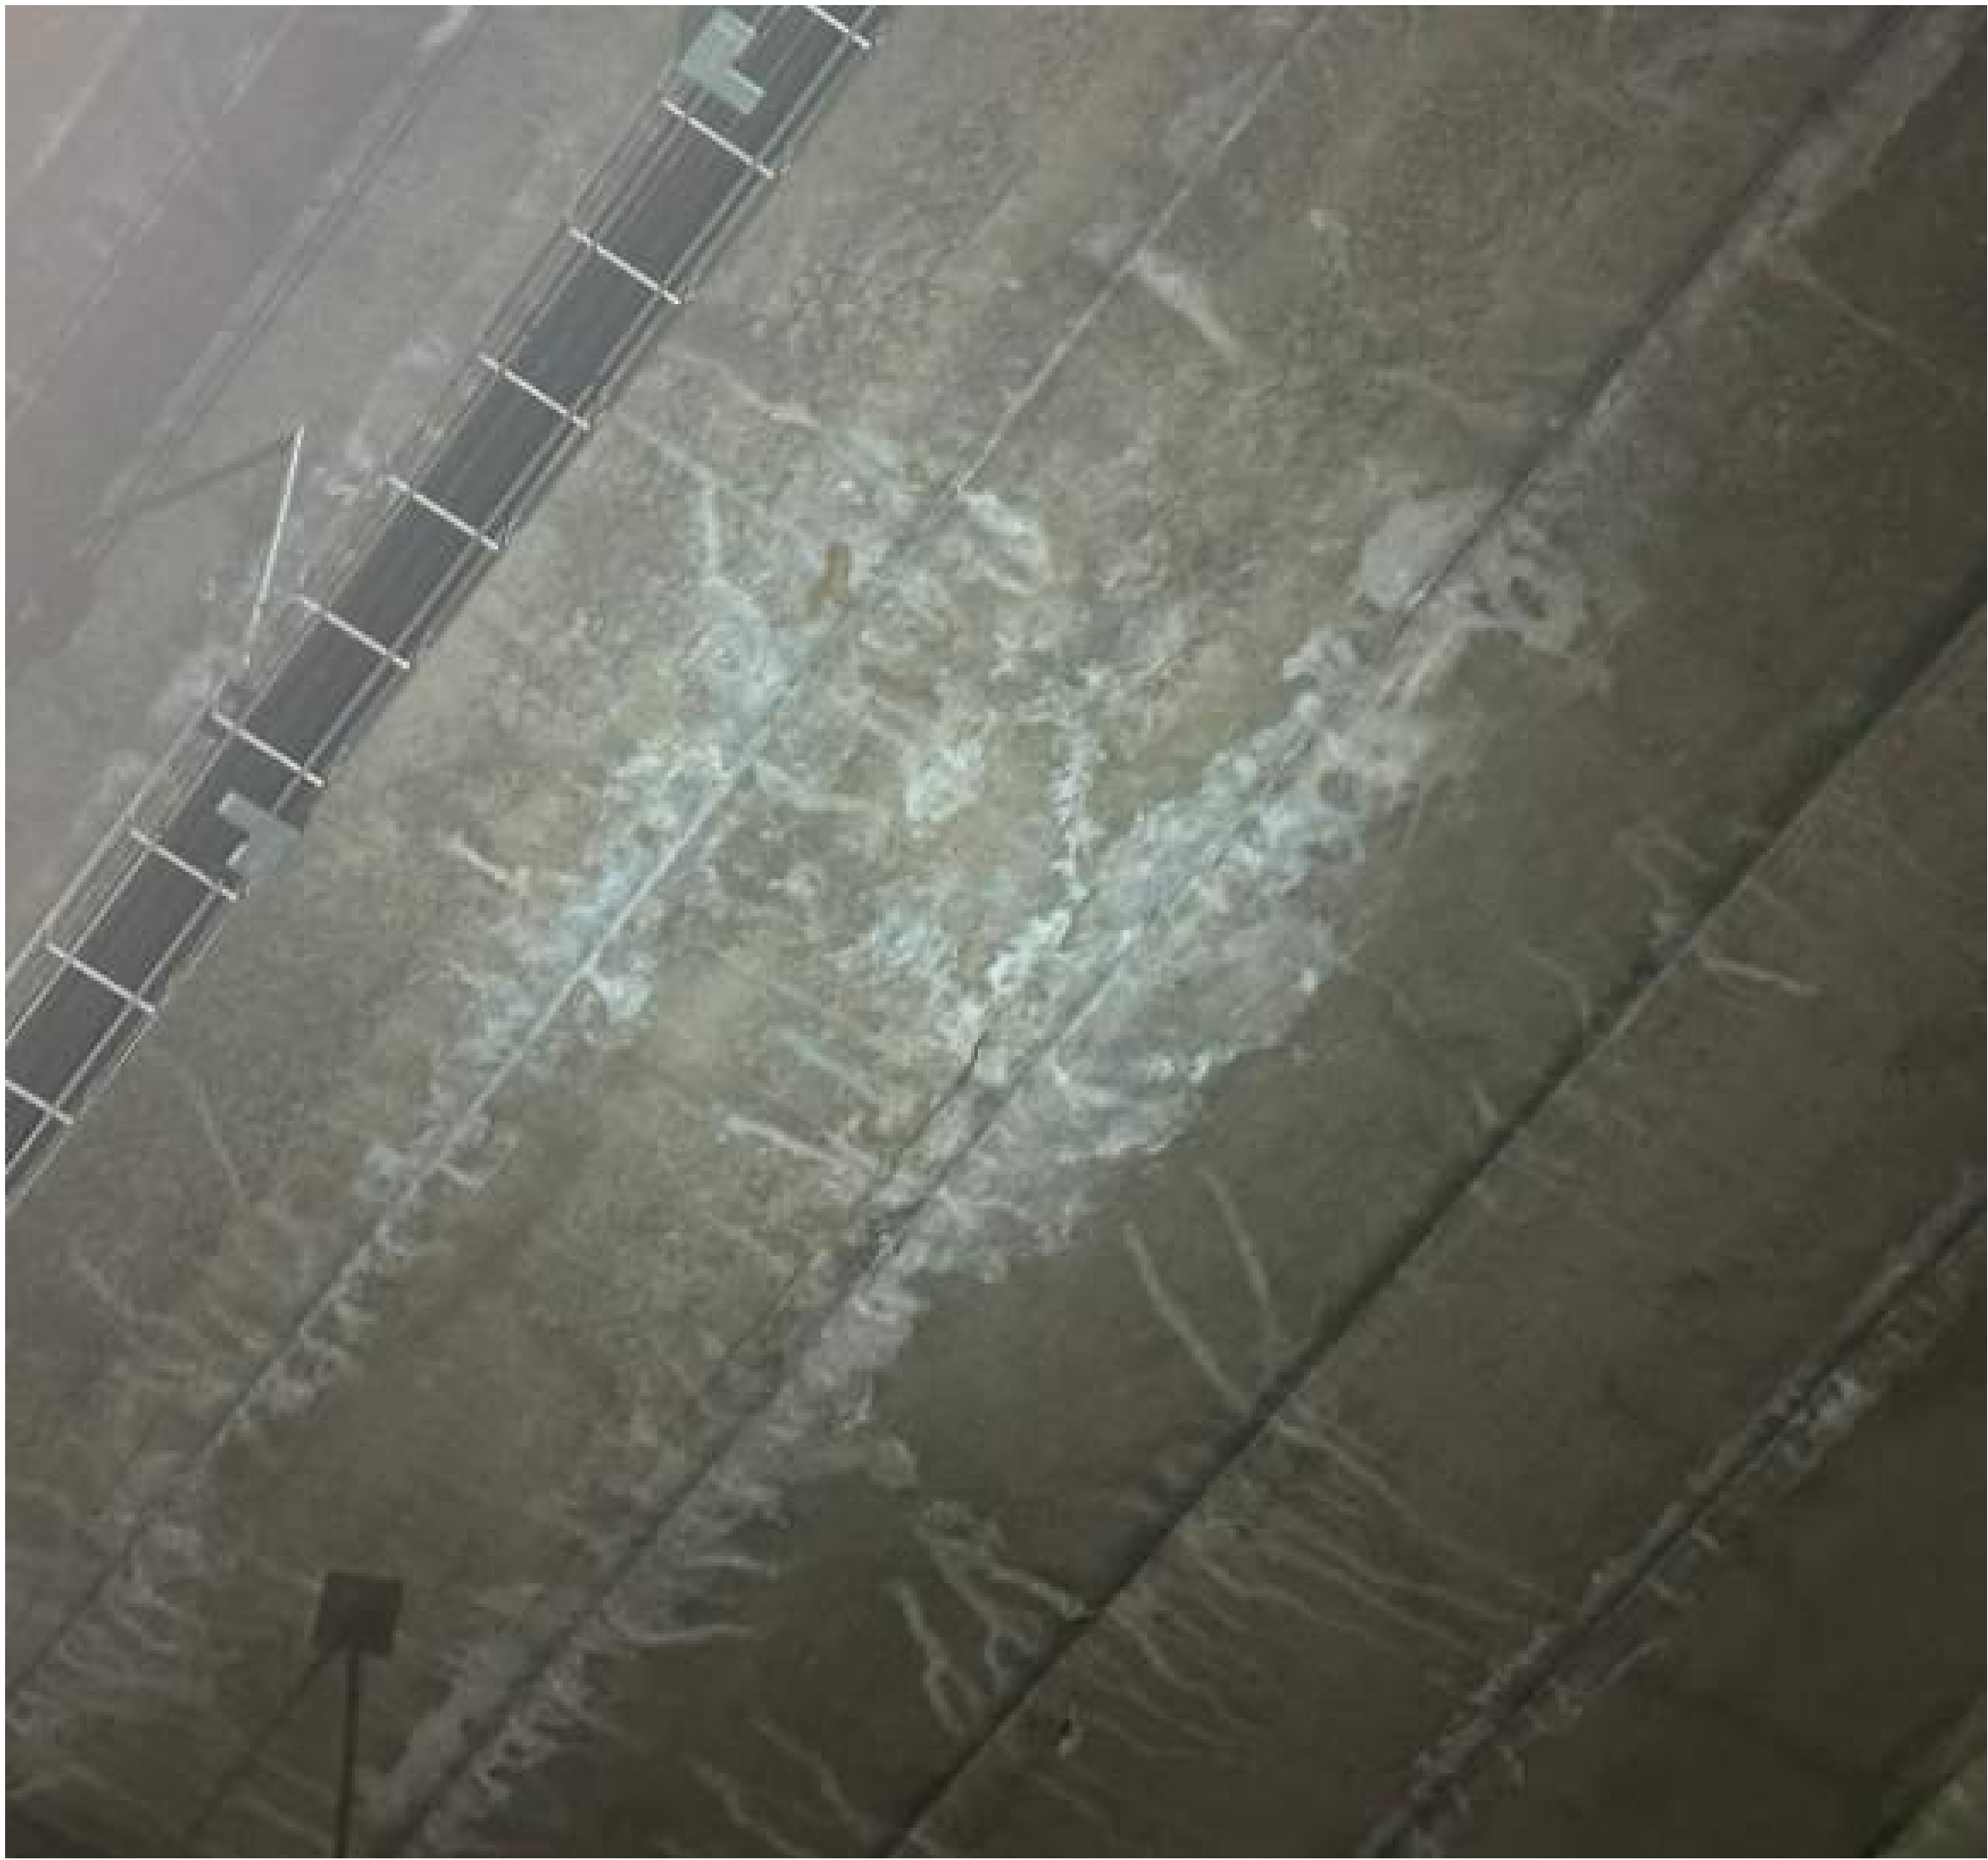
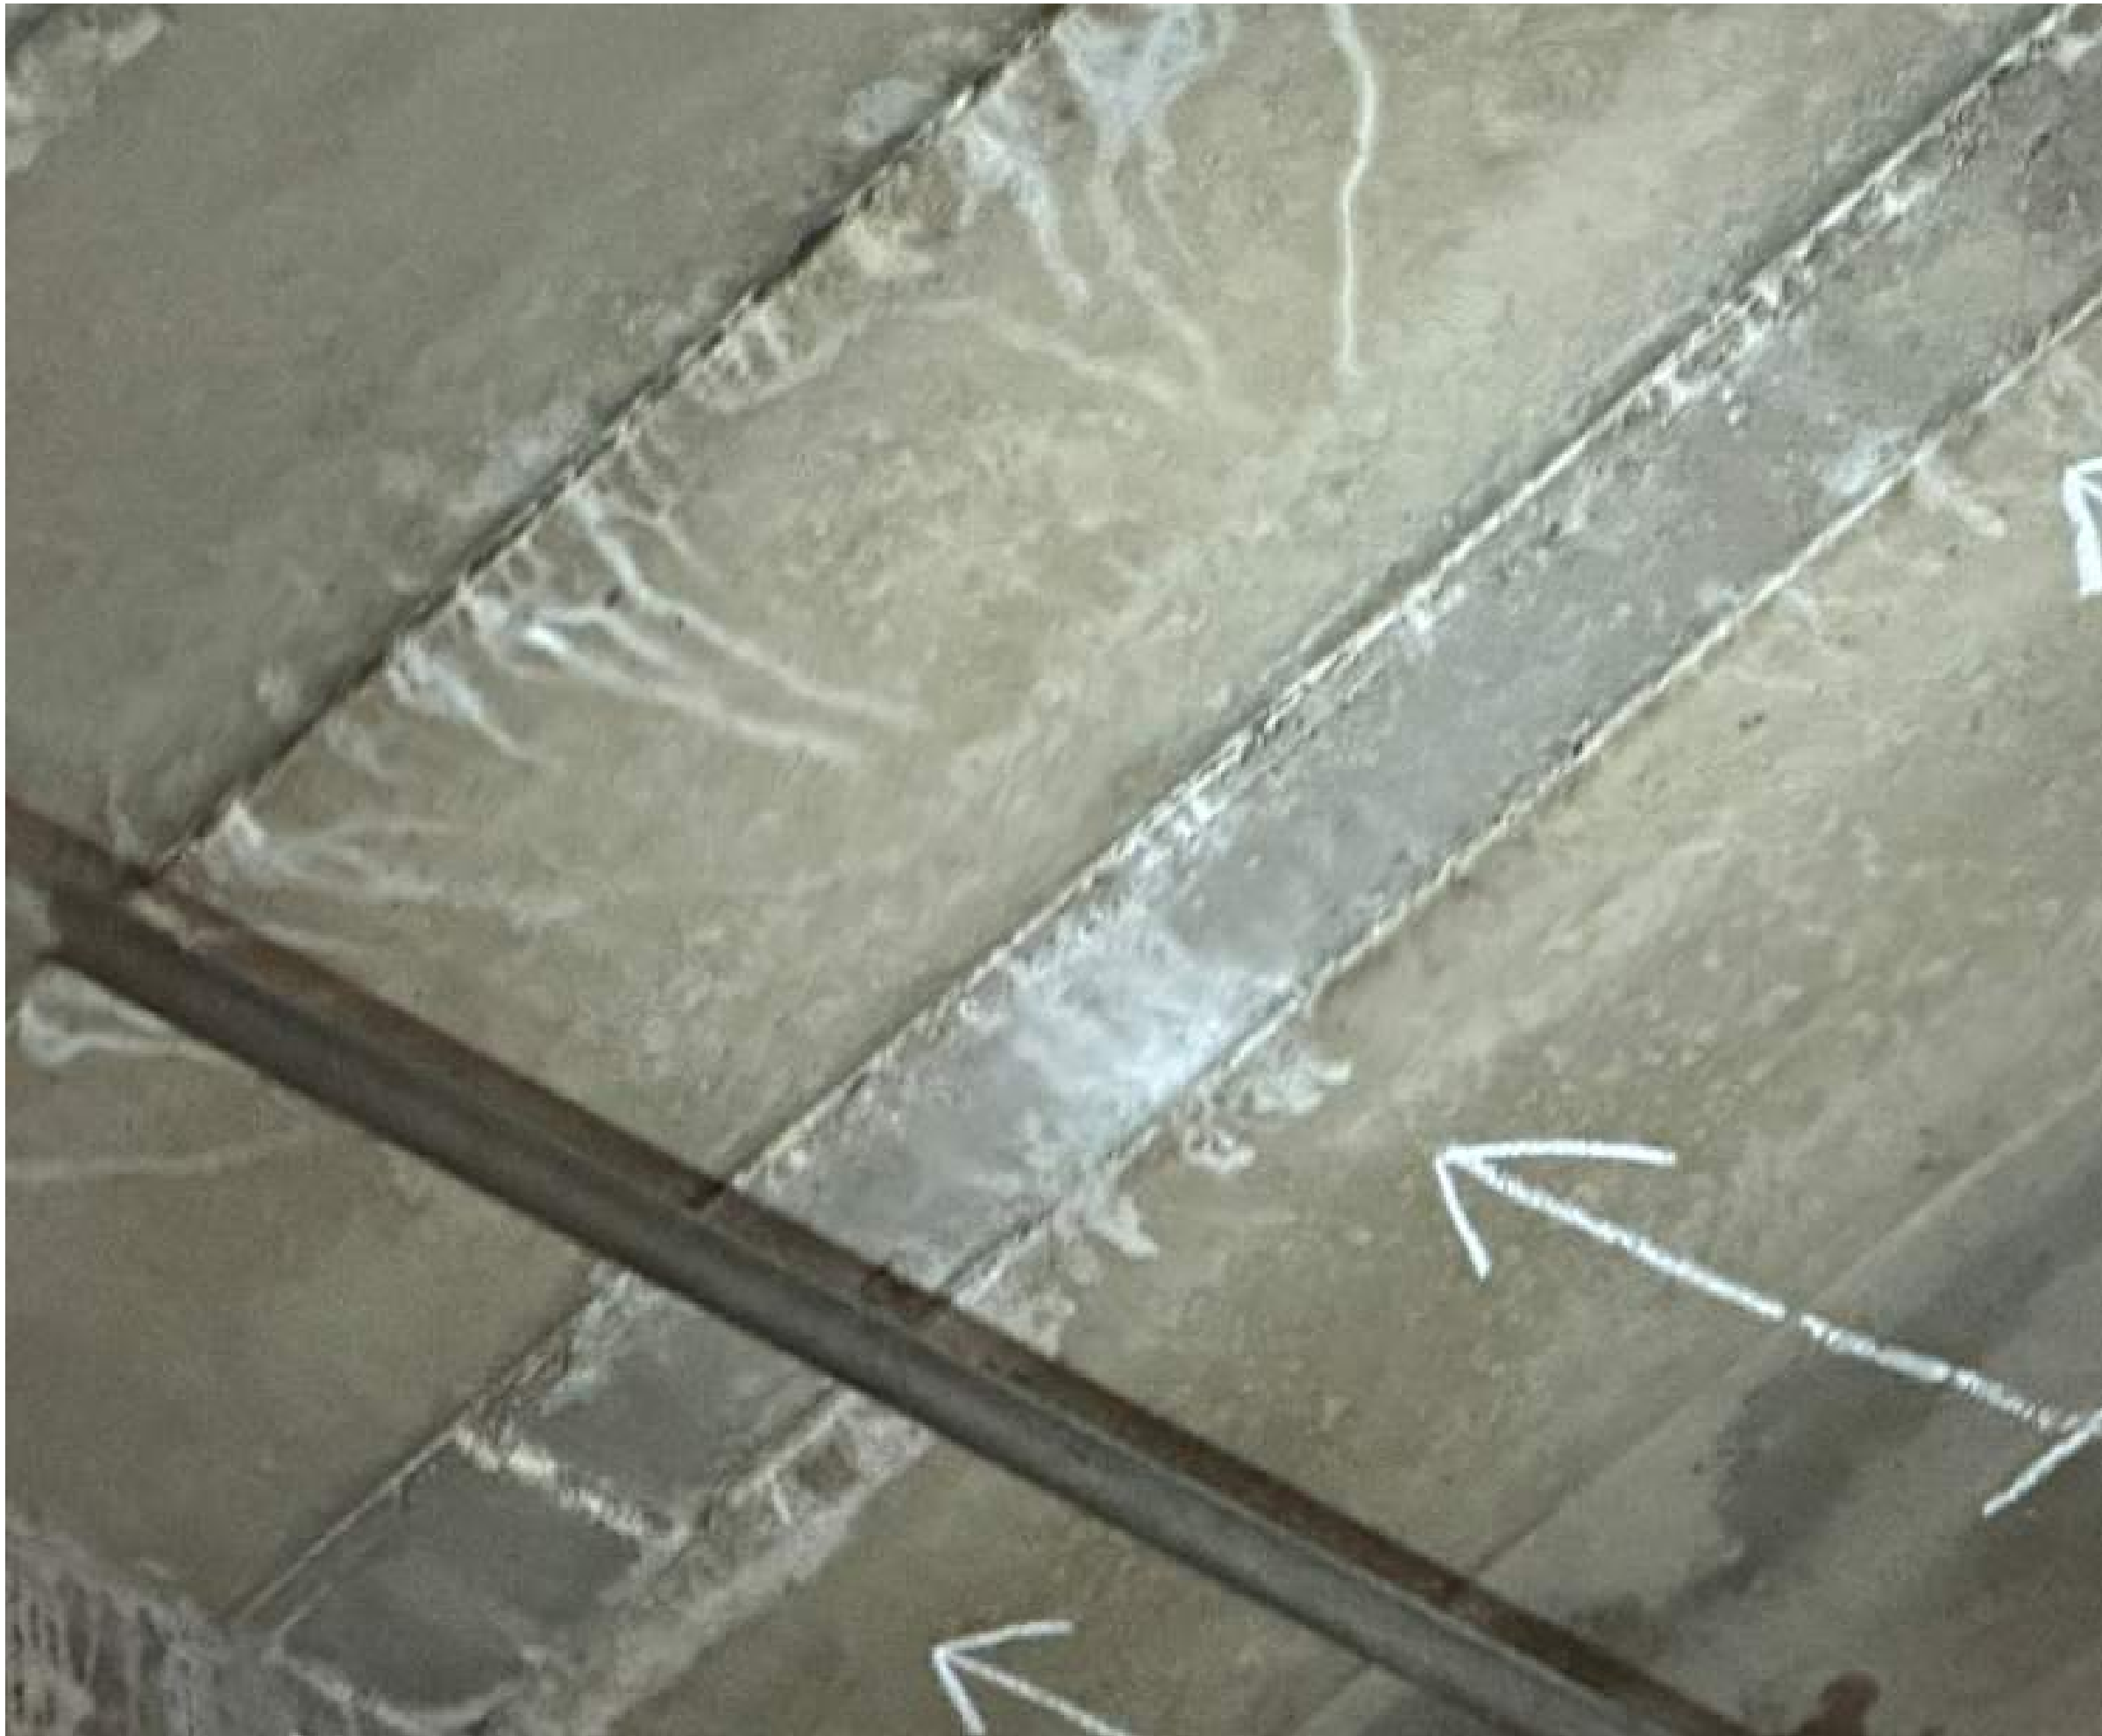
TYPE 3: VISUALLY IN  
BAD CONDITION  
(LONGITUDINAL  
CRACKS PRESENT  
AND/OR LARGE  
AMOUNTS OF  
SEAPAGE THROUGH  
BENDING CRACKS)  
PLANKS EXAMPLE:

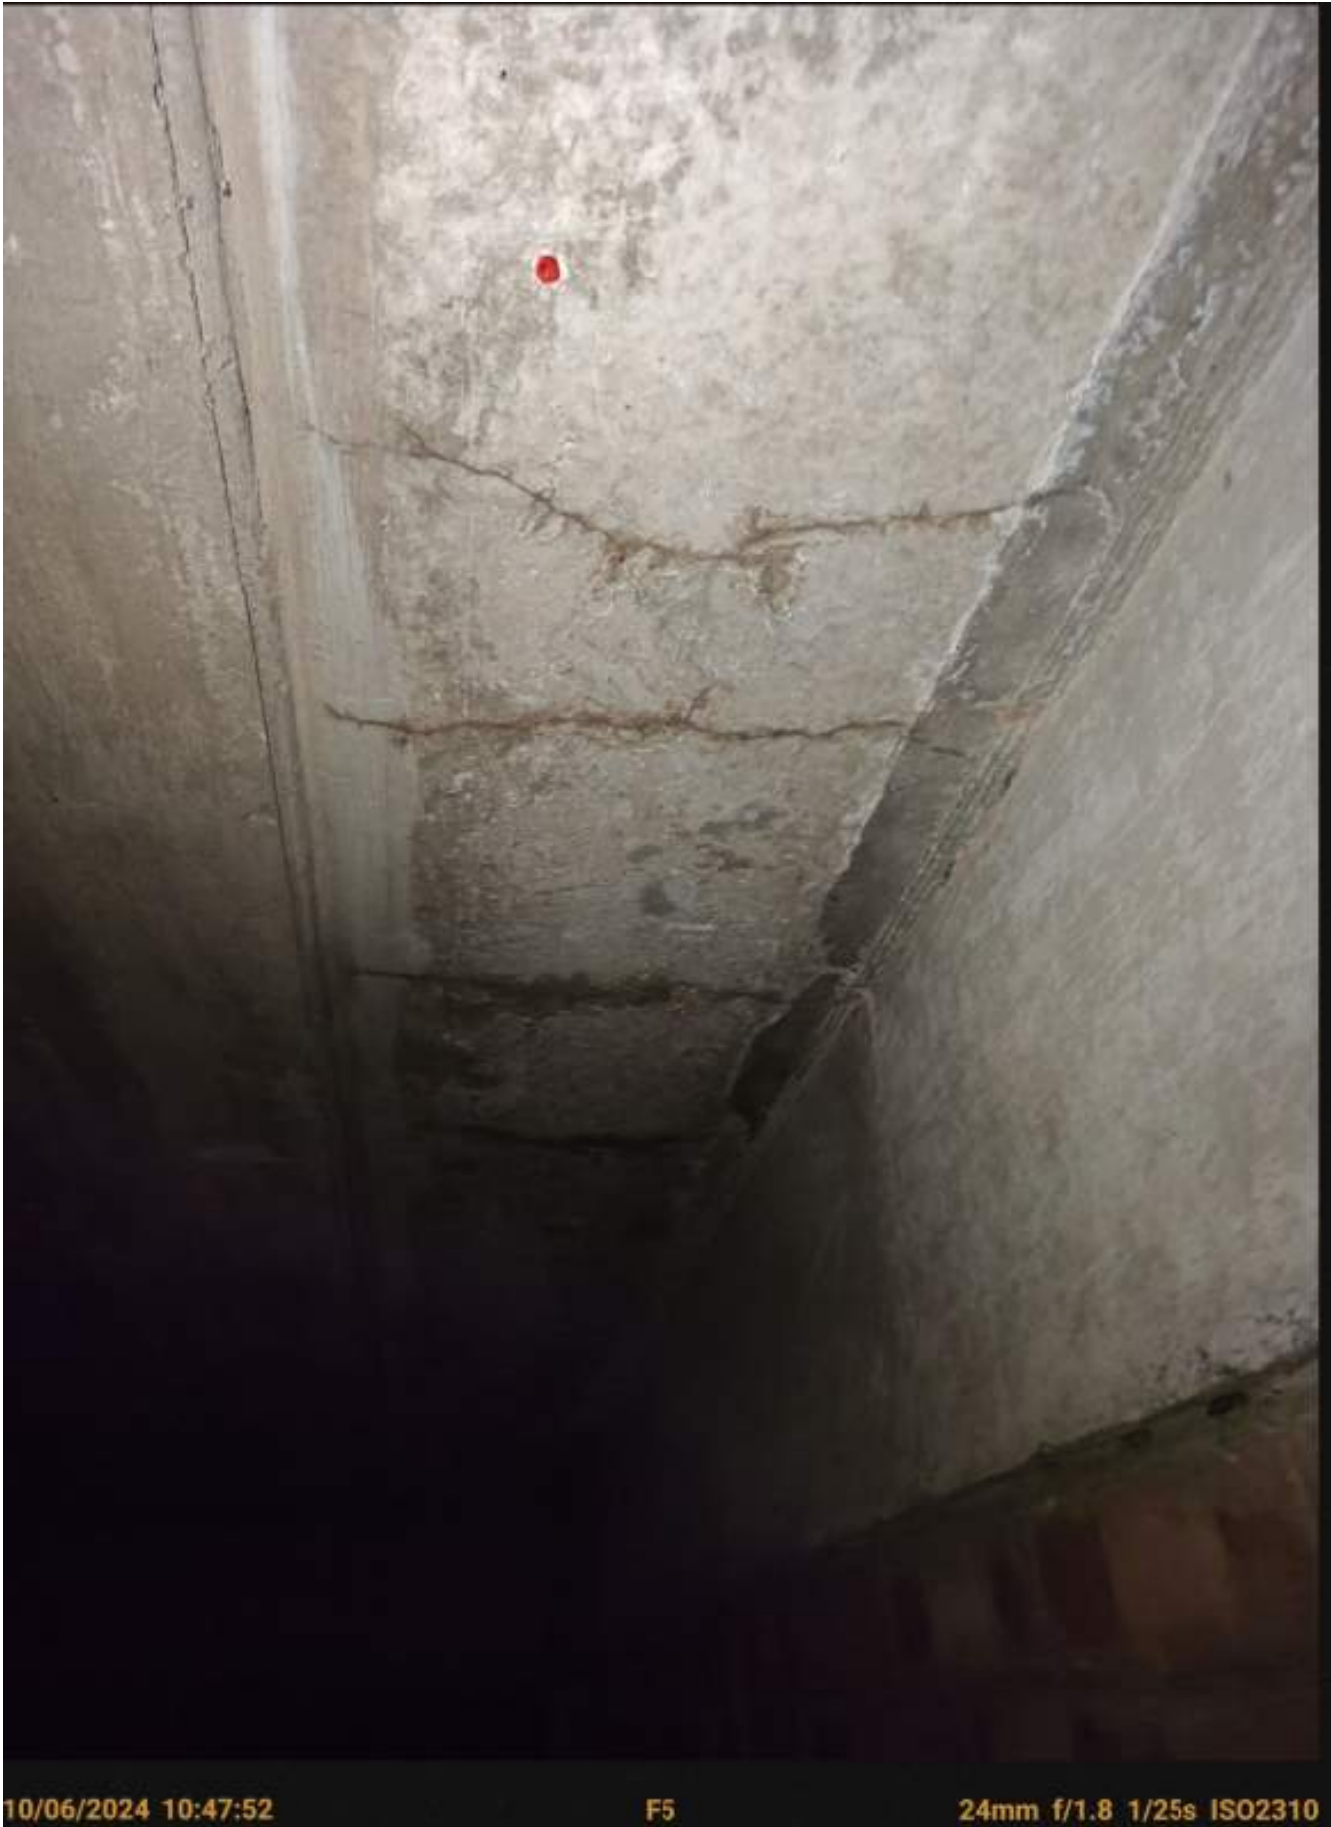
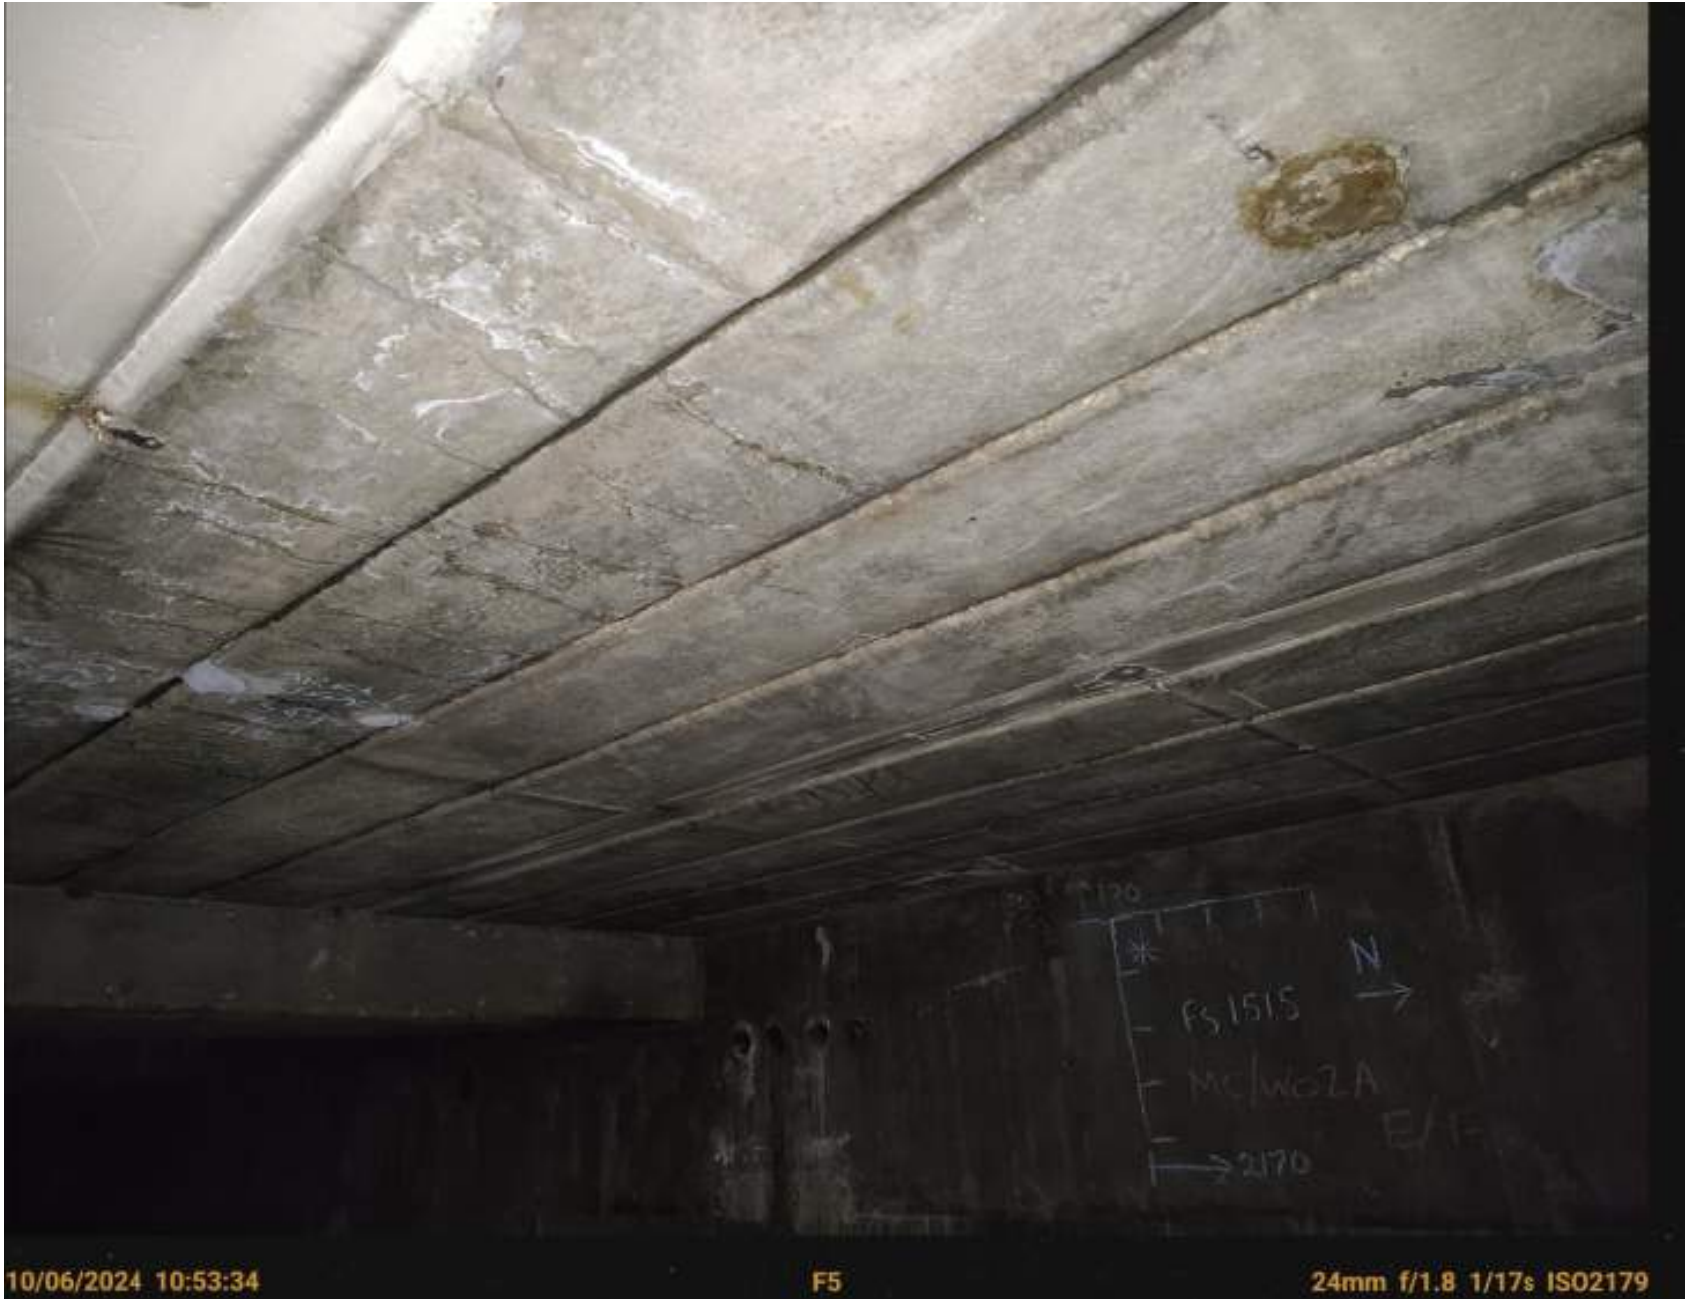
CONDITION SURVEY EXAMPLE IMAGES - PROPOSED REPLACED PRECAST RC PLANKS

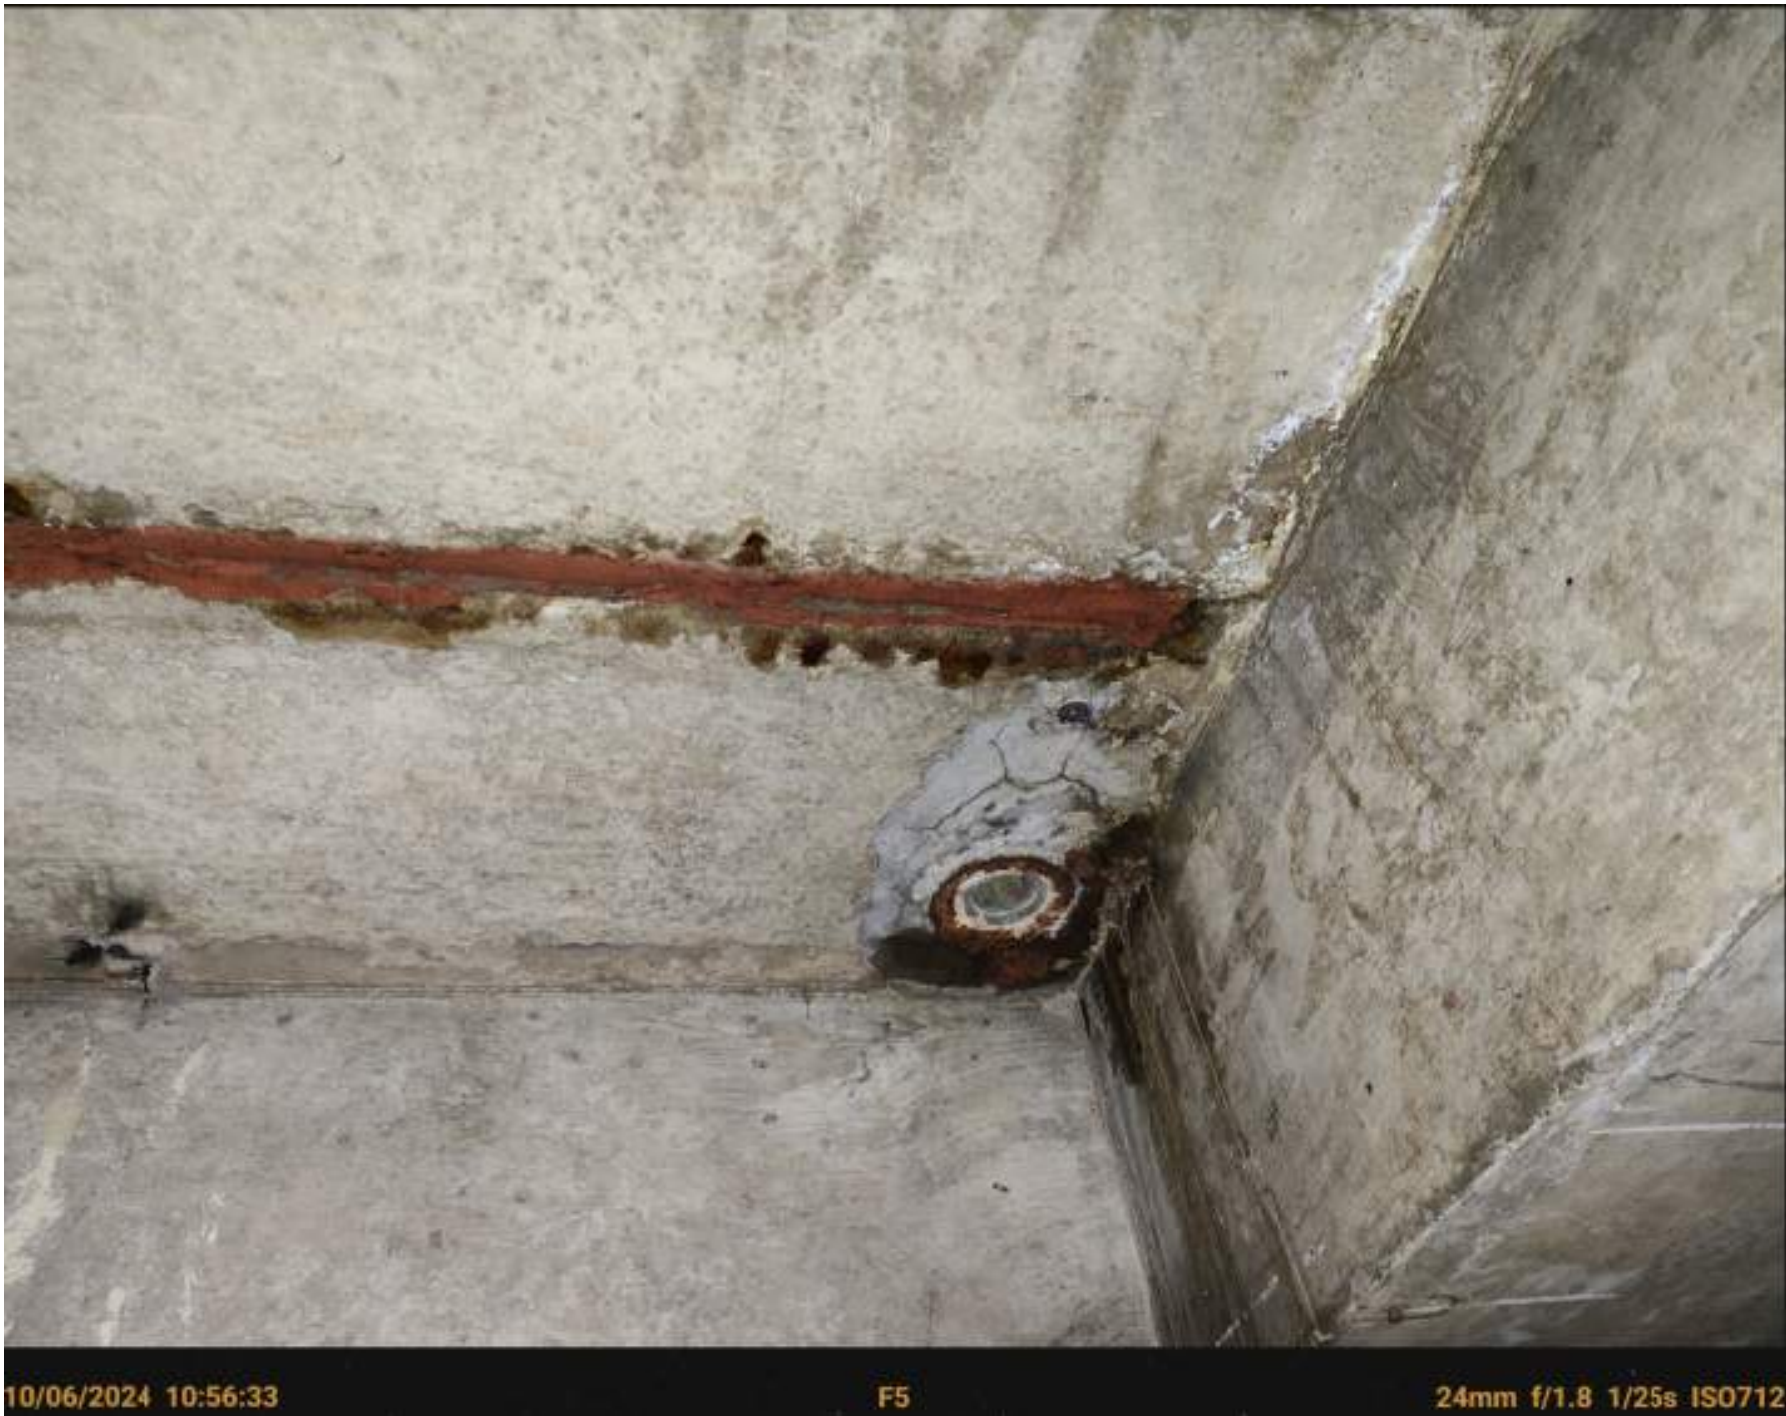
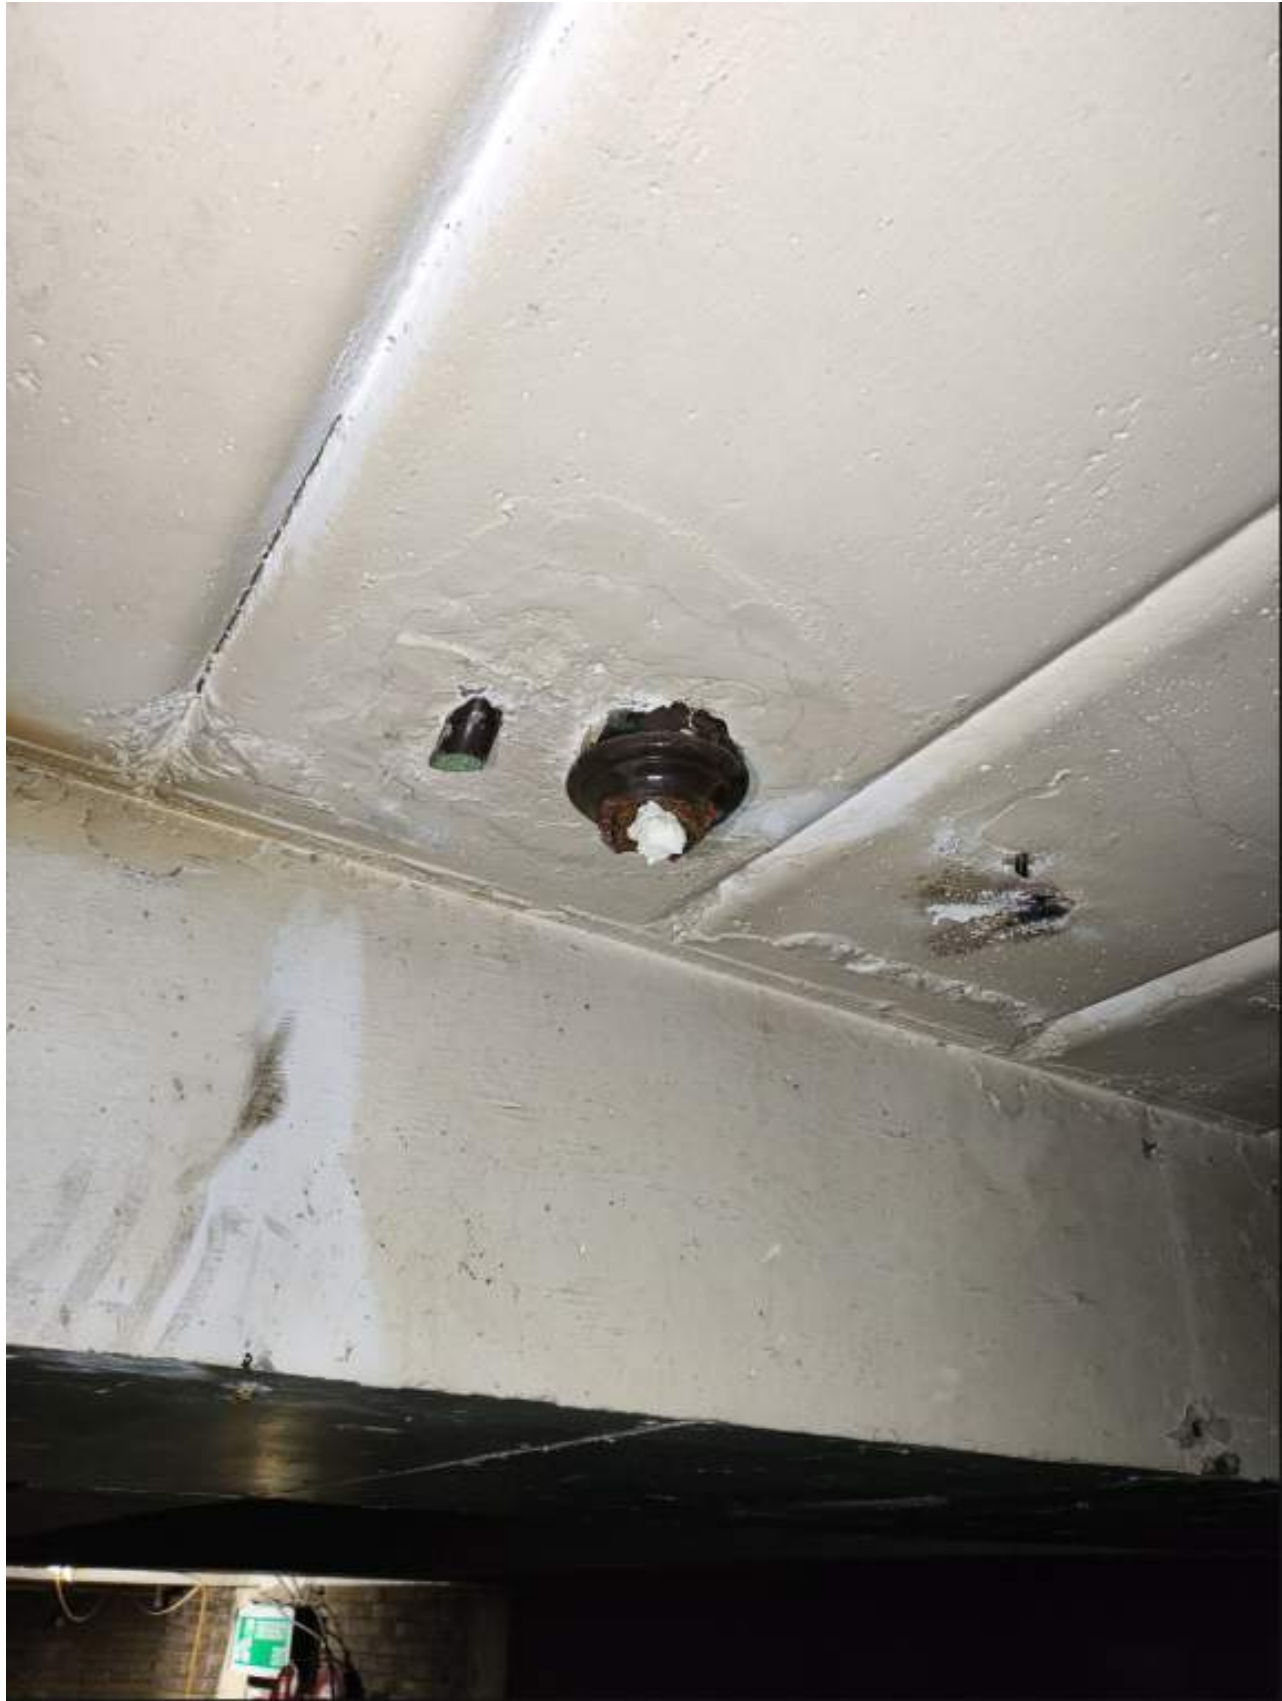
CONDITION SURVEY EXAMPLE IMAGES - PROPOSED REPLACED PRECAST RC PLANKS
