## OUR CULTURAL HEART

# Existing Precast RC Plank/Slab Investigation Report

**Curtins Ref: 081801-CUR-00-XX-PR-S-00006**

Site Address: Queensgate Market, Princess St, Huddersfield HD1 2RS

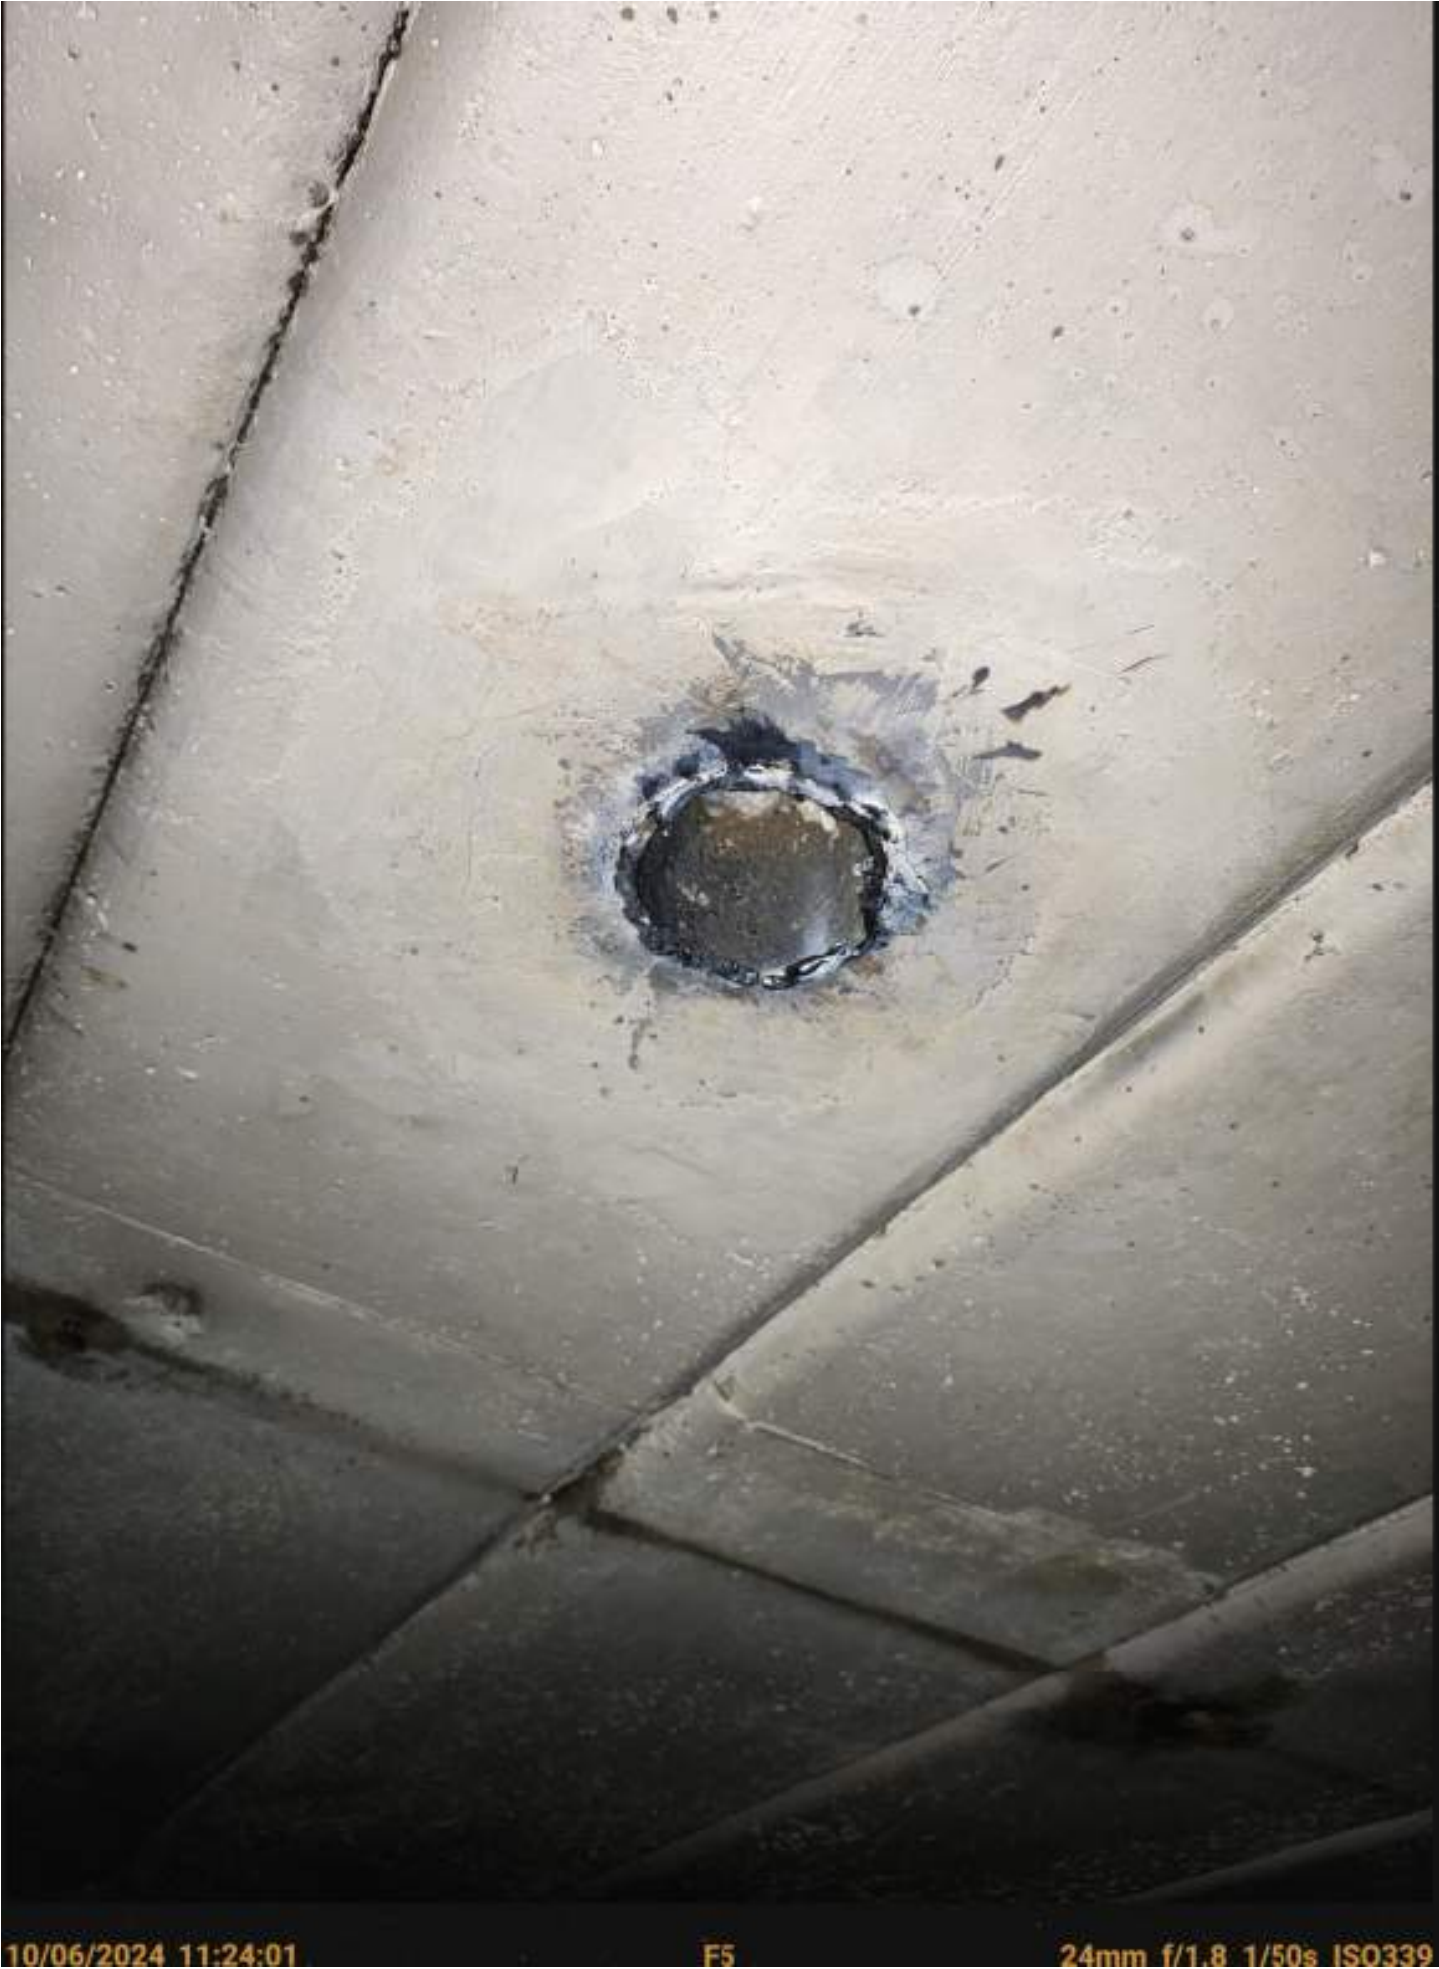
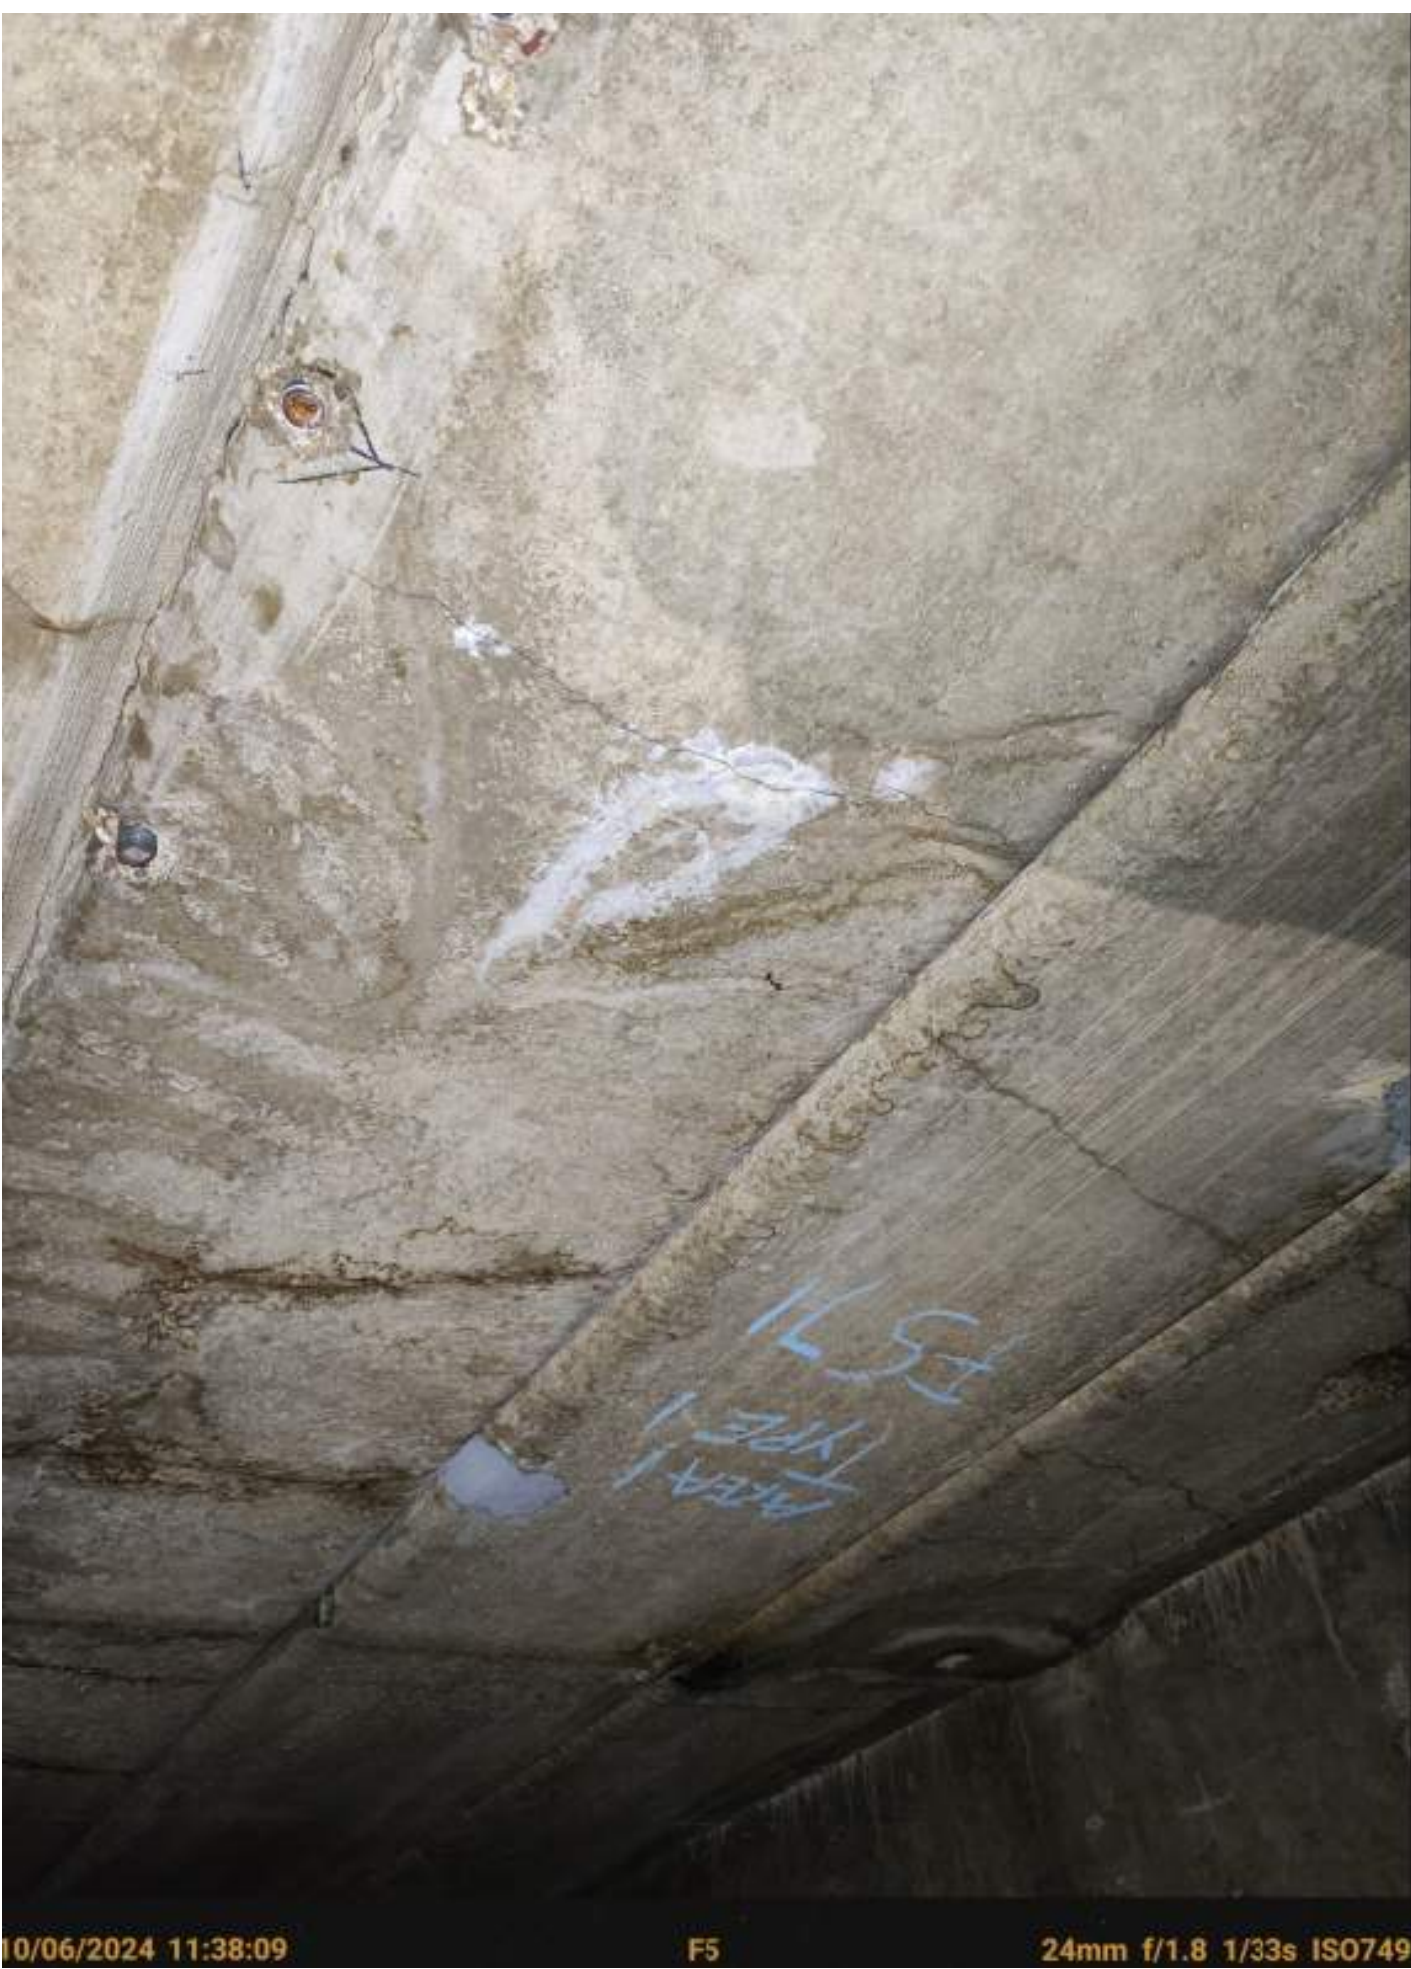
CONDITION SURVEY EXAMPLE IMAGES - PROPOSED REPLACED PRECAST RC PLANKS

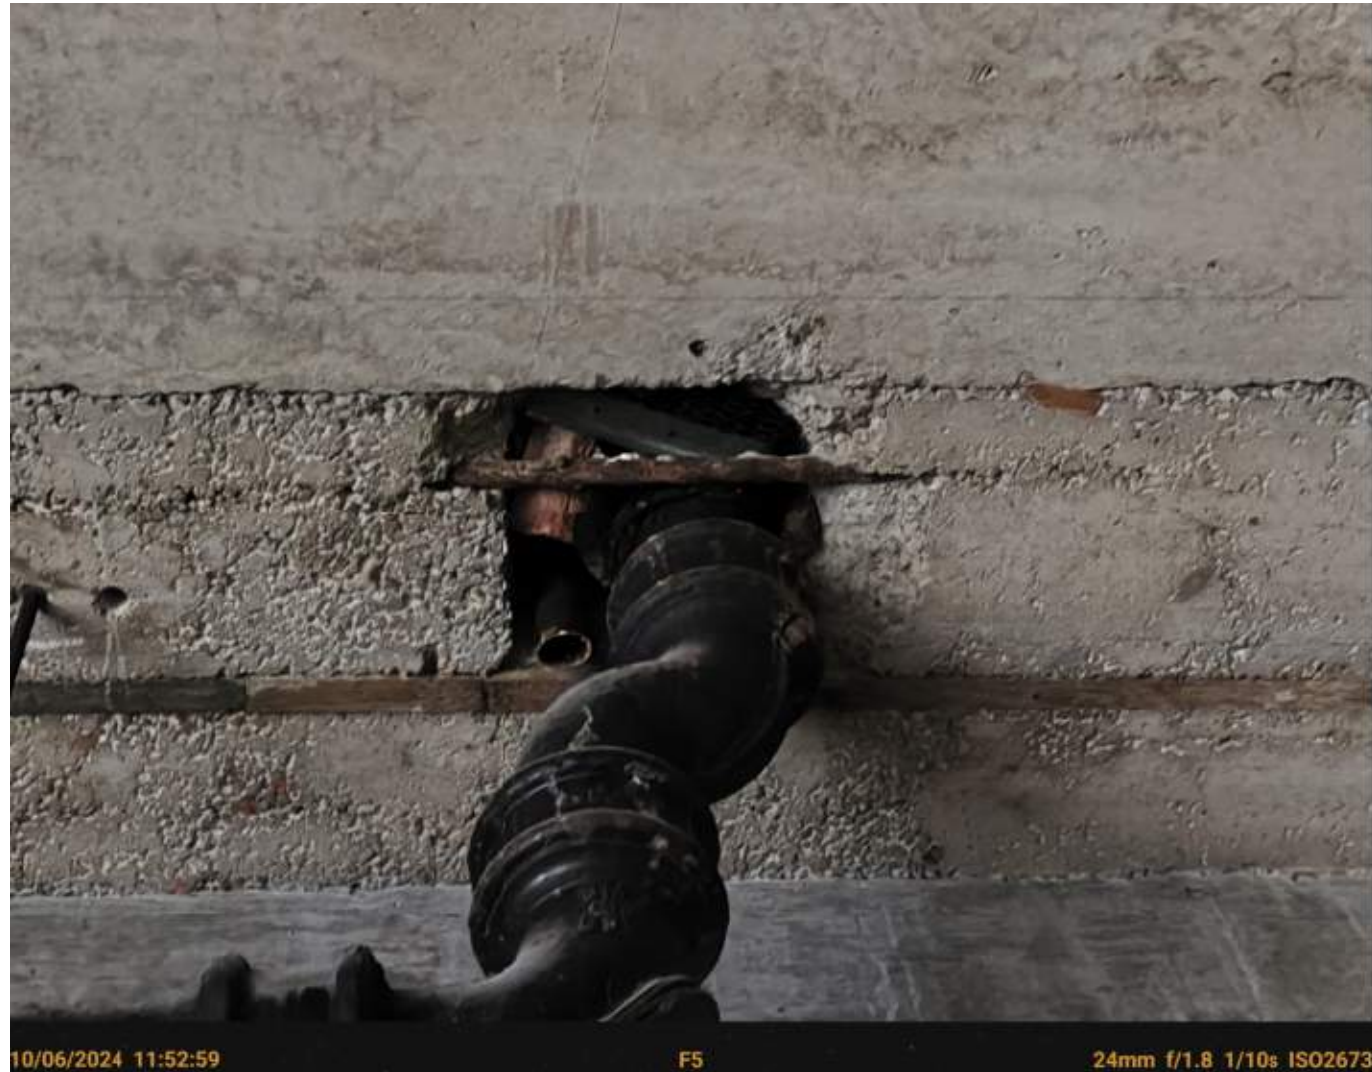
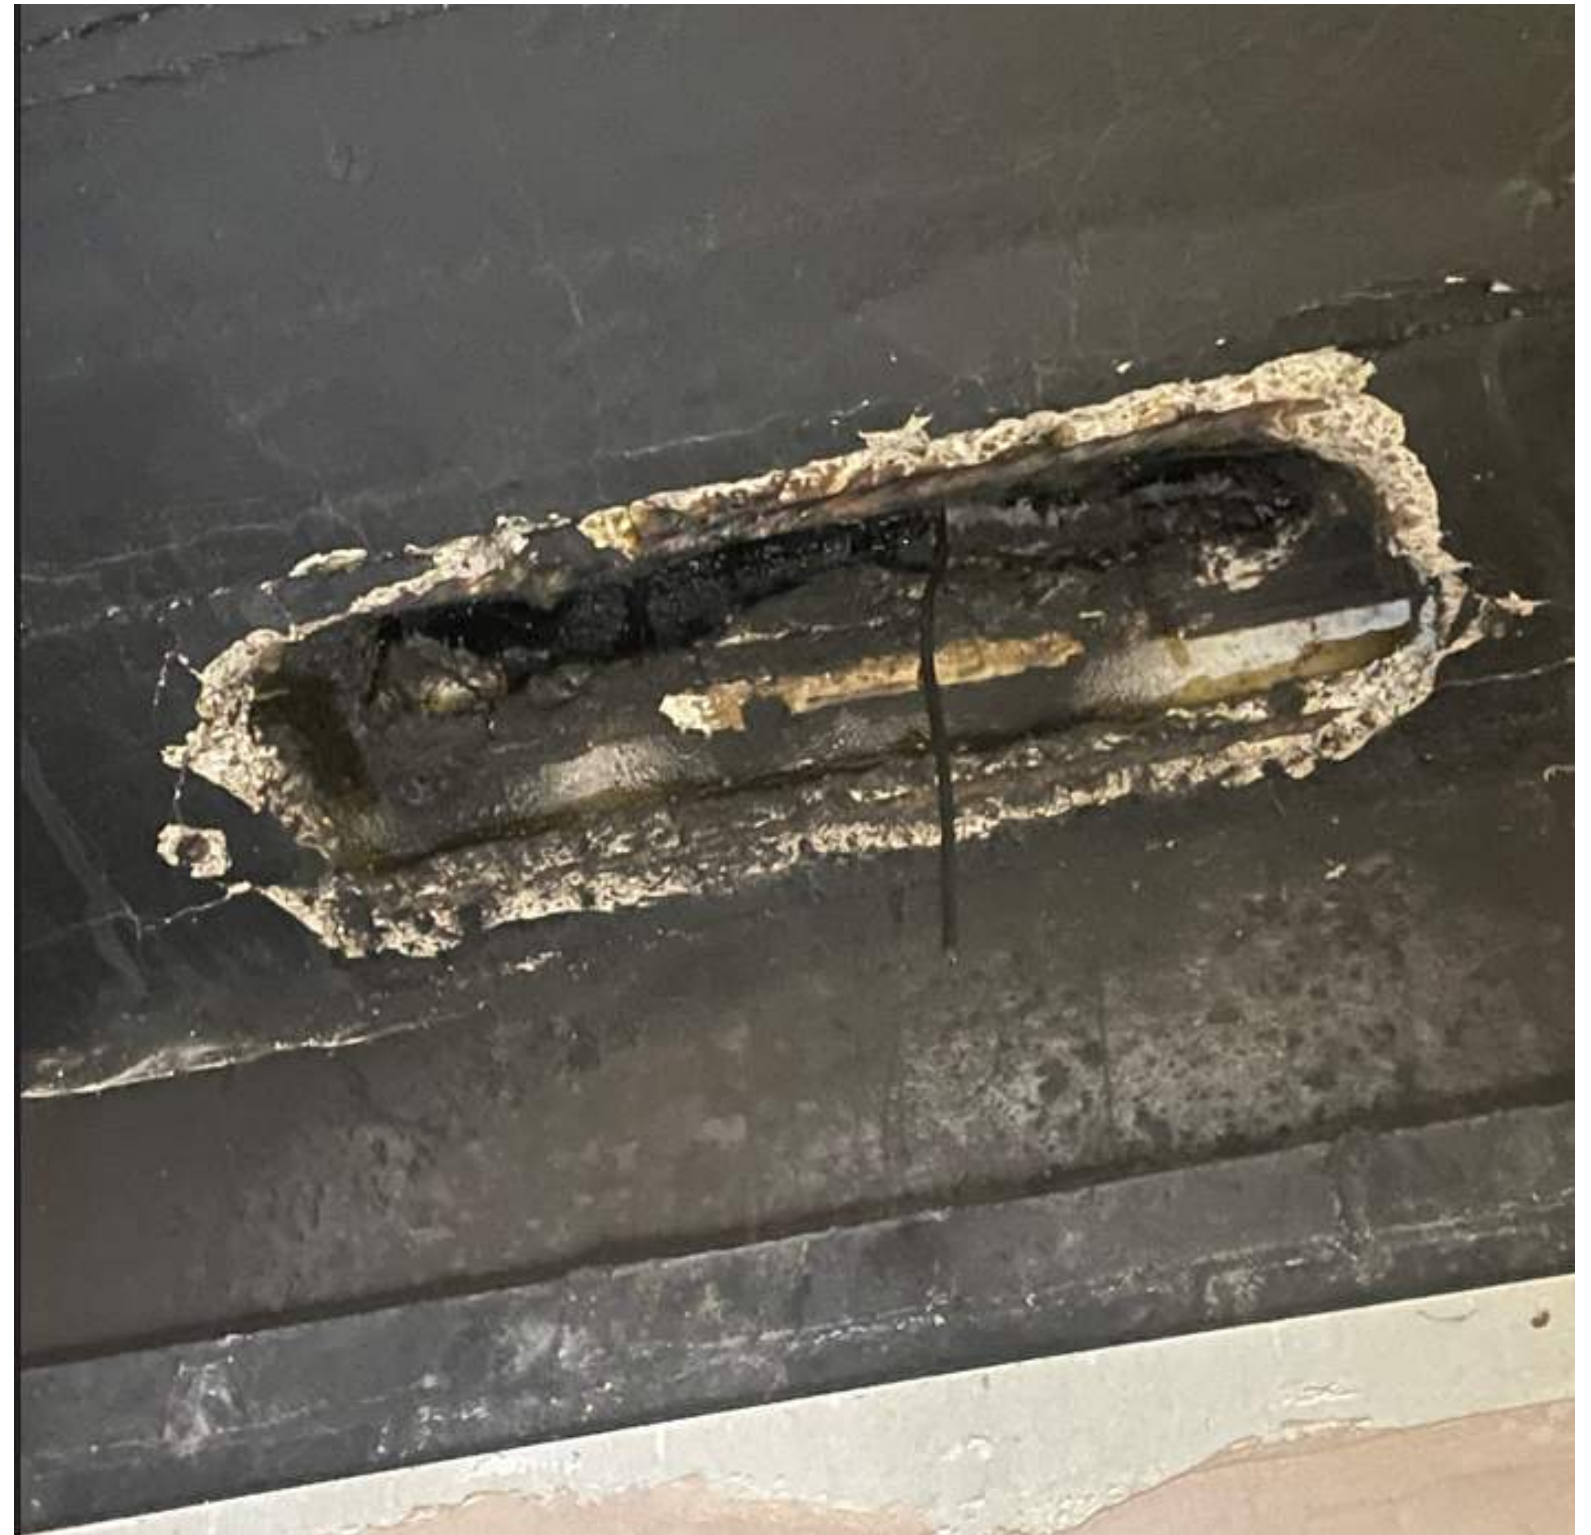
## CONDITION SURVEY EXAMPLE IMAGES - PROPOSED REPLACED PRECAST RC PLANKS

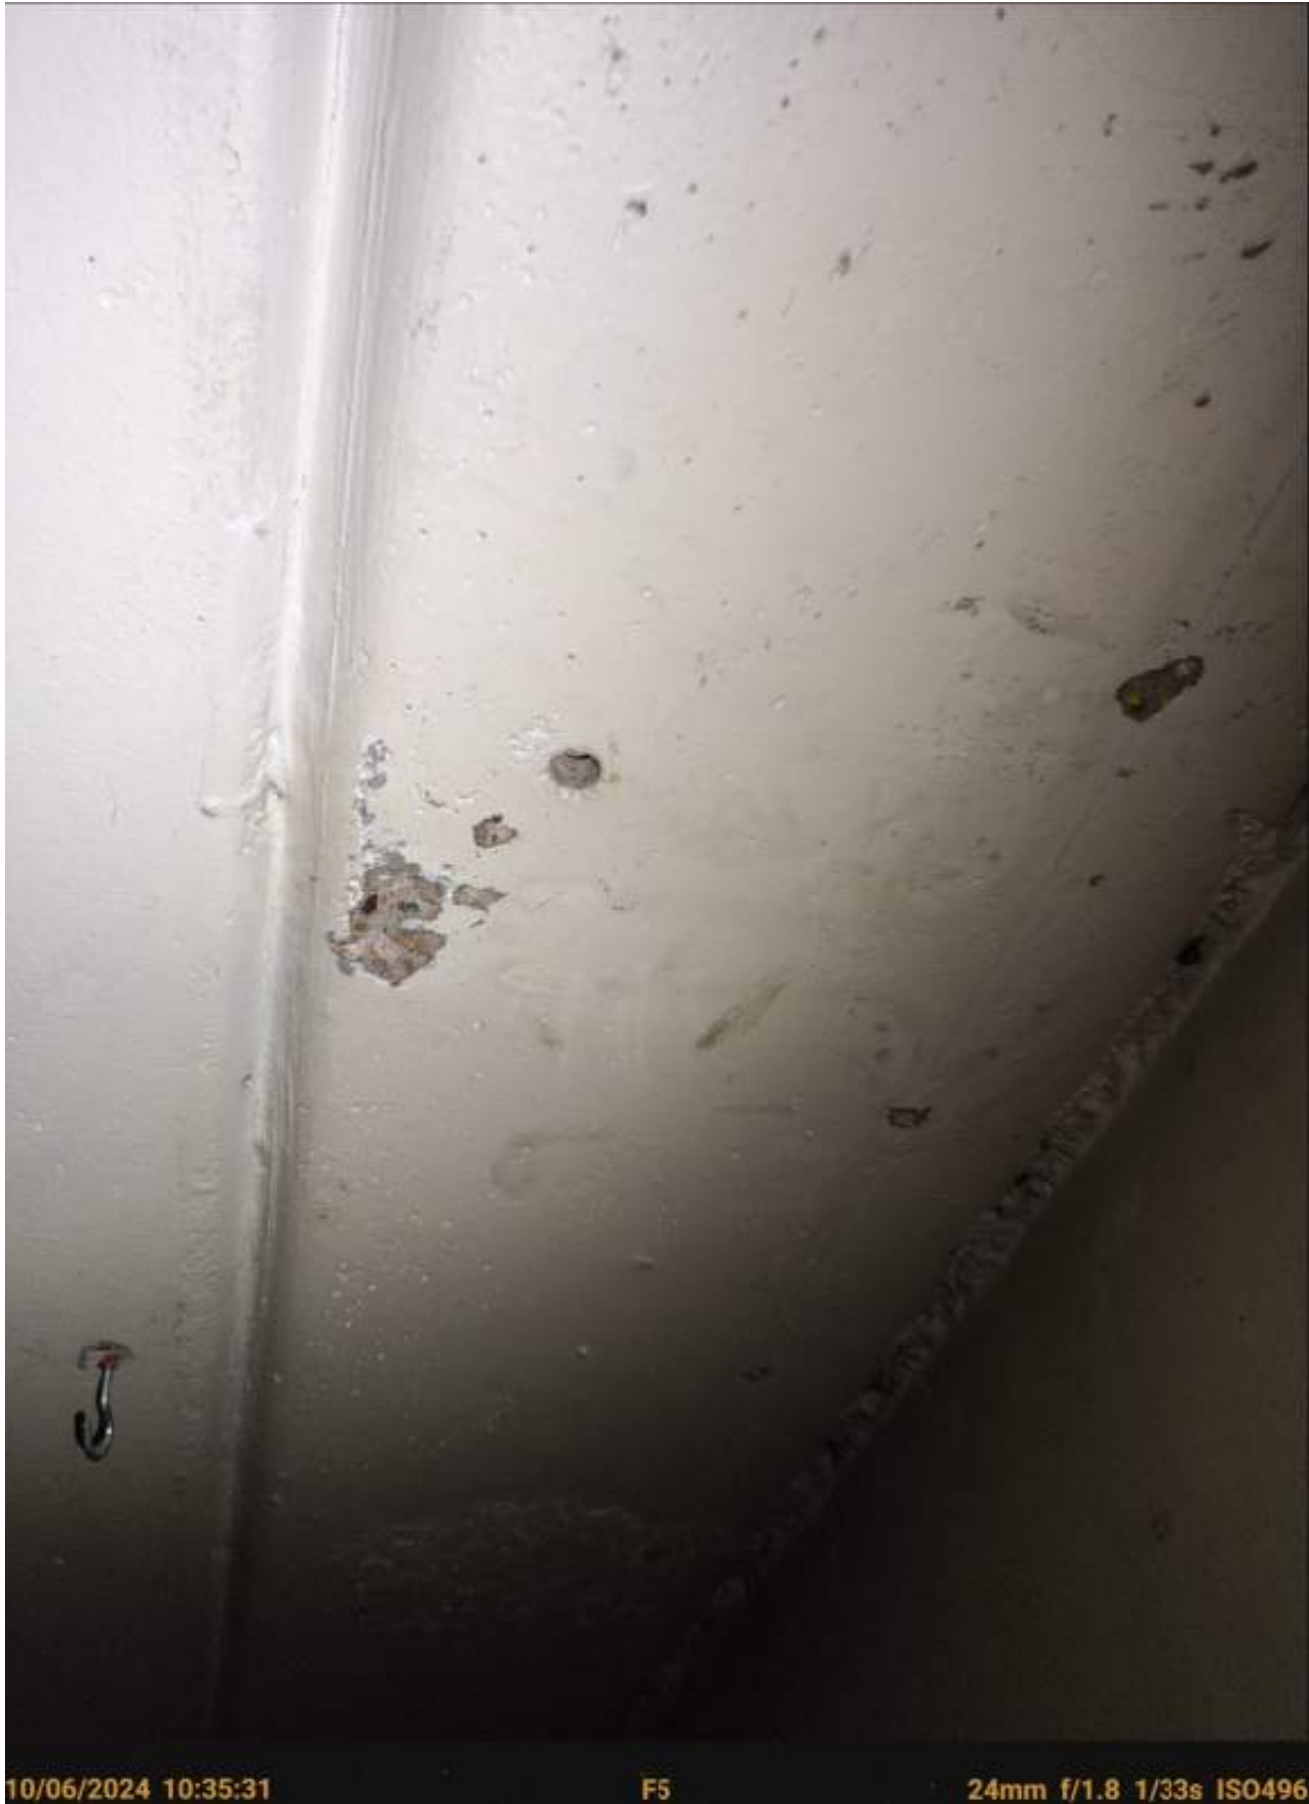
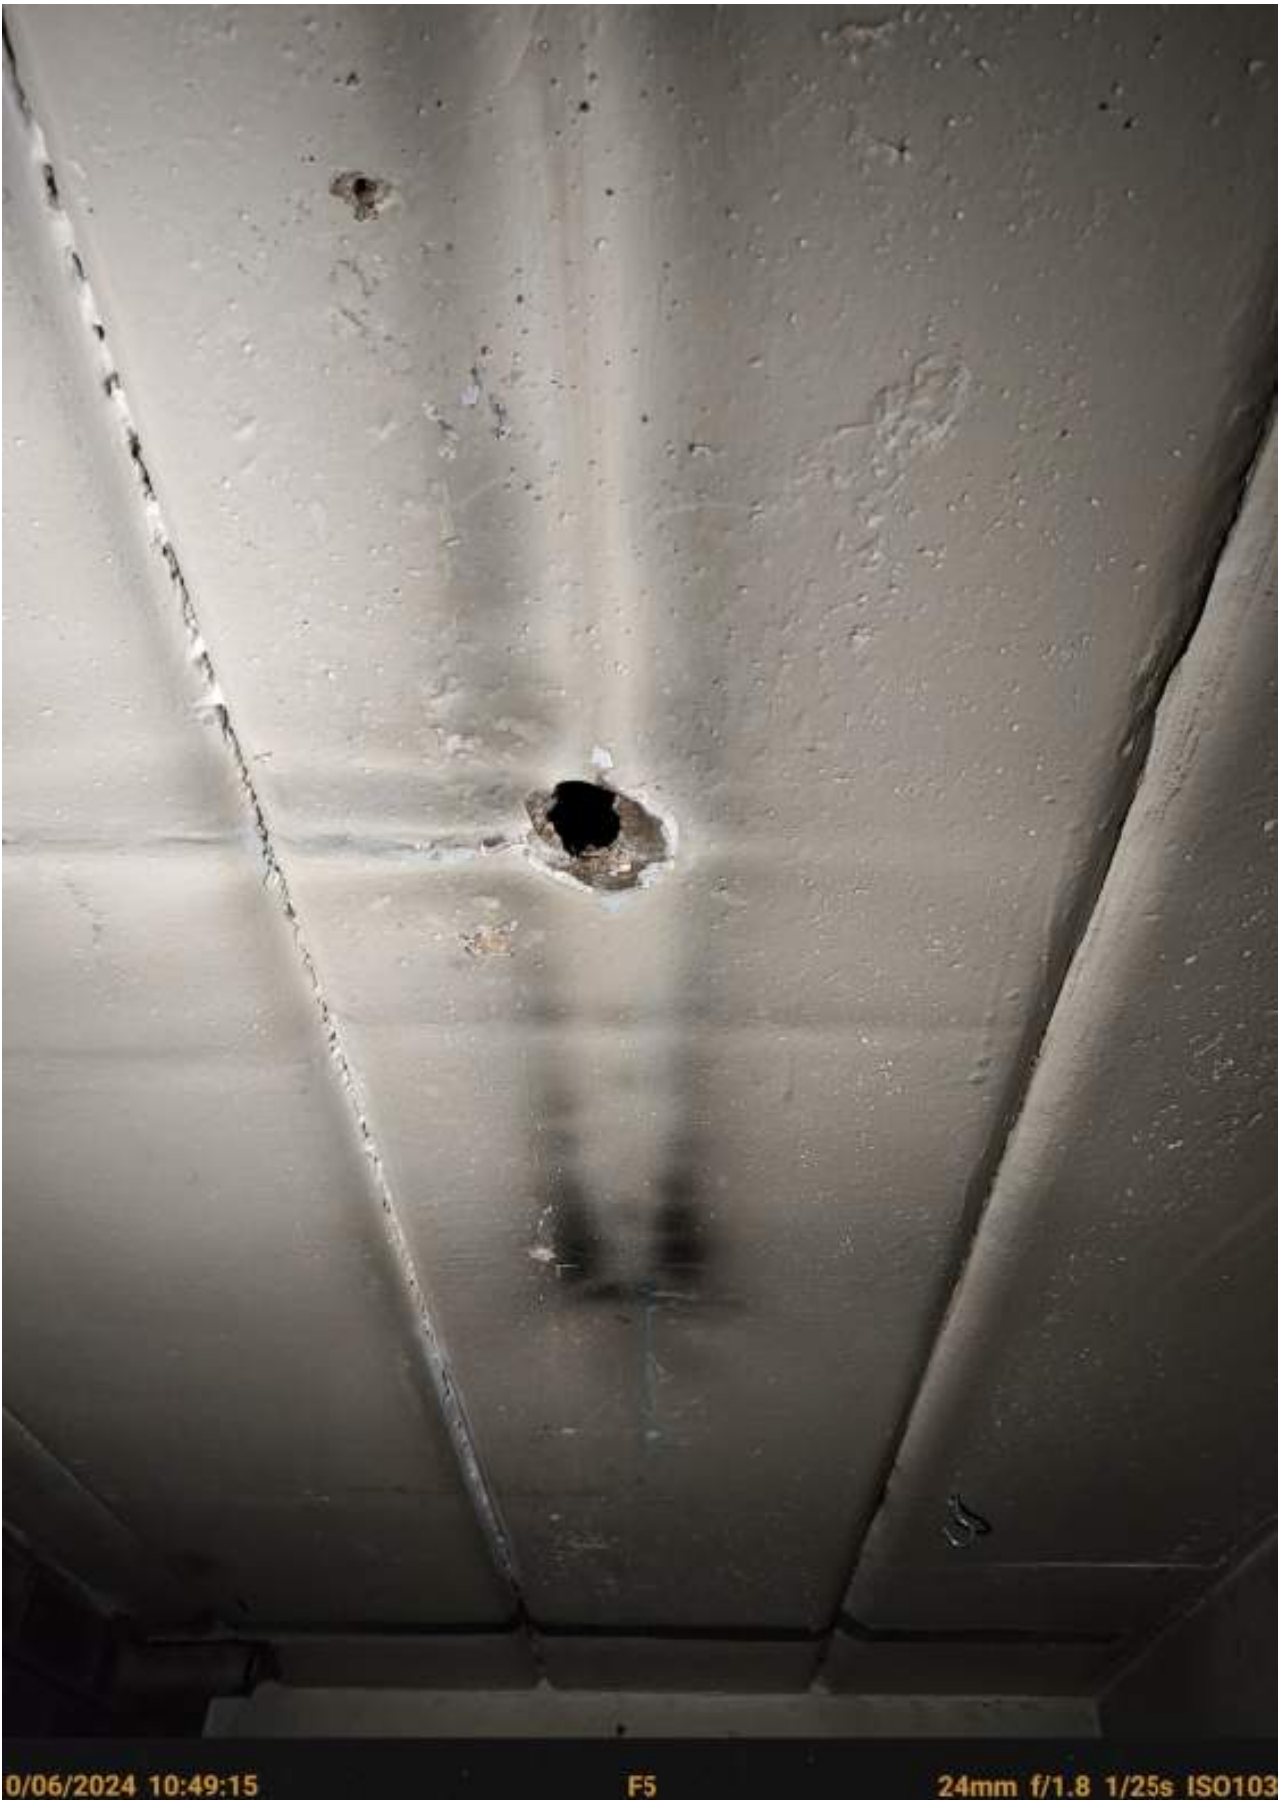
CONDITION SURVEY EXAMPLE IMAGES - PROPOSED REPAIR PRECAST RC PLANKS

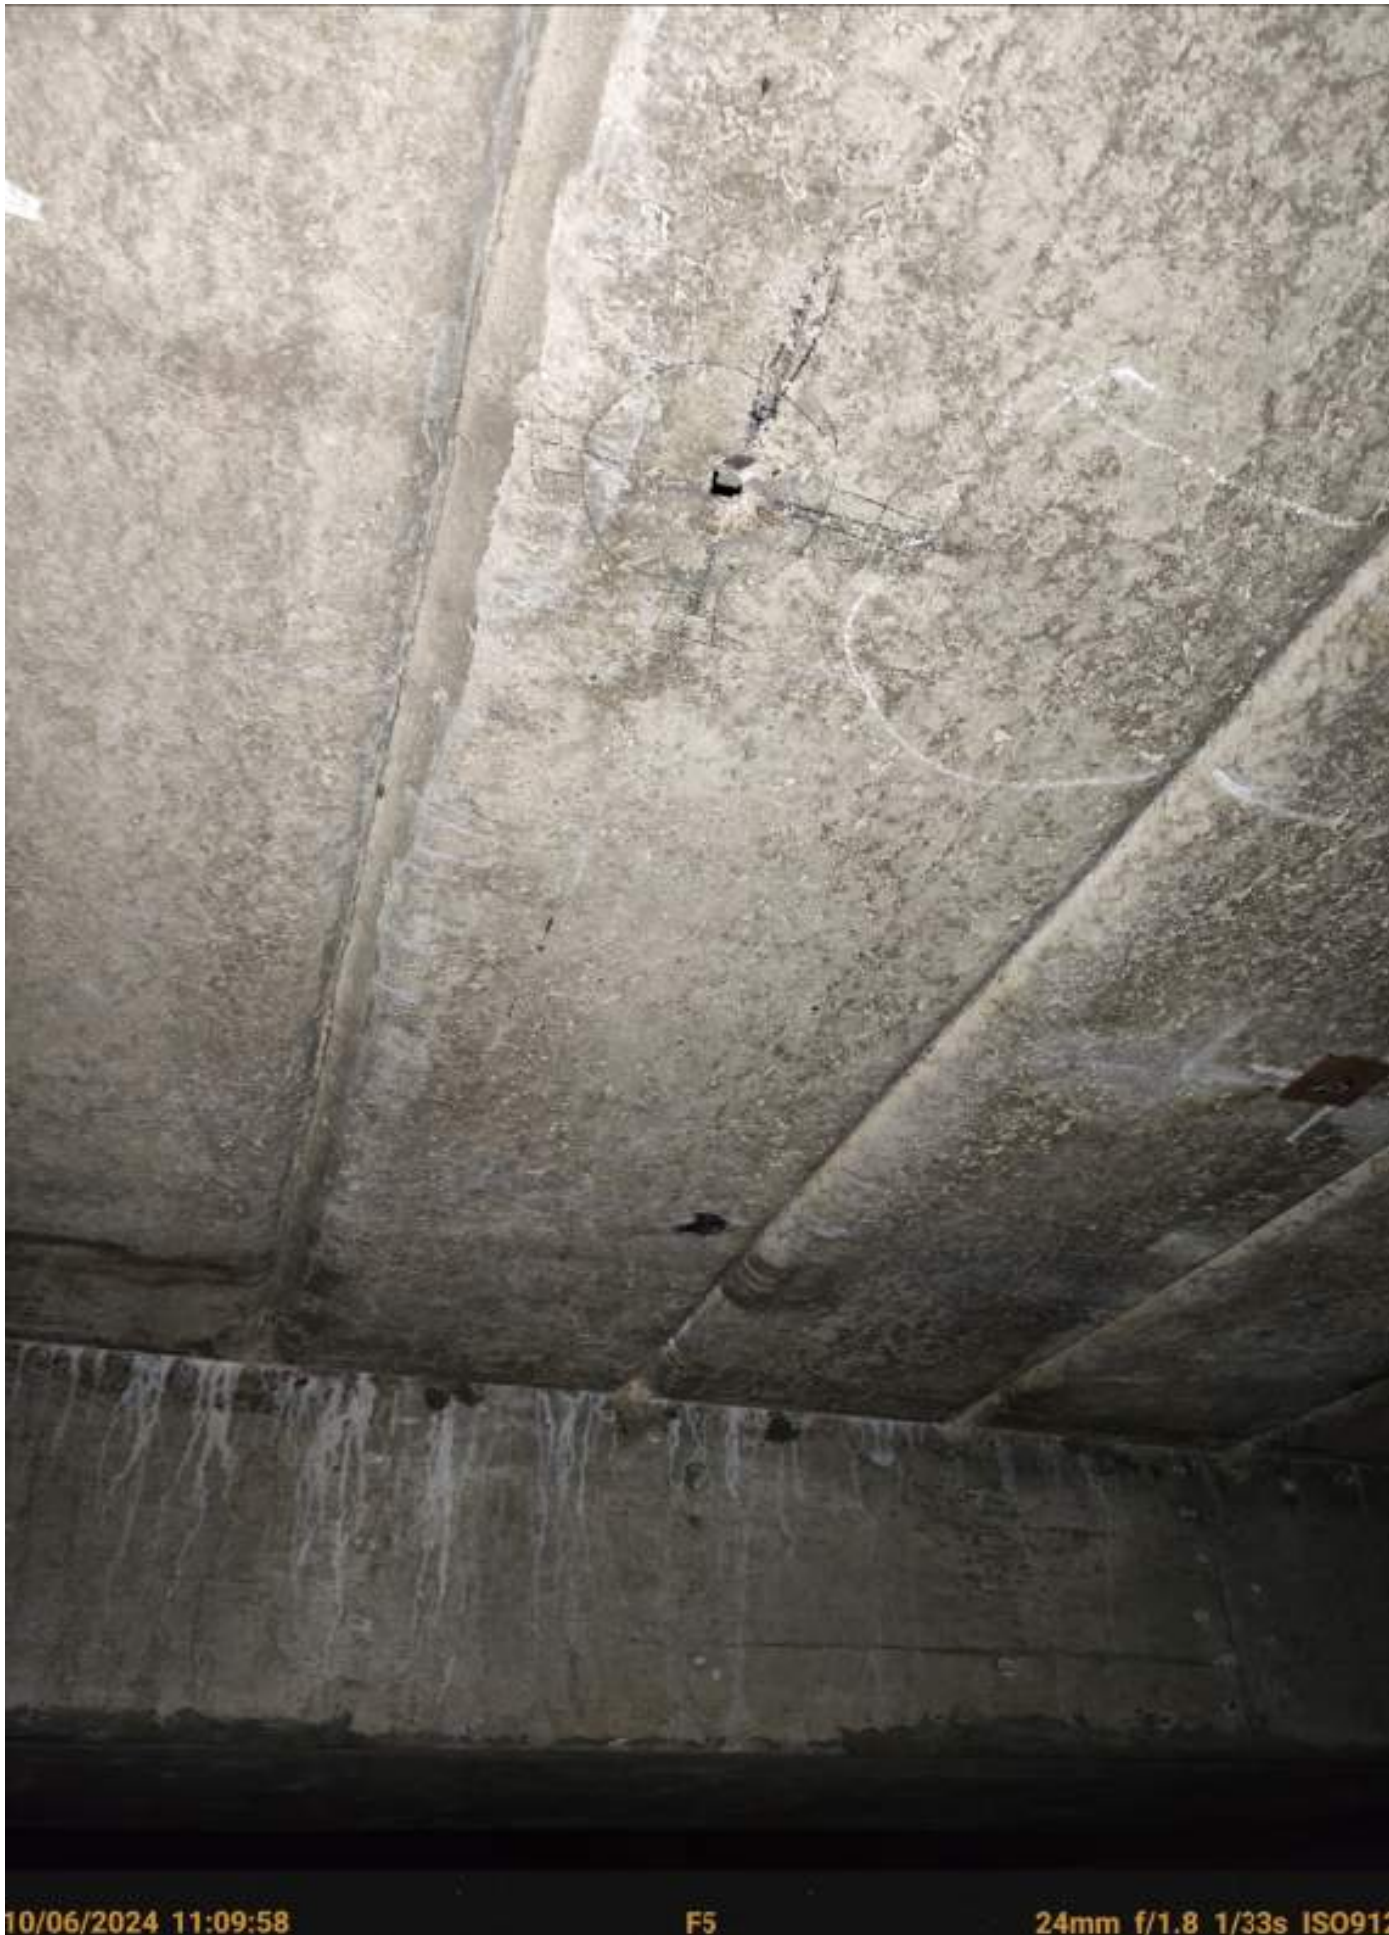
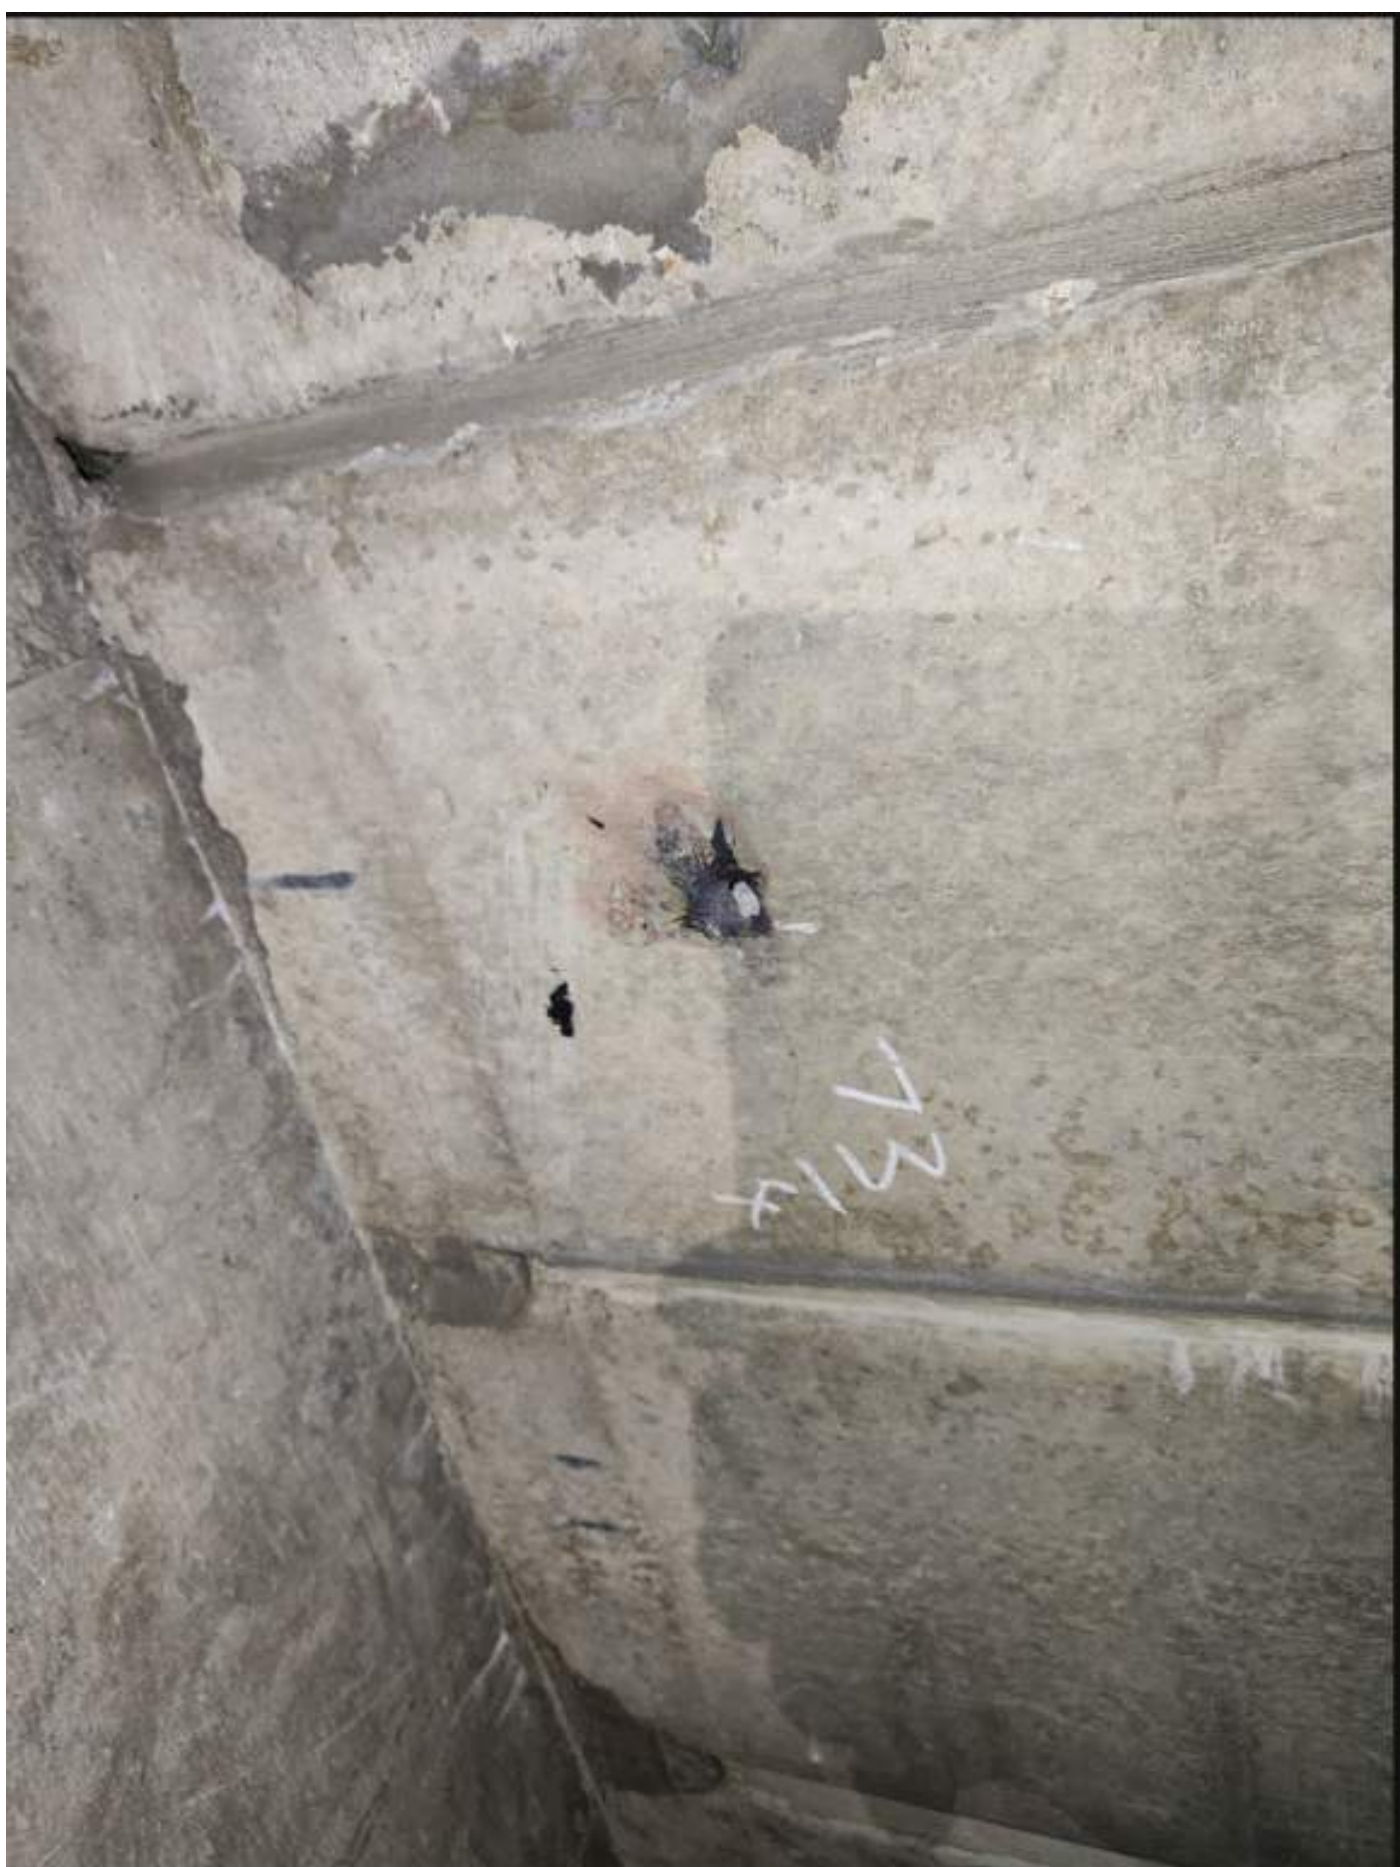
CONDITION SURVEY EXAMPLE IMAGES - PROPOSED REPAIR PRECAST RC PLANKS
