# ARBORICULTURAL ASSESSMENT REPORT

257 Oxford Road, Gomersal, Cleckheaton, BD19 4PX

PRI Ref: 274448

Survey Date: 17/10/2023

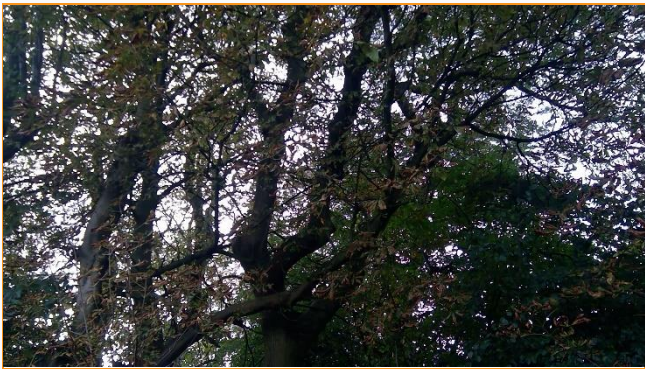
T7 - Ash

| Tree No | Common Name | Age Class | Condition | Height (m) | Crown Spread (m) | Stem diam. (mm) | Dist to bldg. (m) | Roots Implicated | Pruning history | Recommendation | Tree work constraints | Notes | Owner address | Owner |
|---|---|---|---|---|---|---|---|---|---|---|---|---|---|---|
| T7 | Ash | Mature | Poor | 20* | 12 | 700* | 6* | Y | Subject to past management. | Fell and treat stump with eco plugs (broadleaved). | Restricted access, neighbours garden. | Roots identified in the trial pit. Dieback evident in crown. Section dismantle to ground level and treat stump. | Pollard Hall<br>Oxford Road<br>Gomersal<br>Cleckheaton<br>BD19 4PX | P3P |

| T7 | Ash | Fell and treat stump with eco plugs (broadleaved). | Yes | Yes | 3P |
