## Popeley Farm, Gomersall – WORKSHOP Structural inspection for planning

**Description:** For client and planning approval.

**Project:** Popeley Farm  
**Client:** Mr J. Clay  
**Description:** Structural inspection  
**Date:** 4<sup>th</sup> September 2023

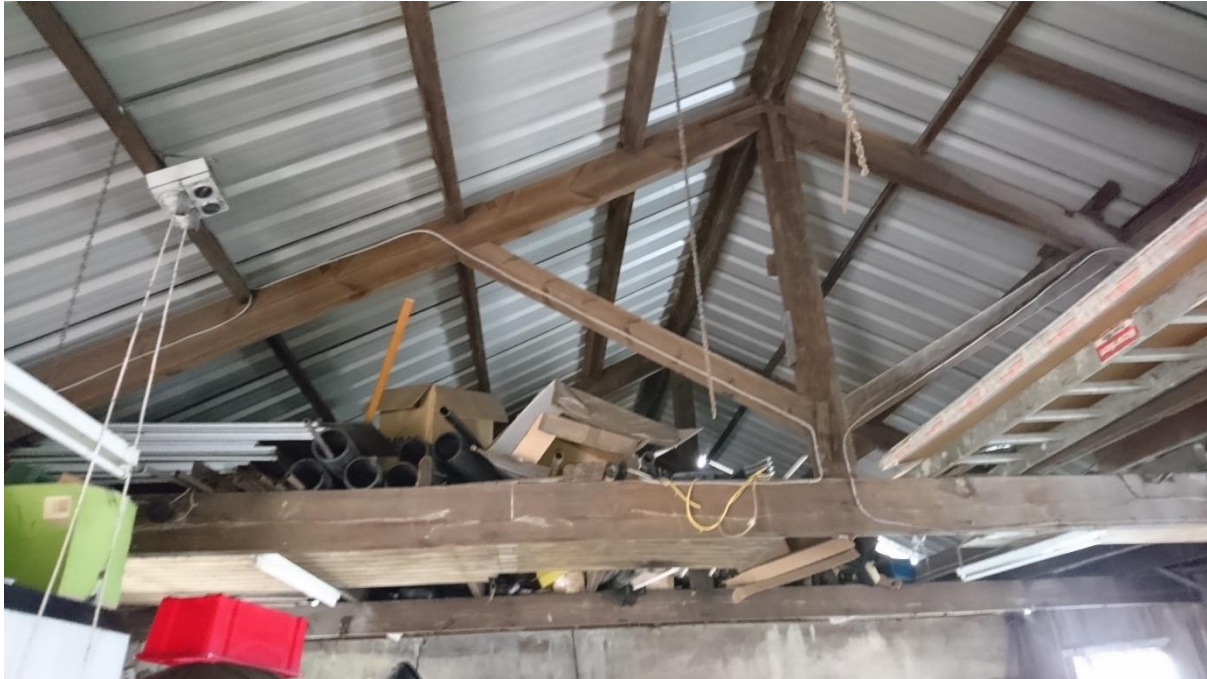
The roof construction over the workshop is formed from profiled metal roof sheets, supported by five slender timber purlins per slope and five slender kingpost type trusses, two of which form the gable 'spandrel panels'.

The timber generally appears to be in good condition and free from significant decay or infestation. The capacity of these timbers should be checked against the proposed roof build-up by calculation. Strengthening works may be required, especially to the purlins.

*Figure 4: Internal view of the roof in the Workshop.*

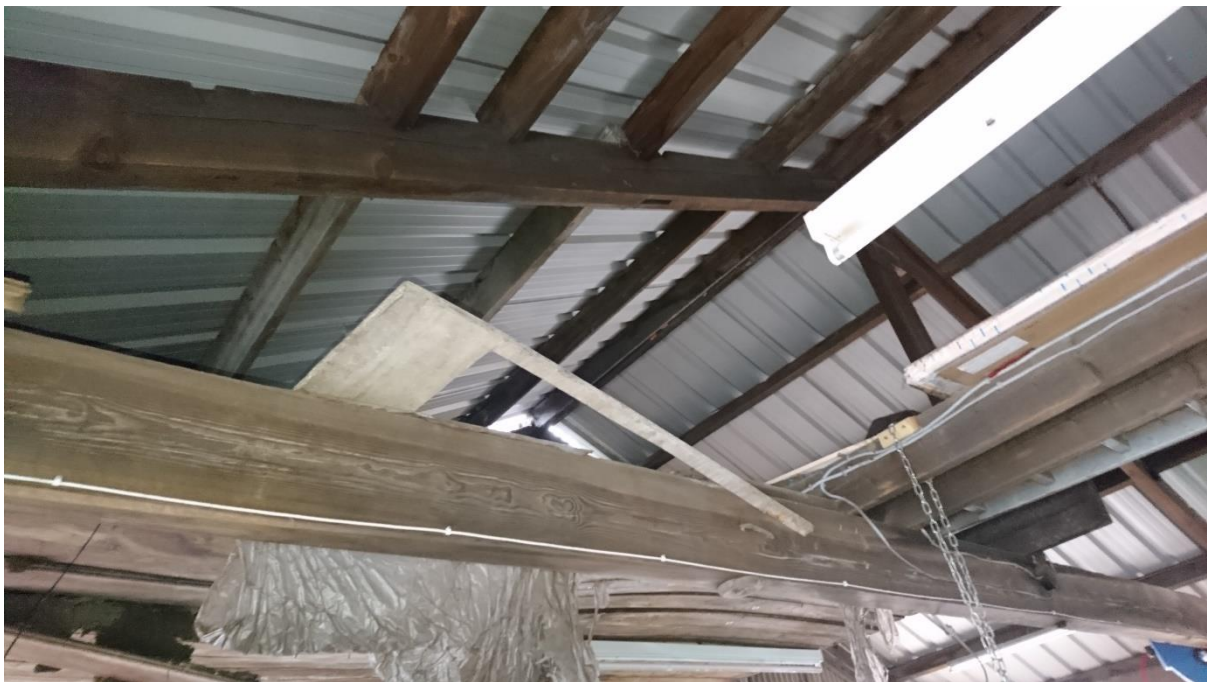
Two of the five trusses have had the queen post timbers removed to facilitate roof storage, which should be replaced.

*Figure 5: One of two trusses in the workshop missing a queen post*

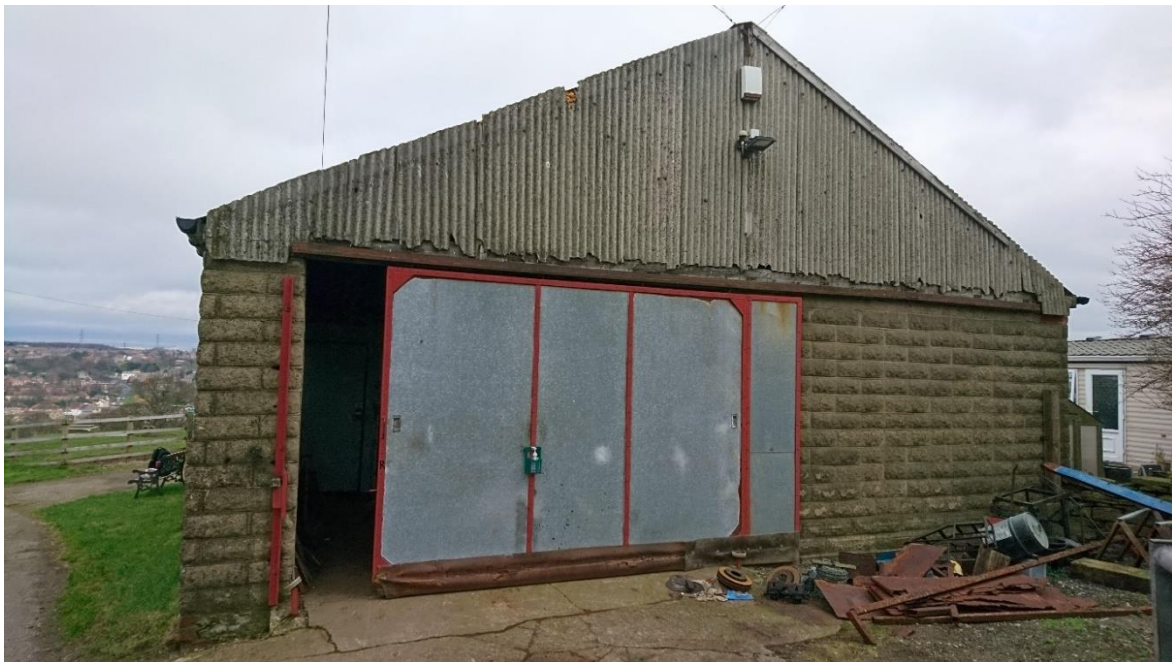
The southwestern gable forms the primary opening into the workshop and features a sliding steel door mounted from the truss tie beam. Viewed externally, there is a small crack of around 2mm width running vertically, the cause of which is not immediately obvious.

The corrugated cement fibre cladding to the truss which forms the apex of this gable has become broken and detached at its lower edges and has exposed the untreated timber tie beam of the gable truss to the elements. The cladding should be reinstated to protect the timber structure behind.

*Figure 6: External view of the south-western gable*

The cement fibre cladding should be tested for asbestos.

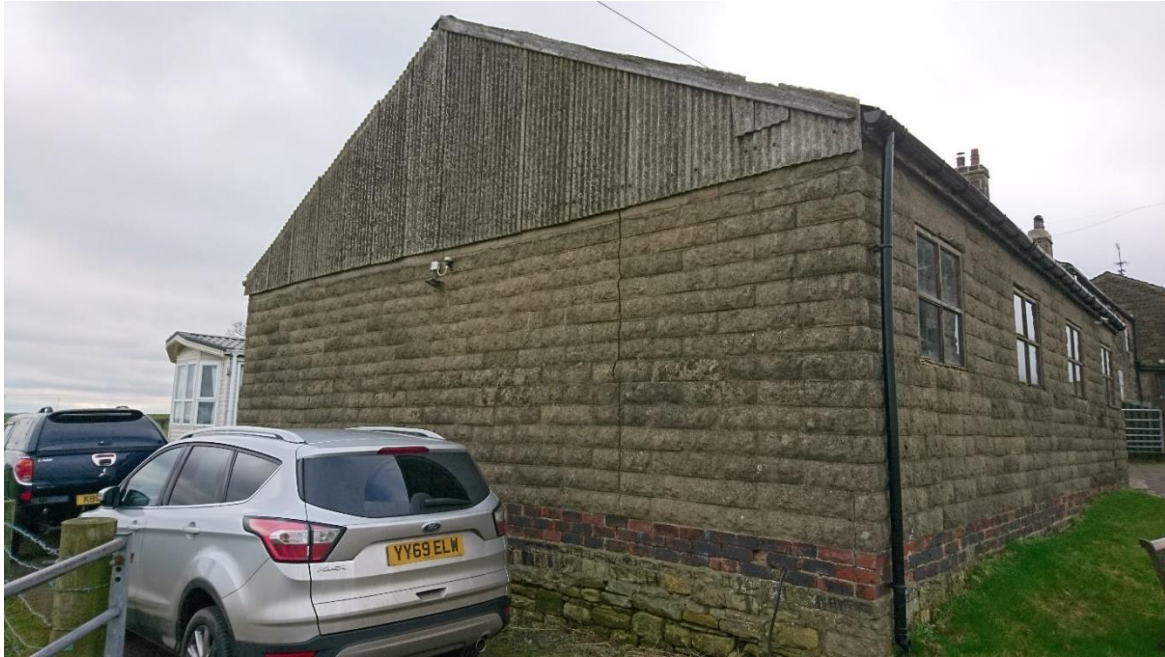
The north eastern gable features two tapering cracks, the larger of which is around 20mm wide at eaves level and tapers to nothing at ground level. A second tapering crack is present which is 5mm at its widest point at eaves level and tapers to nothing at around mid-height of the masonry panel.

These tapering cracks typically relate to a rotational movement of the masonry panel. This rotation is most likely related to the rainwater downpipe which discharges directly to the ground at the northern corner.

*Figure 7: External view of the north-eastern gable, noting tapering cracks.*

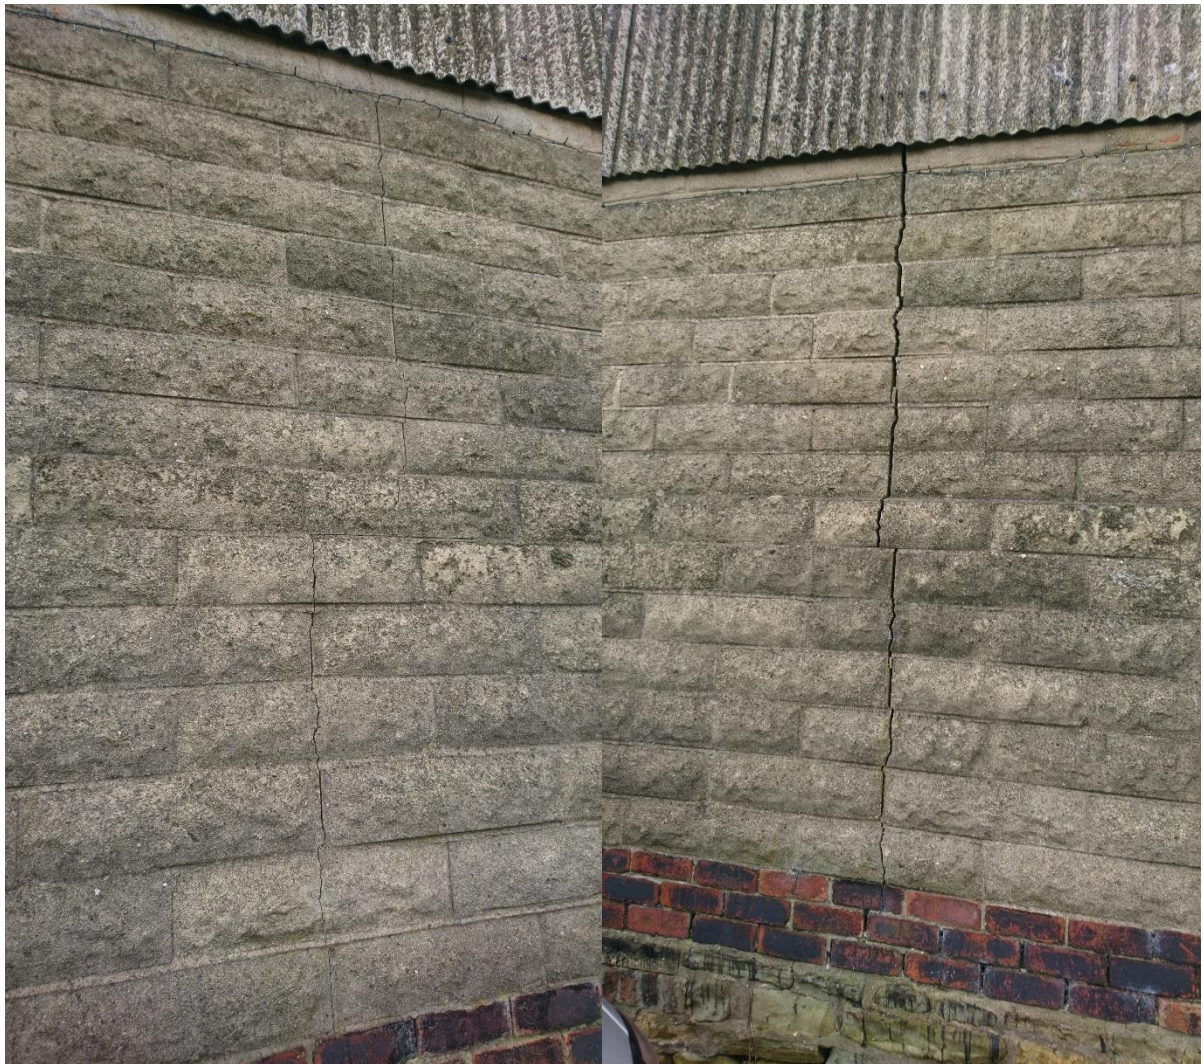
*Figure 8: Detail view of the tapering cracks in the north-eastern gable*

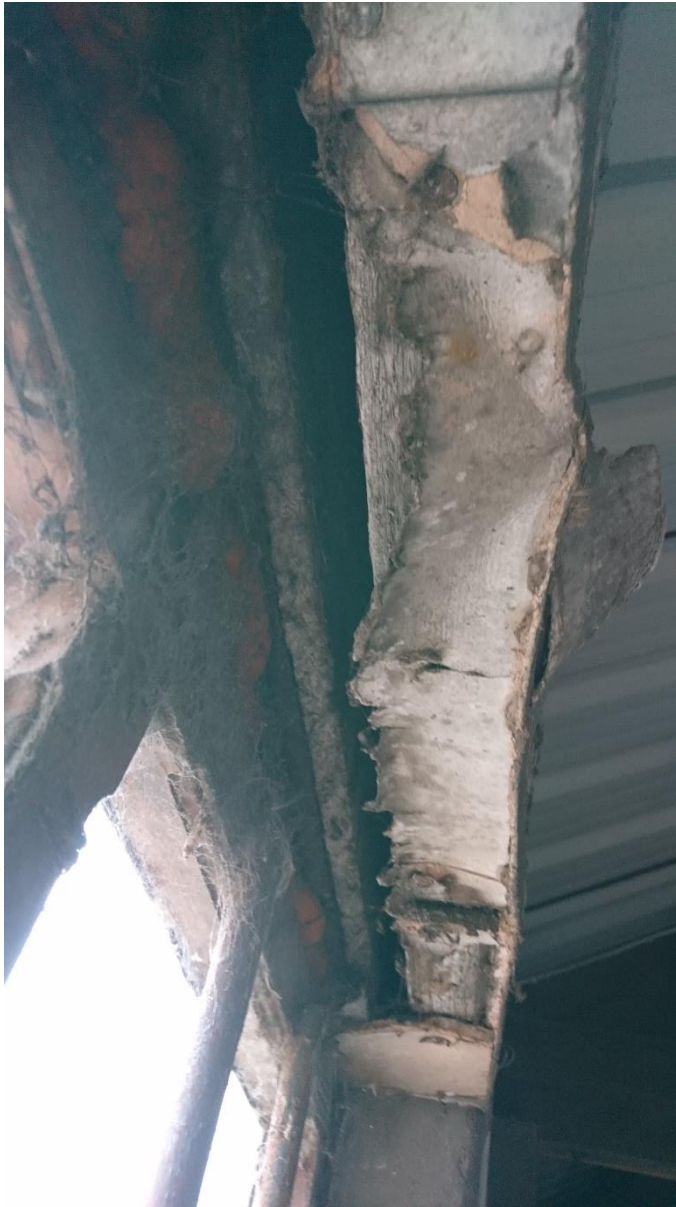
The north-western elevation features four window openings, each complete with a cast in-situ concrete lintel. The trusses are located to bear on the masonry between these openings. The in-situ lintels are in a mixed condition, with some having lost their cover on the bottom outer corner. The inner leaf is a timber provision.

*Figure 9: Internal timber lintels and cavity in the north-western elevation*

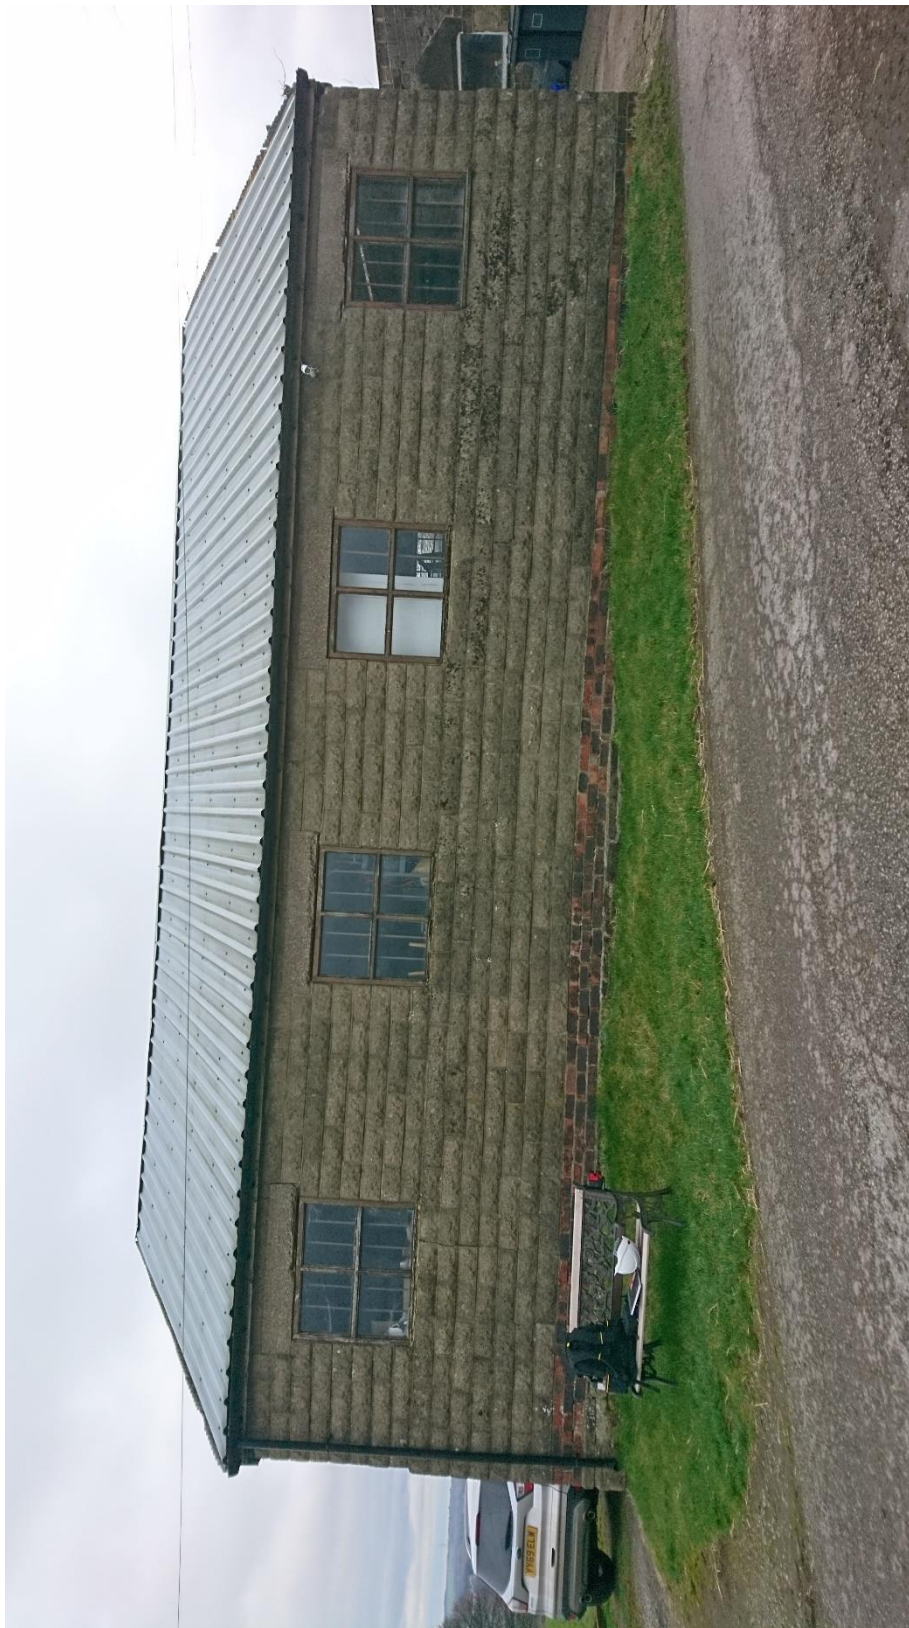
Following a level laser along a bed joint of the exposed red clay substructure masonry reveals that the masonry has dropped by around 65mm. This downward progression is greatest at the north-eastern gable and has developed a system of tapering cracks in the north-western elevation.

*Figure 10: The north-western elevation*

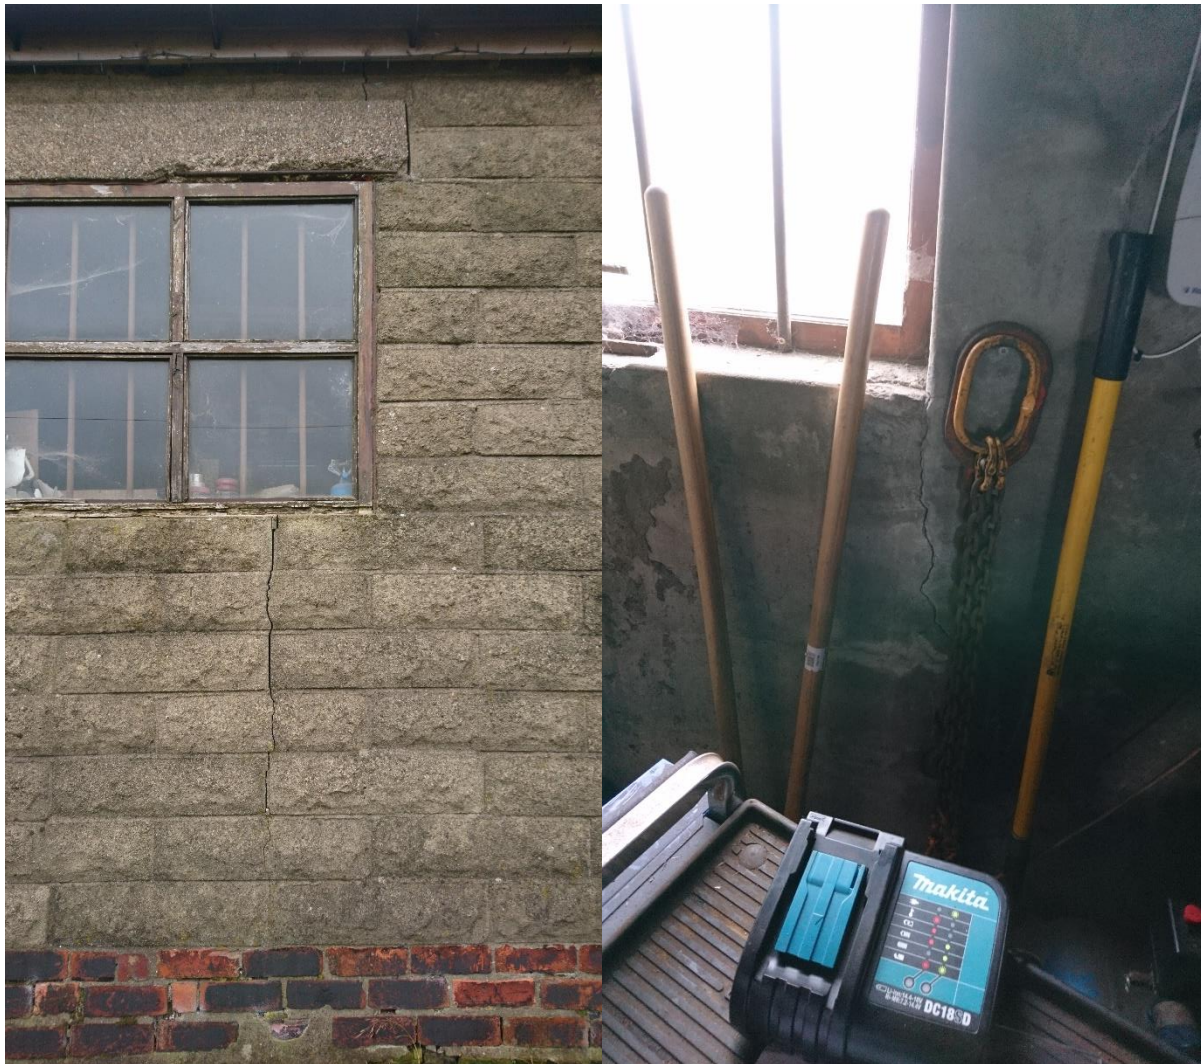
*Figure 11: Internal and external tapering cracks in the north-western elevation*

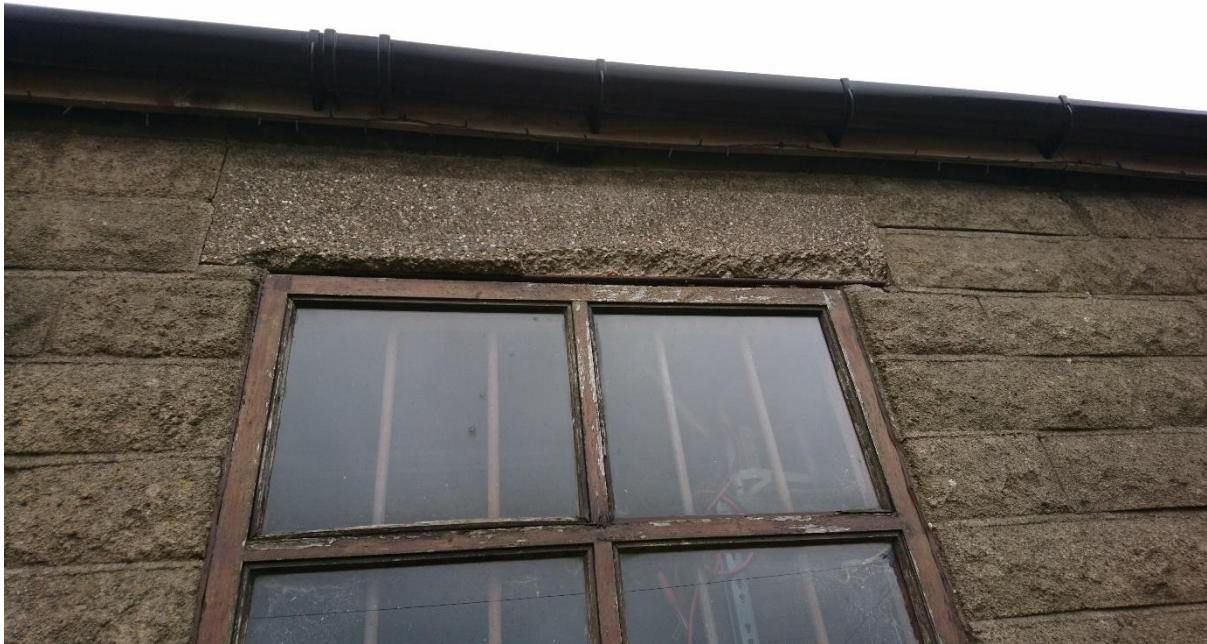
*Figure 12: Loss of cover to the cast in-situ concrete lintels.*

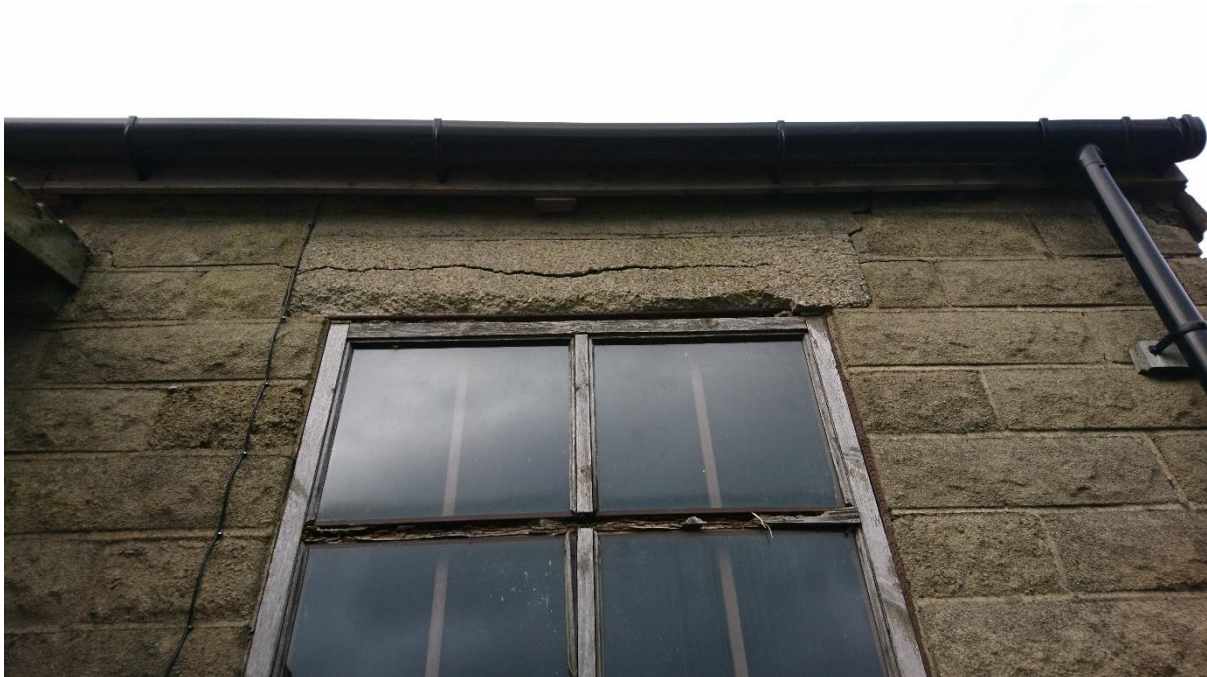
The south eastern elevation is obscured by a number of light lean-to structures, but shares a similar drainage arrangement and features a similar cracking pattern to the North western elevation. The cast in-situ lintels on this elevation have also lost cover to the bottom corners on the outer face.

*Figure 13: Cracking to the masonry and lintels in the south-eastern elevation, noting the rainwater downpipe to image RIGHT.*

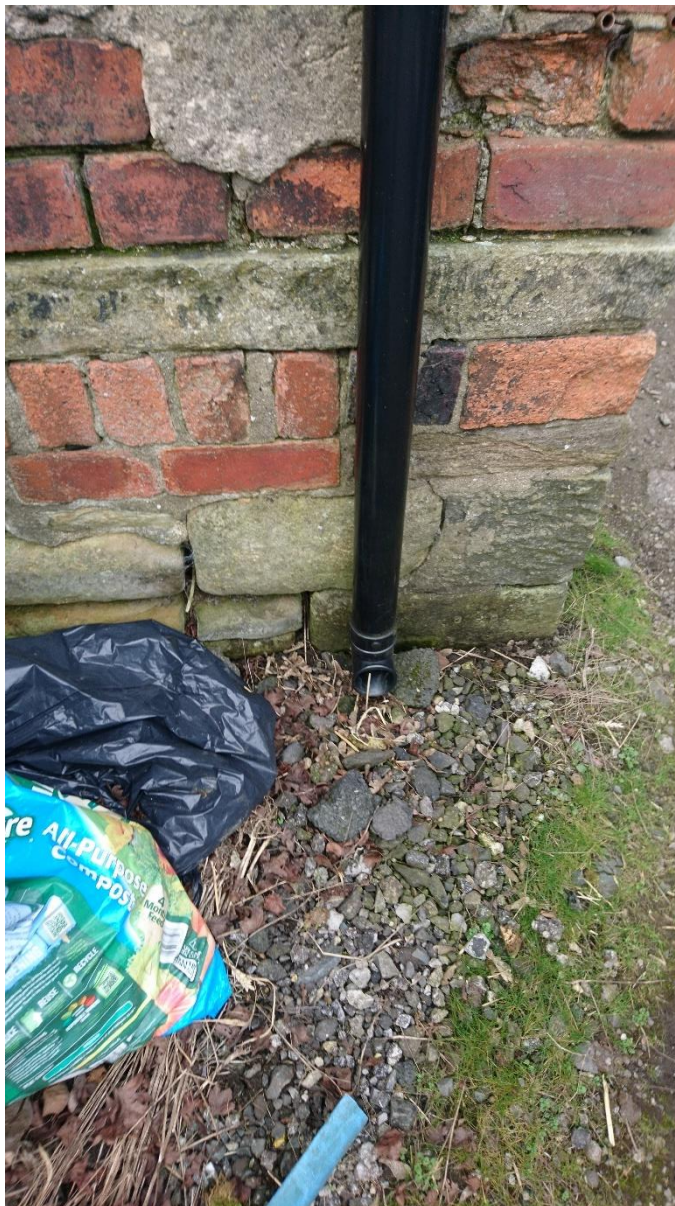
The foundations were not exposed for inspection, but are likely to be compromised due to the observed saturation of the soils which they bear onto from the rainwater drains. These foundations are likely to require underpinning.

*Figure 14: Detail view of the drainage provision to the downpipe on the eastern corner.*

Formal drainage should be provided to a suitable soakaway.

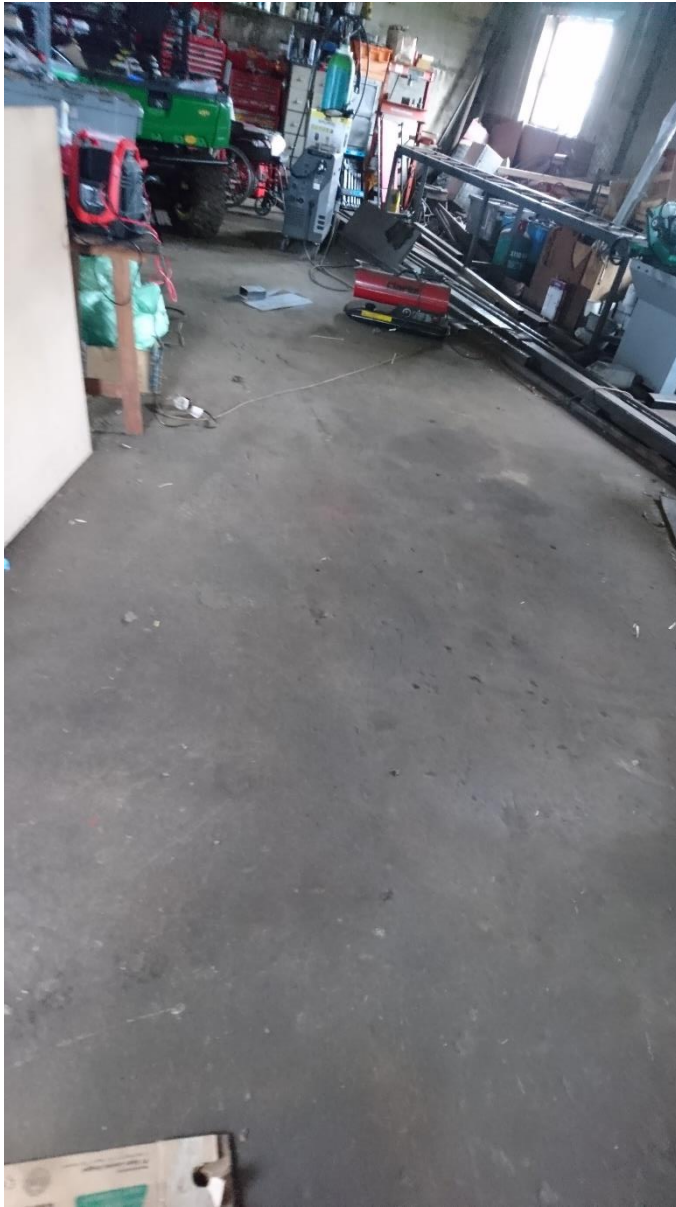
The floor is a smooth concrete provision, which is likely to be suited to conversion provided no structural elements (such as columns) are supported by the floor surface

These floors are unlikely to be insulated or have modern damp proof provisions.

*Figure 15: The smooth concrete floor provision.*
