SAVILLS ARBORICULTURE

BS5837:2012 -
ARBORICULTURAL
IMPACT ASSESSMENT

LINFIT LANE BARNES, 125 LINFIT LANE, HUDDERSFIELD

24th November 2023

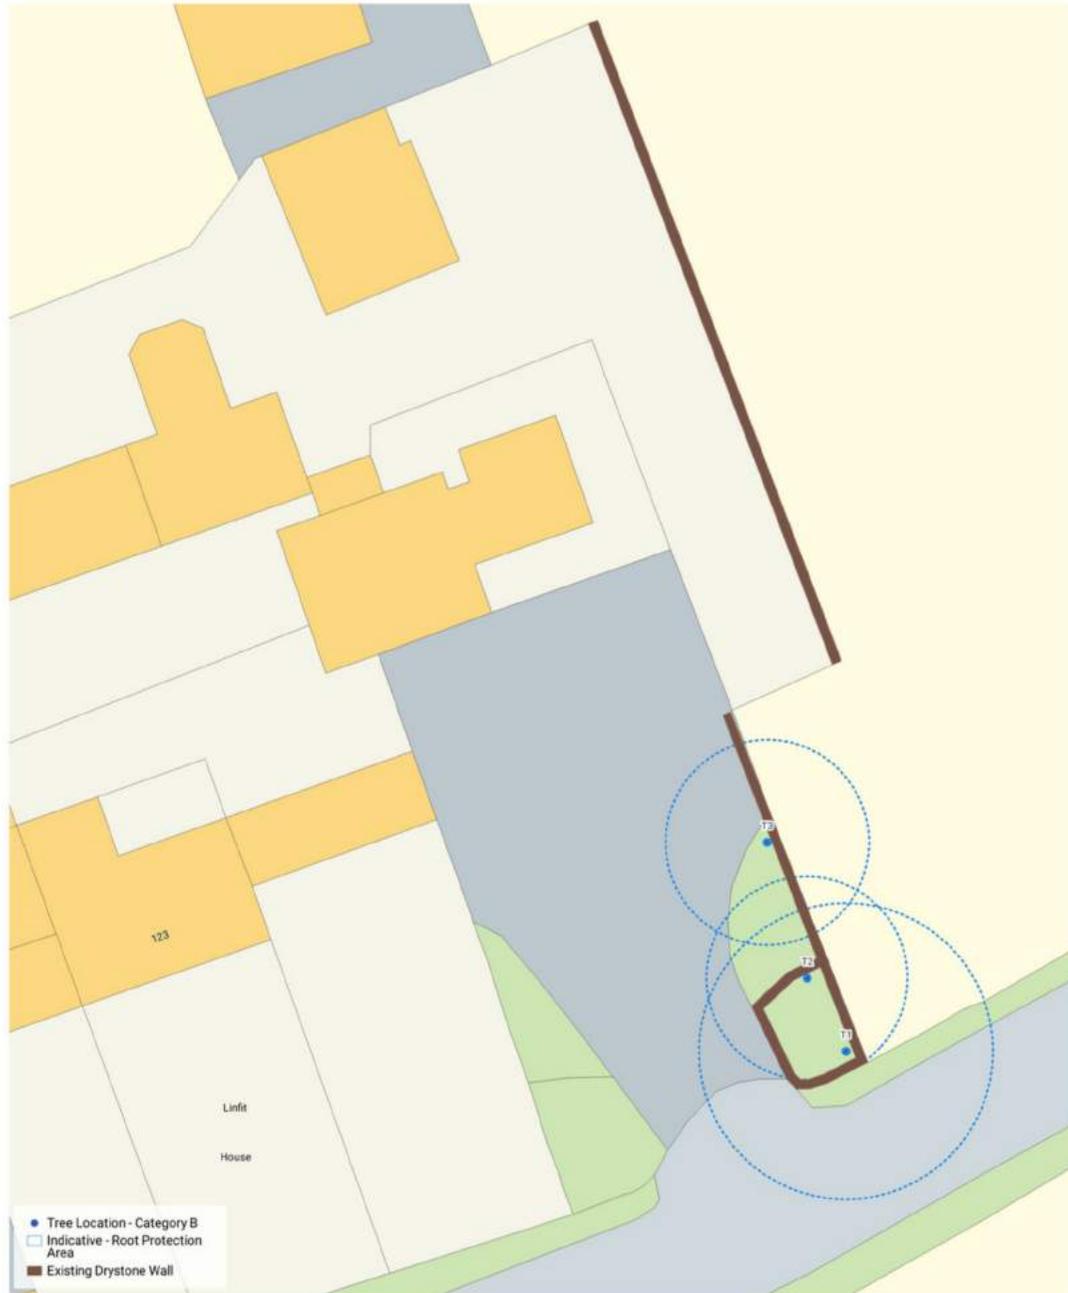
APPENDIX A. BS5837:2012 PRELIMINARY TREE CONSTRAINTS PLAN

| No. | Species | Height | DBH (mm) | Crown Spread | Height to 1st Branch | Life stage | Physiological | Structural | ERC | Observations | Recommendations | BS Category | RPA Radius(m) | RPA m2 |
|---|---|---|---|---|---|---|---|---|---|--|---|---|---|---|
| T1 | sycamore | 13 | 650 | 10 | 8 | M | Moderate | Moderate | 10-20 | previous stem removal, decaying into main stem. | Retain tree | B2 | 7.8 | 191.1345 |
| T2 | sycamore | 13 | 445 | 10 | 1.7 | M | Good | Good | 10-20 | causing disturbance to low stone wall due to proximity | Retain tree | B2 | 5.34 | 89.5844 |
| T3 | Beech | 13 | 450 | 10 | 3 | SM.EM | Good | Good | 40+ | close proximity to stone boundary wall | Retain tree | B1 | 5.4 | 91.60884 |
| G1 | mixed shrubs - Cherry and cypress | 5 | 150 | 2 | 0.2 | SM.EM | Moderate | Good | 20-40 | insignificant landscape planting, unlikely to affect development | Retain tree | C1 | 1.8 | 10.17876 |
