**MINING INVESTIGATION REPORT**

**12 HILLHOUSE LANE, FARTOWN, HUDDERSFIELD,  
WEST YORKSHIRE**

**Report 551079MI May 2015**

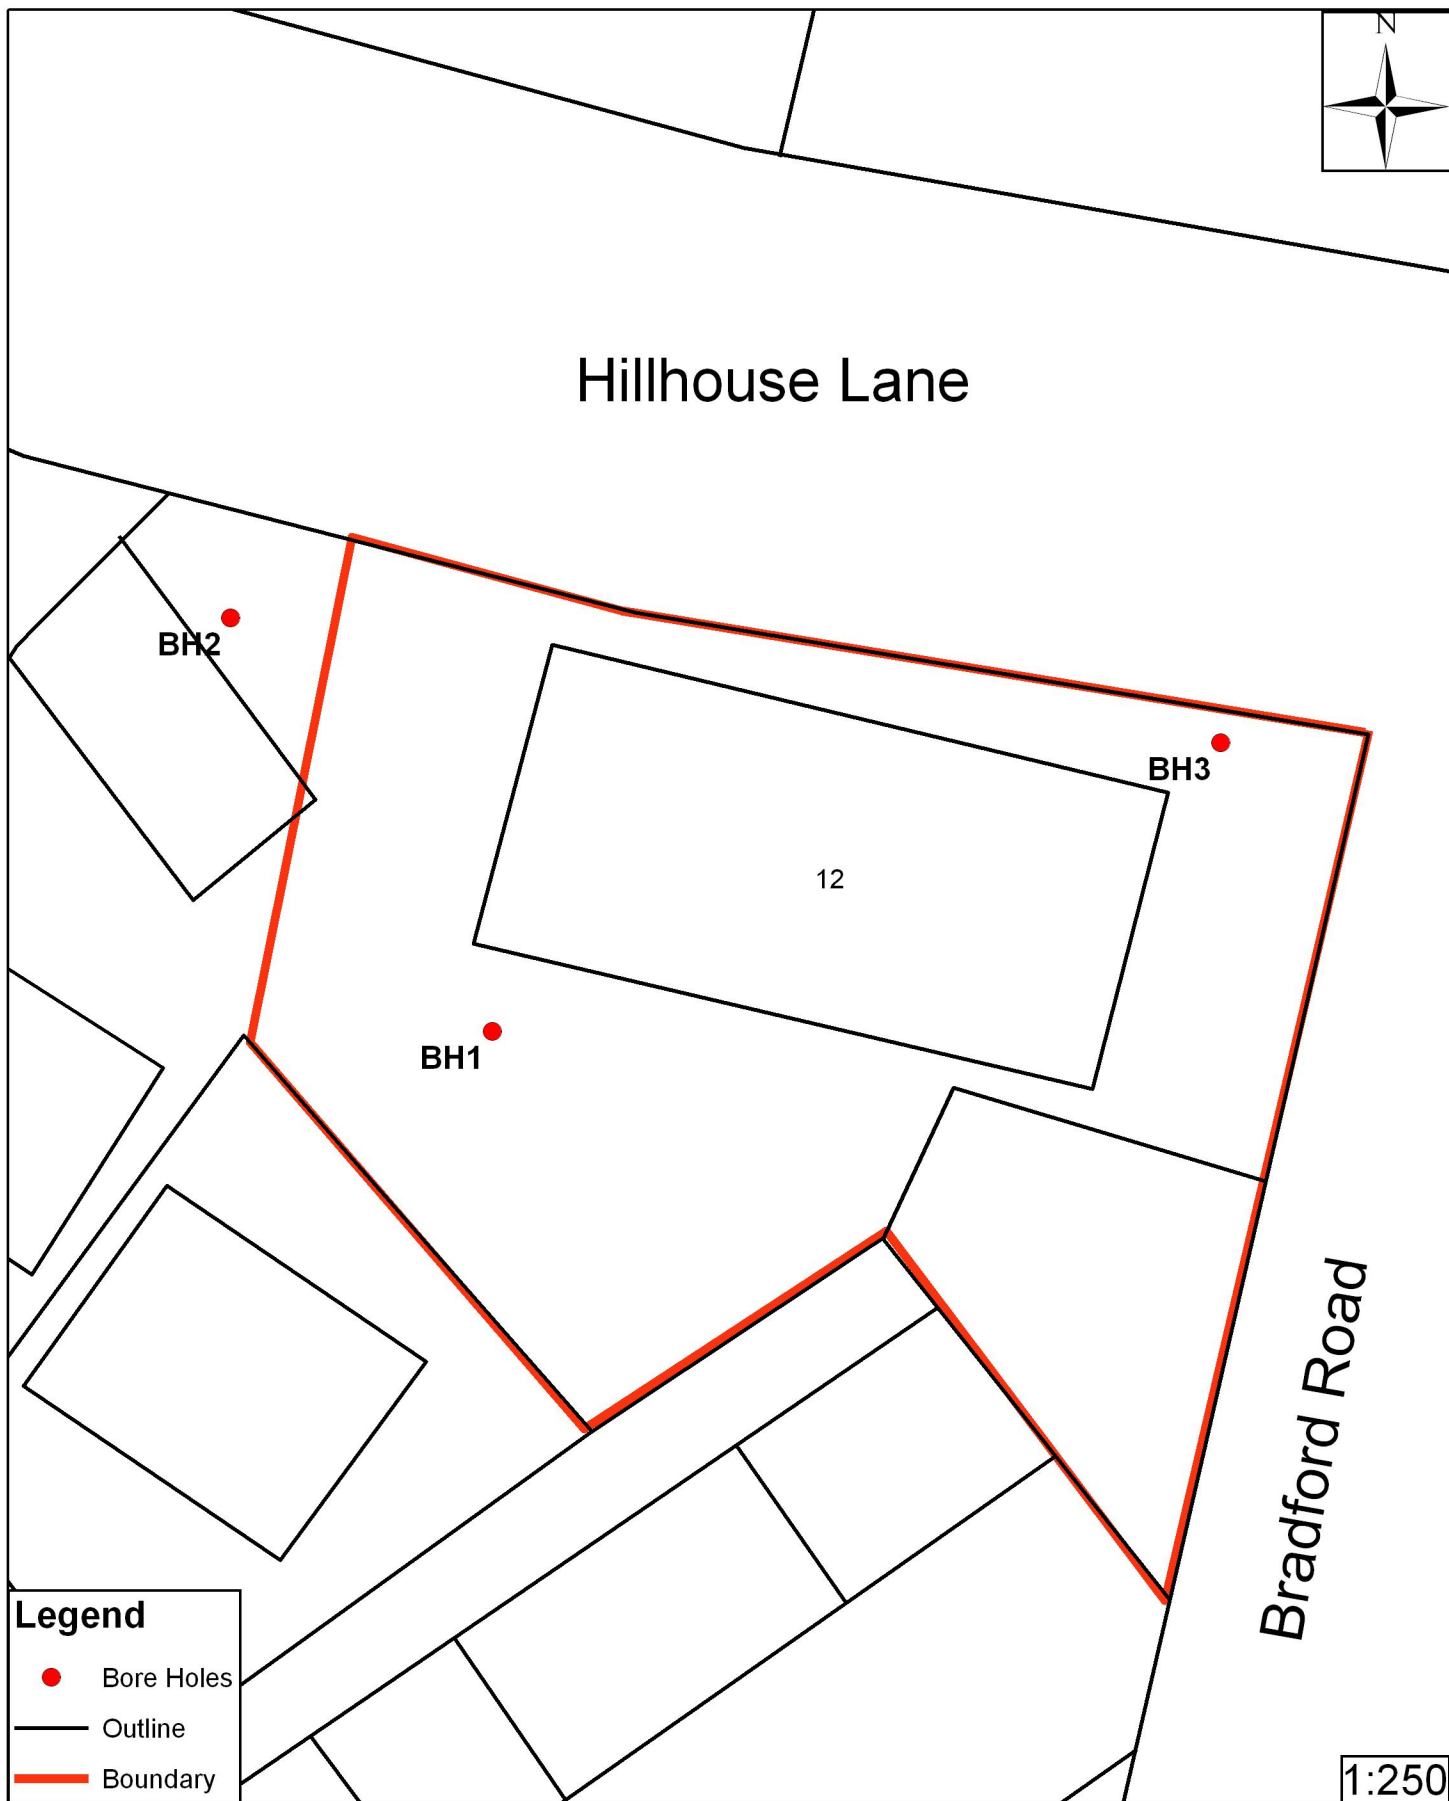
It was noted that the western wall of the existing commercial building had a large crack, which had fractured not only the mortar between the bricks but the actual bricks themselves. Ground levels across the site are essentially level. However, the surrounding areas slope gently to the south and east such that the eastern end of the site is set approximately 1m above Bradford Road. See Fig 2.

survey is available. The positions of the holes were assessed relative to existing features using a tape measure and their approximate locations are shown on Fig 2.

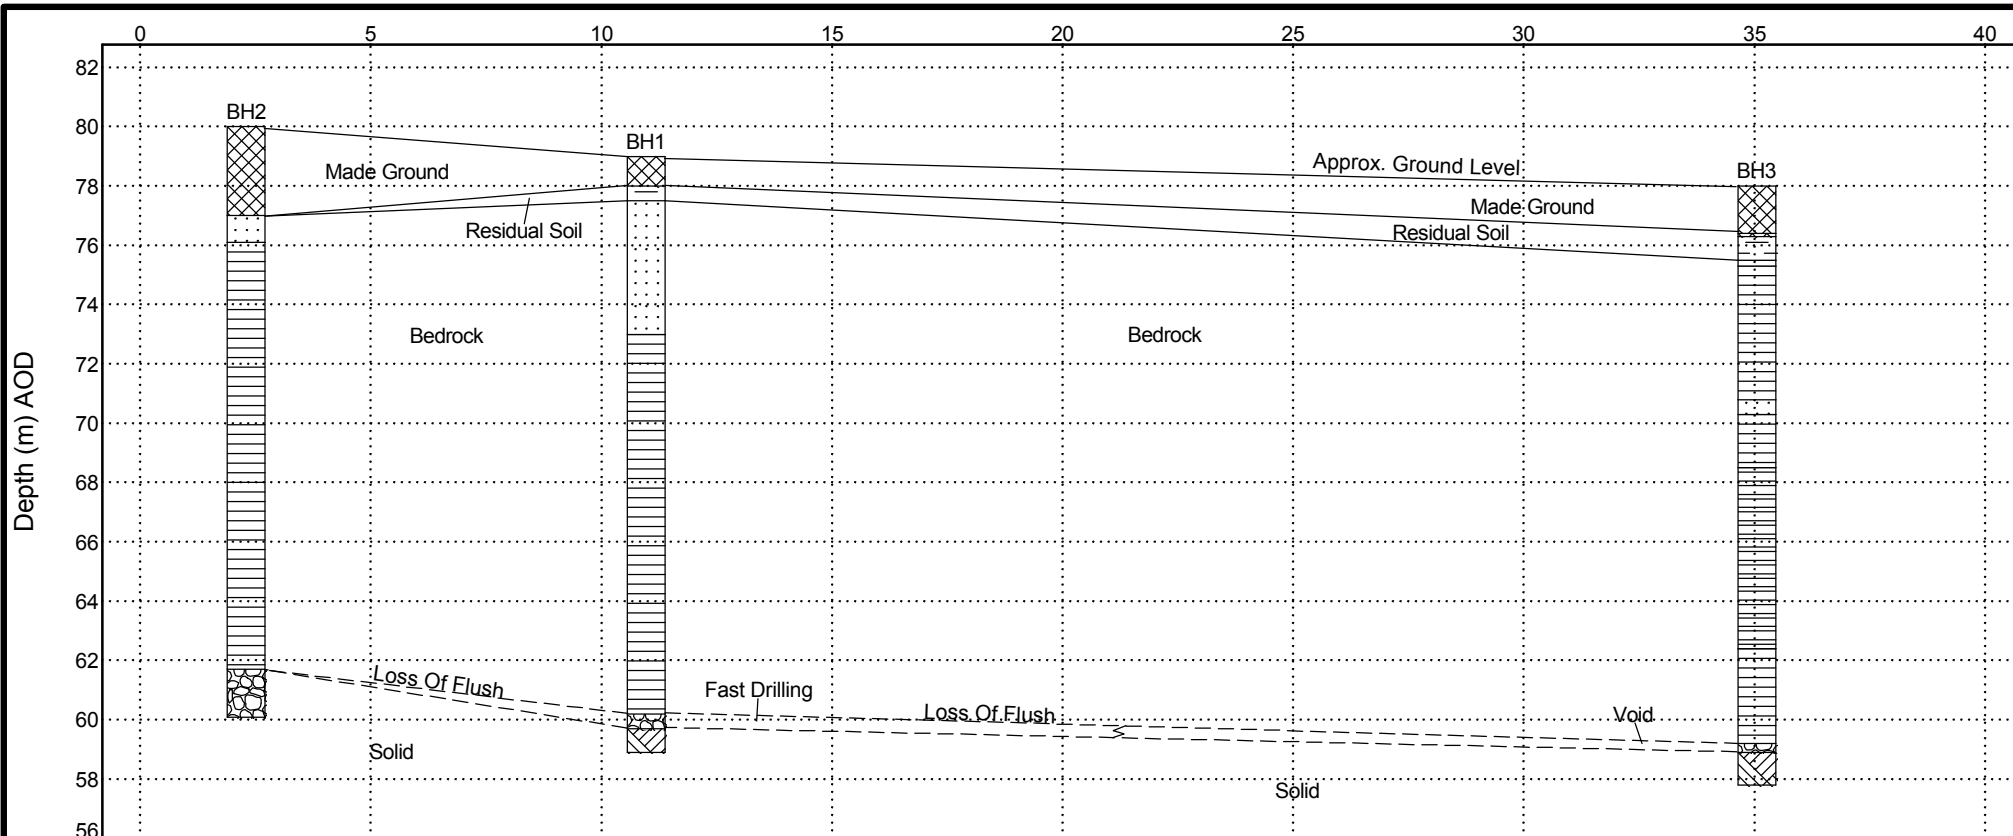
Fig 3

The ground conditions encountered are recorded in detail within the openhole logs and are summarised on a section, Fig 3. Any diagram of the possible configuration of ground conditions between exploratory holes is conjectural and given for guidance only and confirmation of intermediate ground conditions should be considered if deemed critical.

The site was covered by up to 3m of made ground consisting of sandy gravelly clay containing frequent brick fragments. This made ground possibly represents the backfilled cellars of the residential properties that existed on site before 1950, as the made ground in BH3 terminated on a 0.1m thick sandstone slab. The made ground was underlain by sandstone bedrock to a depth between 4.2m to 7.4m, with mudstone and shale below this.

All three boreholes recorded a complete loss of flush at between 18.3m to 18.8m bgl. BH1 found a zone of increased drill speed associated with the loss of flush, between 18.8m to 19.3m bgl. BH3 showed a void between 18.8m and 19.1m bgl, indicative of collapsed workings.

For a piled foundation solution, the depth of workings may be of concern and would require further consideration. For spread foundations founded below the made ground at least 250mm into undisturbed natural ground, the workings found are at sufficient depth not to be a significant concern. However we would recommend that foundations are reinforced to meet the structural engineers requirements. A net allowable bearing pressure of 80 kN/m<sup>2</sup> may be assumed.
