**ARBORICULTURAL SAFETY
SURVEY**

**Kirkwood Hospice
The Kirkwood
21 Albany Road
Huddersfield
West Yorkshire
HD5 9UY**

JCA Ref:
21793/DK

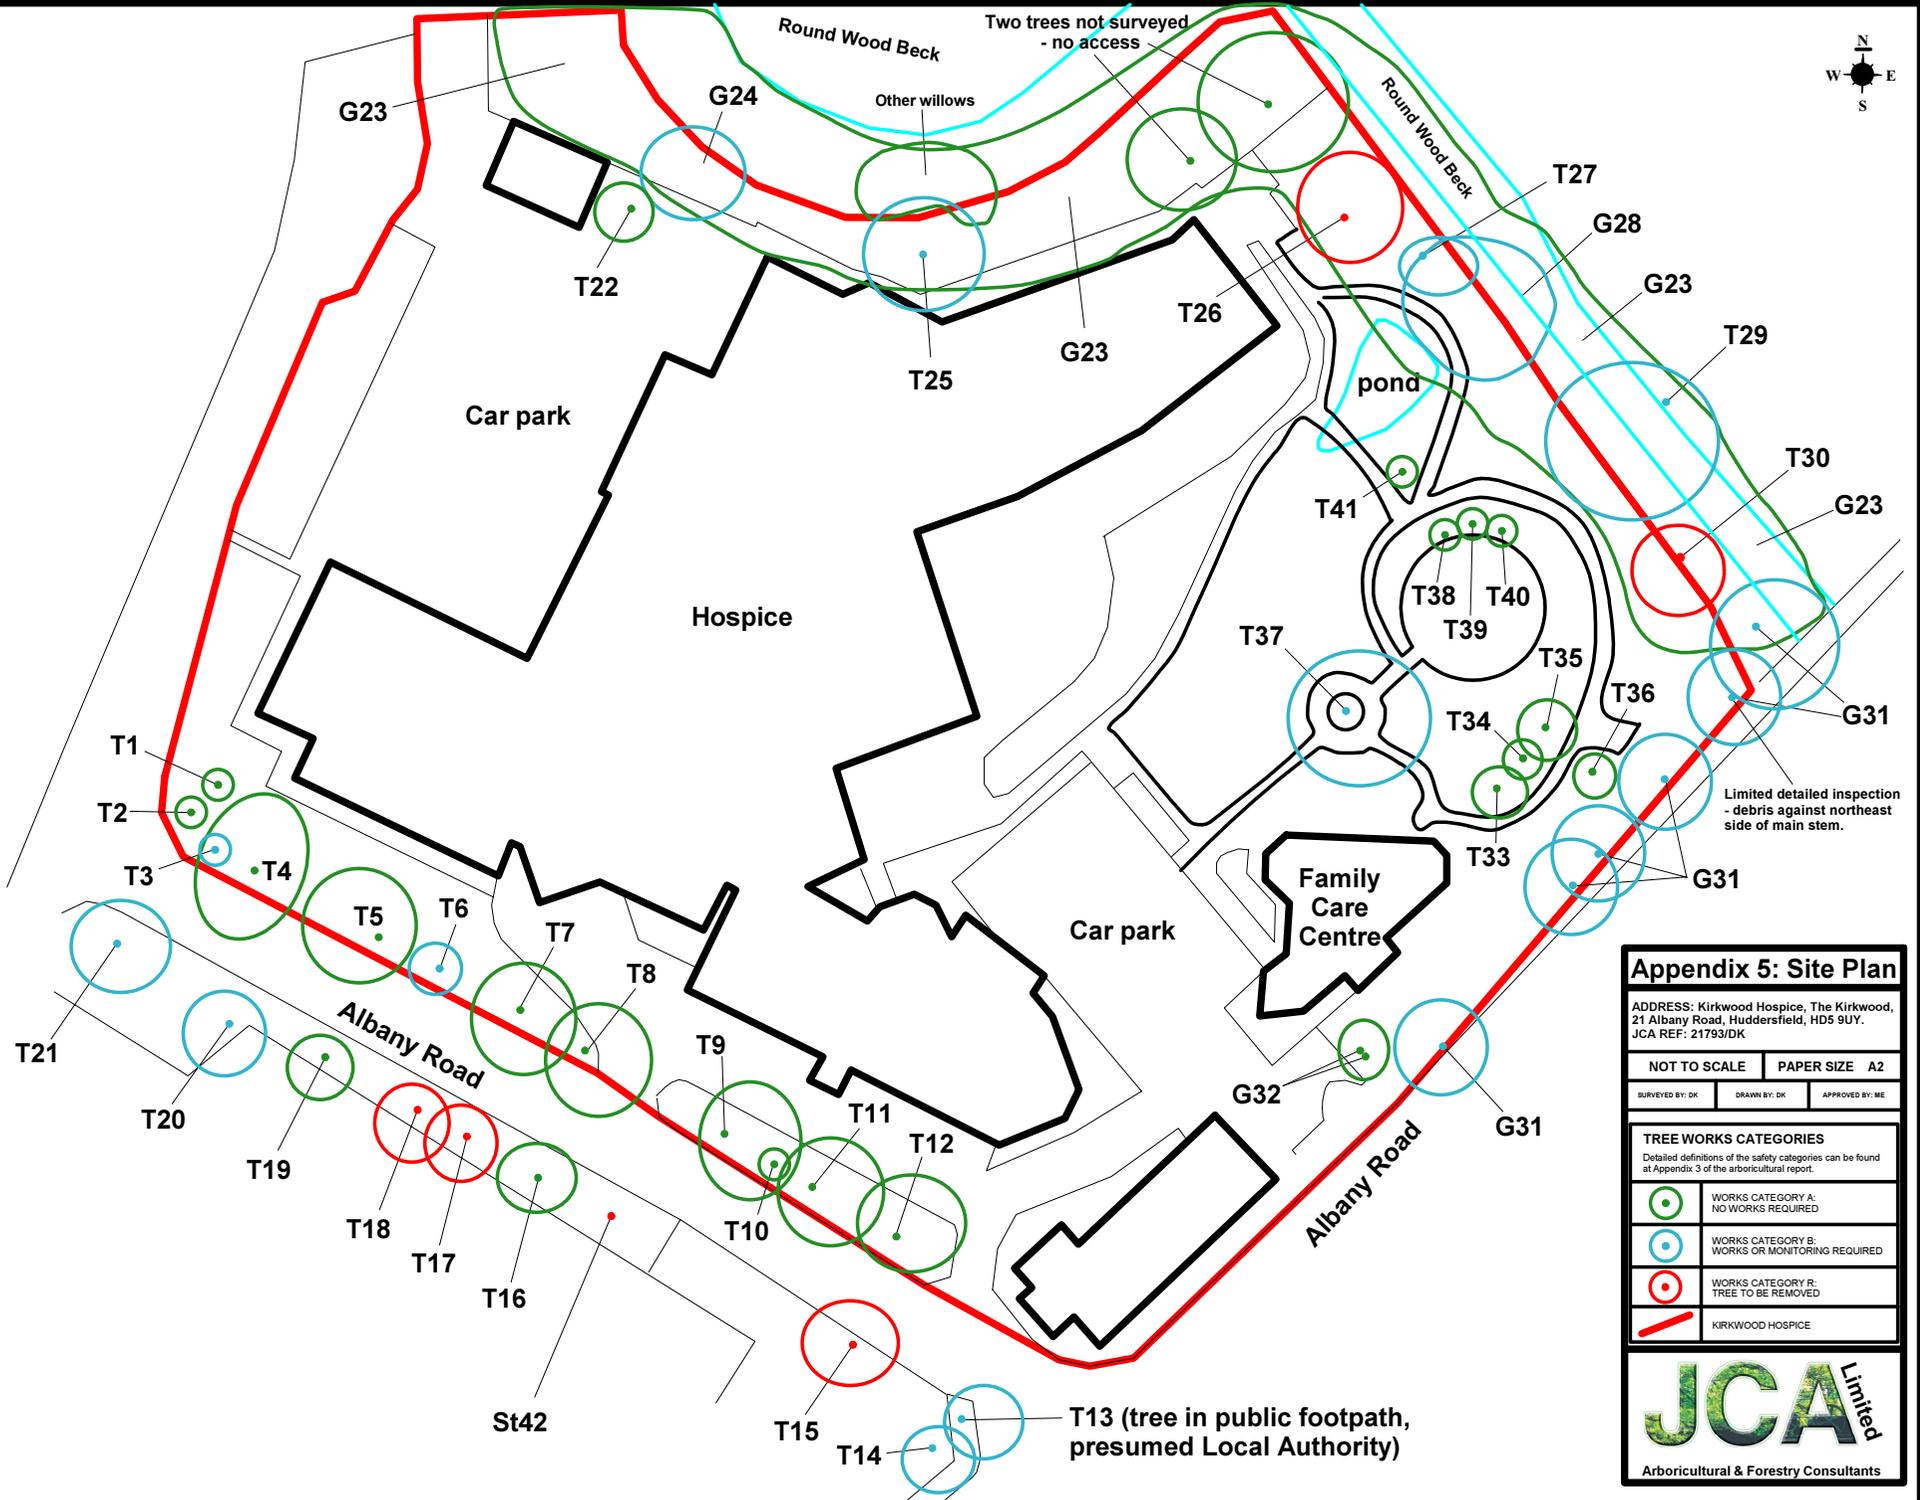
Appendix 5: Site Plan

- 5.2 Following is an overview of our observations and recommendations:
- 5.3 **Five** trees and **one** stump (**T15, T17, T18, T26, T30** and **St42**) have been recommended for removal for arboricultural reasons, as detailed at **Appendix 1**.

- 5.4 The removal of **T15, T17, T18** and **T26** should be undertaken as a matter of **high priority**.
- 5.5 The removal of **T30** and **St42** are of **moderate** and **low priority** respectively.

- 5.6 **Eleven** individual trees and **two** tree groups (**T3, T6, T13, T14, T20, T21, G24, T25, T27, G28, T29, T31, T37**) have been recommend for pruning or other remedial works to reduce their potential risk of harm or to improve their growing conditions, as detailed at **Appendix 1**.

- 5.7 The recommended works to **T3, T13** and **T20** should be undertaken as a matter of **high priority**.
- 5.8 The recommended works to **T6, T14, T21, G24, T25, T27, G28, T29, T31** and **T37** are of **moderate** or **low priority**.
