Arboricultural Consultancy for AXA Insurance

Insured	Mr Stephen John Edwards	Address	20 Wellington Court, Bradford, BD11 2HY		
Client	Subsidence Management Services	Contact	Ian Domigan	Claim No.	IFS-AXA-SUB-22-0099767
ES Ref	SA-249643	Consultant	Keith Burgess	Contact No.	0330 380 1036
Report Date	05/04/2022

Scope of Report: To survey the property and determine significant vegetation contributing to subsidence damage, make recommendation for remedial action and assess initial mitigation and recovery prospects. The survey does not make an assessment for decay or hazard evaluation.

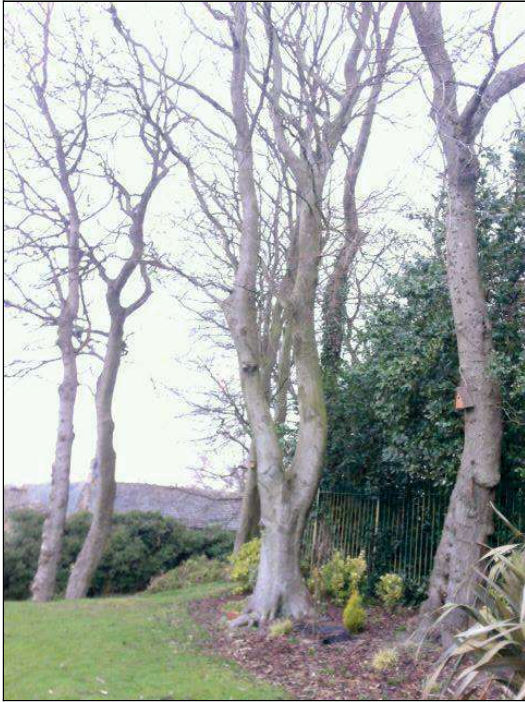
T1 - Beech

Please note that the footing of the insured property fall within the anticipated rooting distance of additional vegetation which we believe presents a foreseeable risk of future damage and accordingly we have made recommendations in respect of this.

Tree No.	Species	Age Cat	Approx. Height (m)	Distance to Building (m) *	Ownership	Action	Requirement
T1	Beech	3	18	14.8	C - Insured	Action to avoid future risk	Do not allow to exceed current dimensions by way of regular pruning.
T2	Lime	3	18	12.0	C - Insured	Action to avoid future risk	Crown reduce overall canopy by 30% (minimum) to achieve a crown volume reduction in line with BRE IP7/06. Maintain at reduced dimensions by re-pruning back to points of previous reduction on a 3 year (max) cycle.
T3	Lime	3	18	9.0	C - Insured	Action to avoid future risk	Crown reduce overall canopy by 30% (minimum) to achieve a crown volume reduction in line with BRE IP7/06. Maintain at reduced dimensions by re-pruning back to points of previous reduction on a strict 2-3 year cycle.
T9	Monkey Puzzle	1	3	5.8	C - Insured	Action to avoid future risk	Do not allow to exceed 5m height / spread by way of regular pruning.

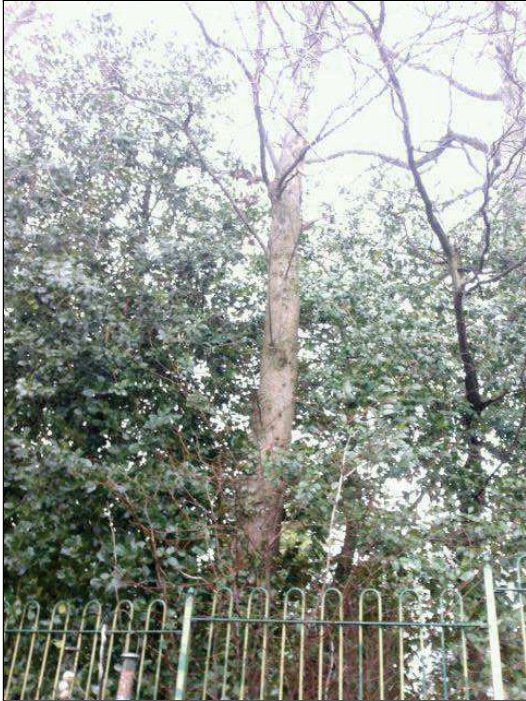
T4 - Lime

Our survey of the site identified the Lime (T4), Beech trees (T5 & T8) and Oaks (T6 & T7), given their proximity relative to the advised area of damage, we have identified their collective / cohesive influence as the primary cause of the subsidence damage.

The size and proximity of the above vegetation is consistent with the location of damage; it is our opinion on balance of probability that roots from the above vegetation will be in proximity to the footings of the insured property.

Consequently, complete removal of the Lime (T4), Beech trees (T5 & T8) and Oaks (T6 & T7) will offer the most certain arboricultural solution likely to restore long-term stability.

Tree No.	Species	Age Cat	Approx. Height (m)	Distance to Building (m) *	Ownership	Action	Requirement
T4	Lime	3	18	5.5	F - Commercial Third Party	Remove	Remove close to ground level; do not treat stump due to translocation risk. Where such a risk exists, we advise that any emergent regrowth is removed annually.
T5	Beech	3	18	6.8	F - Commercial Third Party	Remove	Remove close to ground level; do not treat stump due to translocation risk. Where such a risk exists, we advise that any emergent regrowth is removed annually.
T6	Oak	3	18	9.0	F - Commercial Third Party	Remove	Remove close to ground level; do not treat stump due to translocation risk. Where such a risk exists, we advise that any emergent regrowth is removed annually.
T7	Oak	3	18	9.3	F - Commercial Third Party	Remove	Remove close to ground level; do not treat stump due to translocation risk. Where such a risk exists, we advise that any emergent regrowth is removed annually.

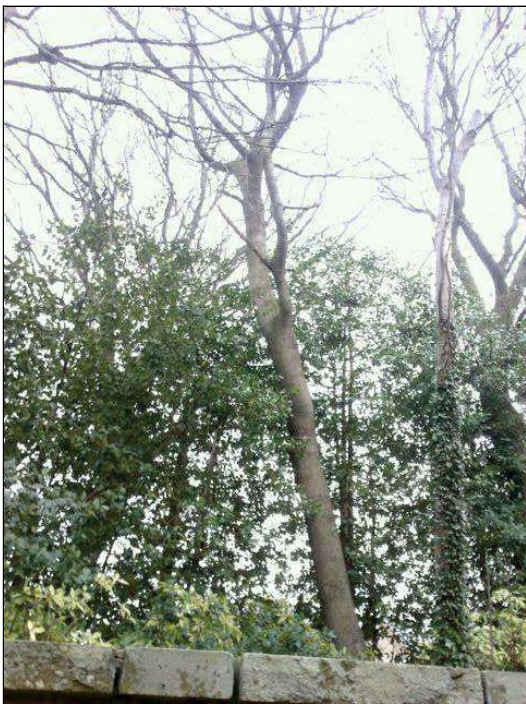
T6 - Oak

Sub Sample	Species Identified	Root Diameter	Starch
TP/BH1:			
0.86-1.9m	<i>Quercus</i> spp.	1	2 mm Low

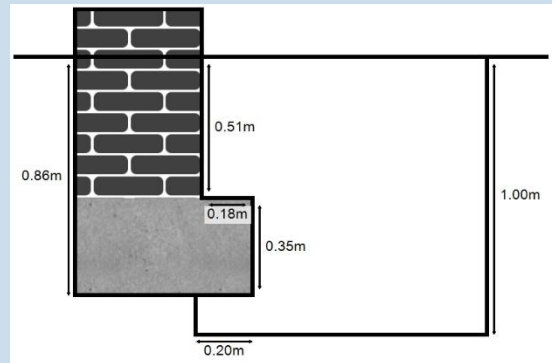
Foundation Detail

Foundations are noted to extend to a depth of 860mm in TP/BH1 and bear onto subsoil described within the borehole log as containing clay, thereby indicating the potential for the observed damage to be the result of clay shrinkage subsidence exacerbated by the influence of vegetation.

House foundation comprised of brick wall to 510mm bgl, bearing on concrete to 860mm bgl, with a total projection of 180mm from the elevation. Underside of foundation (USF) was exposed to 200mm back from the face of the foundation and probed 200mm back from the face of the foundation.

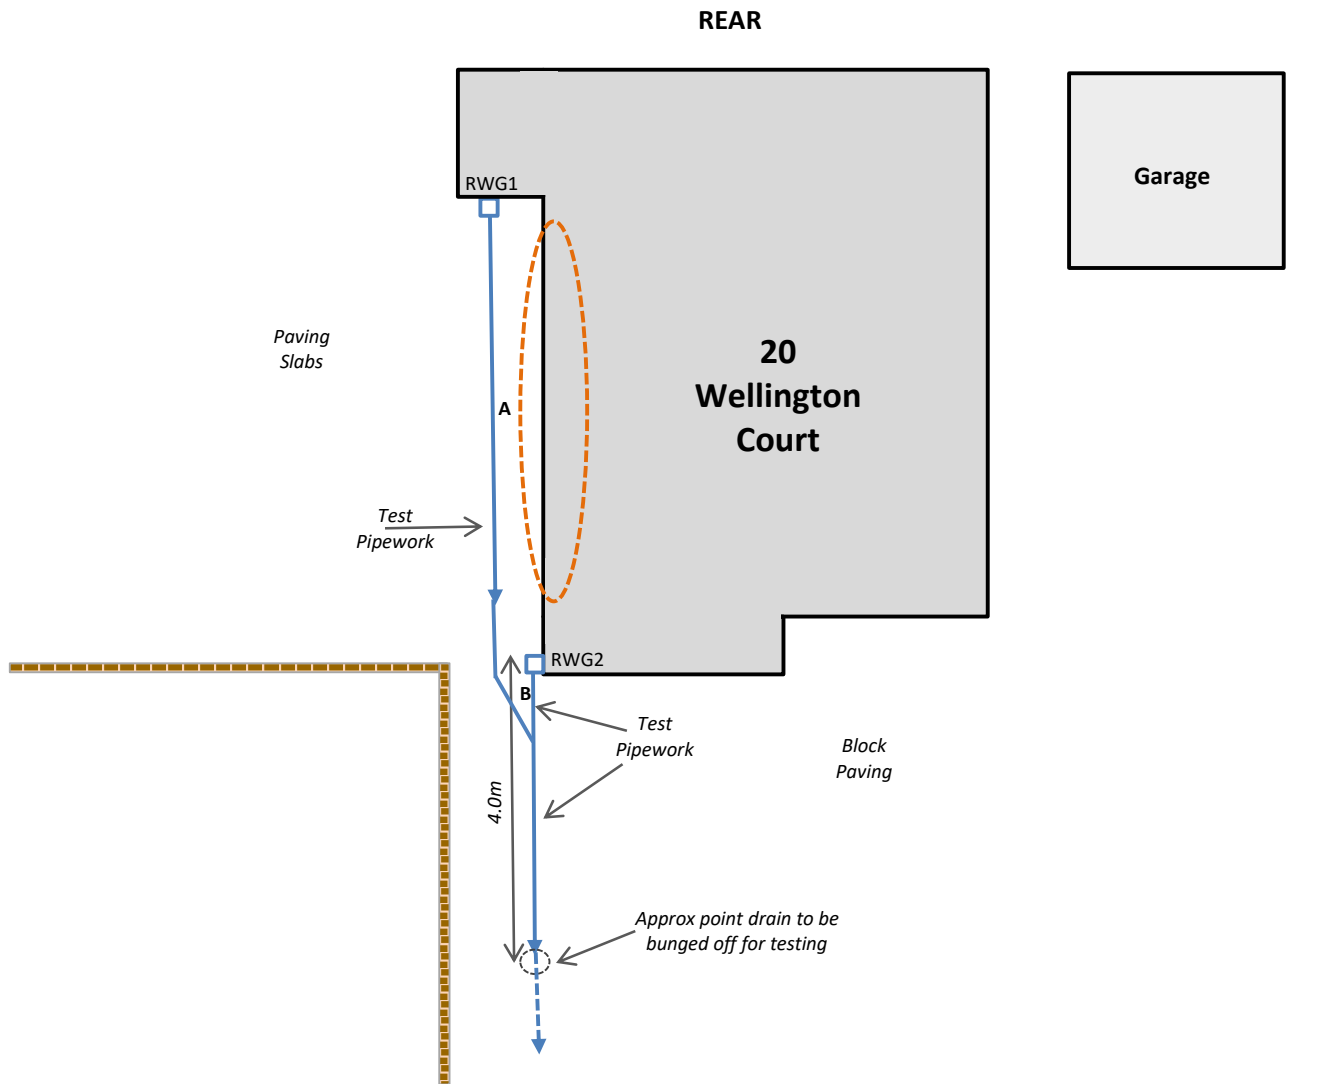
CCTV Survey Result: Structural damage

Excavate and replace the junction noted at 6.4m together with a section of pipework downstream
