Bat Survey to  
Kirkgate Surgery  
Kirkgate  
Birstall  
WF17 9HE

7<sup>th</sup> October 2021

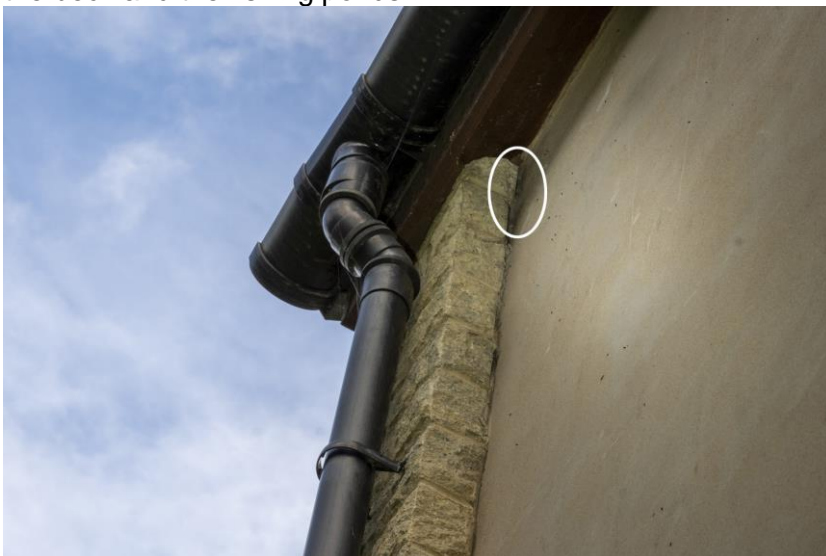
Plate 1 Location of bat roost

The north end of the building houses a fire escape stairway and forms a protruding tower of which the east and west elevations are cement rendered. The render on the west facing elevation is peppered with bat droppings which lead up to the very NW corner of the building where there is a gap where the stone and the render meet. This is almost not visible from the ground, but the droppings lead straight to it and there is dark staining on the render at the entrance. This is a classic spot for common pipistrelle bats which is most likely the species roosting here, though potentially Daubenton's could be a candidate too given the proximity to the beck and the fishing ponds.

The daytime scoping survey established that bats are roosting in a gap in the stonework high up on the NW corner of the building. There are droppings adhered to the walls and dark staining around the entrance of a gap which is about 150mm x 50mm where the rendered west wall meets the facing stone of the north wall. This is a classic roost site favoured by common pipistrelle bats. There are plenty of droppings adhered to the walls which indicates that the roost was in use at some point during the current season. It is not possible to determine if this was a nursery roost or is used by a small number of non-breeders, though nursery roost is more likely. It is also not possible to determine the species of bat without DNA analysis of the droppings or by observing the emergence at the appropriate time of year when catching in a static net would also be possible. It is most likely to be common pipistrelle though two other species can't be ruled out.

Work	Specification
Timing of the works to minimise risks	The works to tie into the existing walls will be undertaken between October to the end of March inclusive. This will reduce the likelihood of bats being present during the works.
Measures to provide alternative roosting sites	The following mitigation measures will be strictly adhered to: <ul style="list-style-type: none"> <li>• Prior to commencement of works, a Schwegler Universal summer bat house 1FTH will be erected</li> <li>• The bat box will be positioned on the SW corner away from the proposed works and be placed high up under the eaves</li> <li>• The box will remain in situ for at least three years to provide both an alternate roosting site and an increase in roosting opportunities</li> </ul>

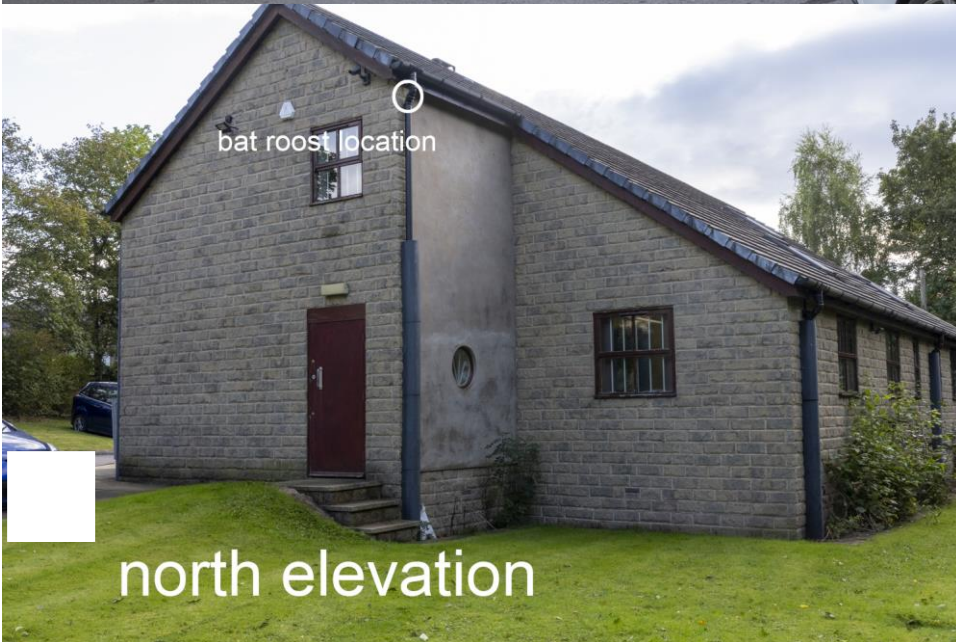
bat roost location

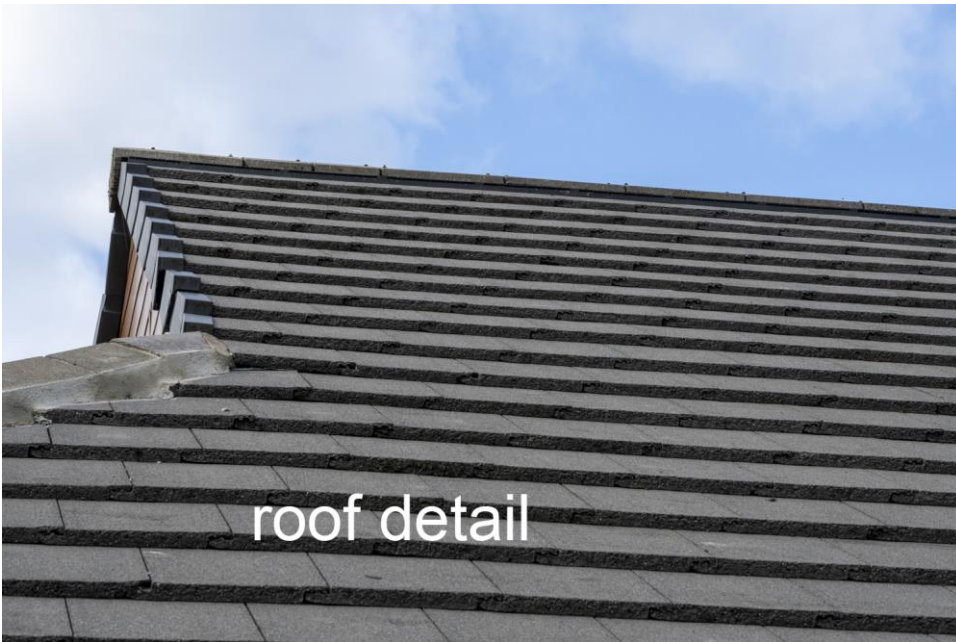
roof detail

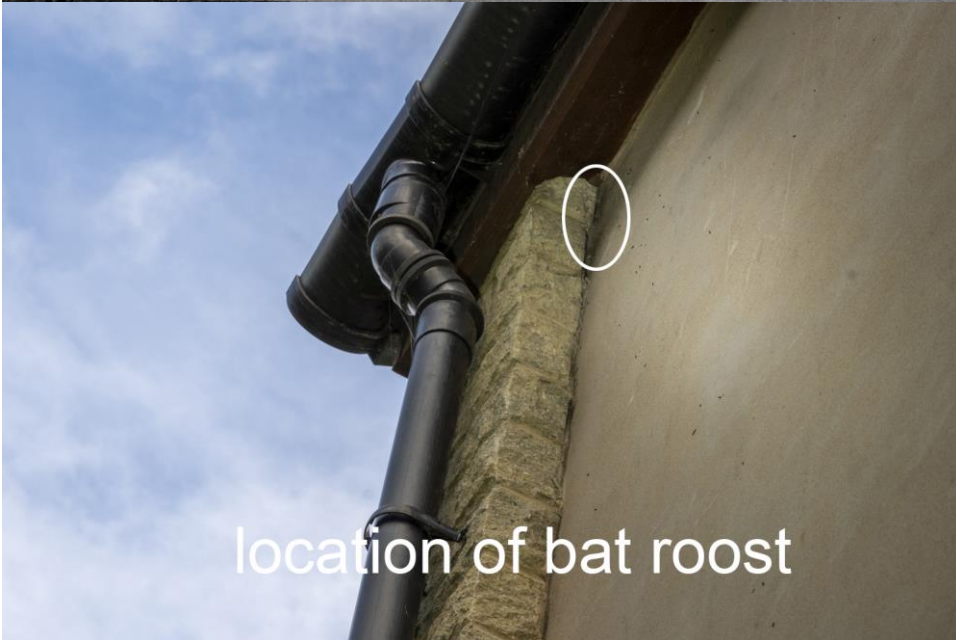
- 1.2 The preliminary roost assessment survey was carried out on 7<sup>th</sup> October 2021 and established that a bat roost is present on the NW corner of the building. The roost is located high up, just below the eaves, where a gap exists between the stonework of the north wall and the render on the west wall.

location of bat roost
