GeoShield Verification Report

PROJECT REFERENCE: GEO103300

PROJECT: Leeds Road, Mirfield

AREA SURVEYED: Plots 7 & 8.

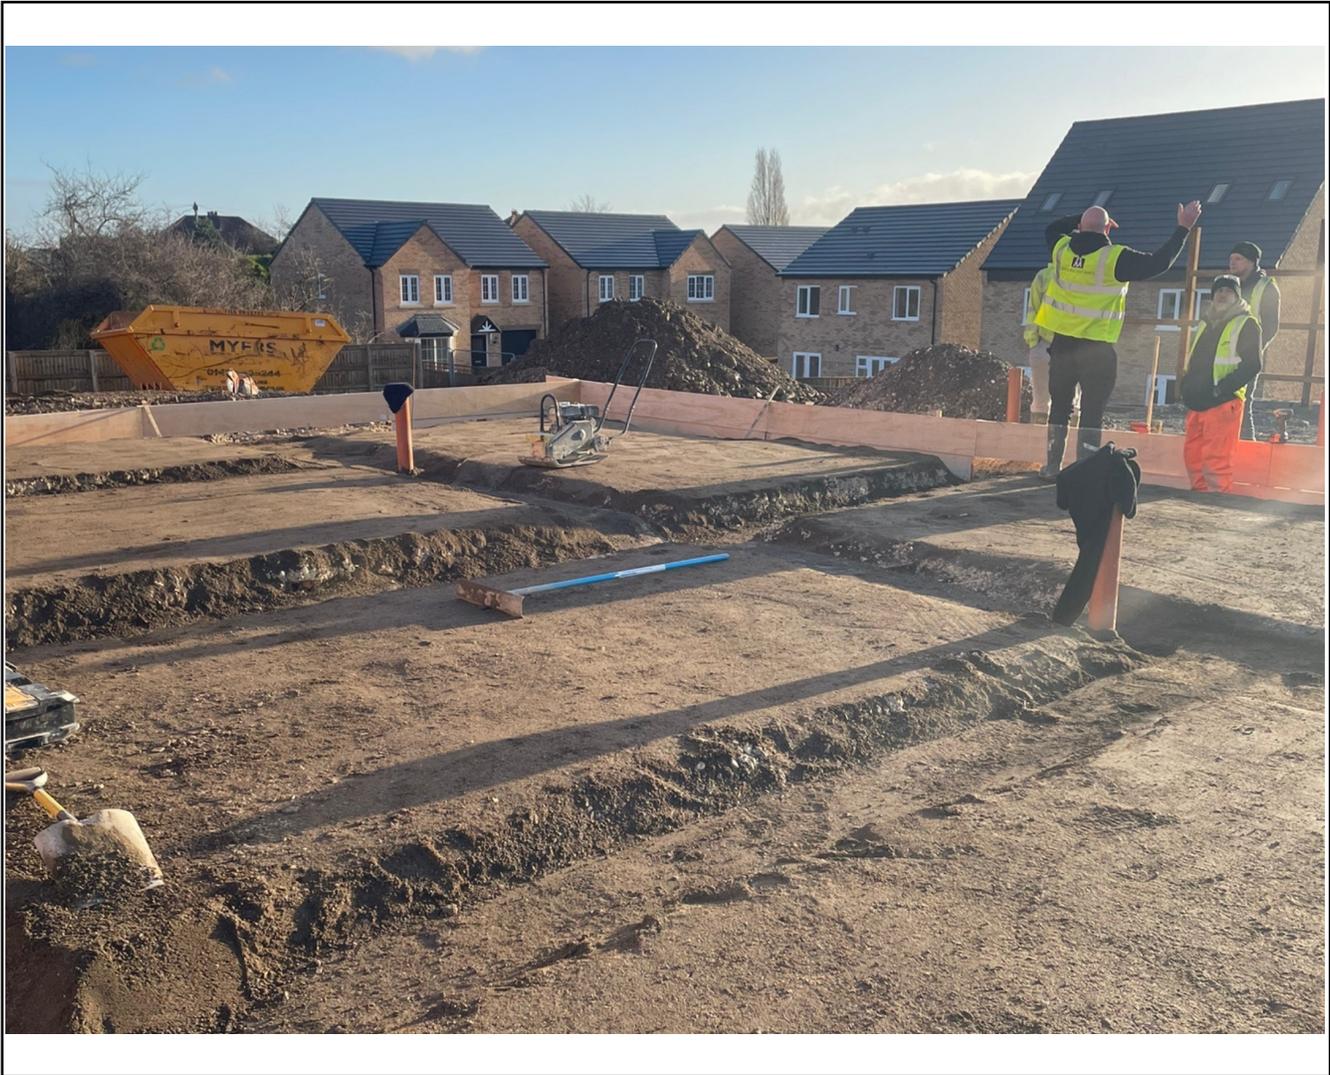
Overview showing substrate being prepared to Plots 7 & 8

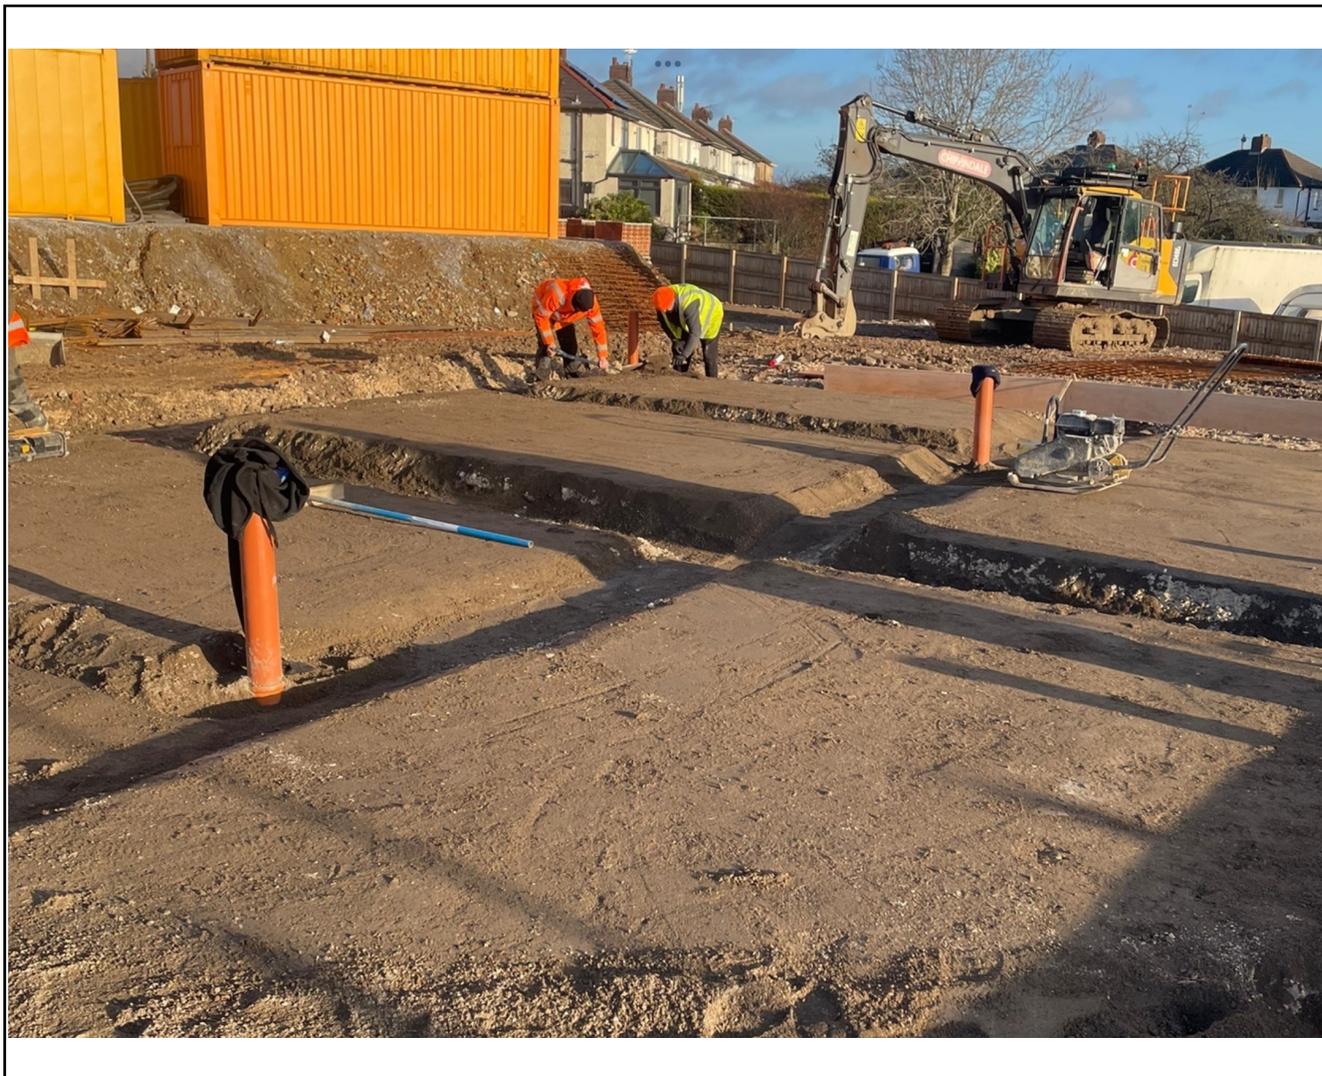
Alternative overview showing substrate being prepared to Plots 7 & 8

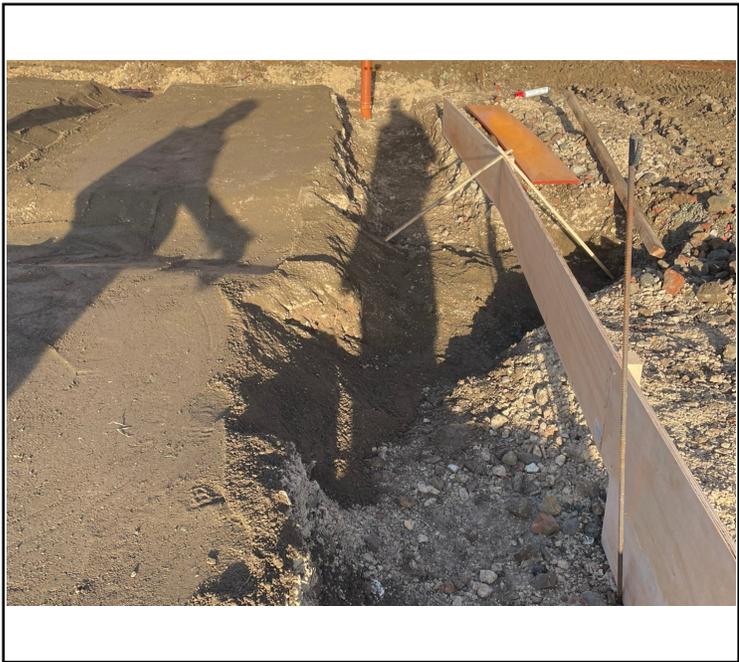
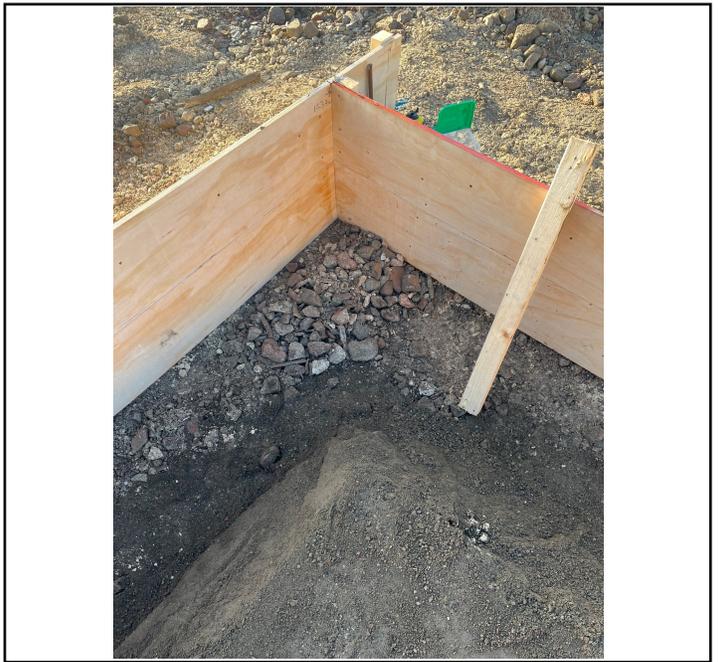
VERIFICATION ITEM ONE

NOTES: Perimeter Thickening Preparation

The images show the extent of the prepared substrate to the perimeter thickening where the proposed tool box tank was to be undertaken. The area was unfortunately incomplete where there was quite a lot of stone lining the trench thickening which would not be

suitable to install the Rhinoplast TGB upon. In addition, the perimeter formwork was not

complete either especially in the left image where there were large gaps beneath.

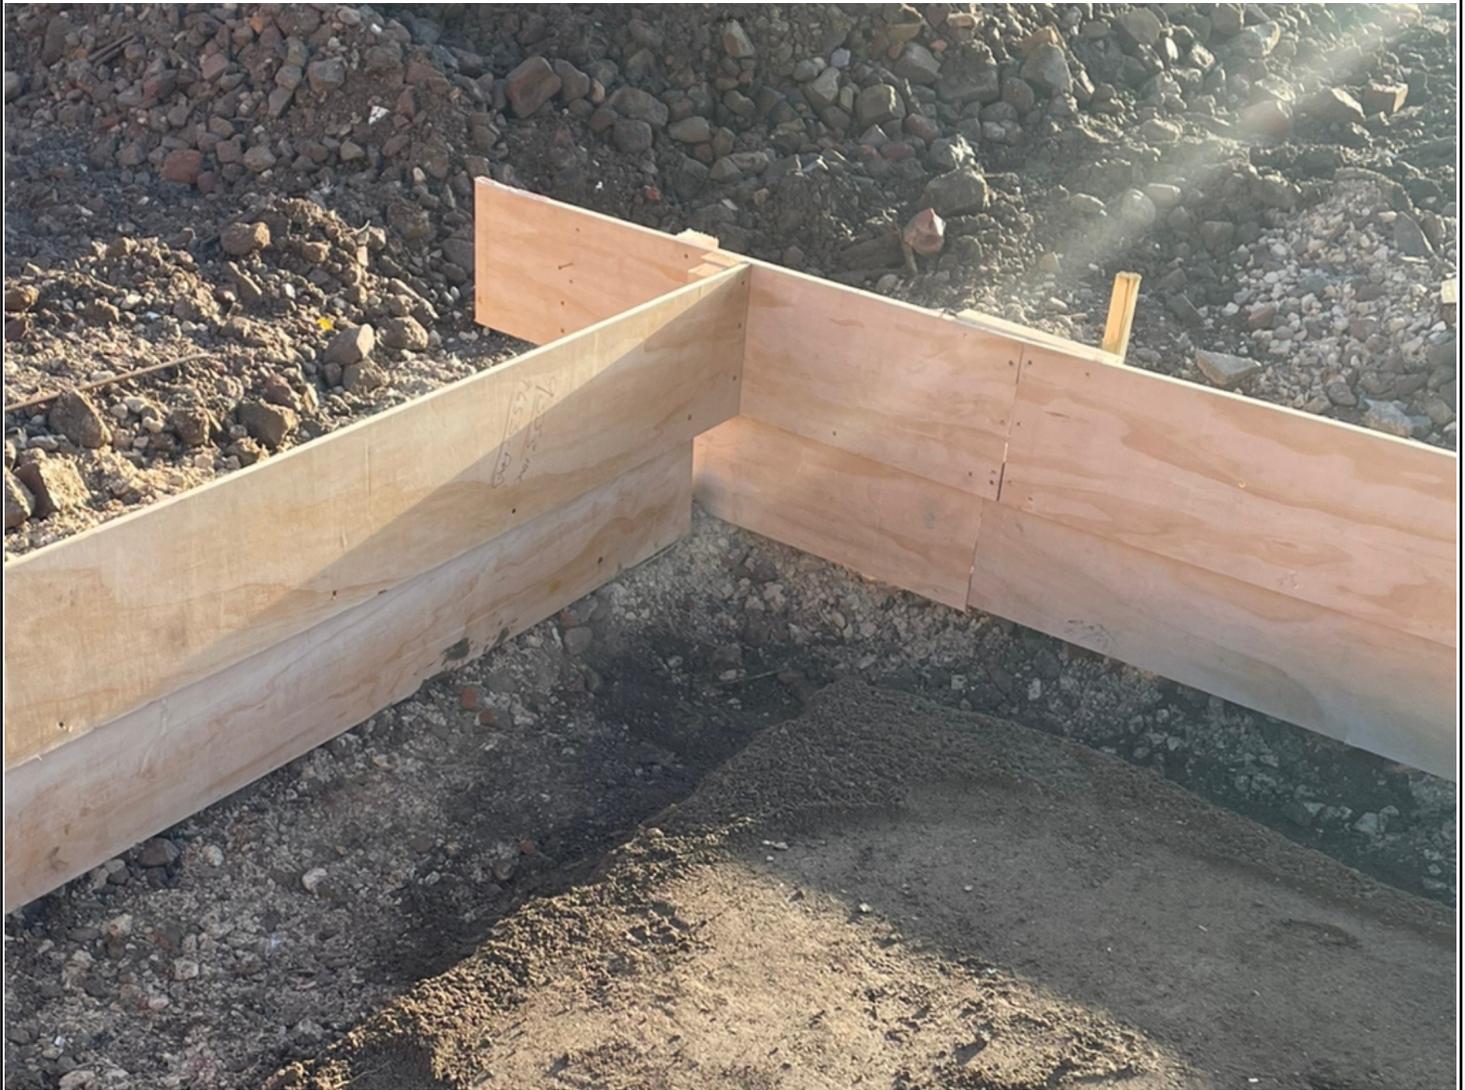
The overview image shows formwork at the corner of Plot 7 where the substrate within the thickening trench was far from complete and further preparation required. This was explained to both Andy Butterworth and Aiden McCrystal who were concerned that the further preparation works would hinder placing the Rhinoplast by close 21/12/2023

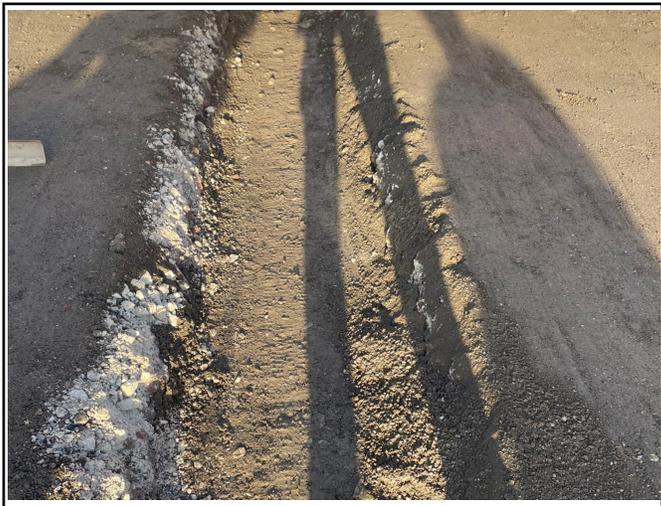
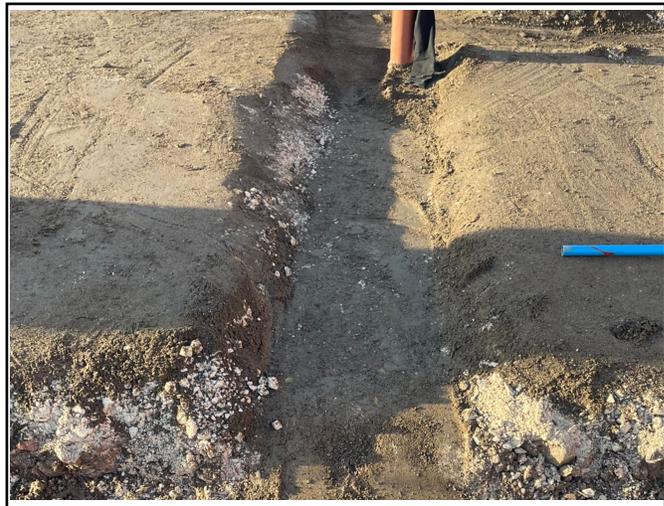
VERIFICATION ITEM TWO

NOTES: Internal Thickening Preparation

The two images show the extent of the internal thickenings where like the perimeter thickenings, un-prepared. The main issues was the amount of stone lining the battered sides of the thickening trench and further sand blinding would be required to line these

areas before any of the Rhinoplast TGB could be completed. The issues surrounding the amount of preparation works still required would mean the Rhinoplast TGB could not possibly have been installed by close on 21/12/2022 including verification. This prompted a discussion as to an alternative solution because the concrete pour was planned for 22/12/2022 and time was against the proposed inexperienced installers.

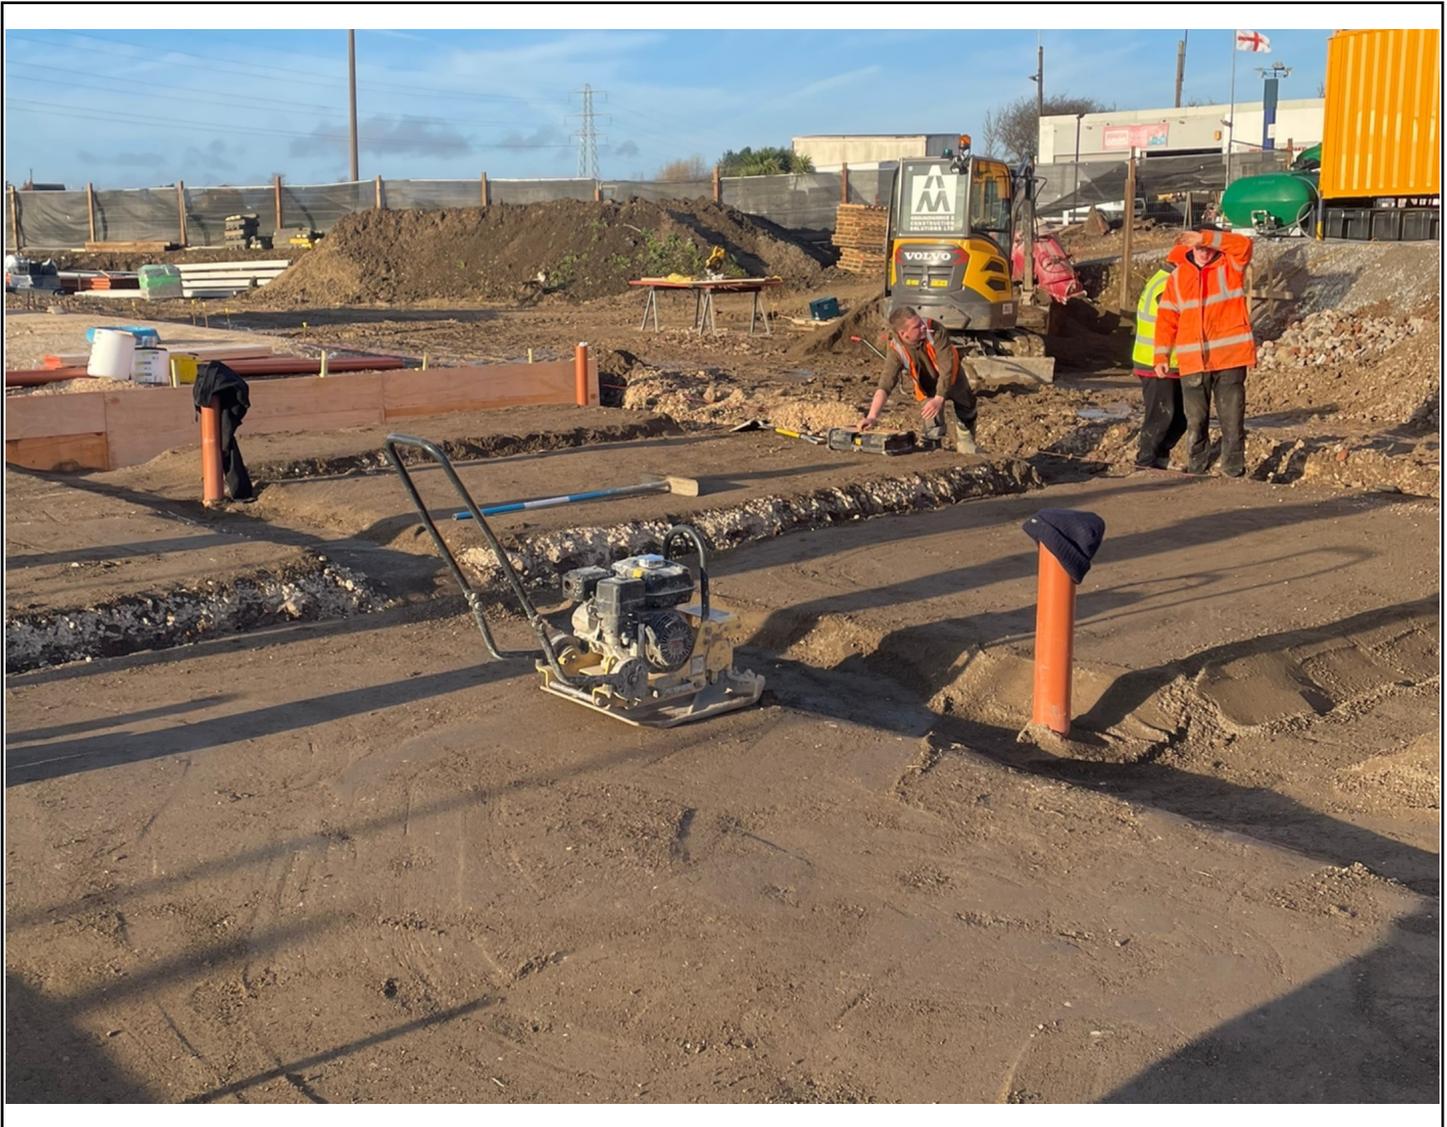
The overview image shows the general substrate area which was being prepared

in readiness for the Rhinoplast TGB. The areas above the thickenings were

more or less completed where the sand blinding had been placed and compacted

and would have been suitable to place the Rhinoplast TGB.
