GeoShield Verification Report

PROJECT REFERENCE: GEO103300

PROJECT: Leeds Road, Mirfield

AREA SURVEYED: Plots 11 & 12 (Perimeters and Party Wall)

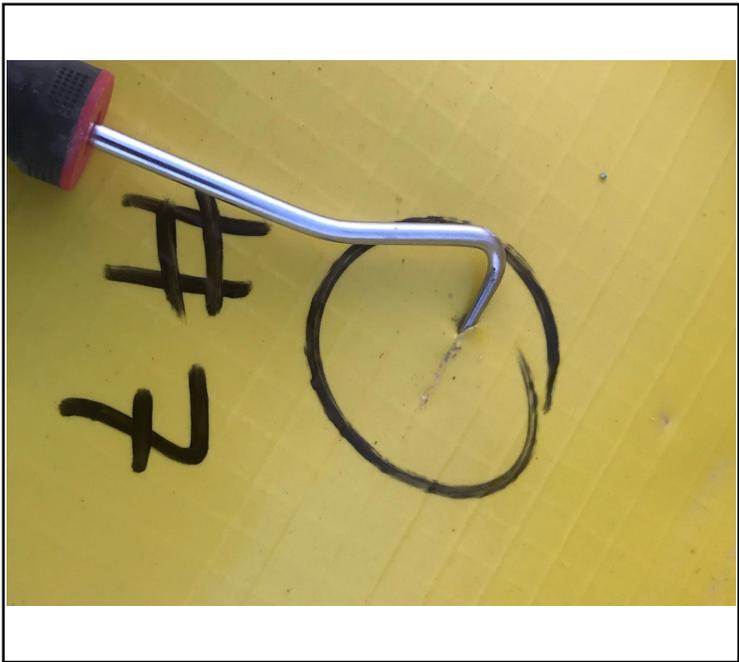
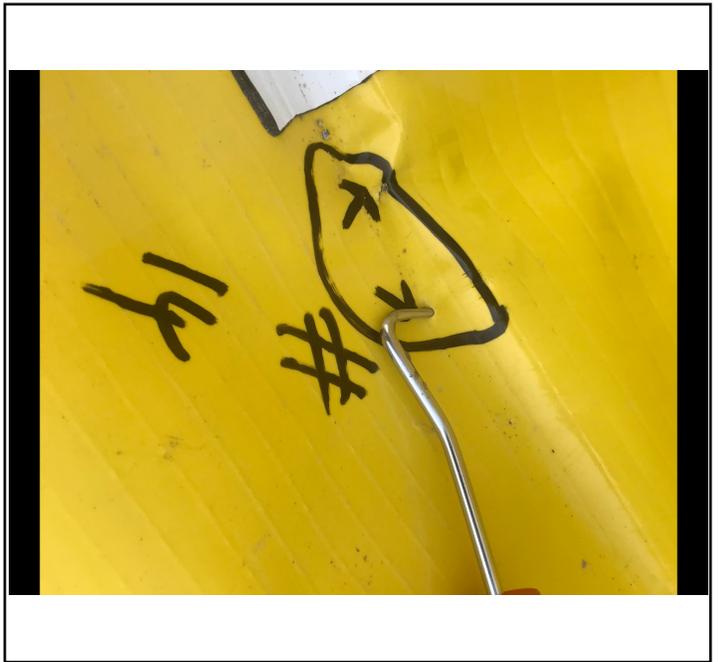
VERIFICATION ITEM ONE

NOTES: Rhinoplast Total Gas Barrier Installation-Damage

The Rhinoplast Total Gas Barrier had been installed around the perimeter of and along the party wall position. The initial inspection was to identify any potential damage where a total of fourteen punctures were identified along the perimeter of both plots. There were

no punctures identified along the strip of Rhinoplast TGB. The punctures looked to have

been caused by bricks which had fallen onto the Rhinoplast TGB following installation.

All remediations were all completed to Plots 11 & 12 this report.

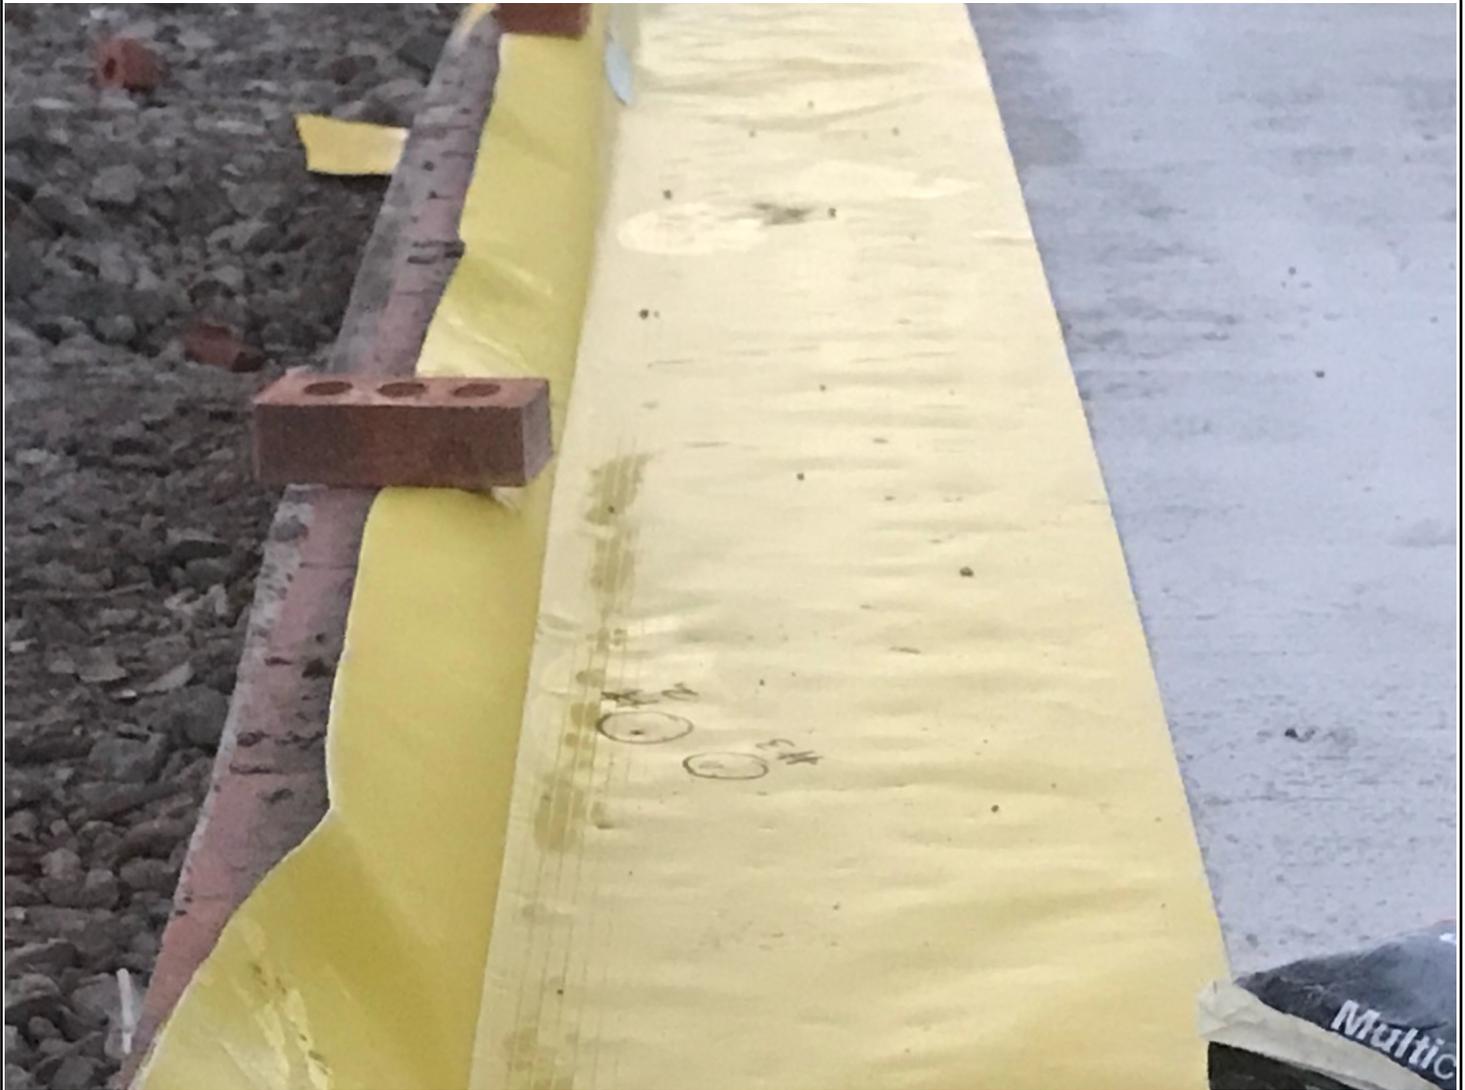
VERIFICATION ITEM ONE

The overview image shows a section of the Rhinoplast TGB along the perimeter. It was

noted that the bricks used to help keep the Rhinoplast TGB in position had been either

knocked off or they slipped off the perimeter brickwork. Either way, the bricks had

caused the fourteen punctures identified during the verification visit this report.

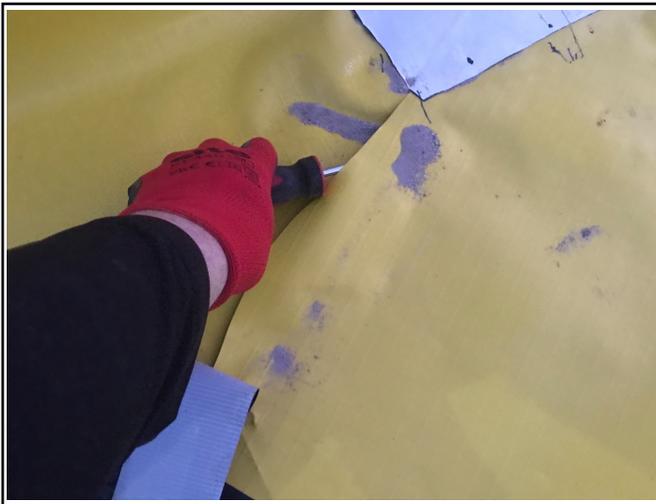
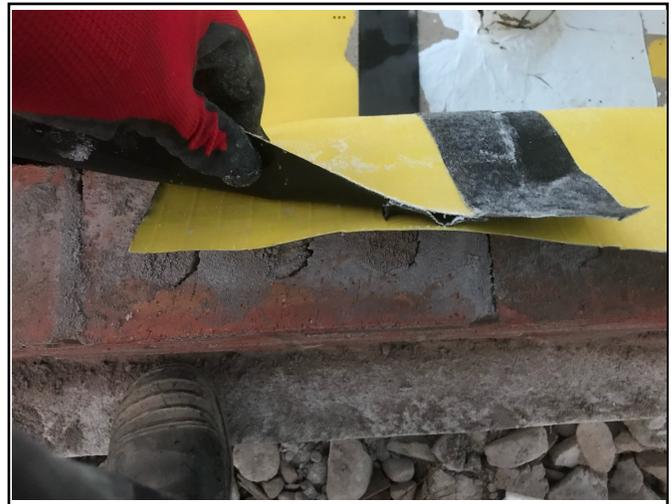
VERIFICATION ITEM TWO

NOTES: Rhinoplast Total Gas Barrier Installation-Lap Joints

The various Rhinoplast Total Gas Barrier lap joints were all dual sealed combining both the Rhinoplast LT Joint Strip and the Rhinoplast High Tack Girth Tape. The left image shows where the Rhinoplast LT Joint Strip was exposed by carefully peeling

back the Rhinoplast High Tack Girth Tape. The Mechanical Point Stress Test

was then undertaken which identified the Rhinoplast LT Joint Strip had been used

providing the required seal. The right image shows the completed lap joint

terminating at the perimeter. It was evident that the minimum required lap of 150mm

had been achieved and the dual tape system was adopted to complete the lap joint

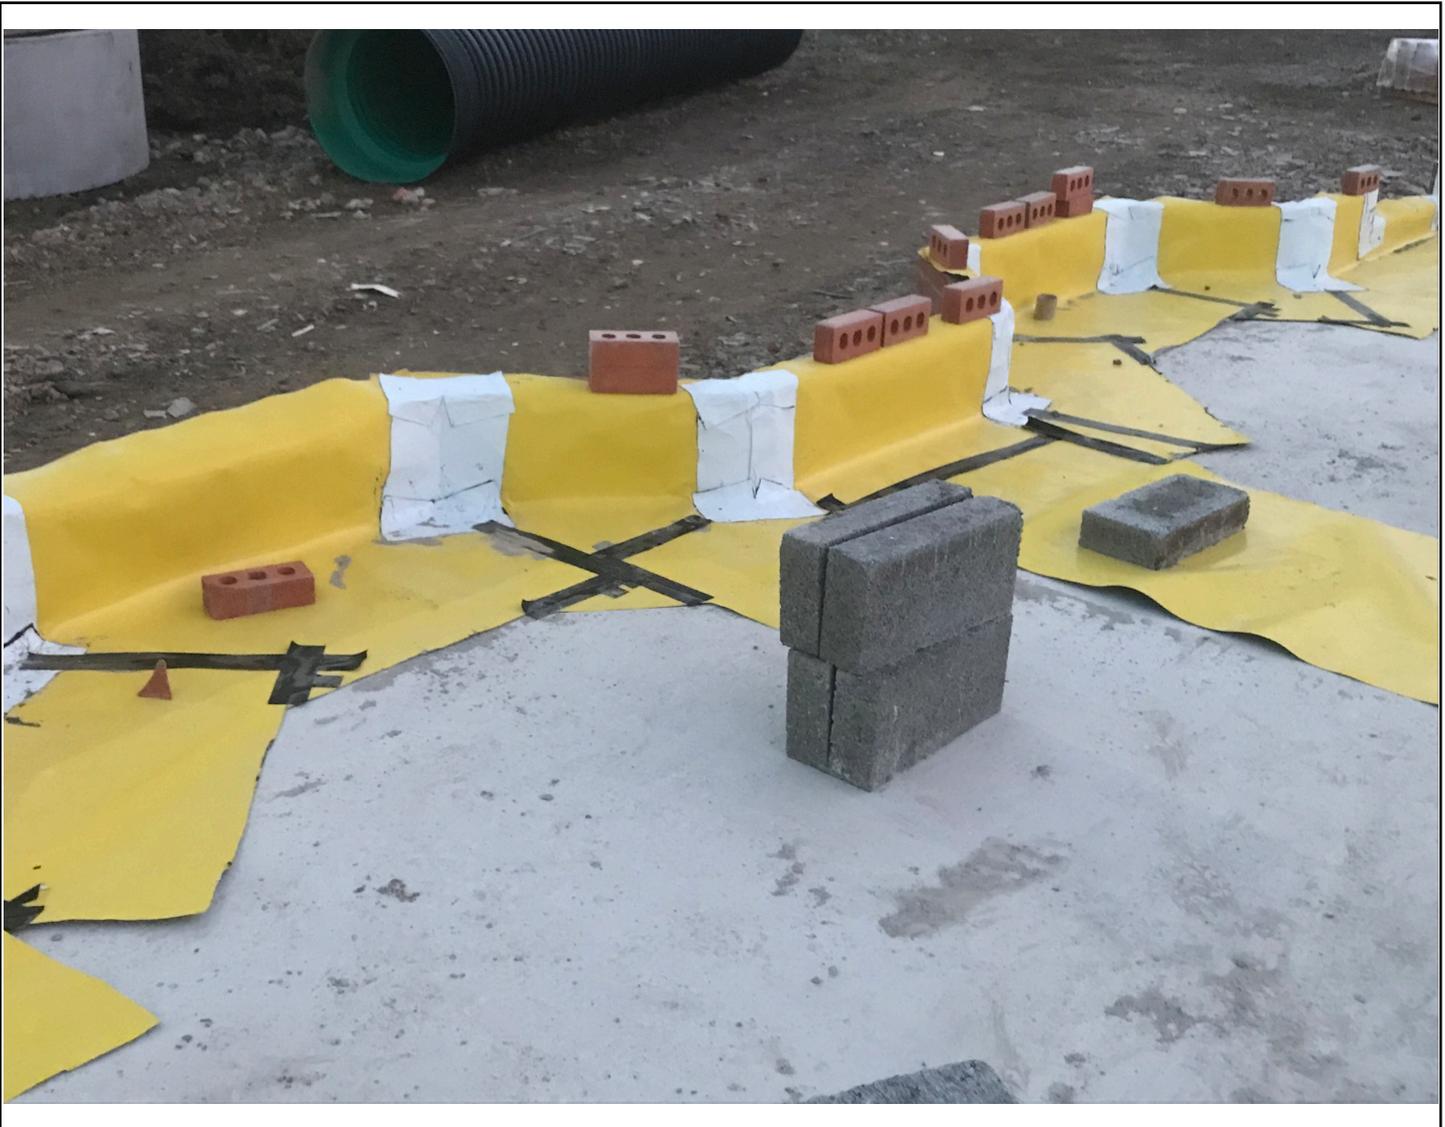
VERIFICATION ITEM TWO

The overview image shows one of two elevations where the majority of the

Rhinoplast Total Gas Barrier lap joints were completed.

The lap joints were inspected from either beneath or by sampling the lap joint

as reported above and no issues were identified during the verification.

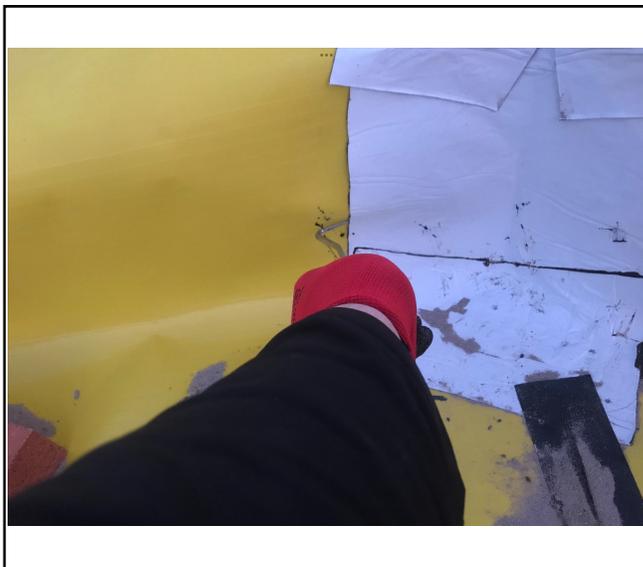
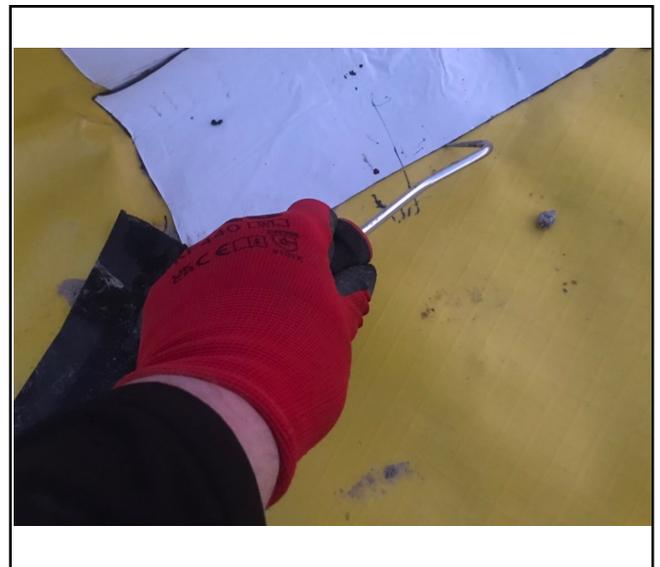
VERIFICATION ITEM THREE

NOTES: Internal Corner Detailing

The various reveals and internal corners were all sealed using strips of Gas Resistant Detail Strip to ensure a complete seal. The initial inspection noted that the Gas Resistant Detail Strip had been securely adhered to the Rhinoplast TGB where the

heat applied activated the bitumen backing which in turn improved the adhesion properties especially when pressure applied during the installation.

The images also show the Mechanical Point Stress Test being undertaken along the edges of the Gas Resistant Detail Strip where no capillary leaks were identified

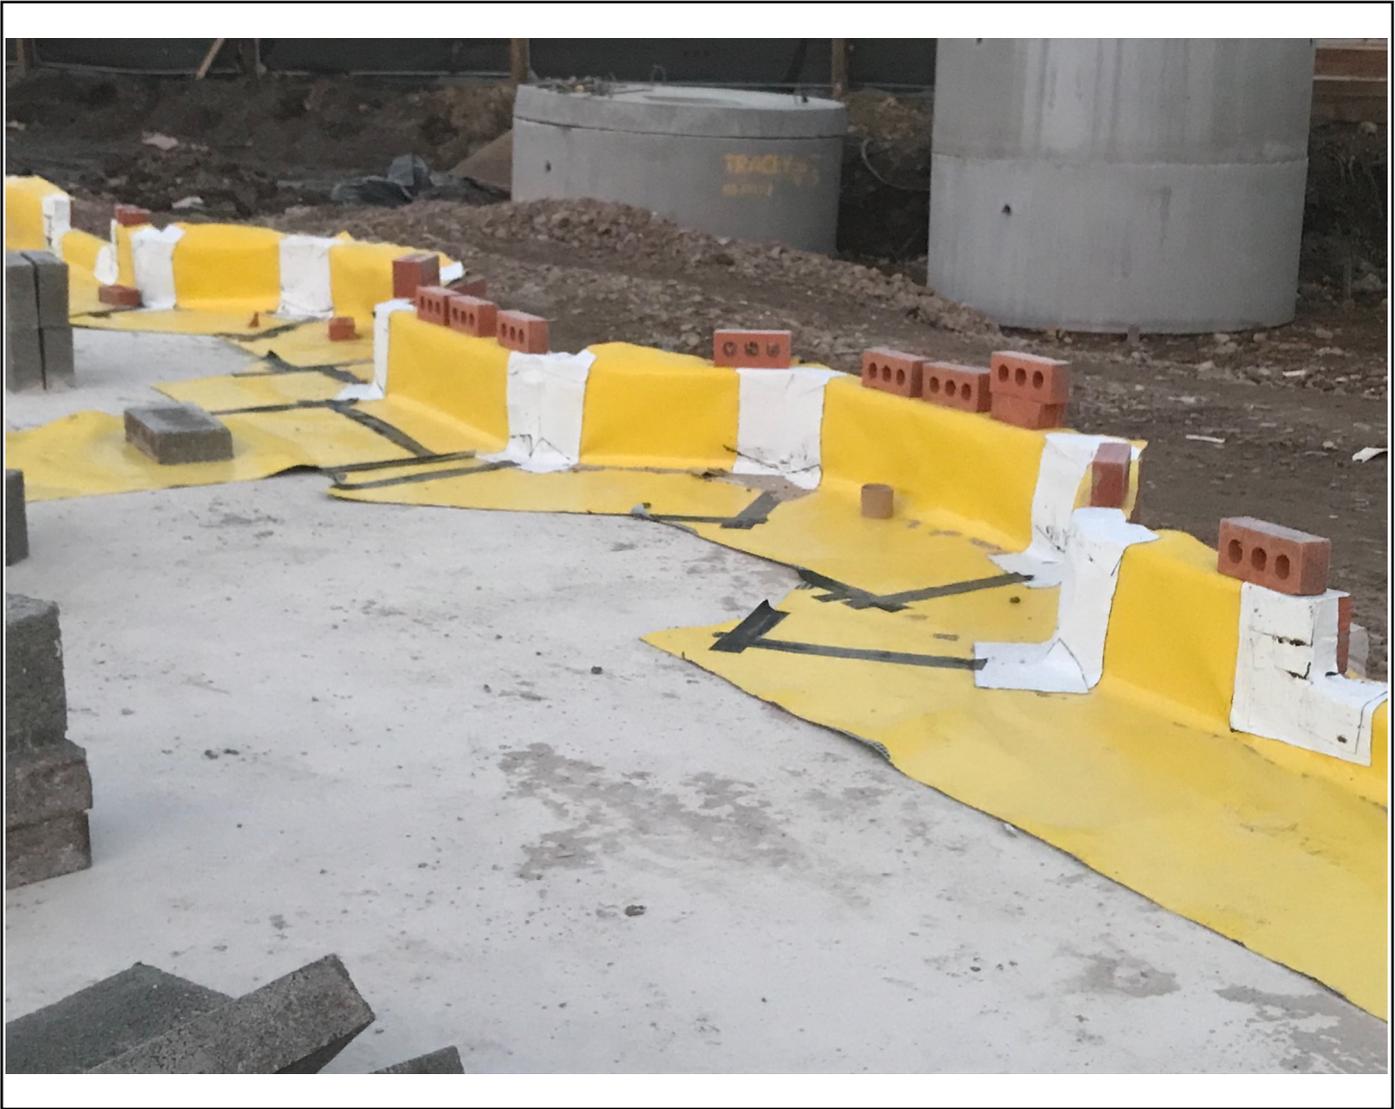
VERIFICATION ITEM THREE

The overview image shows the typical perimeter installation of the Rhinoplast

Total Gas Barrier where the various lap joints proved to be correctly sealed. The

internal/external corners and reveals were all successfully sealed using strips

of Gas Resistant Detail Strip.

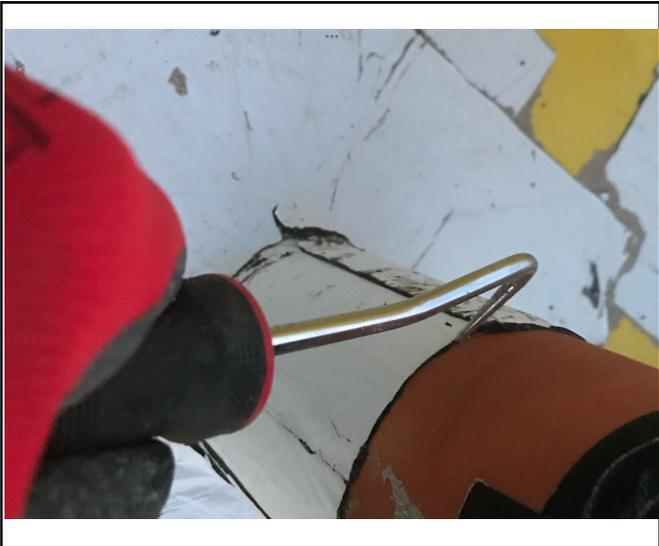
Mechanical Point Stress Test to

pipe penetration detailing

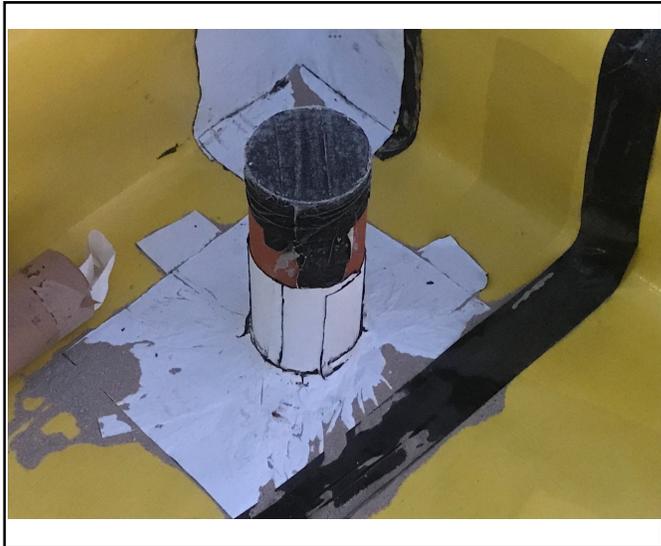
View of typical pipe penetration sealed

with Gas Resistant Detail Strip

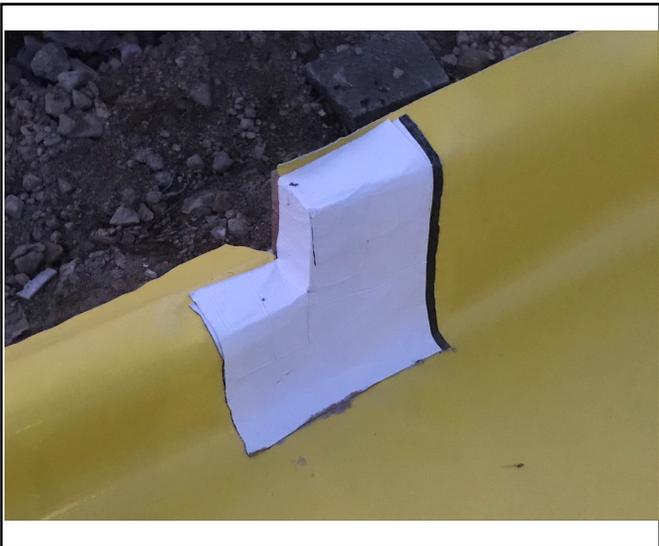
View of threshold/reveal sealed with

with Gas Resistant Detail Strip

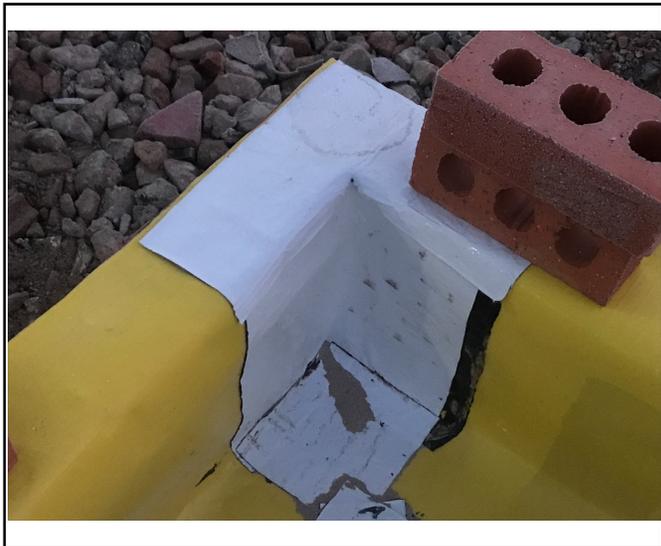
View of internal corner sealed with

with Gas Resistant Detail Strip
