INVESTIGATION FACTUAL REPORT

ADDRESS: 46 West Park Street, Dewsbury, WF13 4LD

OUR REF: HH/21/68187

SITE AND DRAINAGE LAYOUT

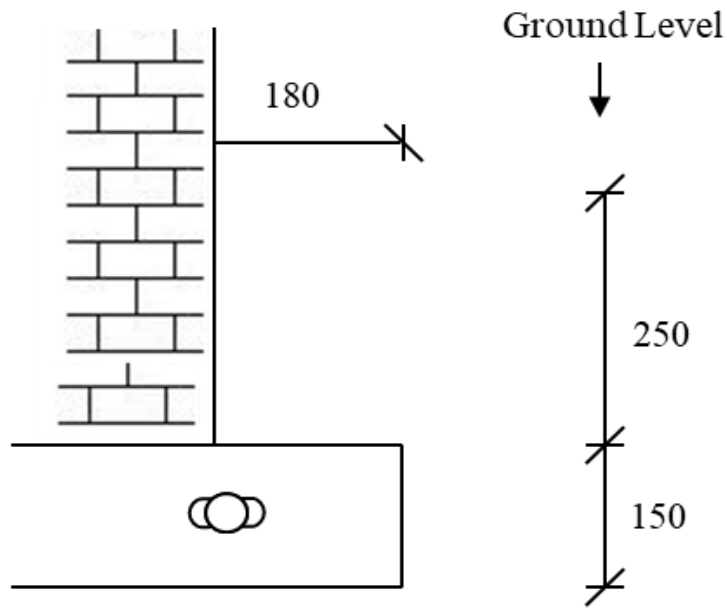
FOUNDATION PIT RECORD

For strata information, please refer to borehole log TPBH1.
