ADDENDUM INSURANCE REPORT
Retained

DATE OF ISSUE:	14 th March 2022
OUR REFERENCE NO:	72126981
YOUR REFERENCE NO:	74851548913
Eaton Gate Household Davies Group Ltd (Stoke) 2nd Floor, East Court Riverside Park Stoke-on-Trent Staffordshire ST4 4EY	46 West Park Street Dewsbury WF13 4LD

SUMMARY

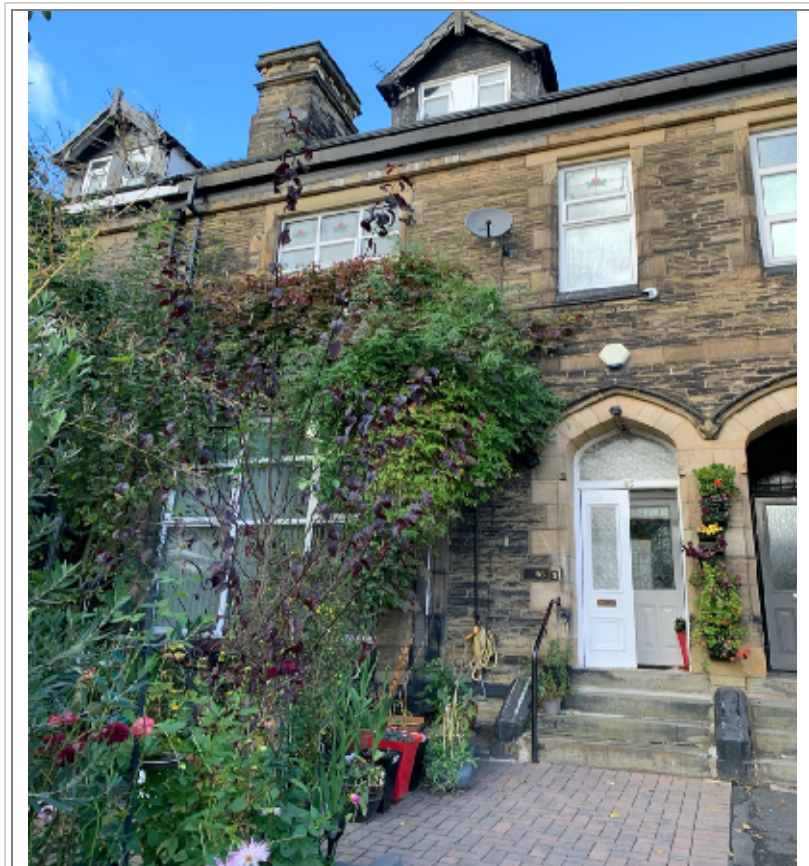
General view of property
