**CCTV REPORT FOR: 18 THE GREEN
HUDDERSFIELD
HD2 1QB**

Insured: Mr. A. & Mrs. E. Doherty
Reference: DLG-SN-22-004909 Ins Ref: 084336015

Site Visit: 20-Feb-23
Report Date: 25-Apr-23

Address: **18 THE GREEN, HUDDERSFIELD, HD2 1QB**

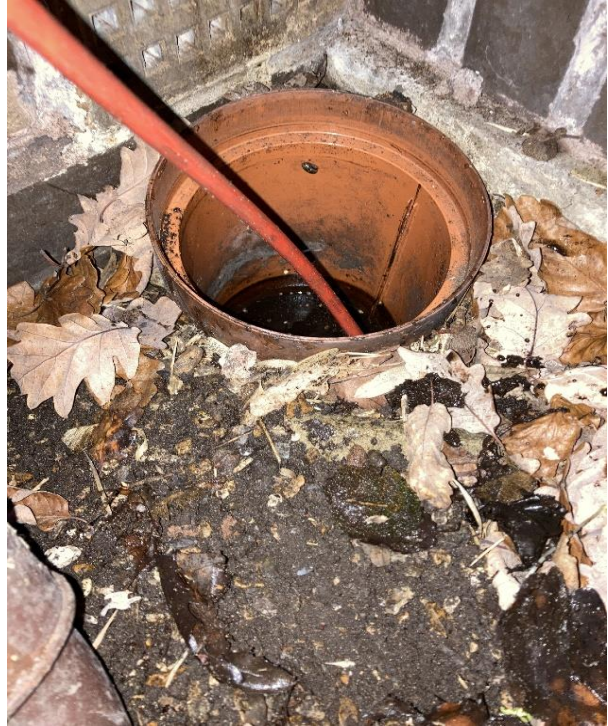
RWG1

Run 1 - Storm - Private:
No visible pipework defects.

No recommendations are required.

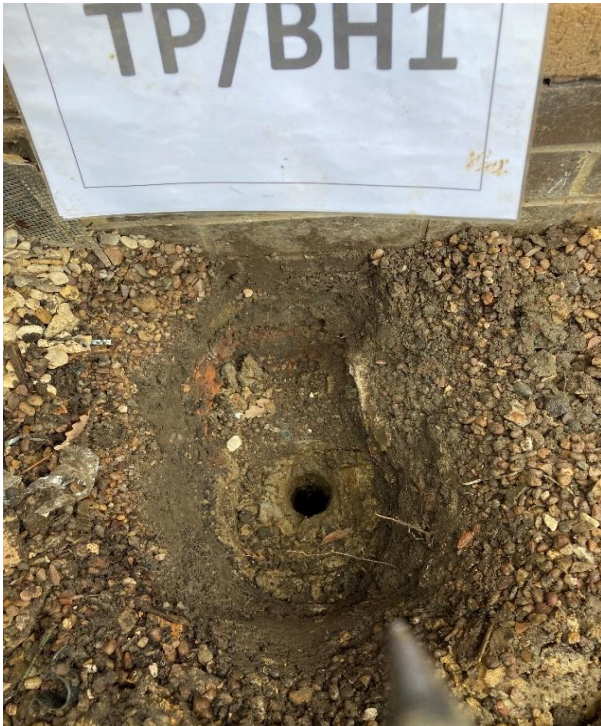
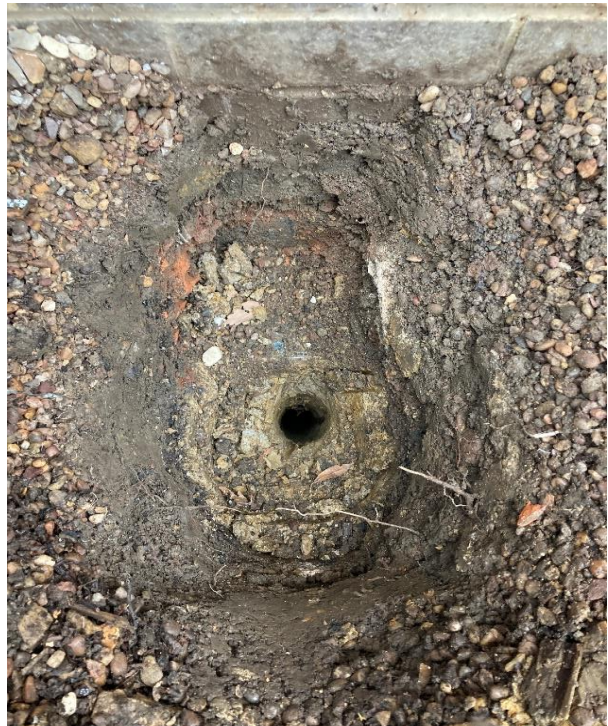
T/H1

General Comments :
 Ground was very dry in area of trial hole and difficult to auger.
