This is a section of the block plan, for planning application 2024-91236. It includes the bungalow (at 92), and the house planned for plot 23. The blue line has been added to show what should see looking down the side of the bungalow, from the back to the front. Note, all of the house at plot 23 is on the left-hand side of that blue line.

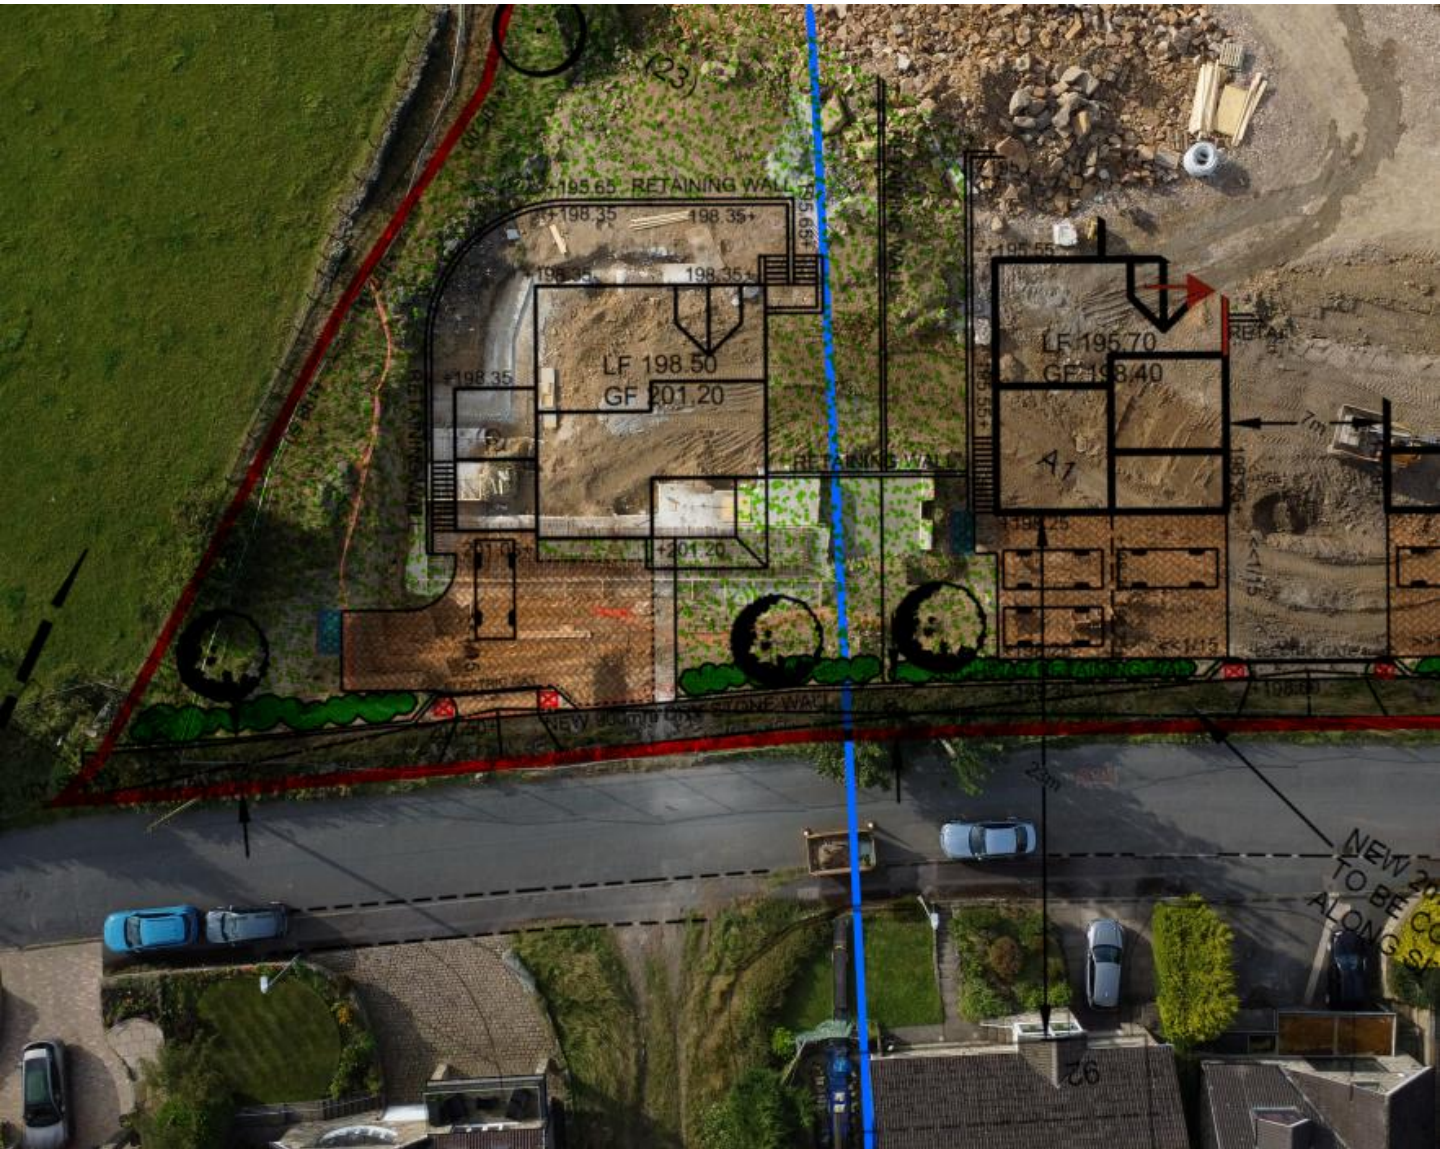
This is an aerial photograph, with the block plan superimposed. It shows where I believe the new house on plot 23 should be built.

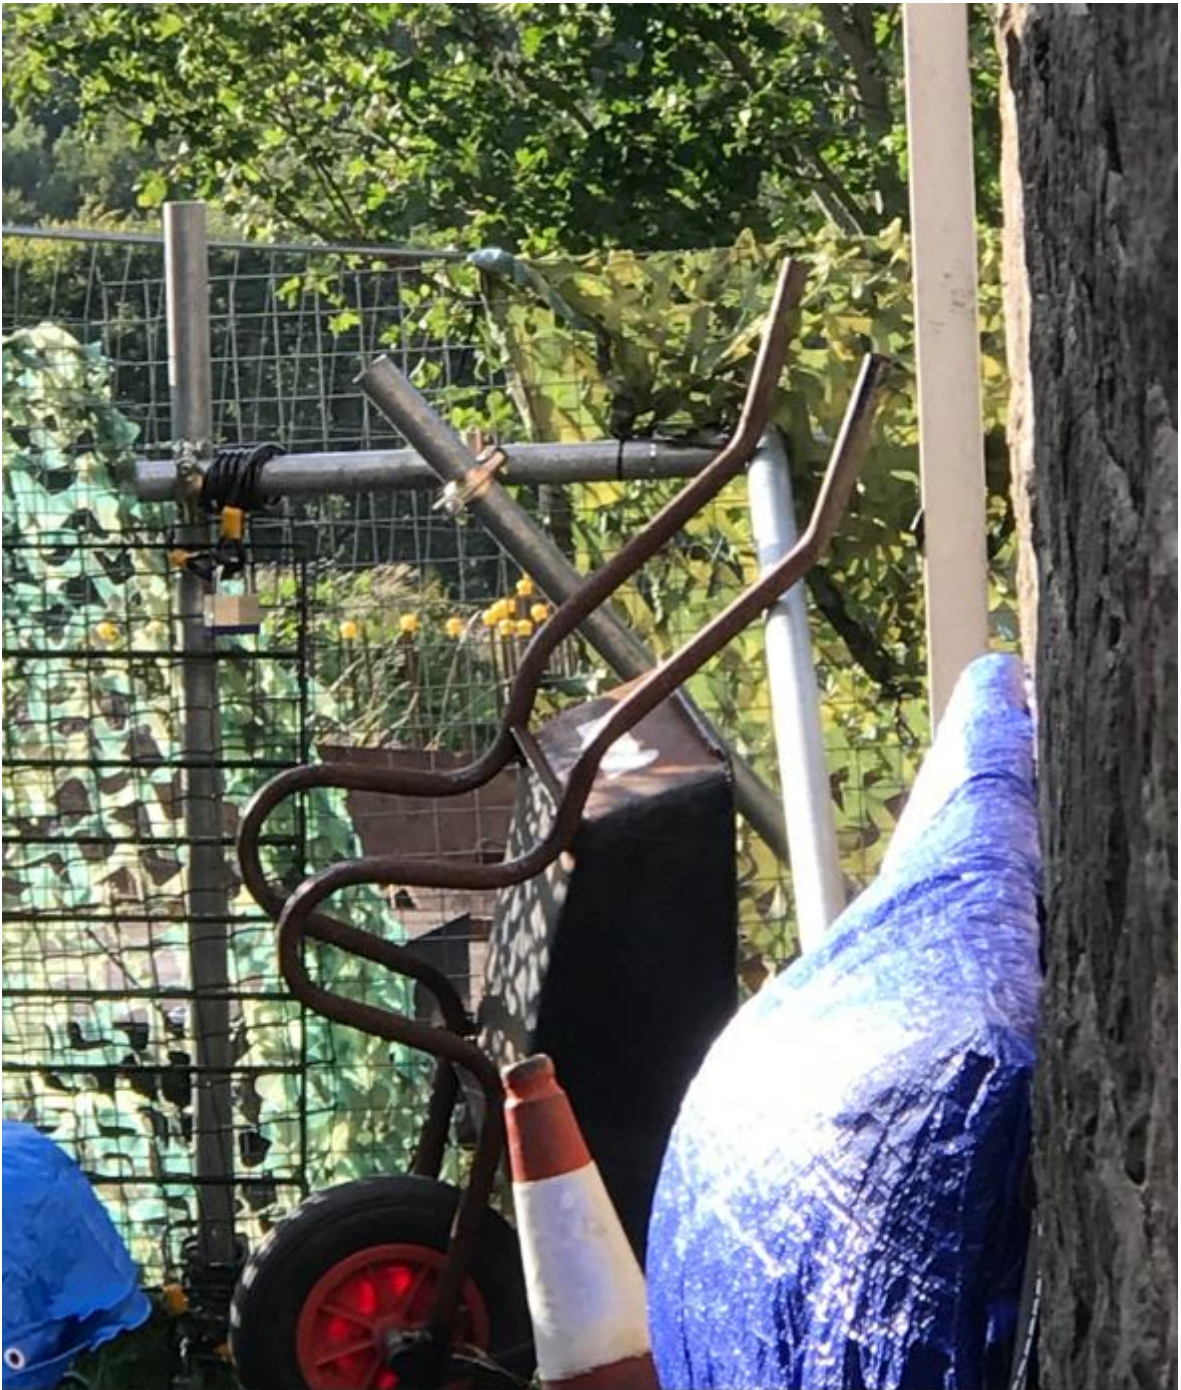
This is the actual gable end of the bungalow, looking back to front. It ought to follow the blue line from the previous page. If you look beyond the wheelbarrow, through the fence, you will see yellow caps, on top of the rebar, on the site opposite. That is the end point of the rebar, where it stops running parallel with the road, and heads in to the site.

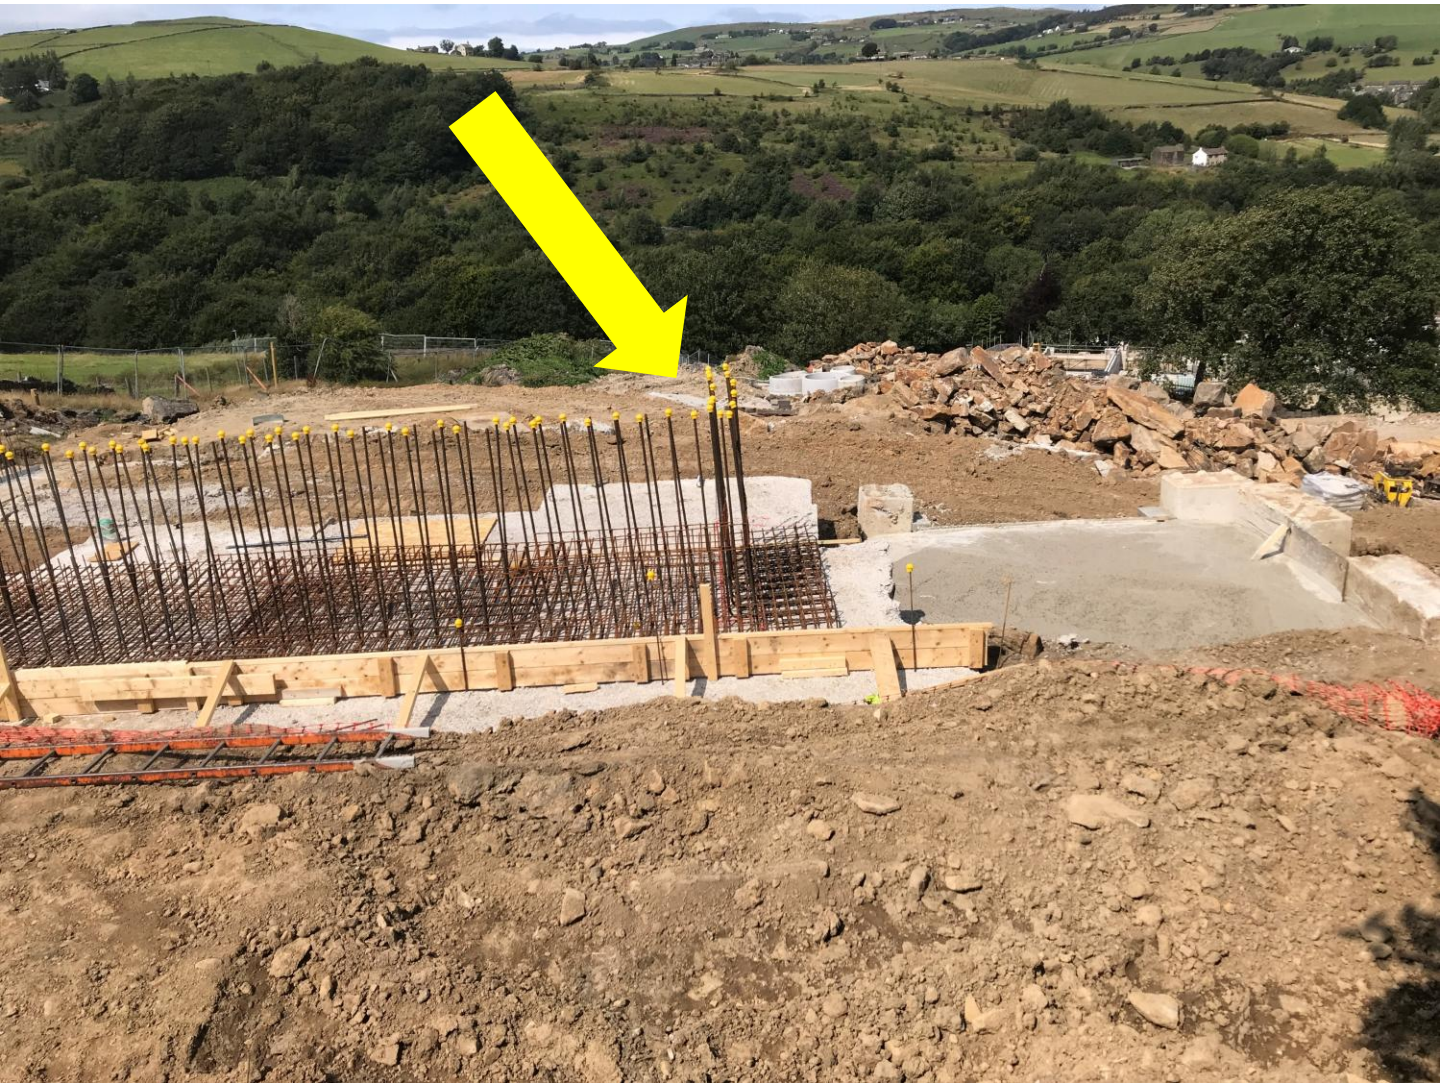
The yellow arrow points to the same yellow caps seen on the previous page.

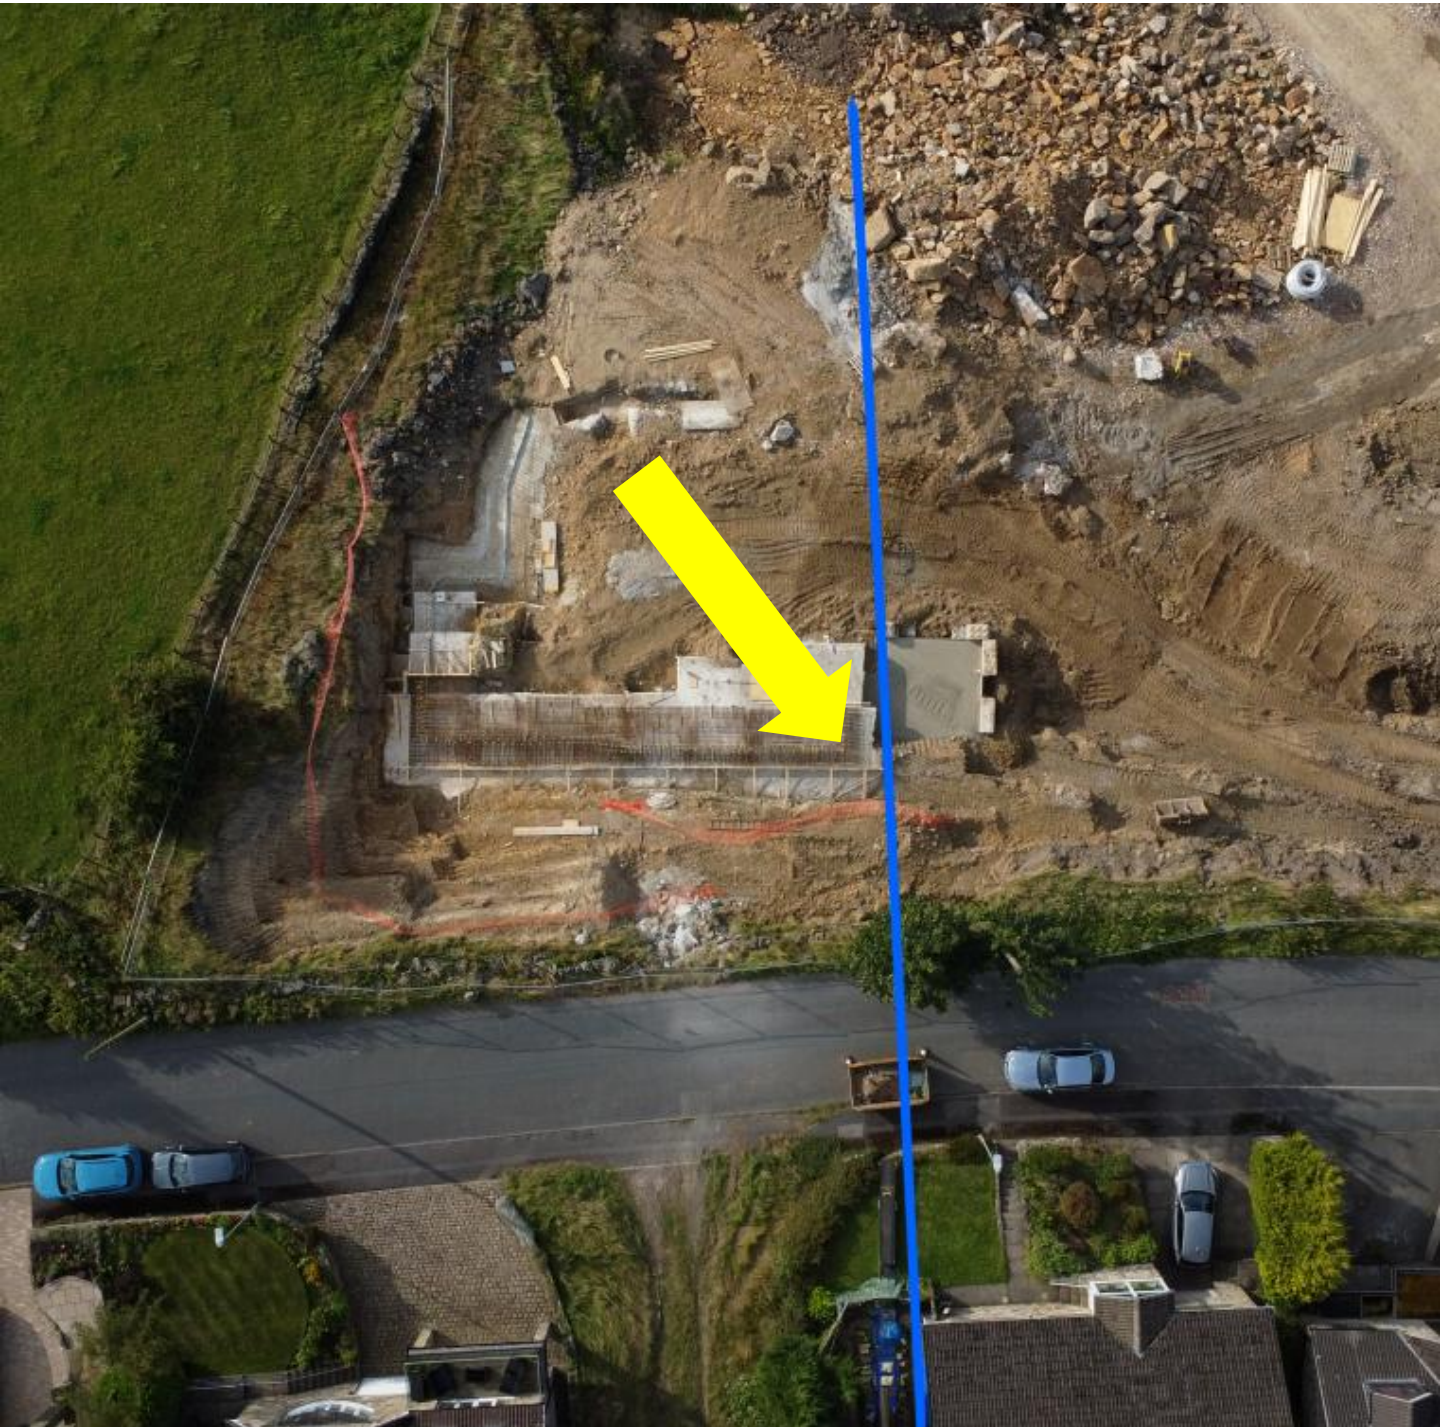
This is an aerial photo, taken yesterday, showing the same blue line as mentioned previous. I have added a yellow arrow that shows where the rebar ends, and turns in to the site. This is the same rebar seen on the previous page.

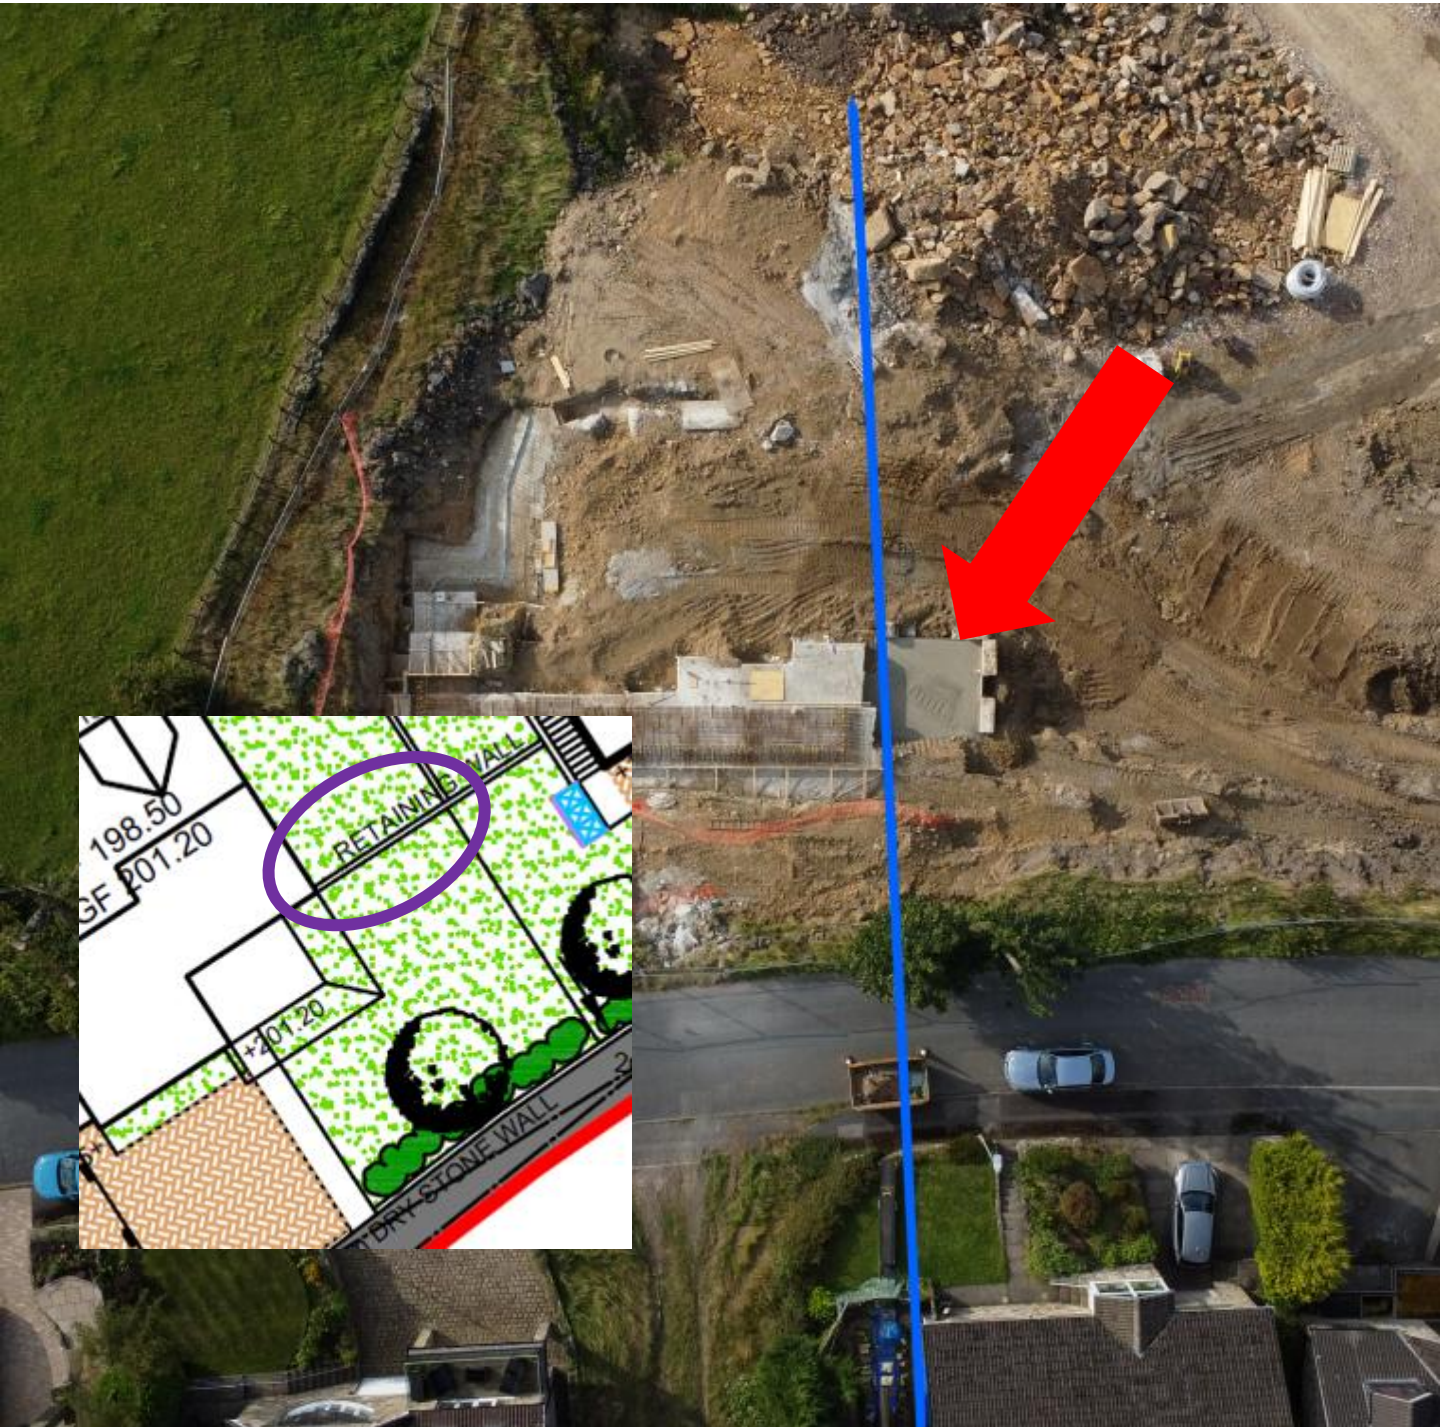
I previously thought the concrete pour, pointed to by the red arrow, was (an over engineered base) part of the retaining wall, shown in the inset picture (identified by the purple ellipse).

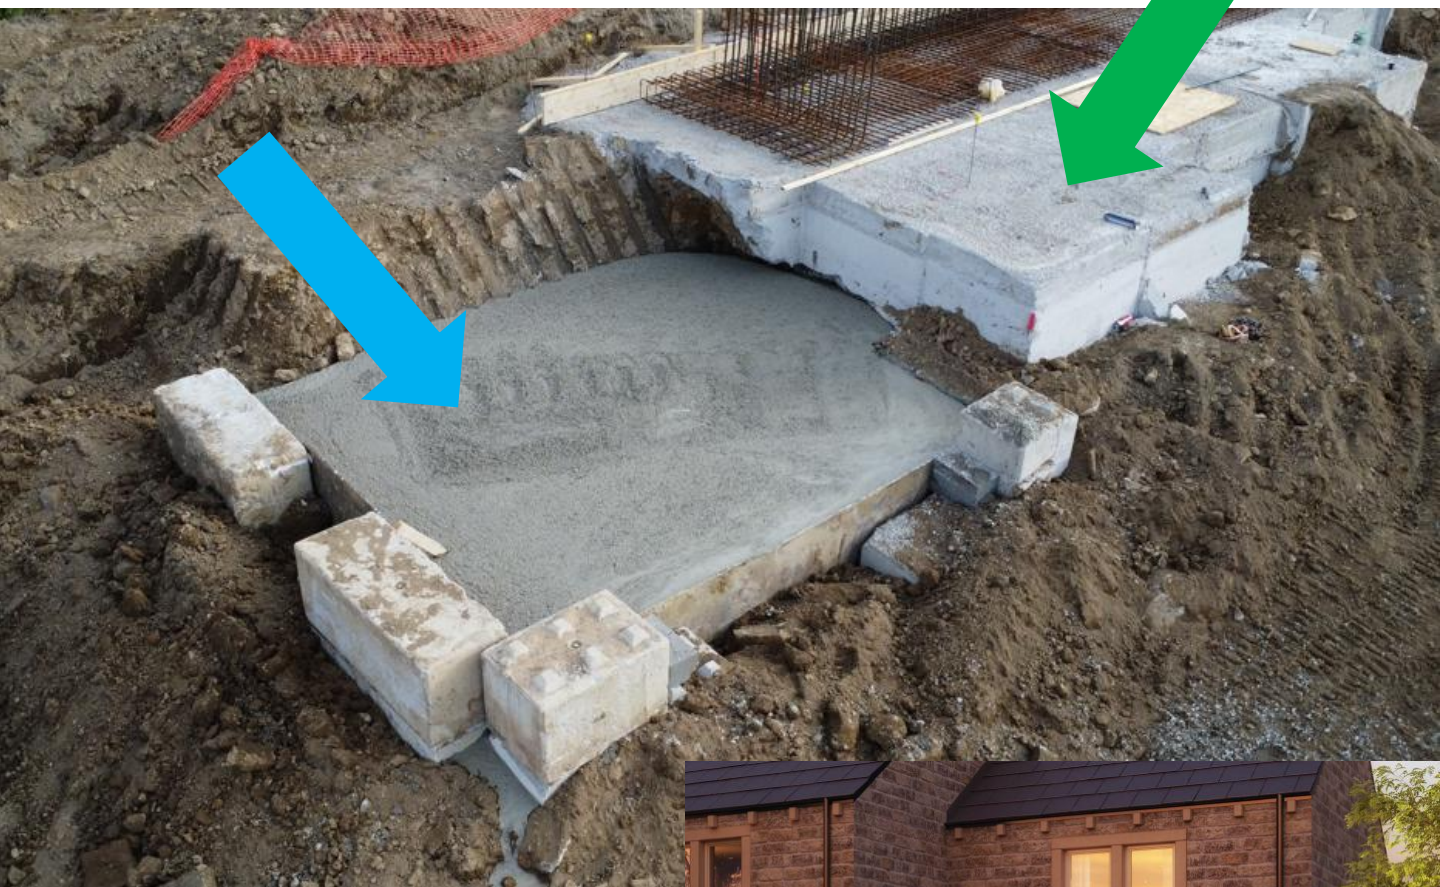
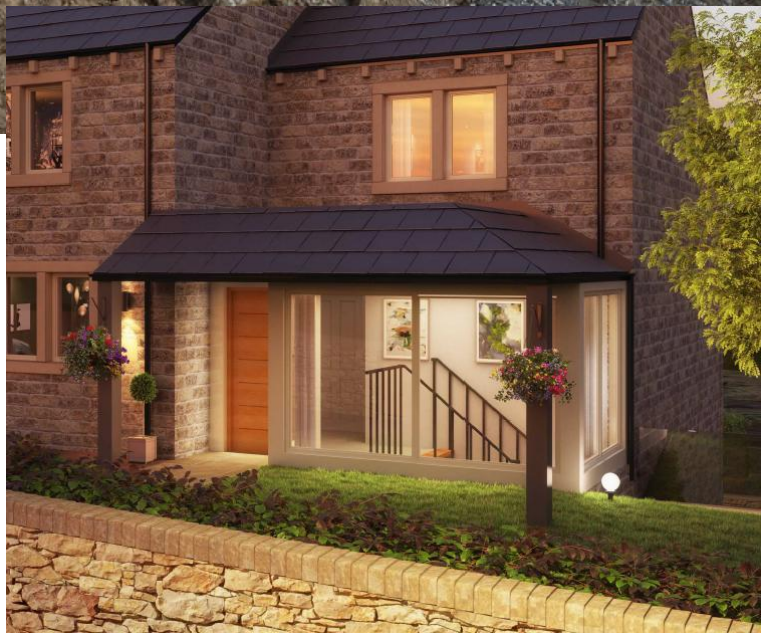
I then thought maybe the concrete pour was part of the stairs that go between the lower ground floor, and the ground floor. The concrete pour being the lower ground floor level (cyan arrow), with the first floor to be built up, on top of the concrete pour where the rebar is (green arrow).

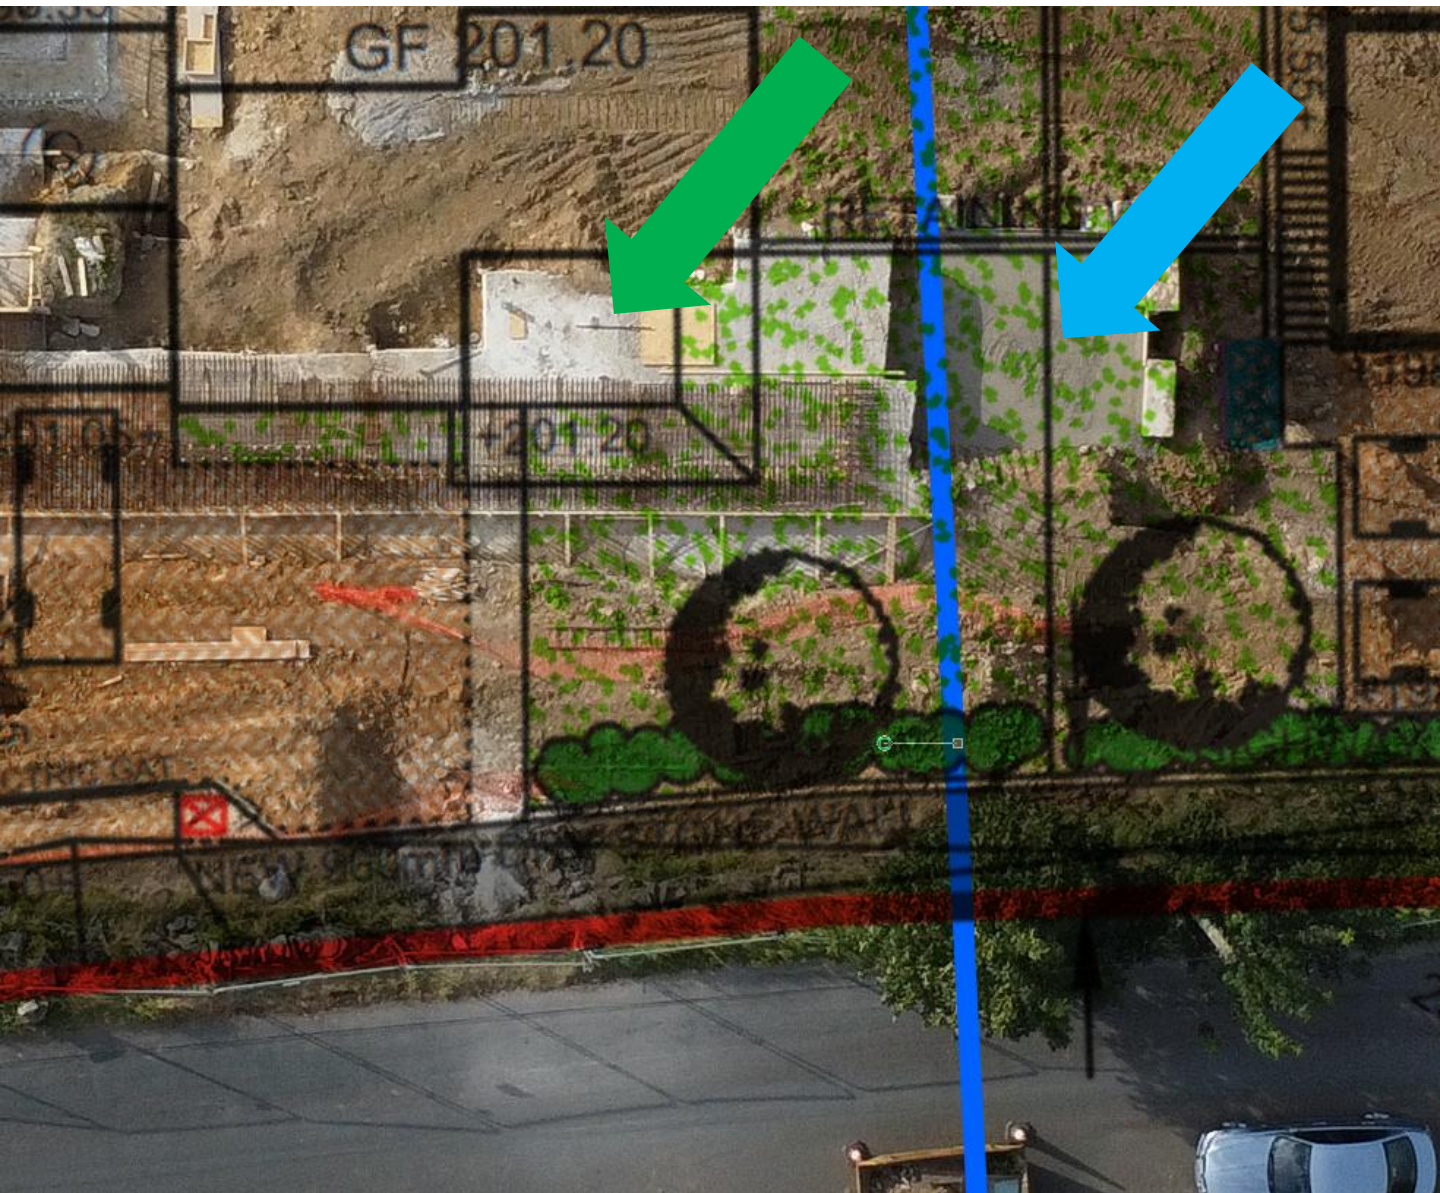
If the concrete pour (blue arrow) is for the stairs, then it should be where the green arrow is.

That would mean the house is being built in the wrong place (because it is to the right of the blue line), or it is being built bigger than it should be.

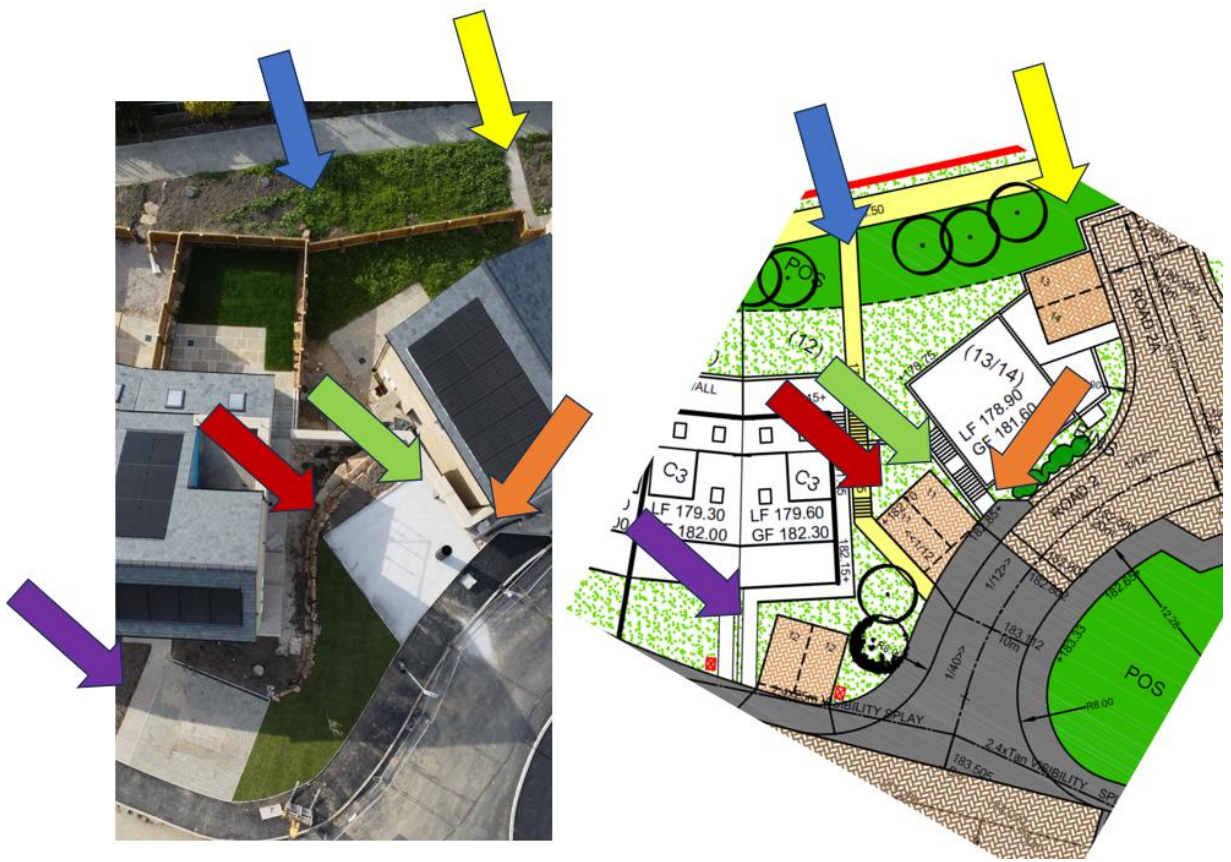
Paving misaligned, and landscaping missing
-

Path missing
-

Path added
-

Large stone wall added
-

Area of landscaping missing
-

Steps from lower floor to roadside pavement missing

For example, above is an extract from the block plan for 2024-91236, showing a rear proportion of plots 12-14.

It shows multiple differences between the plan (right) and photograph (left). The coloured arrows point to some areas of difference.

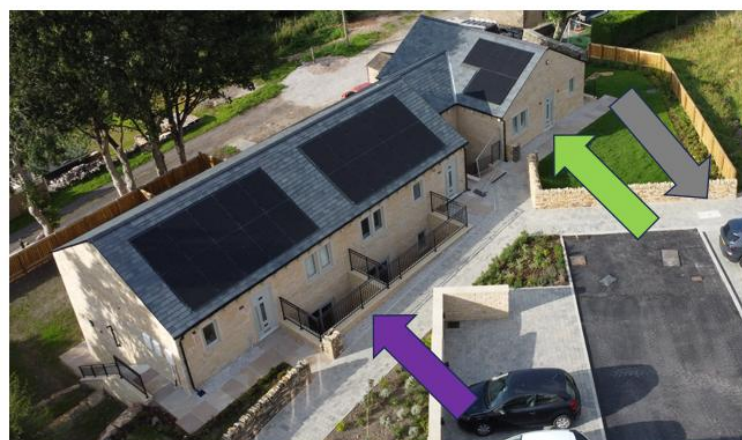
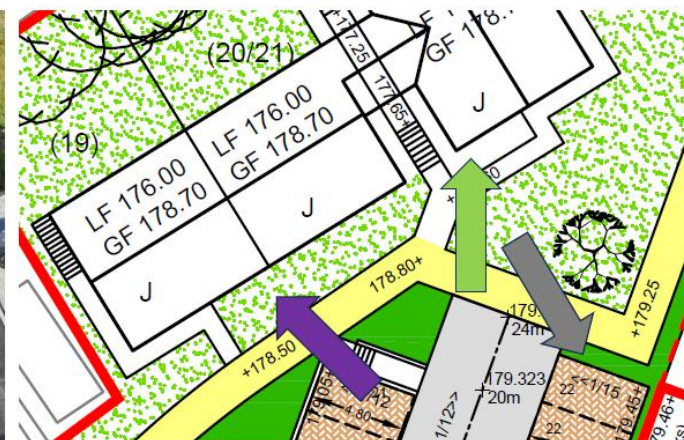
Sunken outside space added
-

Path direction different, with paved area missing
-

Area of landscaping missing

Above is an extract from the block plan for 2024-91236, showing plots 19-23.

It shows multiple differences between the plan (right) and photograph (left). The coloured arrows point to some areas of difference.

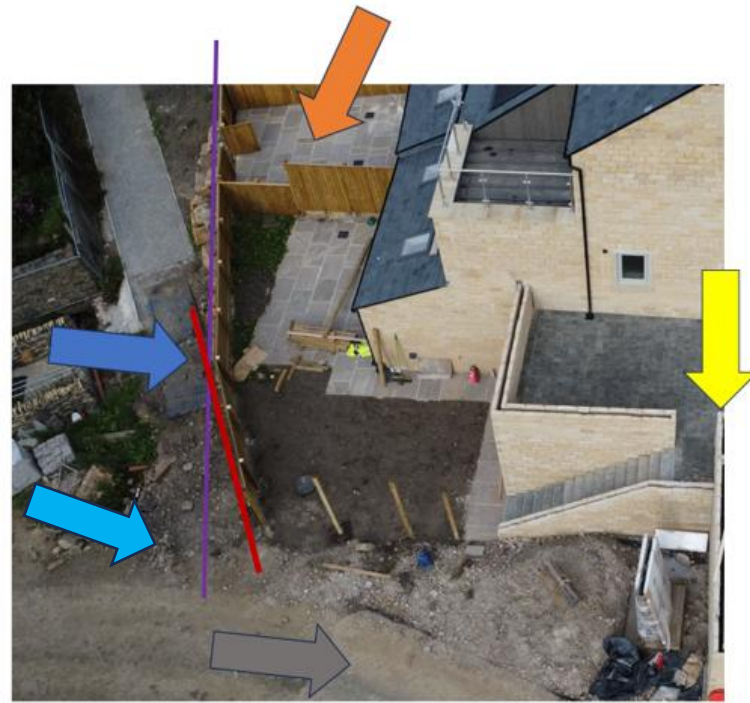
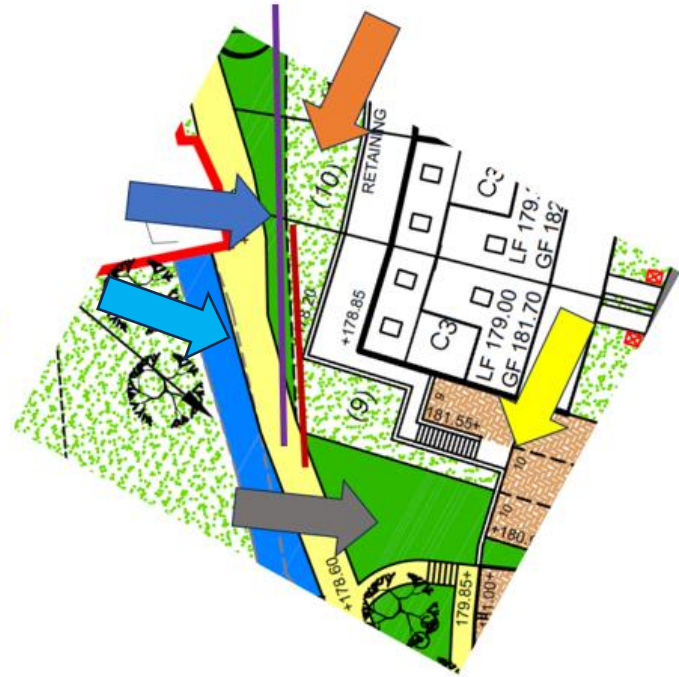
Paved area added, landscaping missing
-

Point where fencing is meant to/does change direction
-

Walling extended
-

Tarmacked road added, landscaping missing
-

Open watercourse largely buried

Above is an extract from the block plan for 2024-91236, showing plots 9-10.

It shows multiple differences between the plan (right) and photograph (left). The coloured arrows point to some areas of difference.

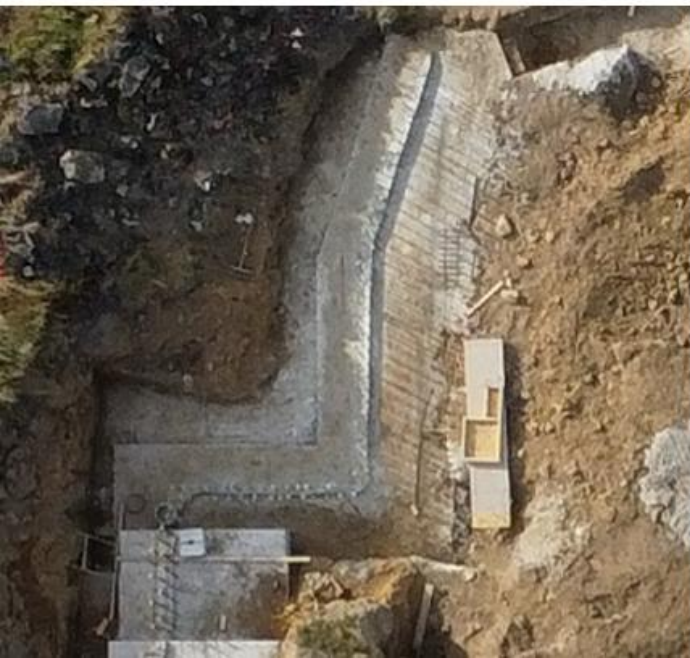
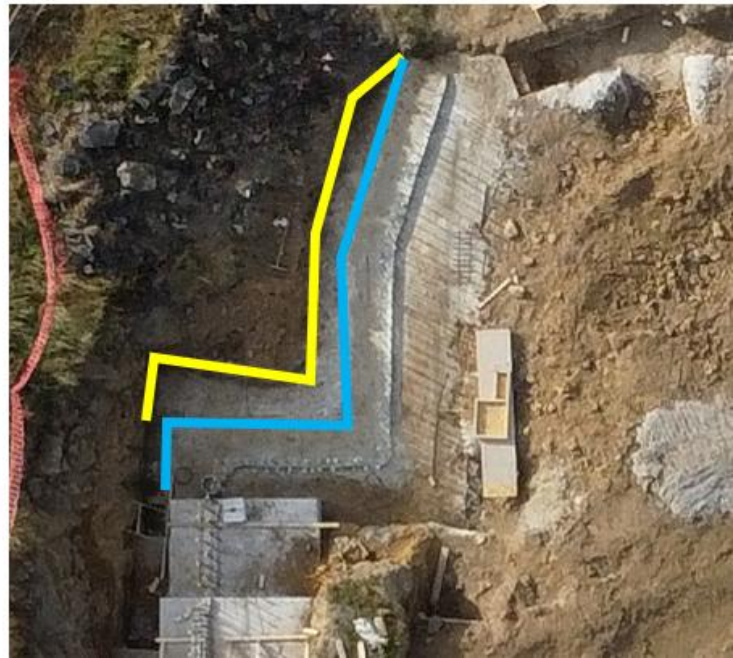
Above is a photograph showing a section of plot 23.

The yellow line shows the outer edge of concrete that was poured as part of the foundations.

It appears, from observations, that the initial pour was in the wrong place, which resulted in it having to be remeasured/repoured; effectively rotating/repositioning the yellow line to the blue line.

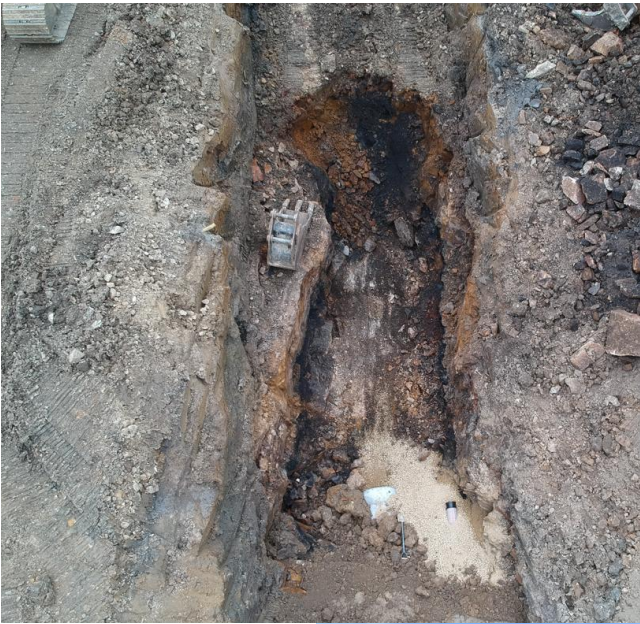
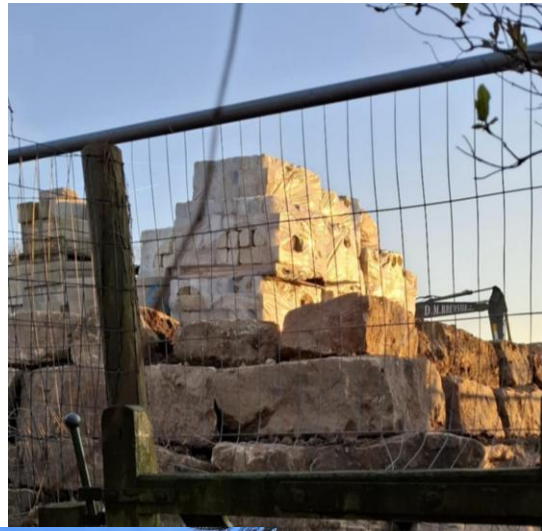
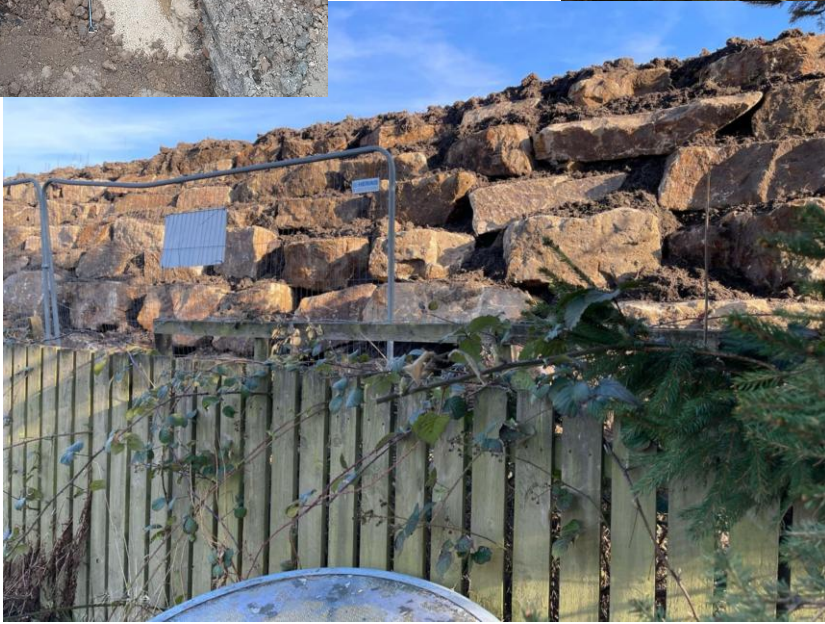
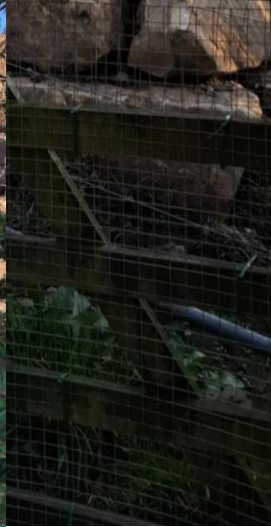
This is meant to be a half meter high wall/hedge.

Not a huge ~149m long, ~3m high wall, built out of large loose stones.

Understood to have come about because the original plan involved digging into clay that was deemed too tough: despite successfully digging to similar depths to lay drainage pipes elsewhere on-site.

This wall also goes against earlier case officer comments that the permitted site design was chosen to minimise the impact of retaining walls.

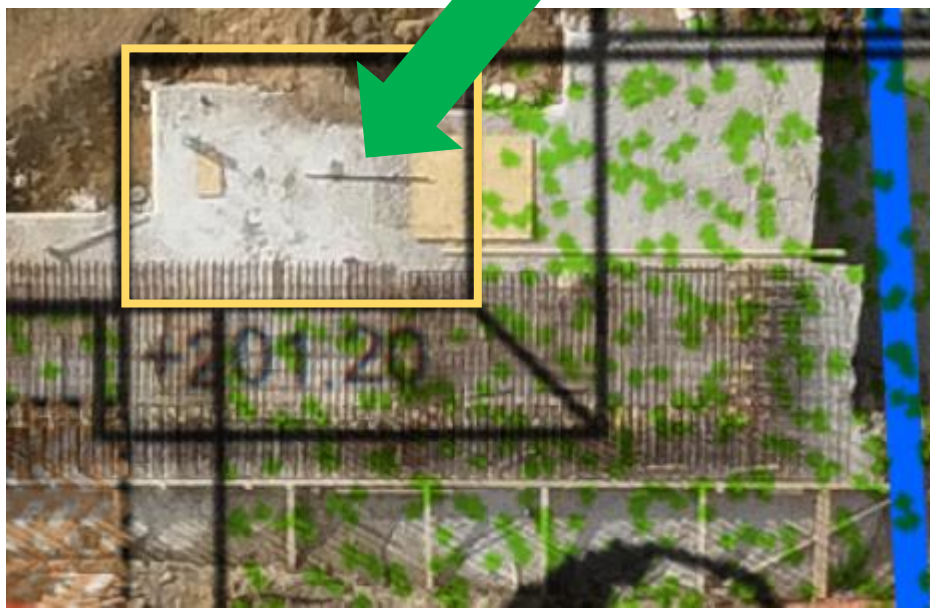
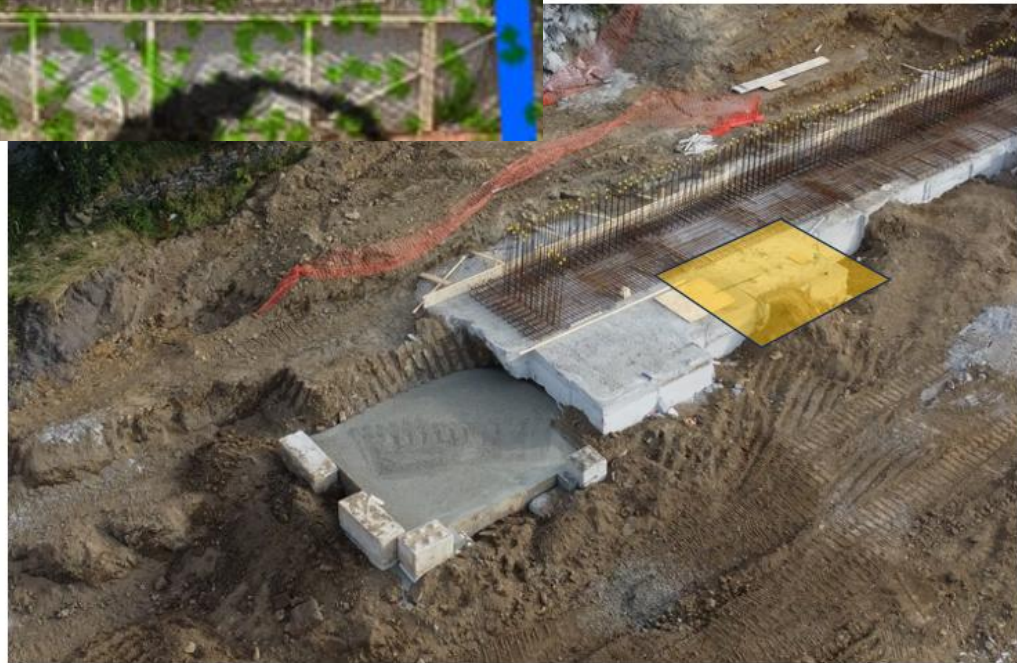
Looking at height, the yellow box, in the left photograph, has a yellow box identifying where I believe the stairs will be, between the Lower Ground Floor and the Ground Floor.

The second picture shows a yellow area that represents the yellow box.

If the stairs are to be built there, the height of the flooring must be above the height of the concrete already in place.

That would mean the height of the Lower Ground Floor would be at that level.

It would see the height of the ground floor significantly higher than the road, and more than illustrated in the application.
