Our Ref: E23/8043/JF/002

Re: Development at Dewsbury Moor Rugby Club

Further to your request we have attended the above site to undertake an inspection of the gas membrane to confirm that the quality of the installation is satisfactory.

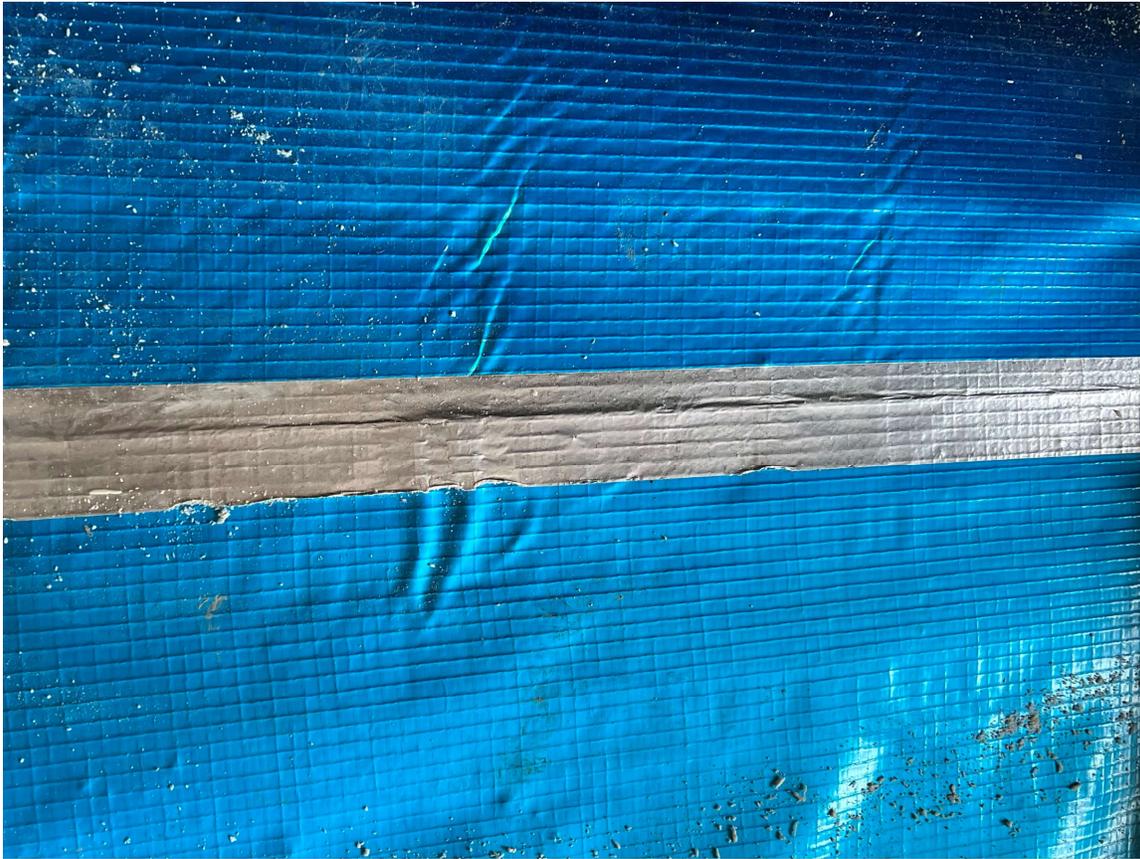
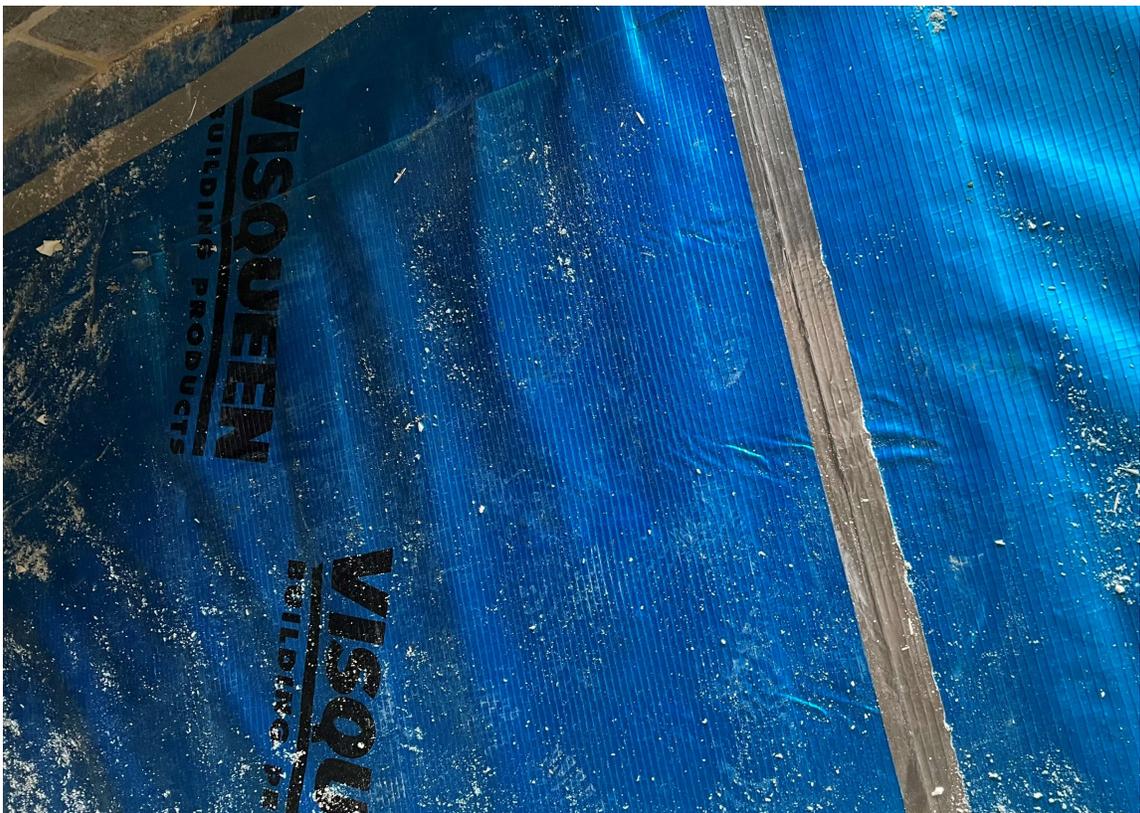
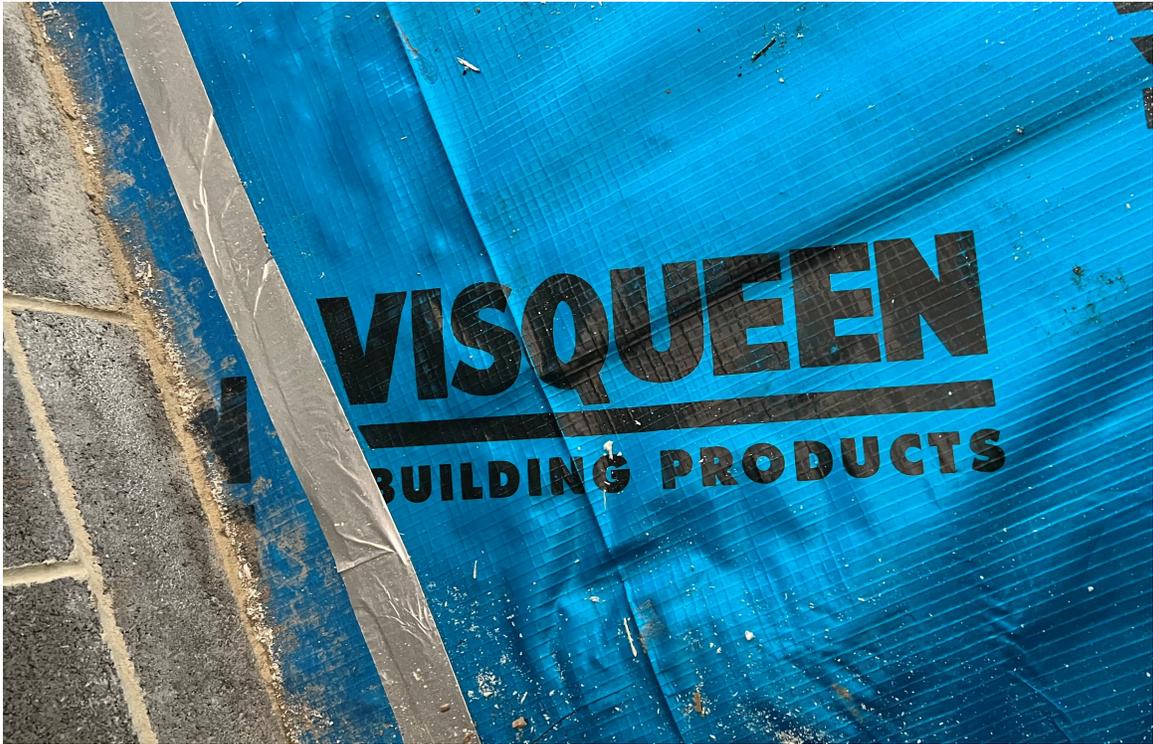
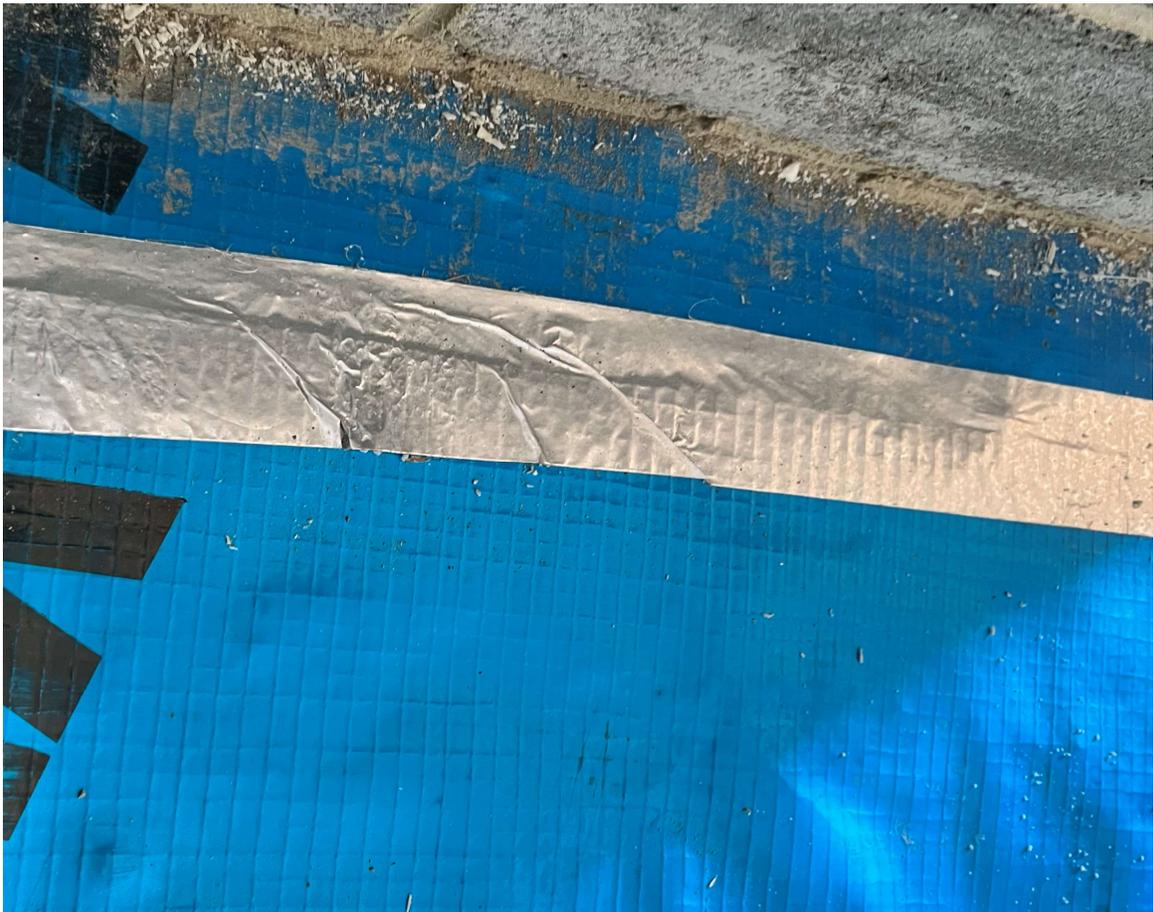
Photographs

The gas membrane at the above development has been inspected in accordance with the above procedure. Initial inspections on site found the membrane installation to be satisfactory, with no repair works being required.

A lack of surface preparation was noted beneath the membrane in a small number of areas. However, following a thorough visual & hands-on inspection, we can confirm that there were no rips or tears in the membrane as a result of any debris beneath. Insulation was also installed immediately after the inspection and followed by screed pour to ensure no damage occurred.
