Preliminary Roost Assessment and Ecological Walkover

Folly Hall, Huddersfield

Reference: 81-859

Date: May 24

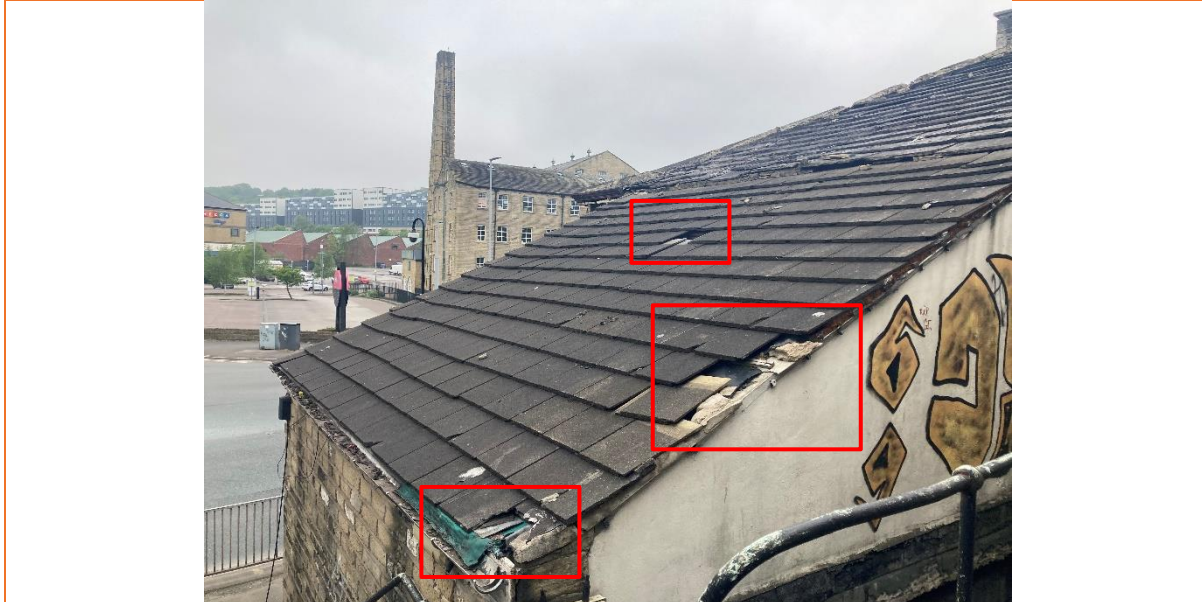
Figure 2 Showing the extension roof (PRF1, 2, 3)

The small extension to the south of the building was constructed of stone brick and mortar, with a slate pitched roof. Multiple potential bat features (PRF) were located on the small extension. Lifted tiles were identified within the roof of the extension (PRF 1,2,3) Due to the size of these features, they are likely to provide roosting opportunities to a small number of crevice-dwelling bats on an occasional basis. However, felt was present underneath the tiles preventing access into the loft void.

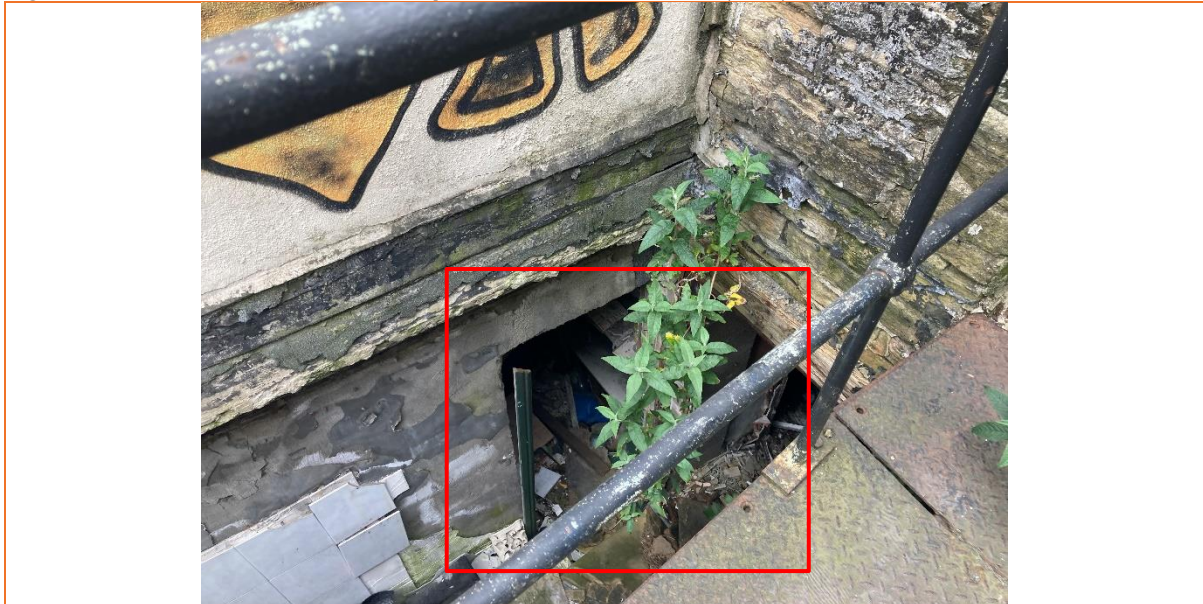
Figure 3 Showing an access point into the extension (AP1)

An access point (AP) into the small extension was identified along the east of the extension. This was within a doorway under where a small section of roof had fallen (AP1). This access point provided access into the small extension; however, an internal survey could not be undertaken as the building was deemed unsafe. Because of this, the presence of potential roost features that could support a small number of bats on a regular basis cannot be discounted.

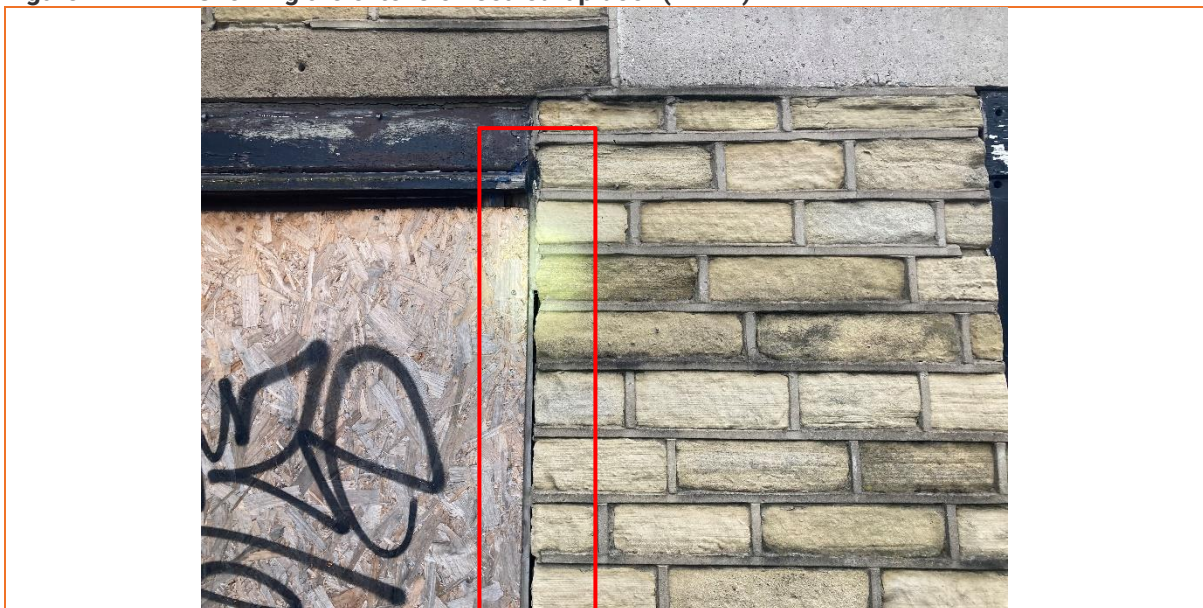
Figure 4 Showing the extension sealed-up door (PRF 4)

A sealed-up door was present on the western side of the extension. A crevice between the brickwork and the door was identified around one side of the door (PRF 4). This feature is likely to provide roosting opportunities for a small number of crevice-dwelling bats on an occasional basis.

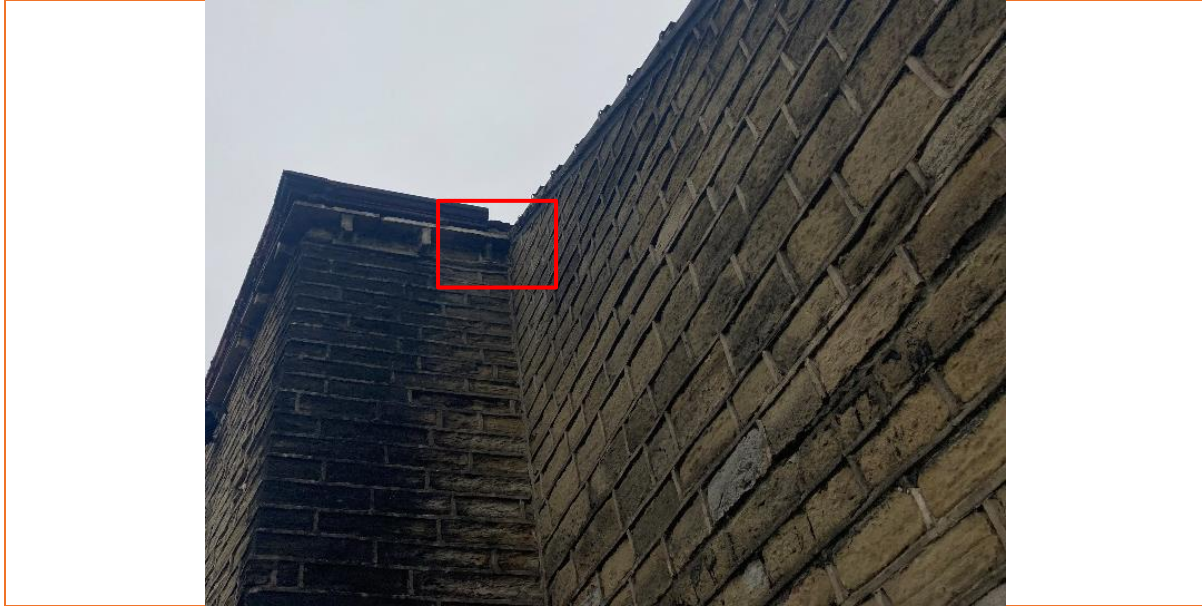
Figure 5 Showing the crevice where the extension meets the main building (PRF 5)

A crevice was identified in the soffit of the building, where the extension met the main building (PRF 5). The crevice was deemed likely to provide roosting opportunities for a small number of crevice-dwelling bats on an occasional basis.

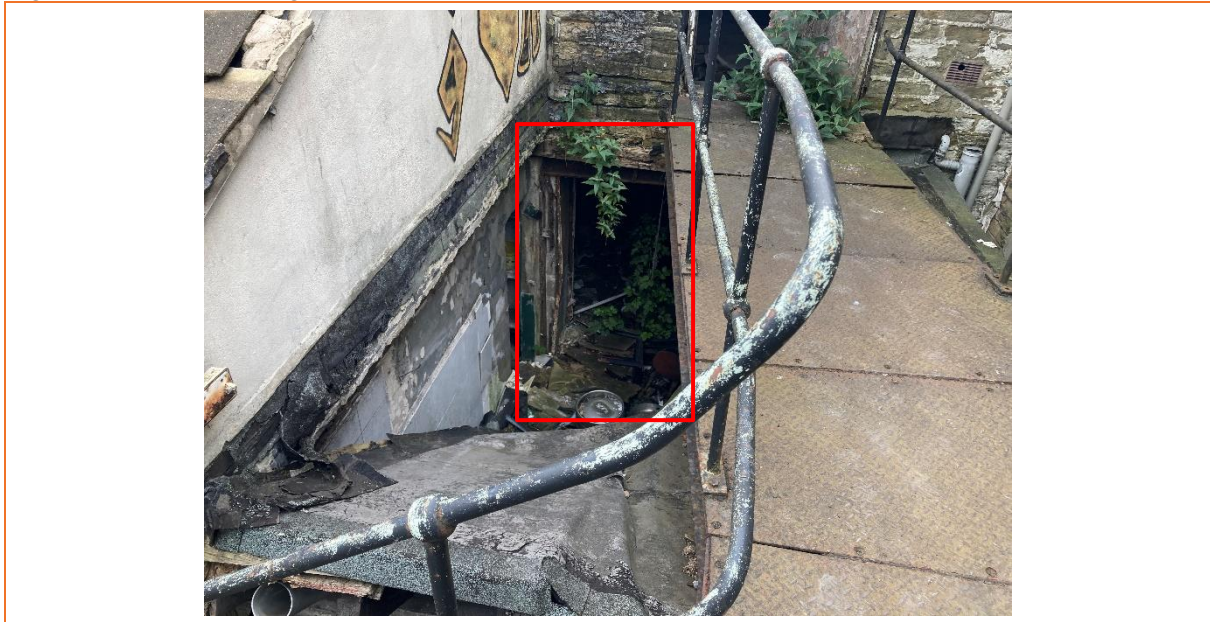
Figure 6 Showing AP2

AP2 and AP3 were located along the south of the two-storey section. Both of these access points were doorways that had been uncovered. Due to an internal survey not being completed, it is assumed that features within the building could provide a small number of bats roosting opportunities on a regular basis.

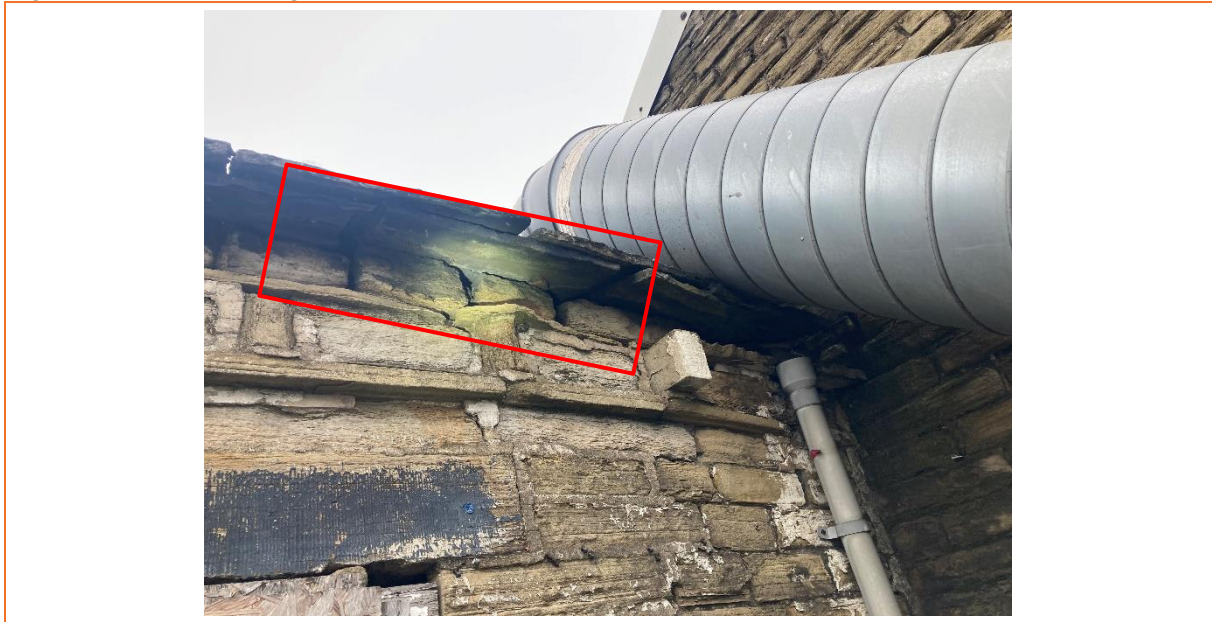
Figure 8 Showing PRF 6

Multiple features were identified along the south of the two-storey section. PRF 6 and PRF 7 were both brickwork cervices within the brickwork above AP3. Both of these features are likely to support individual roosting crevice-dwelling bats on an occasional basis.

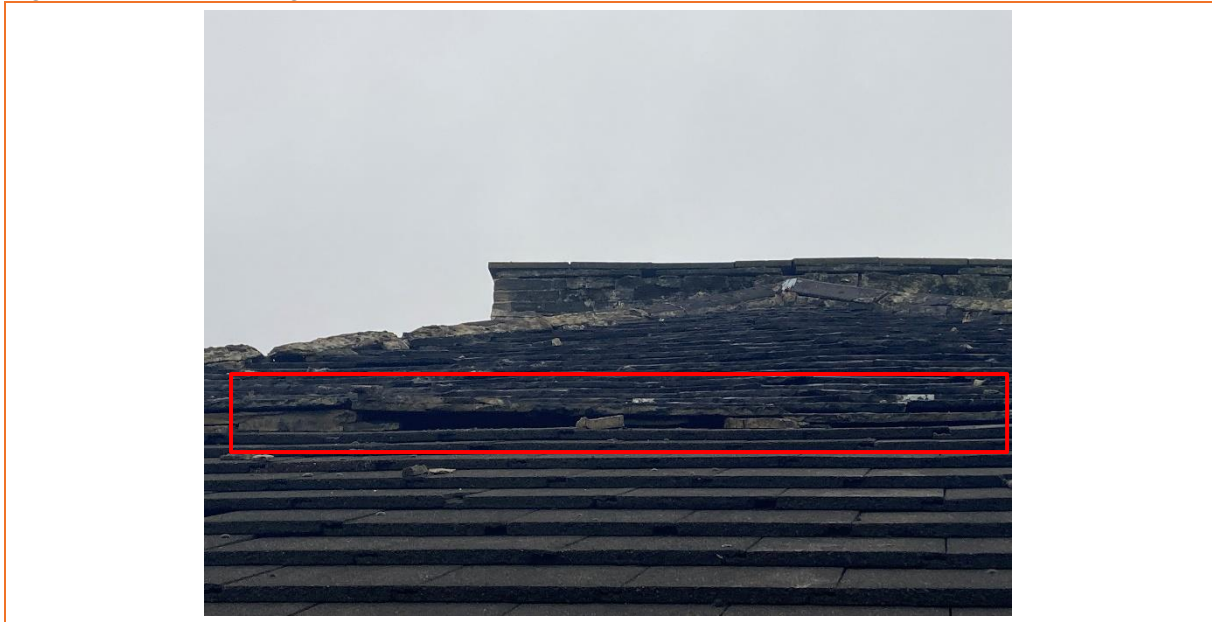
Figure 10 **Showing PRF 8**

A lifted section of tiles was present where the extension meets the roof of the two-storey section (PRF8). The space underneath these tiles is likely to offer crevice-dwelling bats roosting opportunities on an occasional basis.

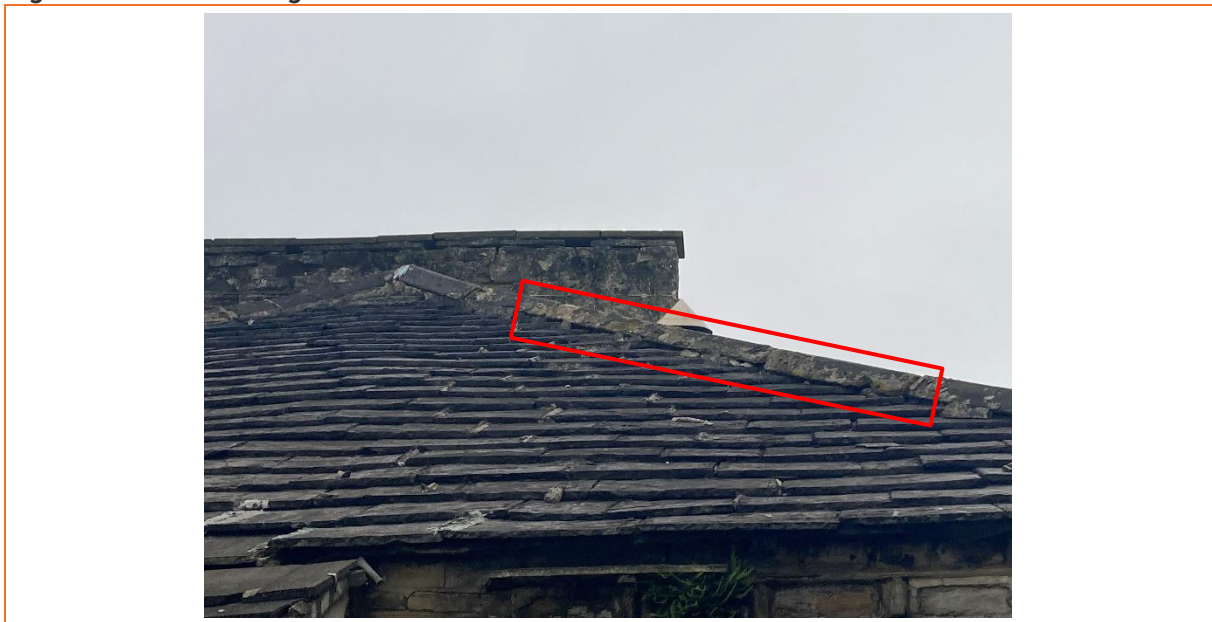
Figure 11 **Showing PRF 9**

Damaged and lifted roof tiles were present along both ridges of the hipped roof (PRF 9 and PRF 10). Due to the size of the ridges, they are likely to support a small number of opportunistic crevice-dwelling bats on an occasional basis. These features have the potential to provide access into the loft void, as an internal survey could not be undertaken. Because of this, the presence of potential roost features that could support a small number of bats on a regular basis cannot be discounted. The loft void is unlikely to support maternity or hibernation roosts as it is exposed to the weather through the large gaps in the roof where the roof collapsed because of the damage caused by the fire. This damage is likely to cause fluctuating temperatures within the loft.

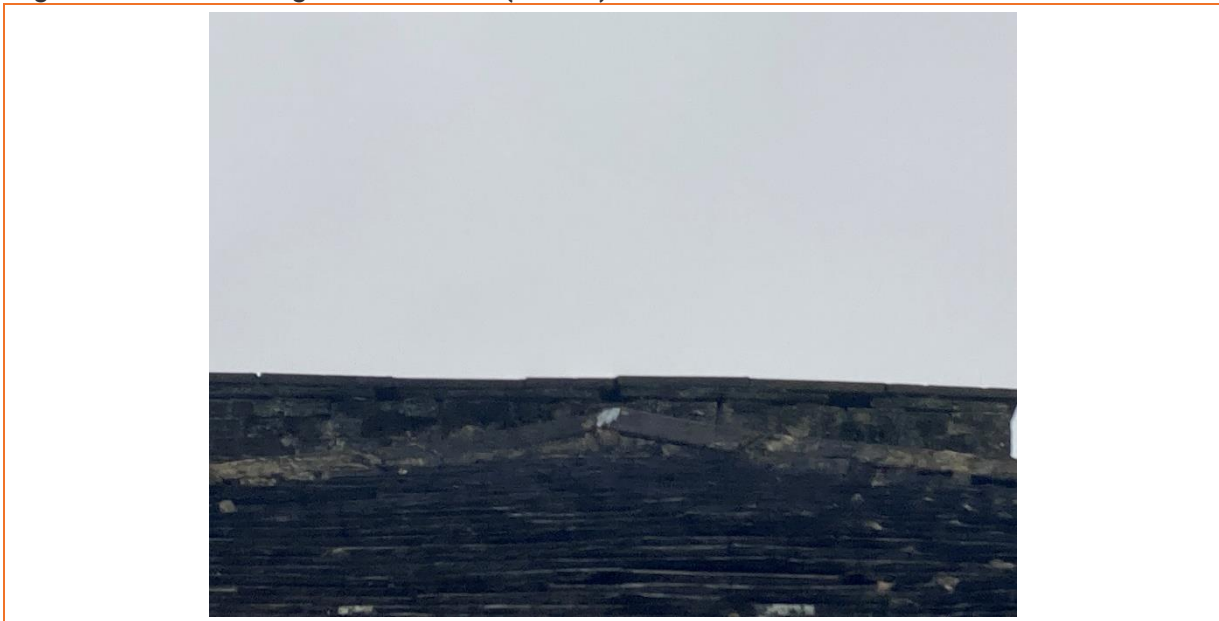
Figure 13 **Showing stone structure (PRF 11)**

A stone brick structure was identified along the top of the hipped roof (PRF 11). Multiple brickwork crevices were noted within the feature. These crevices are likely to support opportunistic crevice-dwelling bats on an occasional basis.

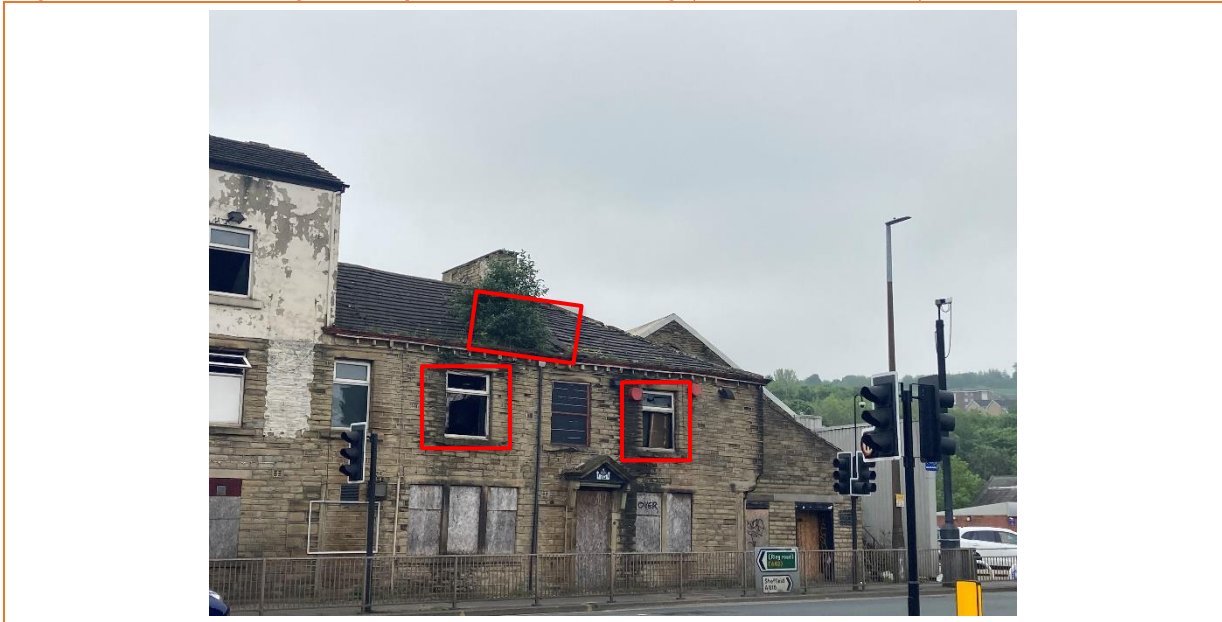
Three access points were identified on the western side of the two-storey section of the building. AP4 and AP5 were windows that had been smashed which provided large gaps that bats could use to access the building. AP6 was a large hole within the roof which had butterfly bush (*Buddleja davidii*) growing out of it. The hole provided access into the loft space. Due to the building being unsafe the interior could not be inspected to determine what features these access point led to. Because of this, the presence of potential roost features that could support a small number of bats on a regular basis cannot be discounted. The loft void is unlikely to support maternity or hibernation roosts as it is exposed to the weather through the large gaps in the roof where the roof collapsed because of the damage caused by the fire. This damage is likely to cause fluctuating temperatures within the loft.

Figure 14 Showing access points into the building (AP4, AP5 and AP6)

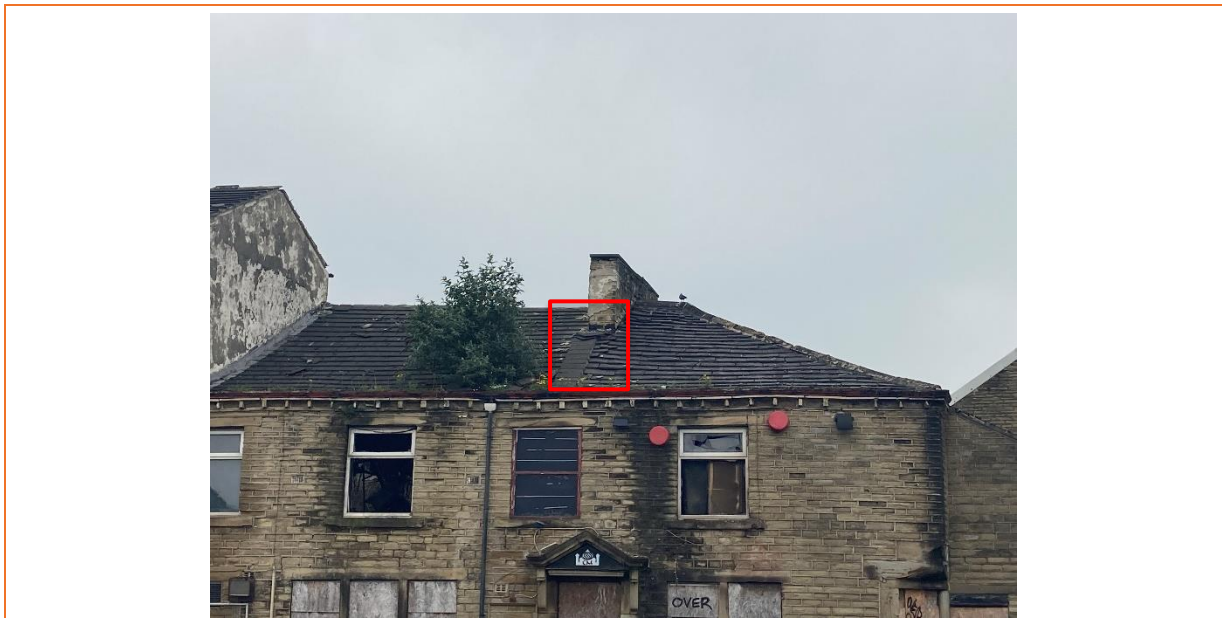
Multiple lifted and missing tiles were identified under the stone structure on the hipped roof. These lifted and missing tiles could provide suitable shelter to support small numbers of crevice dwelling species on an occasional basis.

Figure 15 Showing lifted tiles below the stone feature (PRF 12)

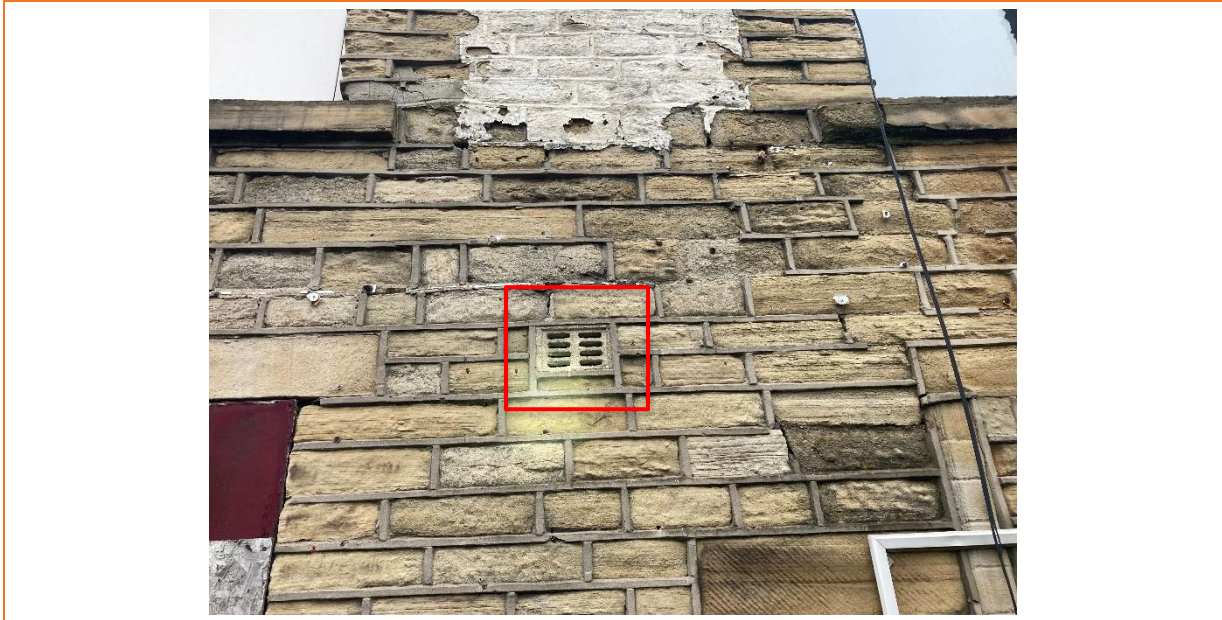
Multiple vents were located along the west of the building. These vents were approximately 2 m high. Due an internal survey not being undertaken; it was undetermined what the full extent of these features was. Because of this, these features have been assumed as having the potential to support a small number of bats on a regular basis.

Figure 16 Showing vents (PRF13, PRF14, PRF15 and PRF16)

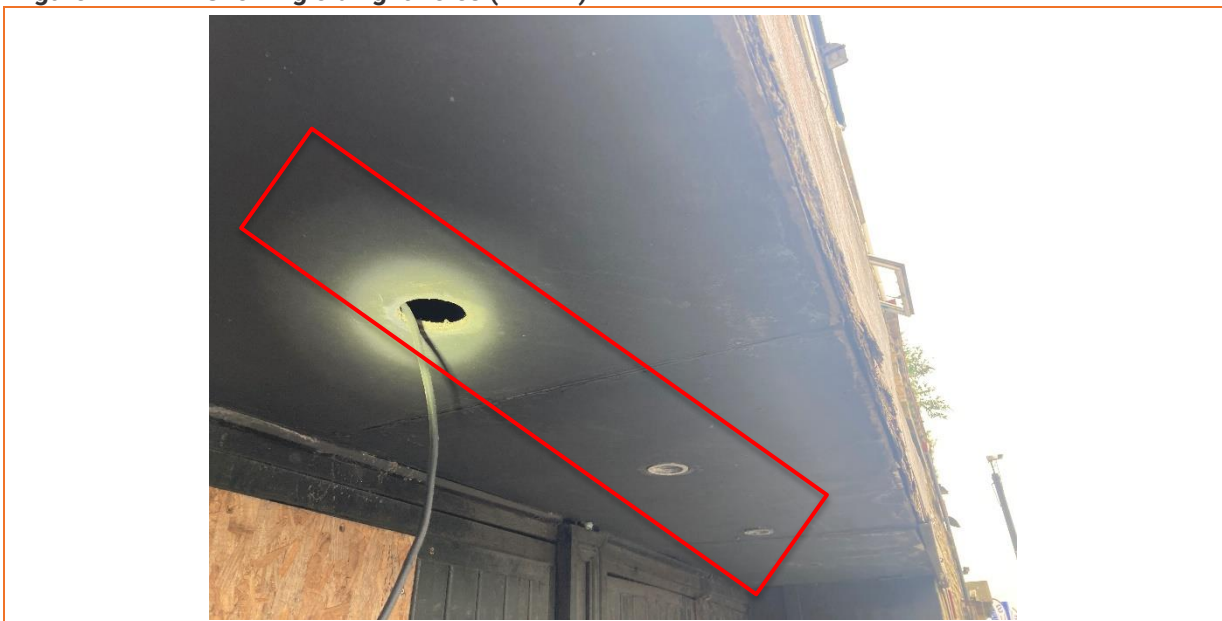
On the west side of the building, above the old main entrance were holes that would have housed light. The removal of these lights has created a crevices beneath. These crevices are likely to provide opportunistic bats roosting opportunities on an occasional basis.

Figure 17 Showing old light holes (PRF17)

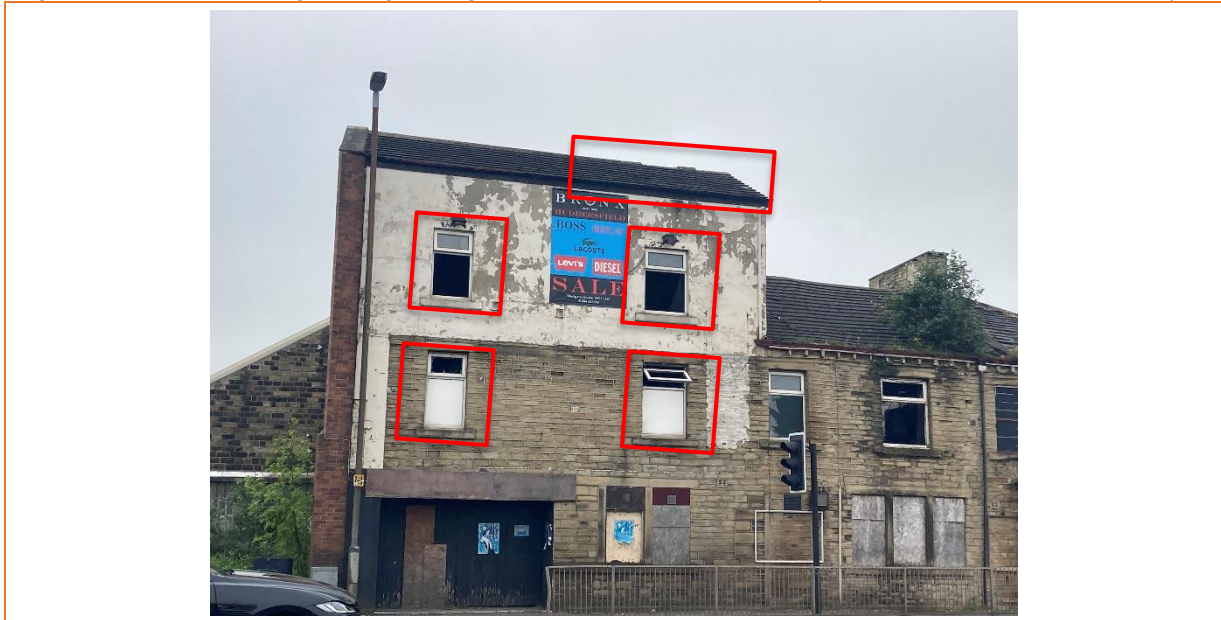
Damaged ridge tiles were identified on top of the pitched roof on the three-storey section of the building. These damaged ridge tiles are likely to provide opportunistic crevice – dwelling bats roosting opportunities on an occasional basis.

Four broken windows were located on the western side of the three-storey section of the building. These windows provided access into the building and to the features that were located within. Due to an internal inspection not being safe to conduct, it is assumed that features within the building would provide a small number of bats roosting opportunities on a regular basis.

Figure 18 Showing damaged ridge tiles and broken windows (PRF18, AP7, AP8, AP9, AP10)

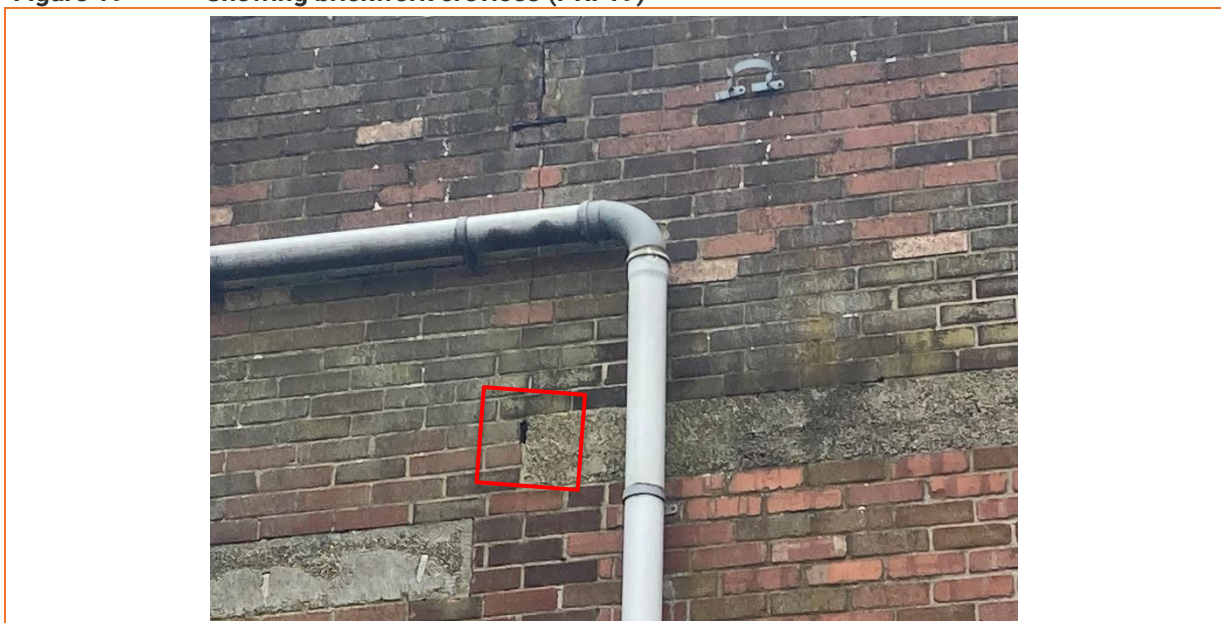
Multiple brickwork crevices (PRF19 and PRF20) were identified along the north of the building. These crevices are likely to provide crevice-dwelling bats roosting opportunities on an opportunistic basis.

Figure 19 Showing brickwork crevices (PRF19)

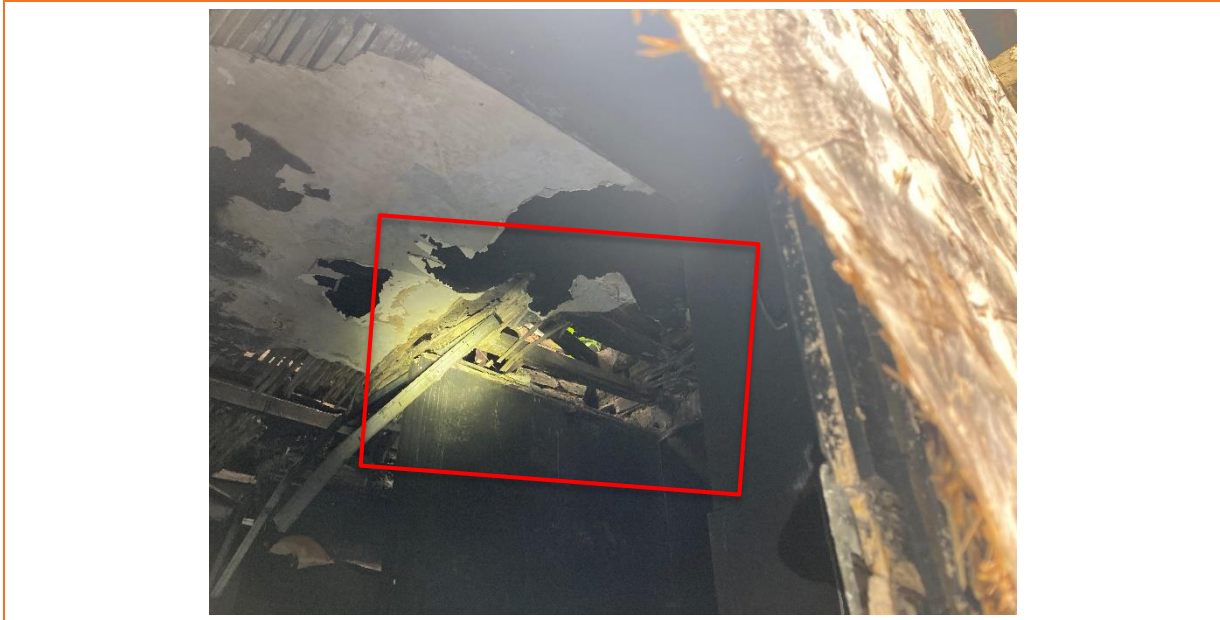
The view of the eastern side of the building was restricted due to the adjoining building. However, two areas of roof were identified to have collapsed (AP11 and AP12). These sections of collapsed roof are likely to provide access into the building. It is assumed that the features within the building provide a small number of bats roosting opportunities on a regular basis.

Figure 20 Showing damaged roof (AP11)

There was a loft void present within the building. The loft void is unlikely to support maternity or hibernation roosts as it is exposed to the weather through large gaps where the roof had collapsed due to fire damage. Please see Figure 20. This damage is likely to cause fluctuating temperatures within the loft, which does not provide the stable conditions that are needed for maternity or hibernation roosts.

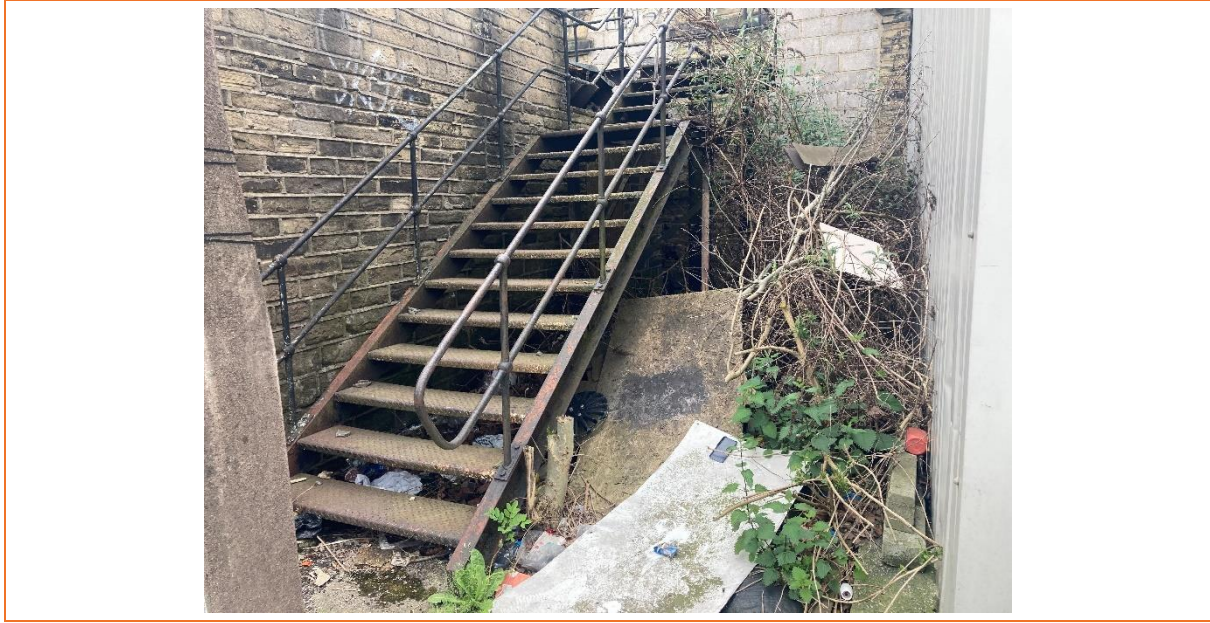
A small section of developed land: sealed surface was connected to the building, which had been colonised by butterfly bush (*Buddleja davidii*). Due to the expanse of the building and developed land: sealed the site offers limited ecological value for local wildlife.

Figure 213 Showing developed land: sealed surface
