Our Ref: UHA/13/l1/AMJ

7<sup>th</sup> May 2024

Plane Street, Huddersfield  
Additional Intrusive Coal Mining Investigation

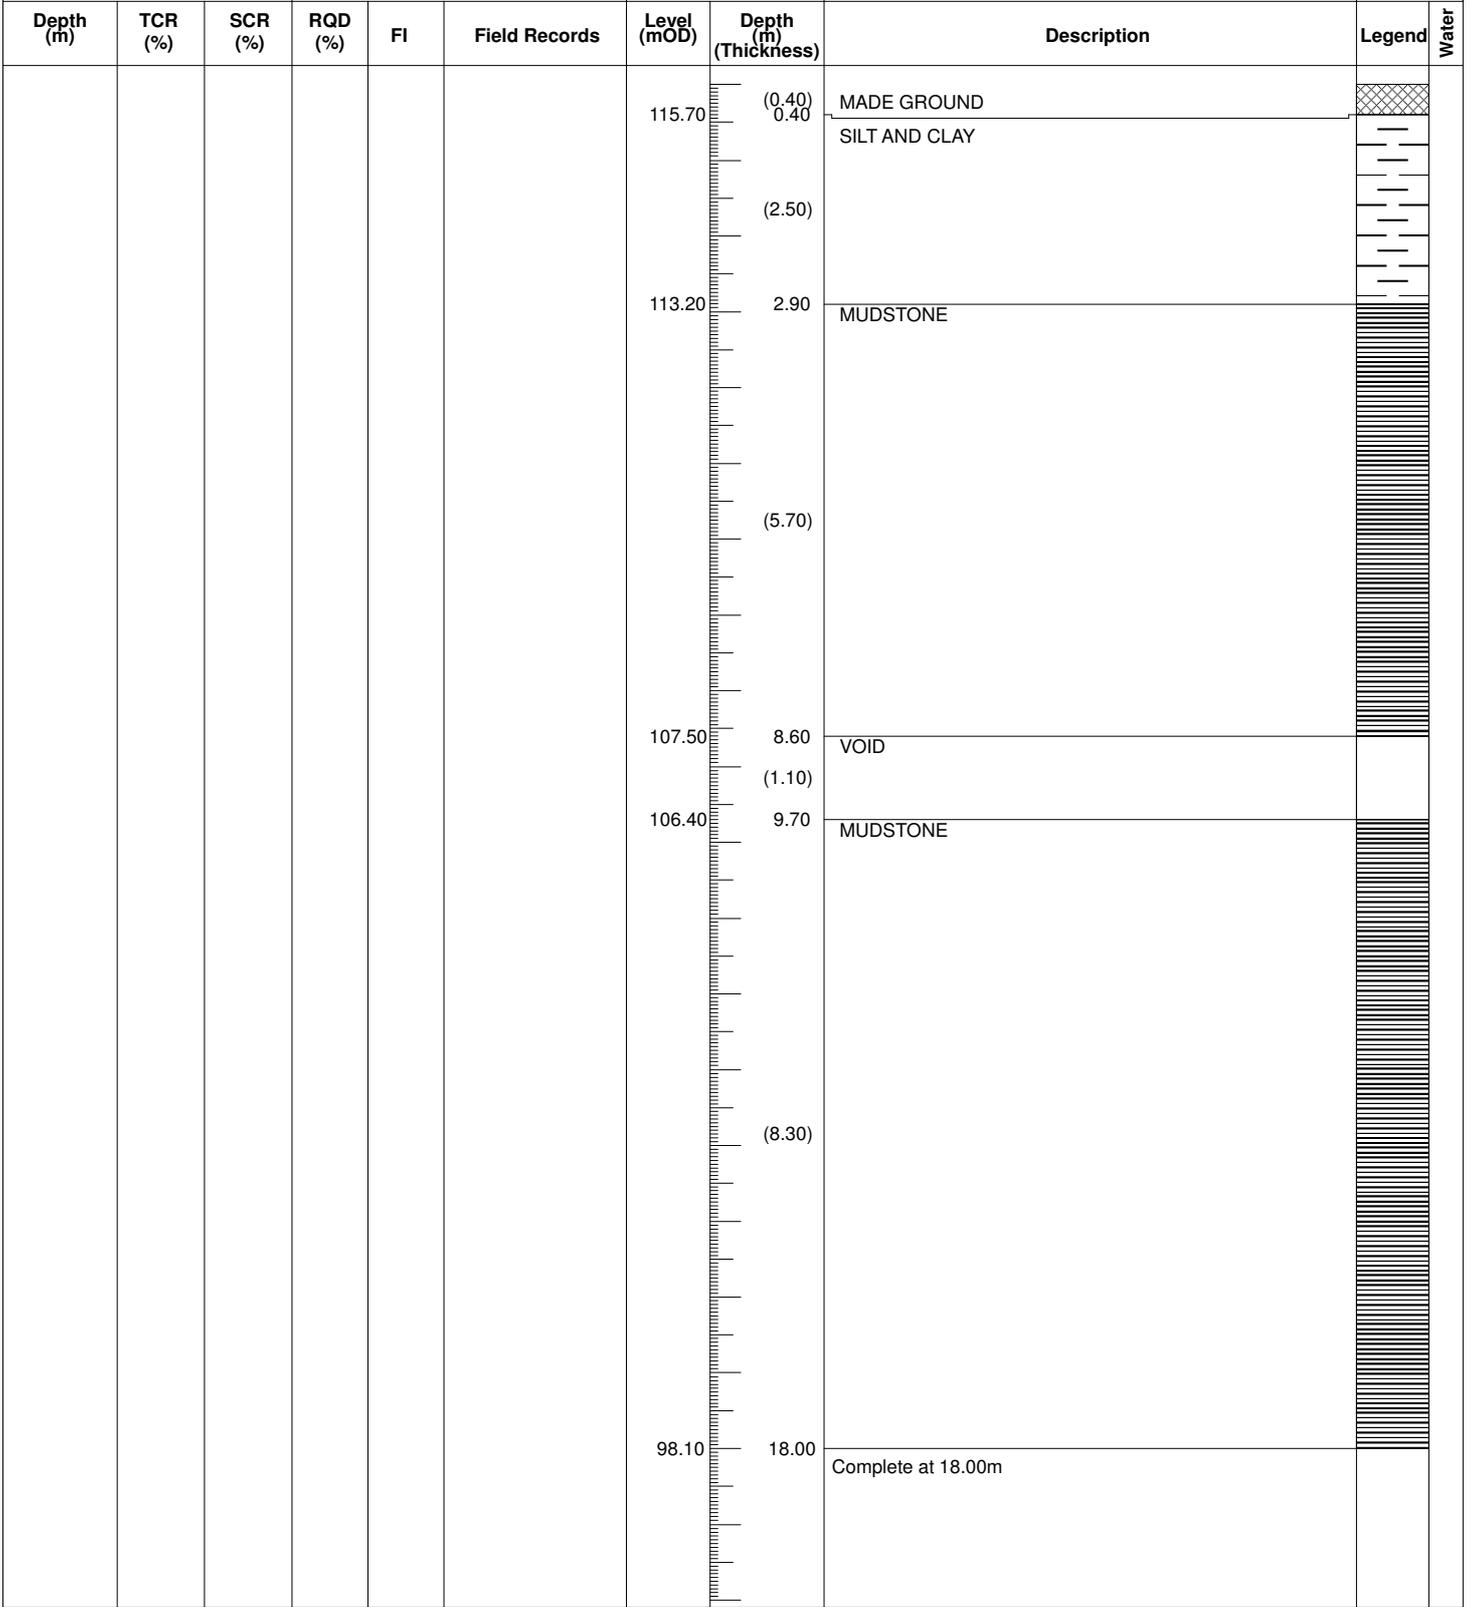
<b>Remarks</b> No groundwater strike recorded by the driller. Water flush lost in broken ground. Backfilled with arisings and bentonite upon completion.	<b>Scale (approx)</b>	<b>Logged By</b>
	1:100	JP
	<b>Figure No.</b> UHA/13.BH02

Five of the boreholes encountered either broken or soft strata or voids (representing underground workings), with associated loss of flush, from depths of between 6.3m and 12.3m. The broken/soft zone or void ranged in thickness between 2.3m (BH1) and 1.1m (BH2).

BH	Depth to Rock (m)	Depth (m) to base of coal or wks	Depth to Original Roof (m)	Rock Cover to Original Seam Roof (m)	Comment on Rock Cover Thickness	Flush Returns
BH1	3.0	8.6 (BG)	7.8	4.8	Insufficient	LOF
BH2	2.9	9.7 (V)	8.9	6	Insufficient	LOF
BH3	2.6	10.5 (IC)	9.7	7.1	Insufficient	Full
BH4	3.1	11.2 (BG)	10.4	7.3	Insufficient	LOF
BH5	3.6	11.1 (BG)	10.3	6.7	Insufficient	LOF
BH6	3.4	12.3 (BG)	11.5	8.1	Sufficient	LOF

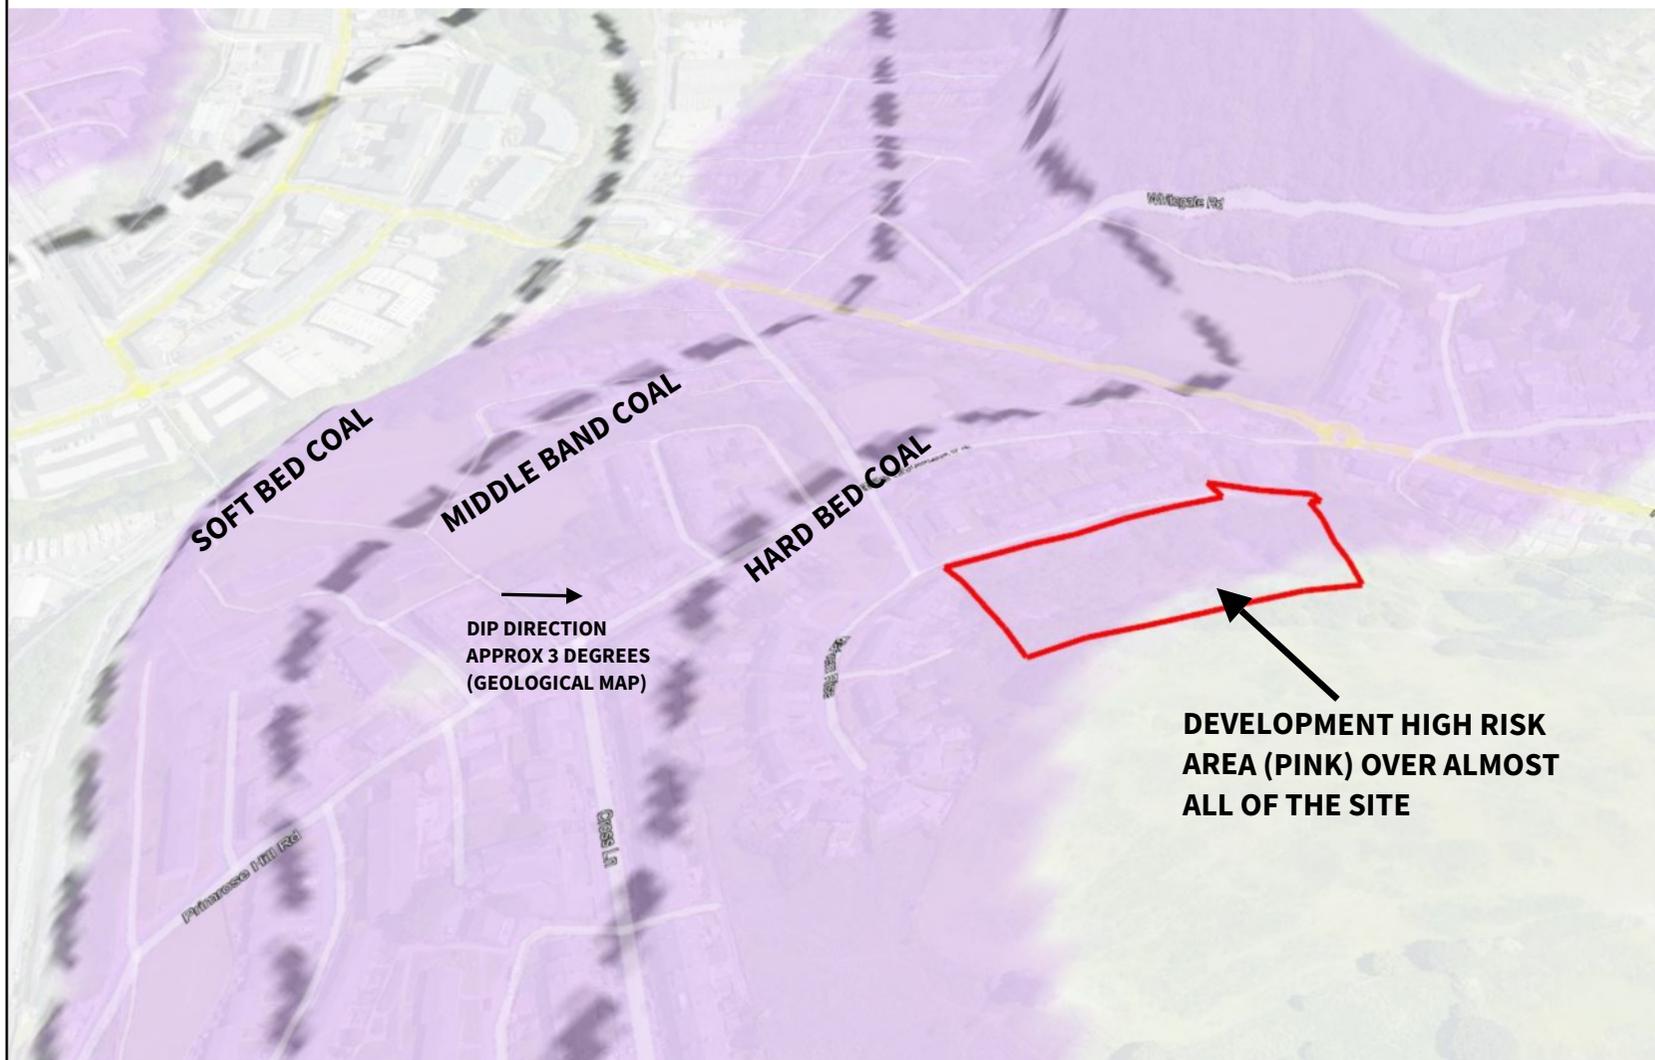
Project	PLANE STREET, HUDDERSFIELD	
Client	UNITY HOUSING ASSOCIATION	
Title	COAL SEAM OUTCROPS AND DEVELOPMENT HIGH RISK AREA PLAN	
Date	MAY 2024	
Drawn	AMJ	Scale AS SHOWN
Job No.	UHA/13

When compared to the geological map which covers the site area (Sheet SE11NW 1:10,000 scale) the Hard Bed coal seam can be clearly seen outcropping to the west of the site (approximately 100m away but at a similar level to the central portion of the site) and a nearby dip angle records the strata (including the coal seam) to be dipping at 3 degrees to the east. This agrees/confirms the findings and assessment of the ARP site investigation.

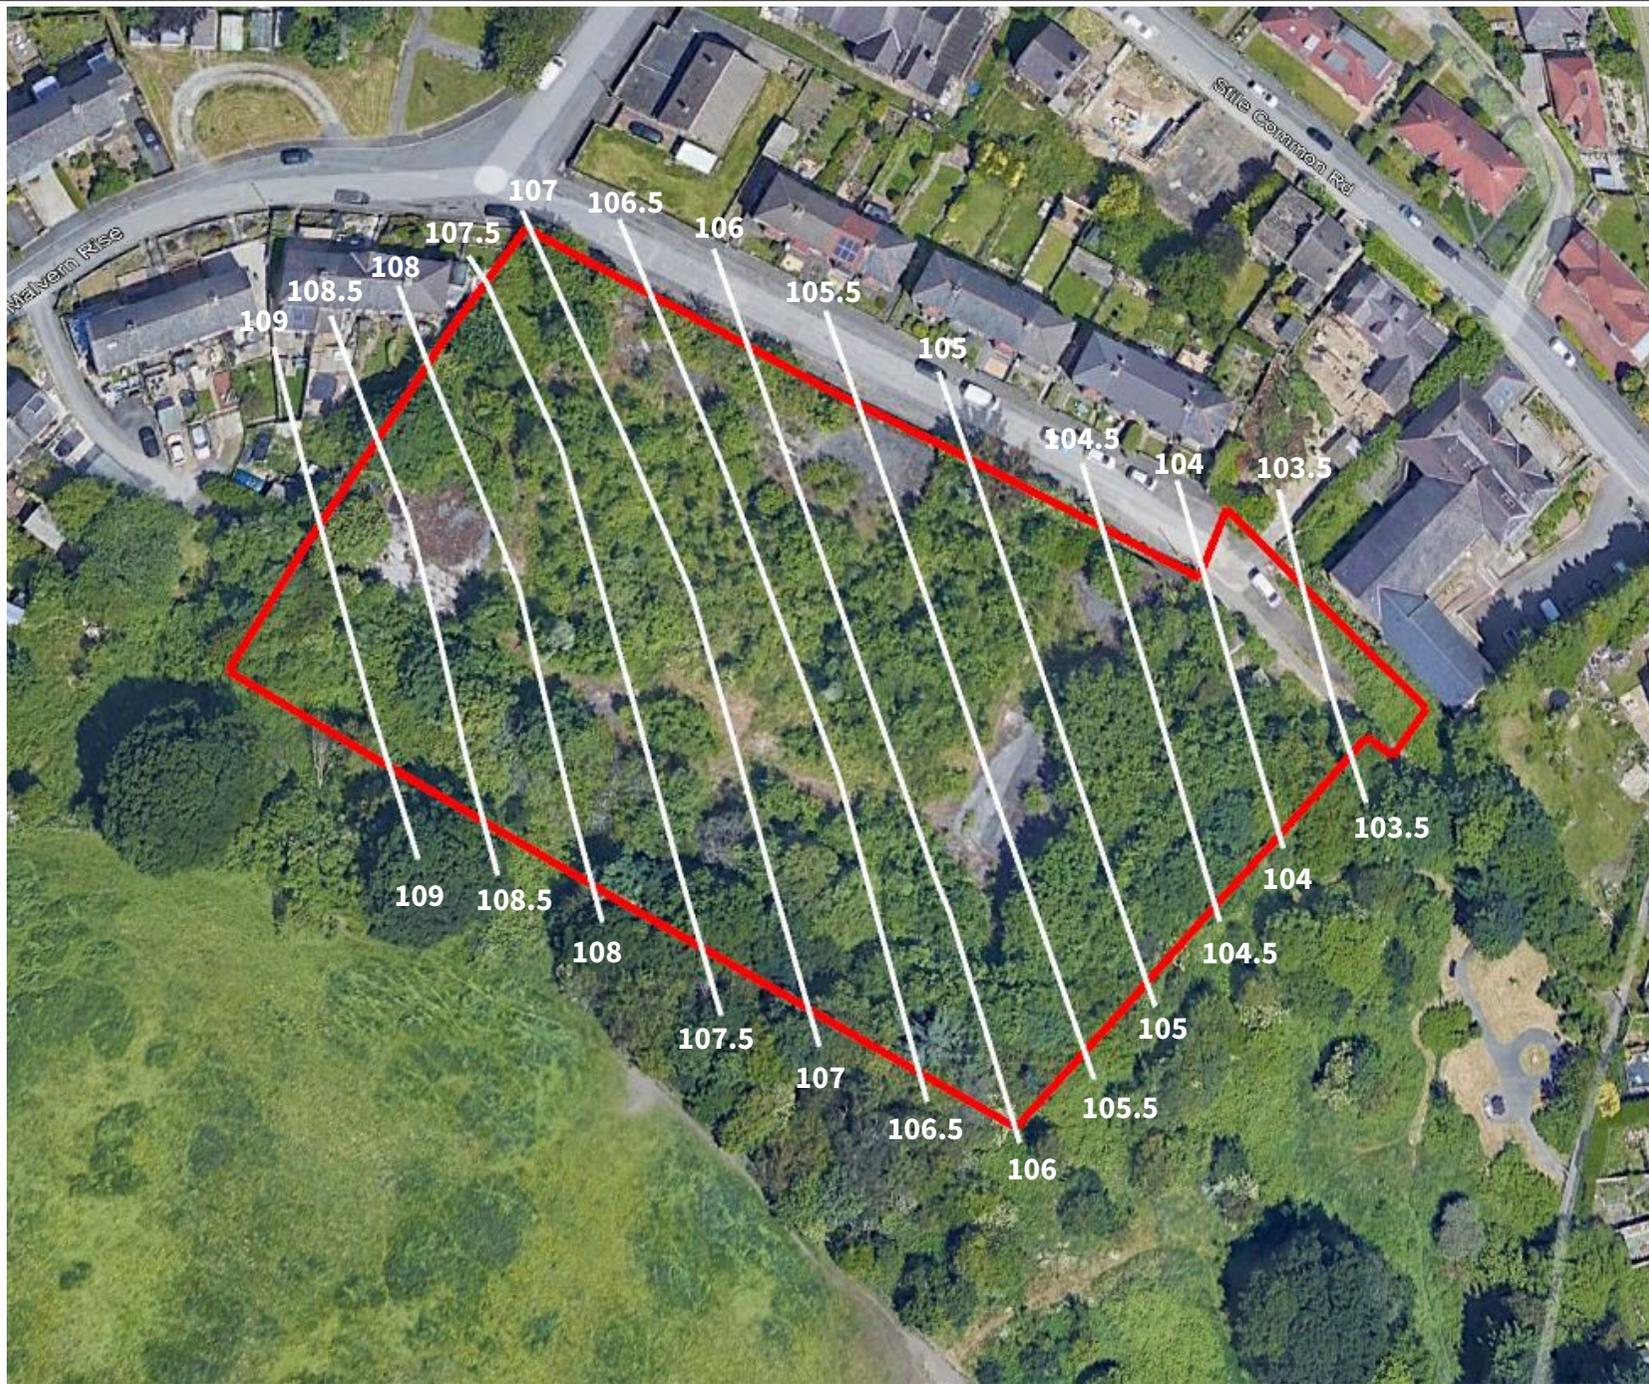
Project	PLANE STREET, HUDDERSFIELD	
Client	UNITY HOUSING ASSOCIATION	
Title	TOP OF HARD BED COAL CONTOUR LEVELS	
Date	MAY 2024	
Drawn	AMJ	Scale AS SHOWN
Job No.	UHA/13

From the coal seam contour plan drawn, the Hard Bed coal seam was calculated to be dipping east-north-east at a shallow angle of just under 3 degrees (2.6 degrees).

Taking the geological map information and the level of the outcrop of the Hard Bed coal seam (to the west of the site) and extending the seam at 3 degrees below the site, gives very similar levels to the actual borehole information recorded and the calculated/inferred levels of the seam.

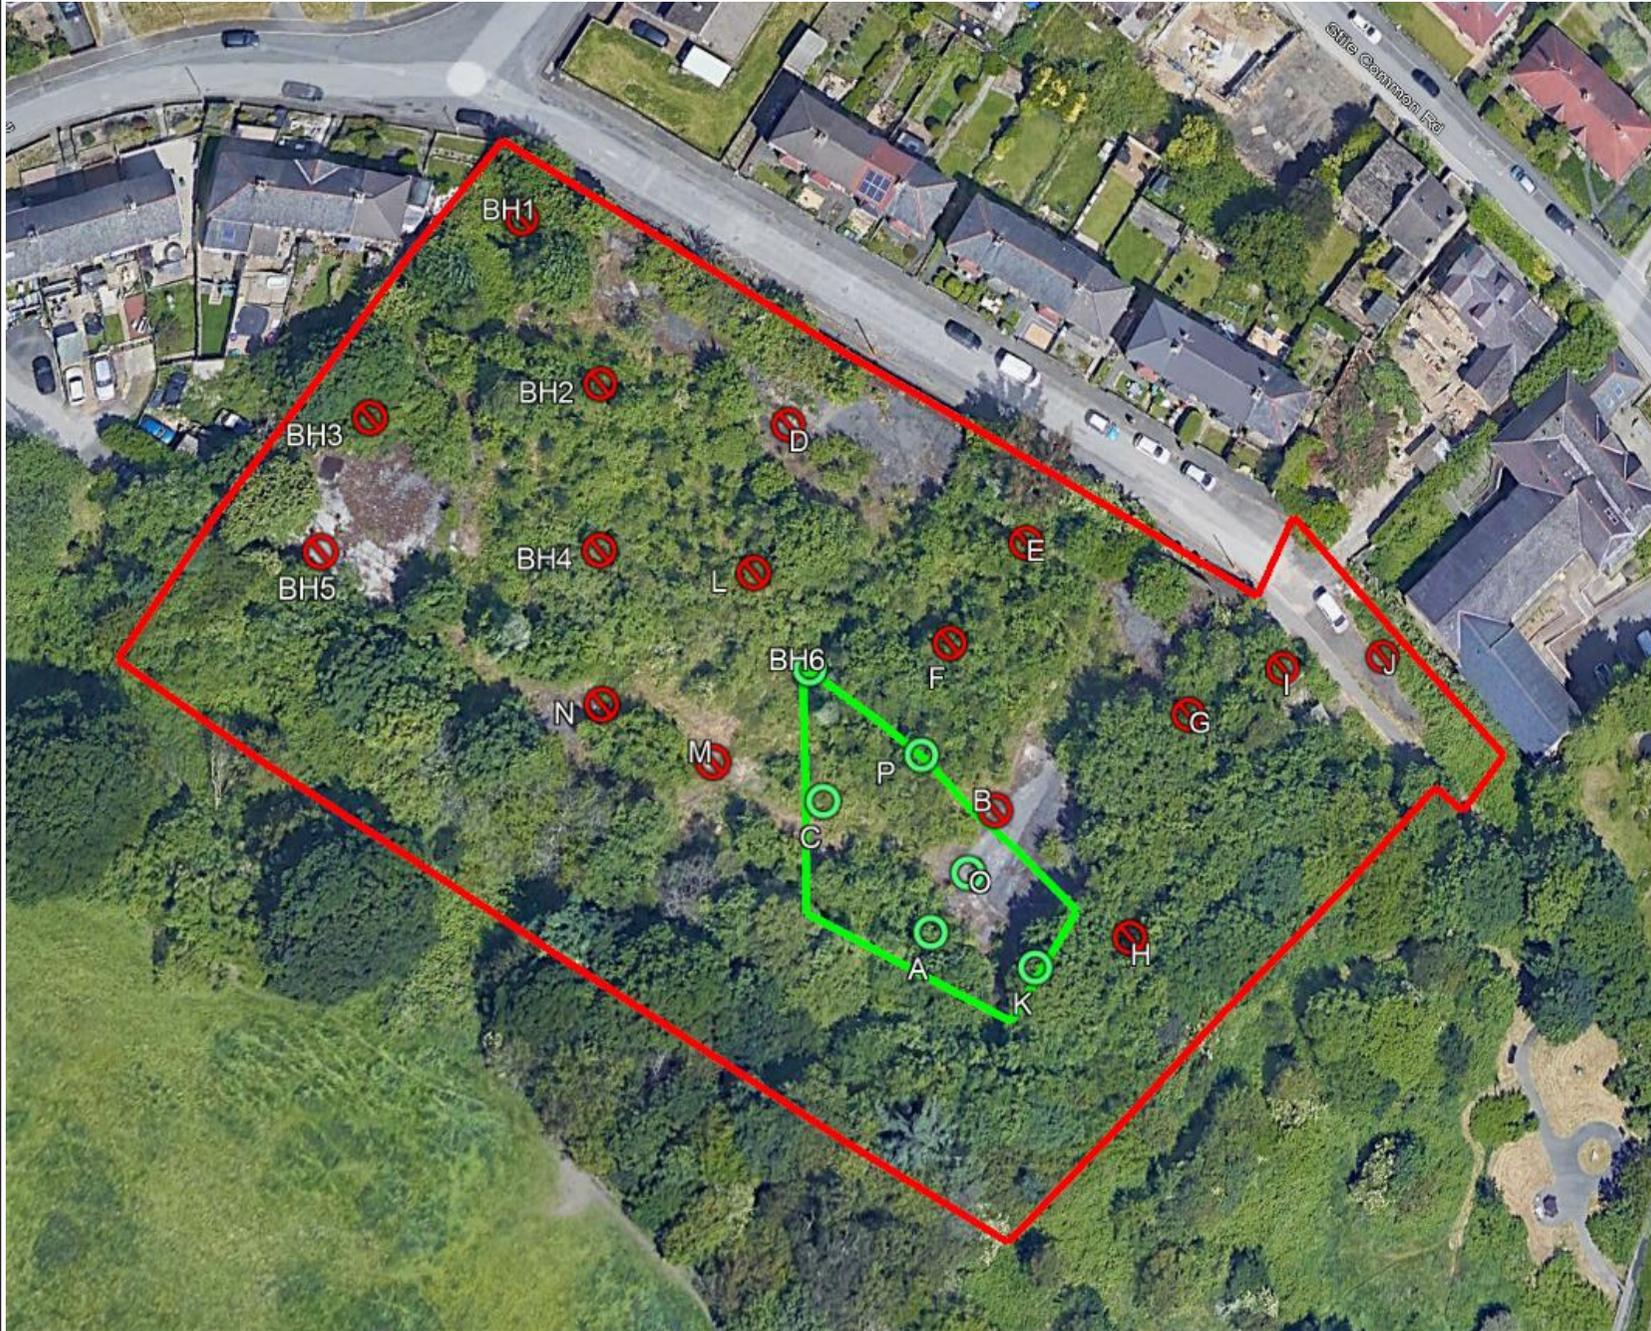
Title  
**POSITIONS SHOWING SUFFICIENT  
& INSUFFICIENT COVER (BASED ON  
0.8M SEAM EXTRACTION)**

Using a 0.8m thick extraction for the coal seam leaves a relatively small area in the southeast of the site that does not require drill and grouting. If it considered that the extracted thickness was more than 0.8m (voids were found thicker than 0.8m) then the entire site will need drill and grouting. We do, however, consider that 0.8m is an acceptable thickness to use as this was the thickest intact seam identified and the voids cannot be as accurately recorded as the intact coal seam can be, and the voids could also represent the start of void migration. Therefore, it is considered excessive to use a void thickness to calculate the required rock cover, in this case.

Position	Ground Level (m AOD)	Bedrock Level (m AOD)*	Top of Hard Bed Coal Level (m AOD)	Rock Cover (m)	Sufficient/Insufficient**
BH1	114.61	111.61	106.81	4.8	Insufficient
BH2	116.1	113.2	107.2	6	Insufficient
BH3	117.87	115.27	108.17	7.1	Insufficient
BH4	117.85	114.75	107.45	7.3	Insufficient
BH5	118.98	115.38	108.68	6.7	Insufficient
BH6	117.64	114.24	106.14	8.1	Sufficient
A	118	114.6	106	8.6	Sufficient
B	116.75	113.35	105.5	7.85	Insufficient
C	118	114.6	106.5	8.1	Sufficient
D	115	111.6	106	5.6	Insufficient
E	114.4	111	105	6.8	Insufficient
F	115.9	112.5	105.5	7	Insufficient
G	114	110.6	104.5	6.1	Insufficient
H	115	111.6	105	6.6	Insufficient
I	110.7	107.3	104	3.3	Insufficient
J	110	106.6	103.5	3.1	Insufficient
K	117.25	113.855	105.5	8.35	Sufficient
L	117	113.6	106.5	7.1	Insufficient
M	118.1	114.7	107	7.7	Insufficient
N	118.1	114.7	107.5	7.2	Insufficient
O	117.5	114.1	105.75	8.35	Sufficient
P	117.4	114	105.75	8.25	Sufficient

In the light of the above, coal mine workings identified from the rotary investigation do not have sufficient rock cover for the proposed development, and it is recommended that stabilisation treatment by injection of grout into a grid of boreholes (known as drilling and grouting) is undertaken.

It is, therefore, recommended that treatment is required for roads and pertinent structures, and 3m beyond, for the proposed development.

There is a small area in the southeast of the site that has been assessed to not require drilling and grouting works, if a 0.8m extracted coal seam thickness is used for sufficient rock cover thickness. It is recommended that during the proposed drill and grout works further investigation is undertaken at this location to confirm cover. The extracted thickness of 0.8m will need to be agreed to be the Coal Authority.
