Cumberworth C.E First School

Heritage Statement

For the Replacement of External  
Windows

31<sup>st</sup> May 2024

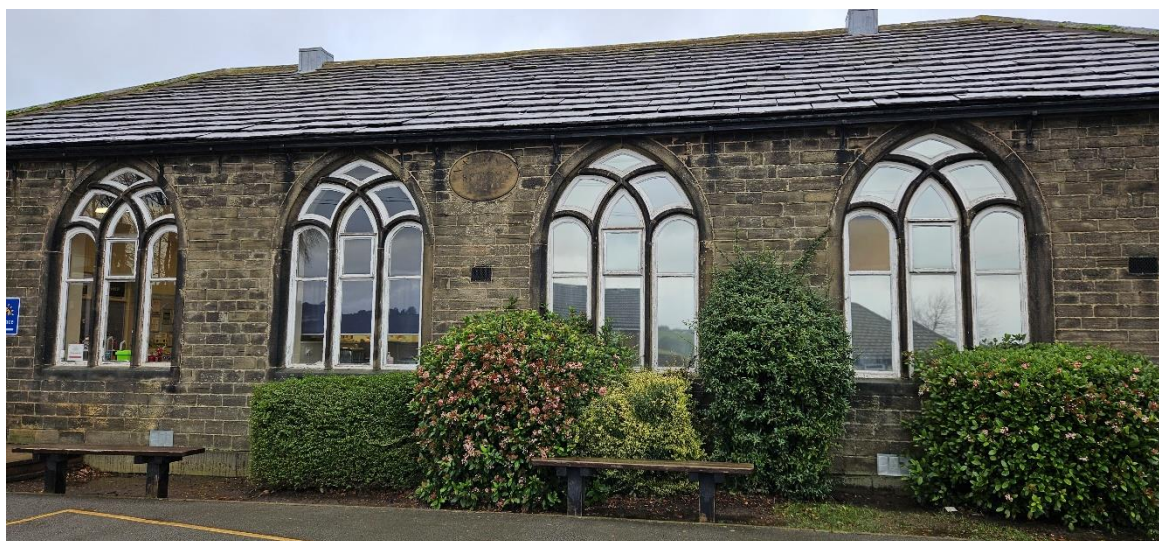
**Photo 1:** Gothic arched windows to front elevation of school, to which the works relate.

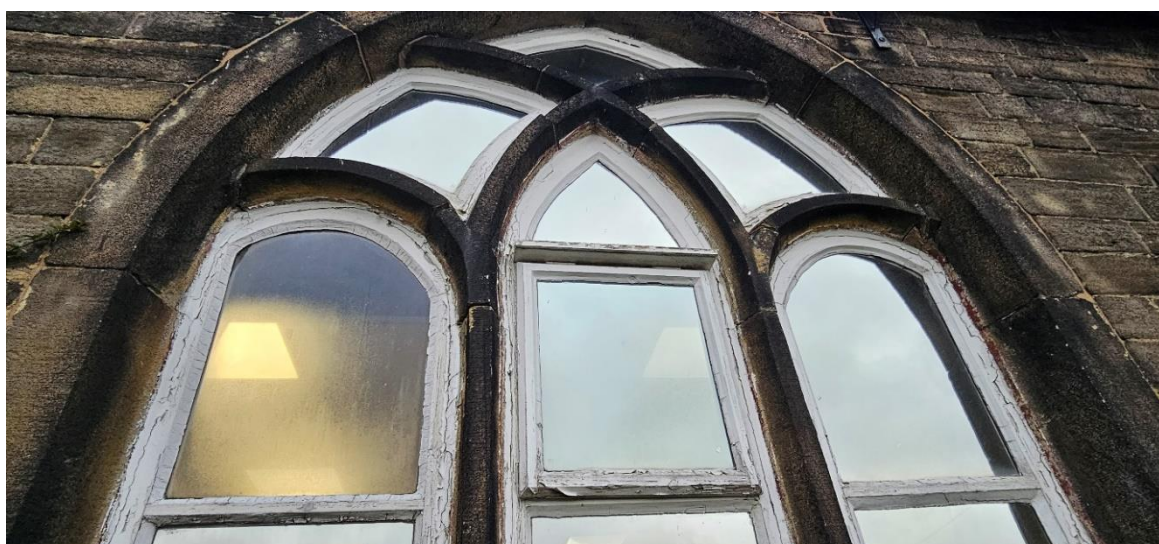
**Photo 2:** Typical detail of arched window, showing stonework and rotten timber framed single glazed windows.

4.5 In light of the above issues, it is proposed that the existing timber window frames are removed and disposed of as these are non-original and of little aesthetic value.

4.6 It is proposed that the three lights to bottom portions of the windows are replaced with Crittall steel framed windows containing low-profile double-glazed units. The central light to each window is to comprise of a side hung opener. Window frames are to be finished with a polyester powder coating, colour: Anthracite Grey (RAL 7016).

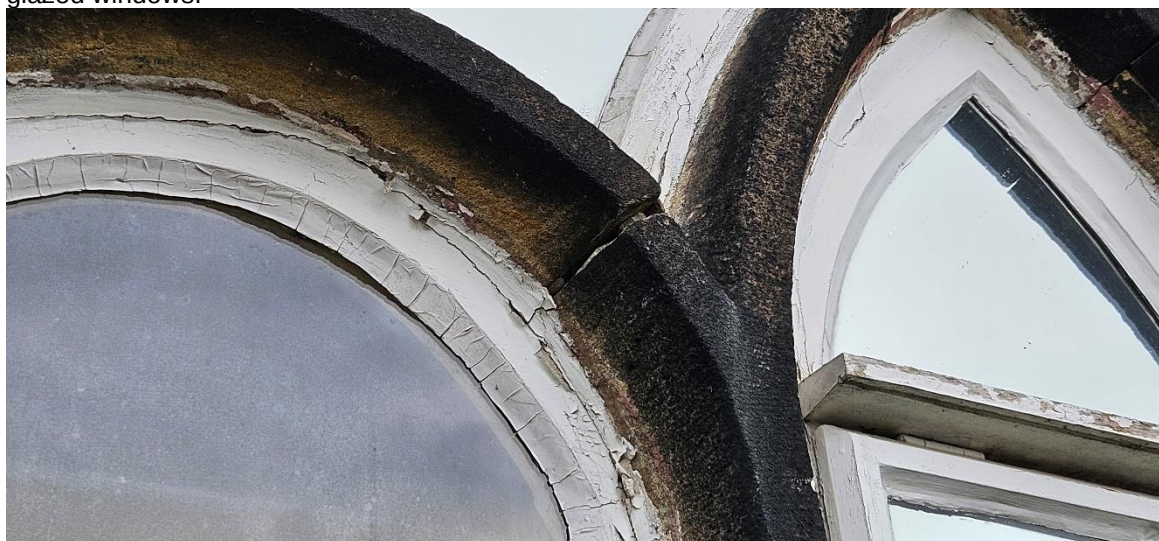
**Photo 3:** Movement evident to tracery with displacement noted between stone sections.

4.9 Replacement of defective sections of stone tracery will be undertaken by a skilled stone mason in strict accordance with the conservation officer's approval.

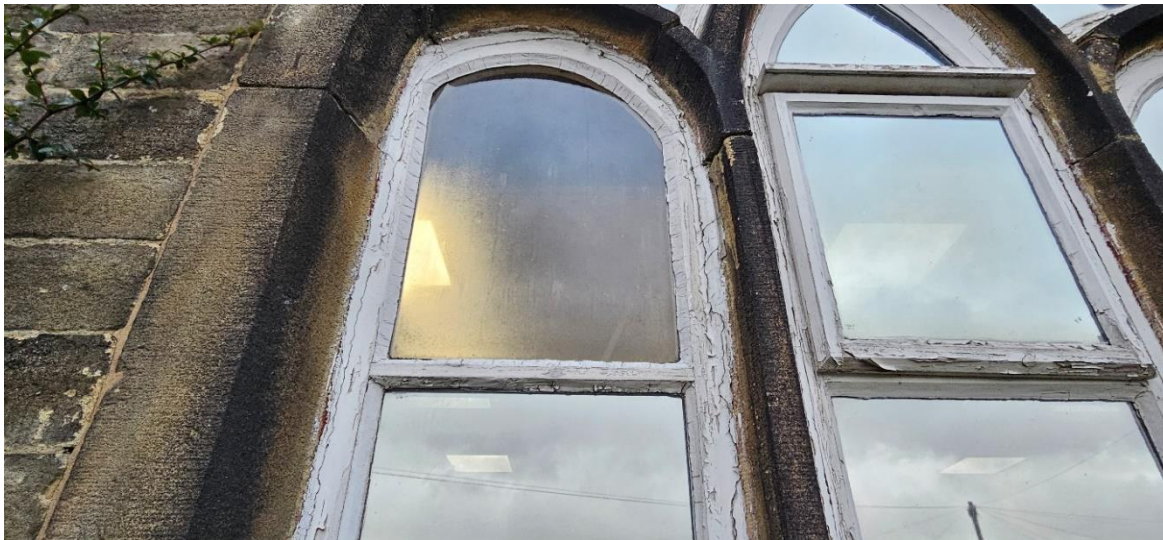
**Photo 4:** General view showing poor condition of timber framed windows inset in between stone arches.

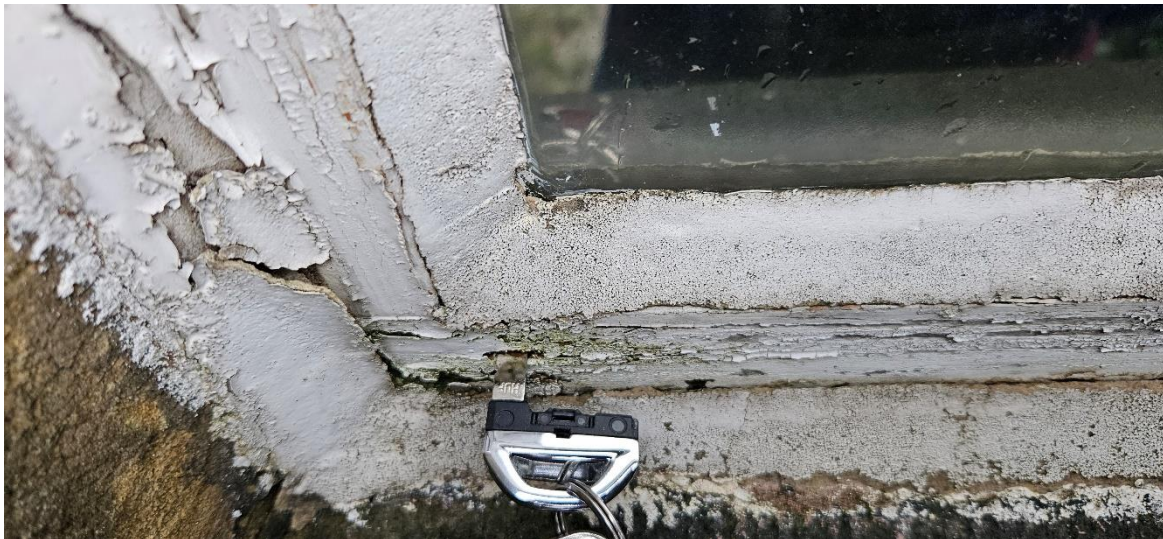
**Photo 5:** Rotten timber window frames with car key easily pushed into soft and saturated timber.

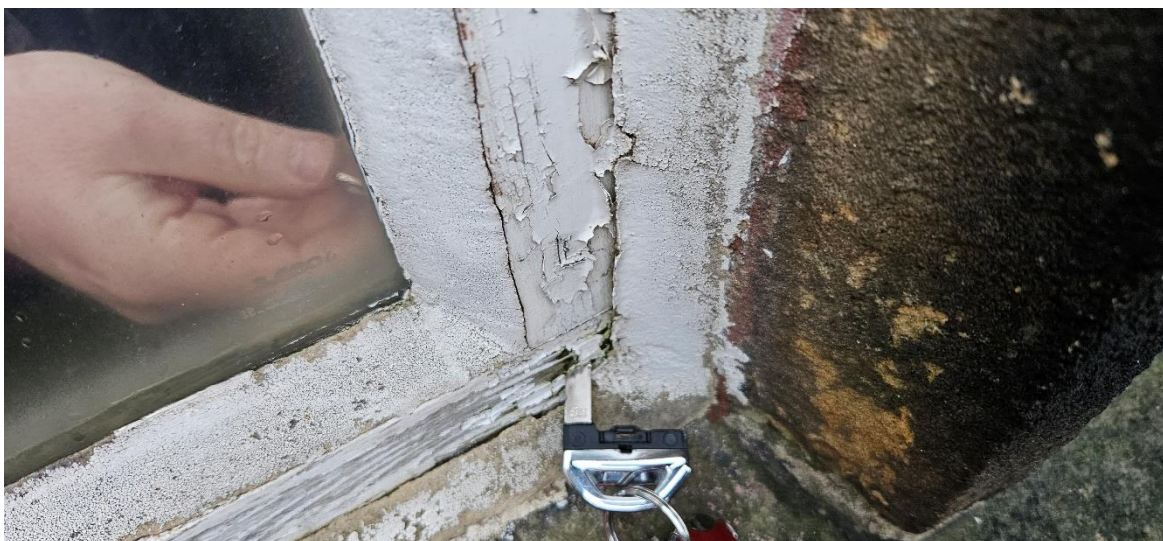
**Photo 6:** Further example of deteriorated and rotten timber framed windows.

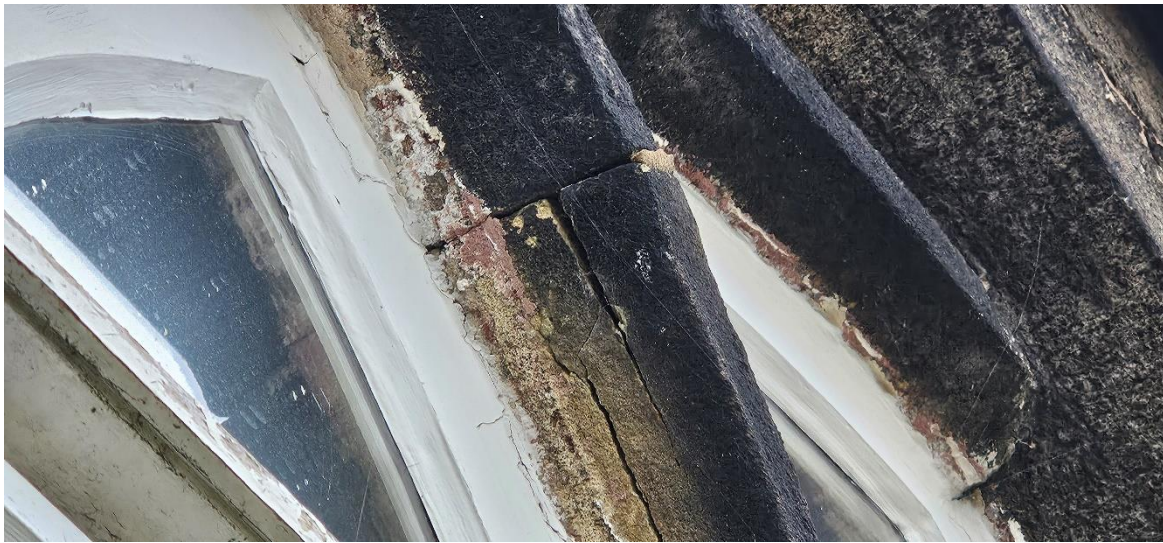
**Photo 7:** Stonework deterioration with splits and cracks in sections of stone arches.

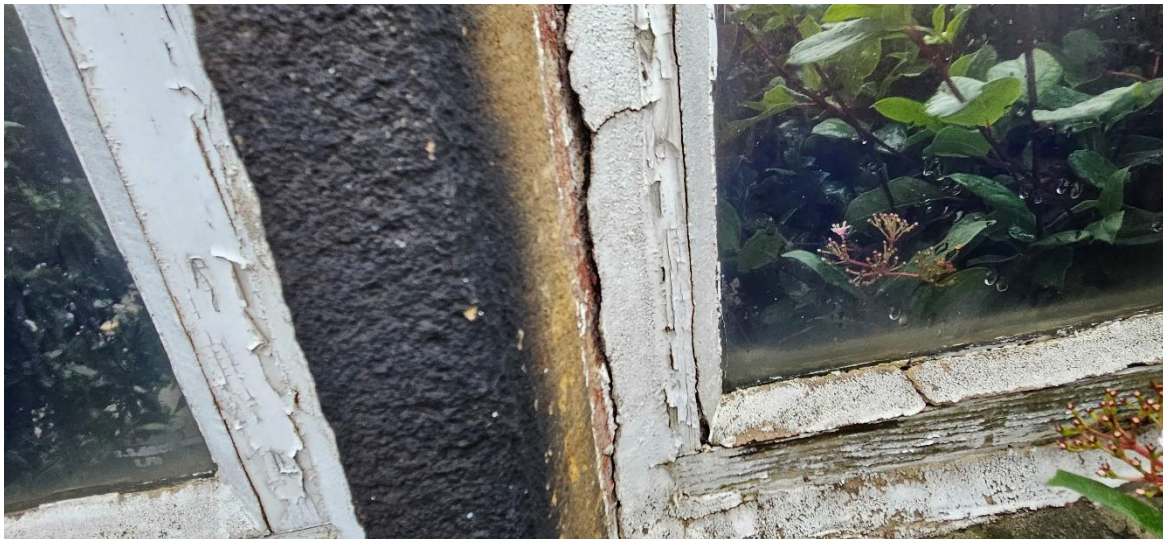
**Photo 8:** Putty infill and mortar repairs are cracked and lifting allowing moisture to penetrate into building.

4.10 It is also envisaged that areas of pointing to the tracery and surround stonework will need to be sympathetically removed and repointed in a lime-based mortar, areas to be agreed on site with the conservation officer.

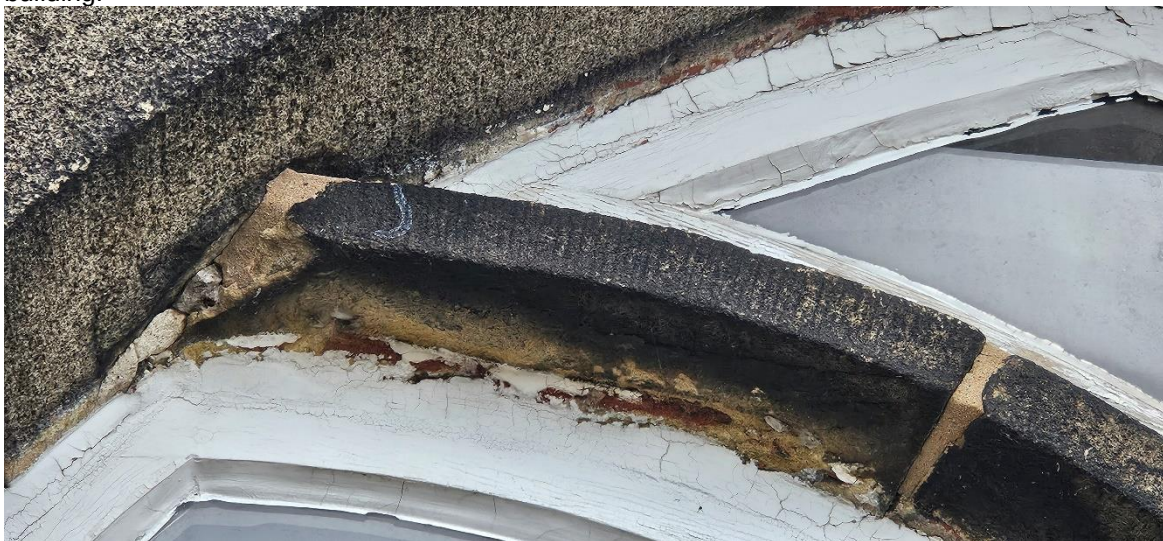
**Photo 9:** Example of previous pointing repairs to fill gaps between sections of stone arch.

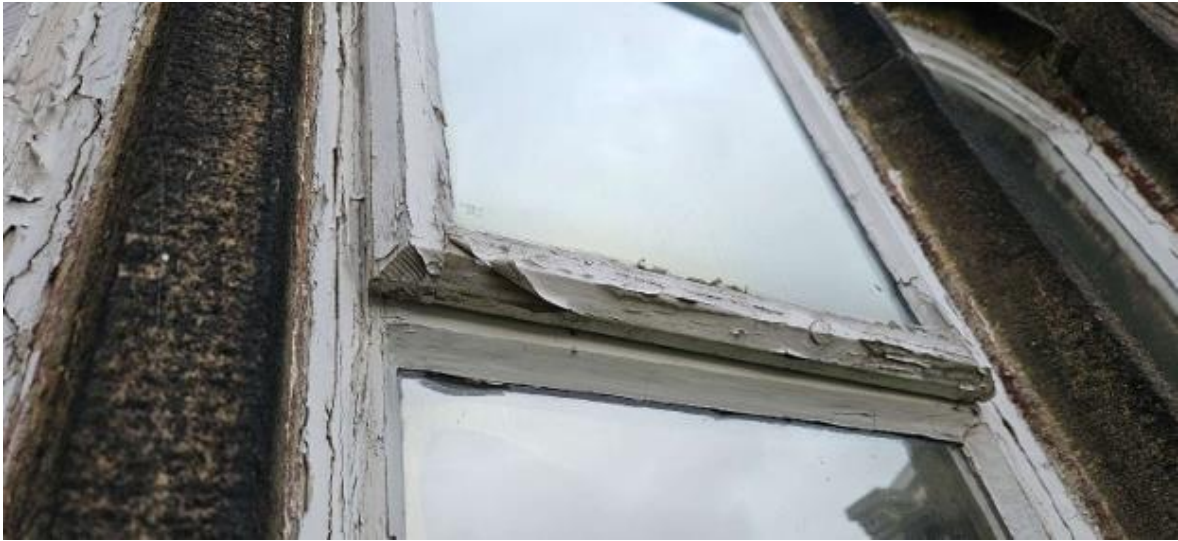
**Photo 10:** Window opener with gaps where frame has twisted / warped.

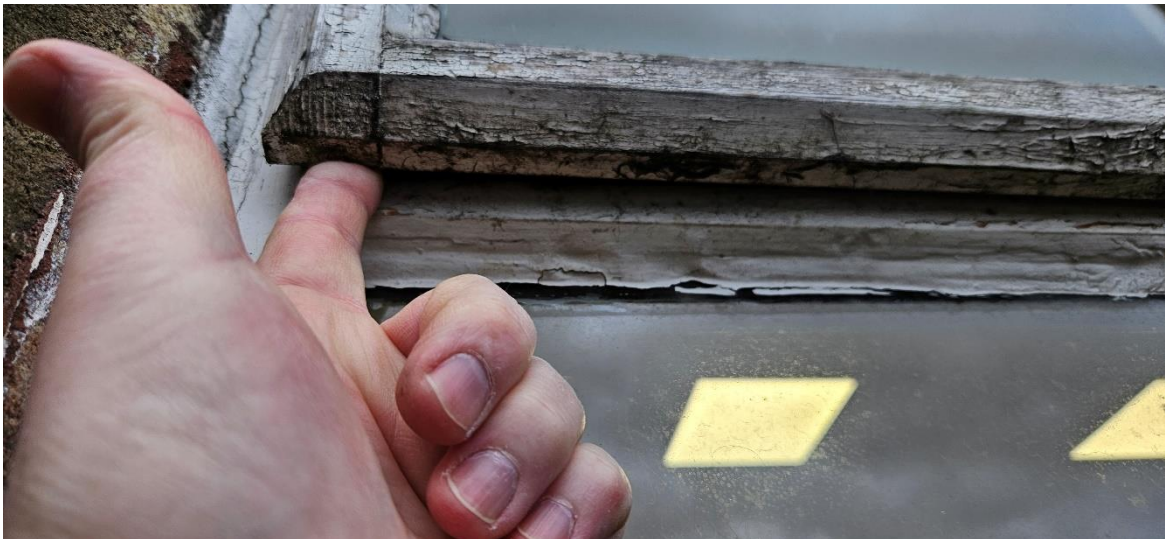
**Photo 11:** Extent of gap between frame and opener demonstrated with finger used for scale reference point.

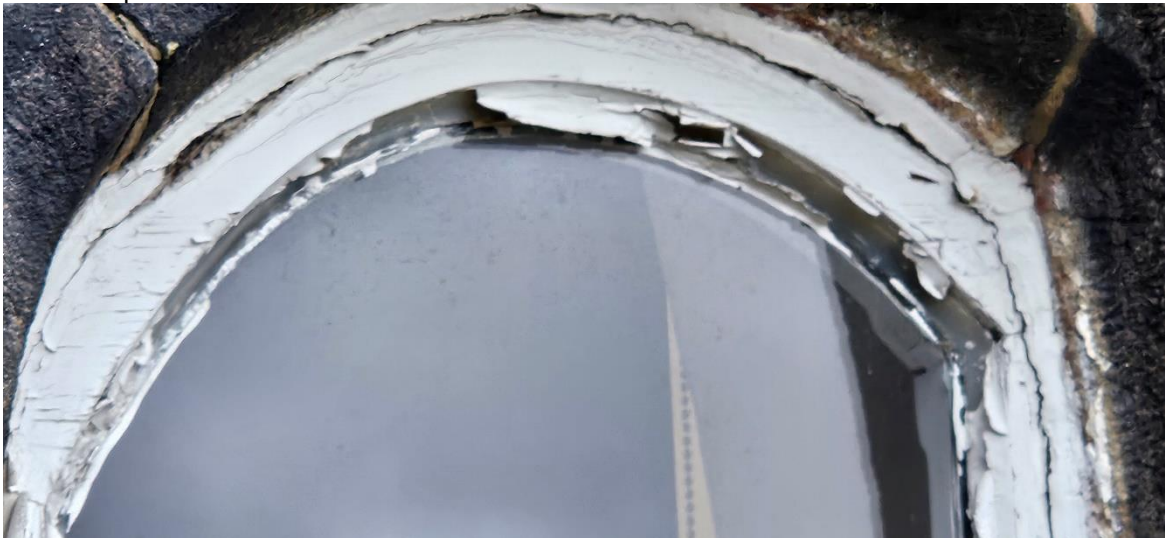
**Photo 12:** Gaps opening up between top of window frame and seal also evident is missing sections of glazing putty exposing edge of glazing pane.

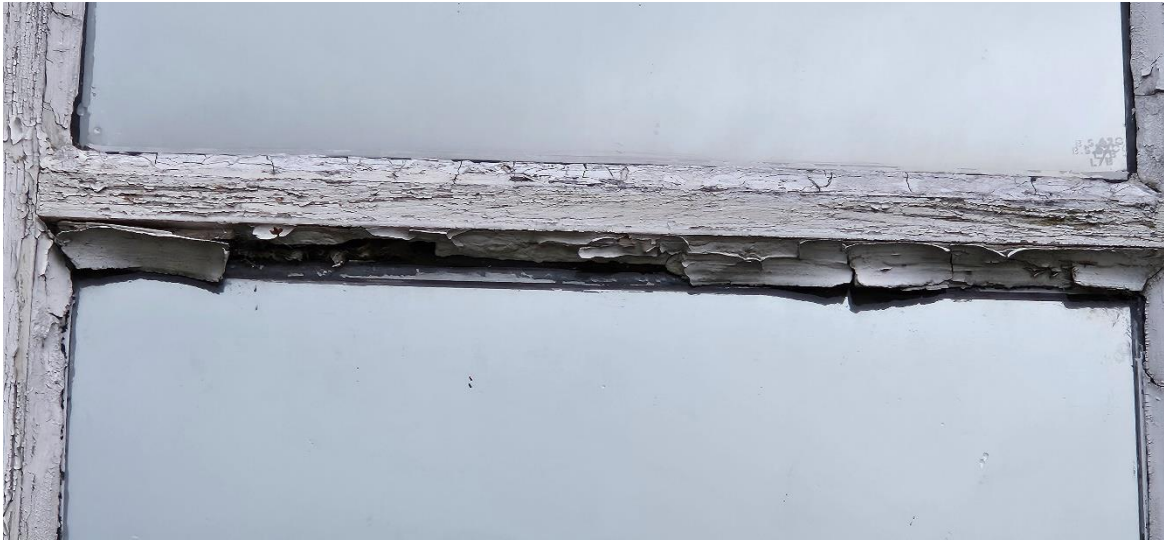
**Photo 13:** Worn and deteriorated timber glazing bead and missing glazing putty which holds glass in place.

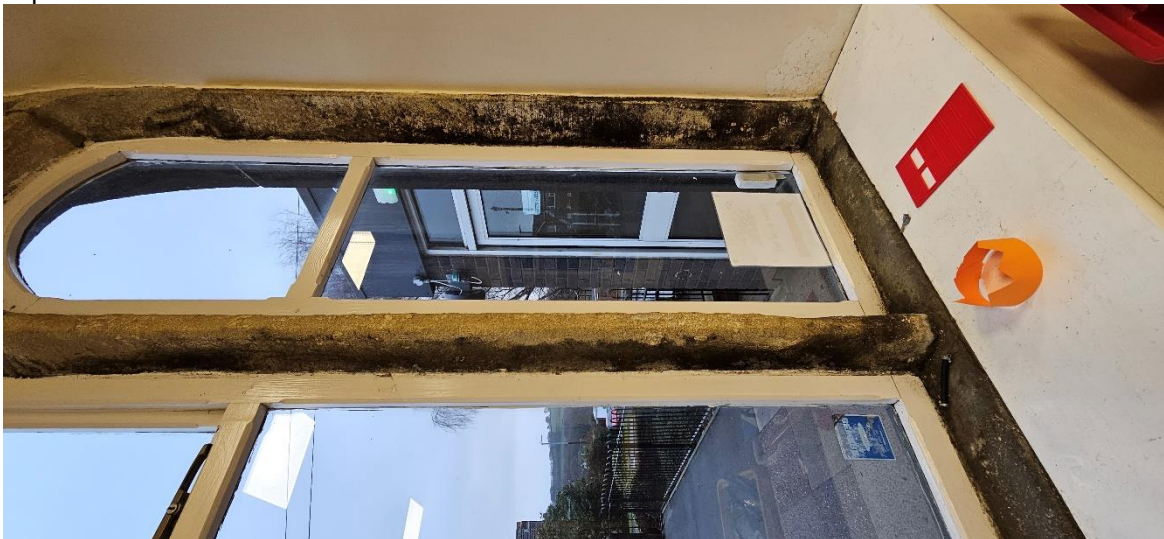
**Photo 14:** Internal view of window showing black mould, moisture staining and wear to stonework.

4.8 The stonework internally will be sympathetically cleaned by method agreed with the conservation officer.

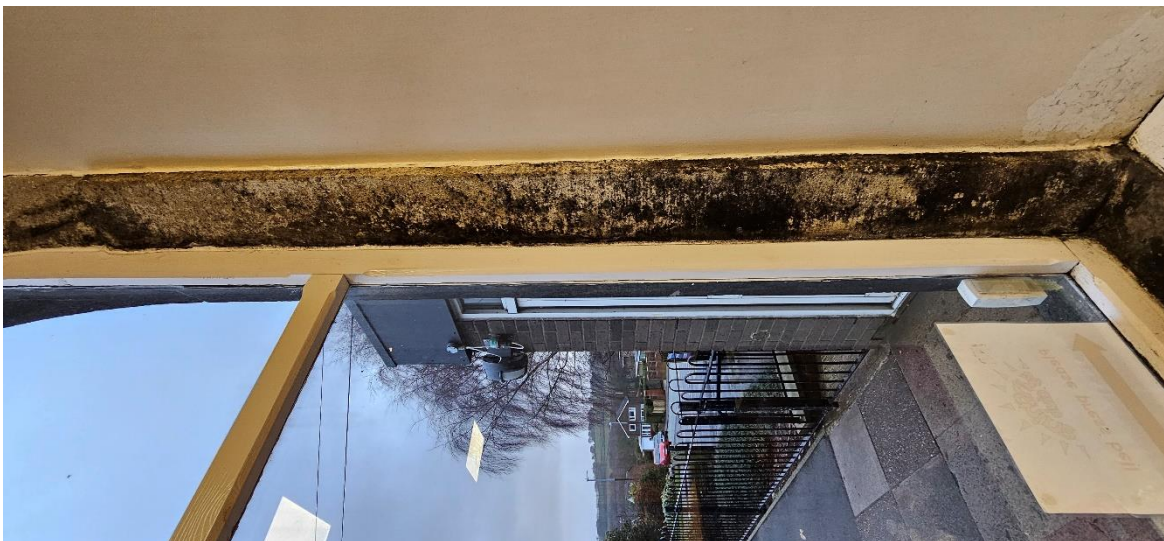
**Photo 15:** Uneven finish of stone and timber frame following contours of stone.

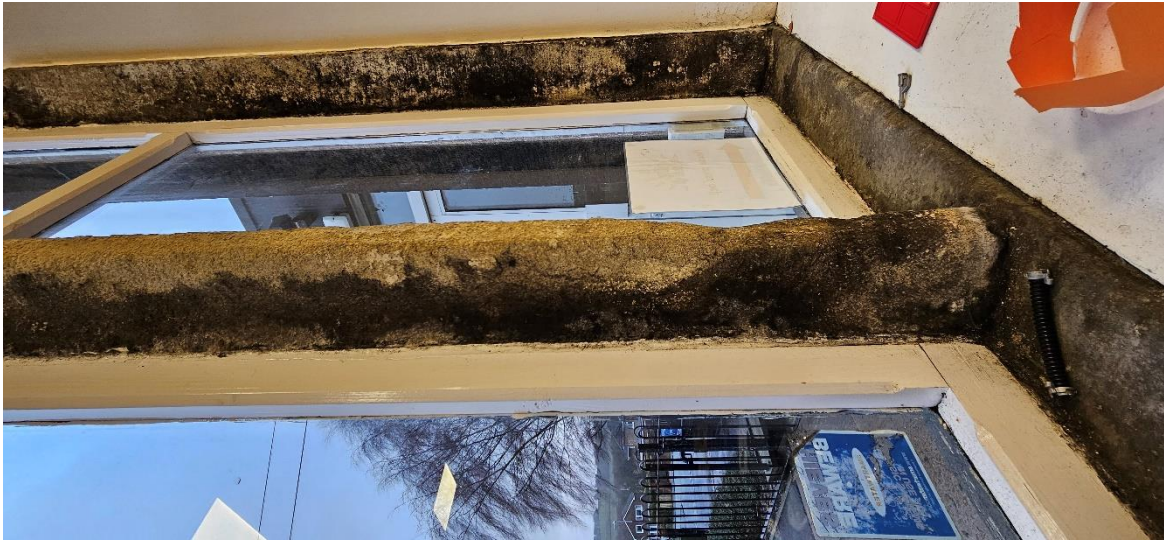
**Photo 16:** Further example of wear and staining to internal stonework from penetrative damp and condensation.

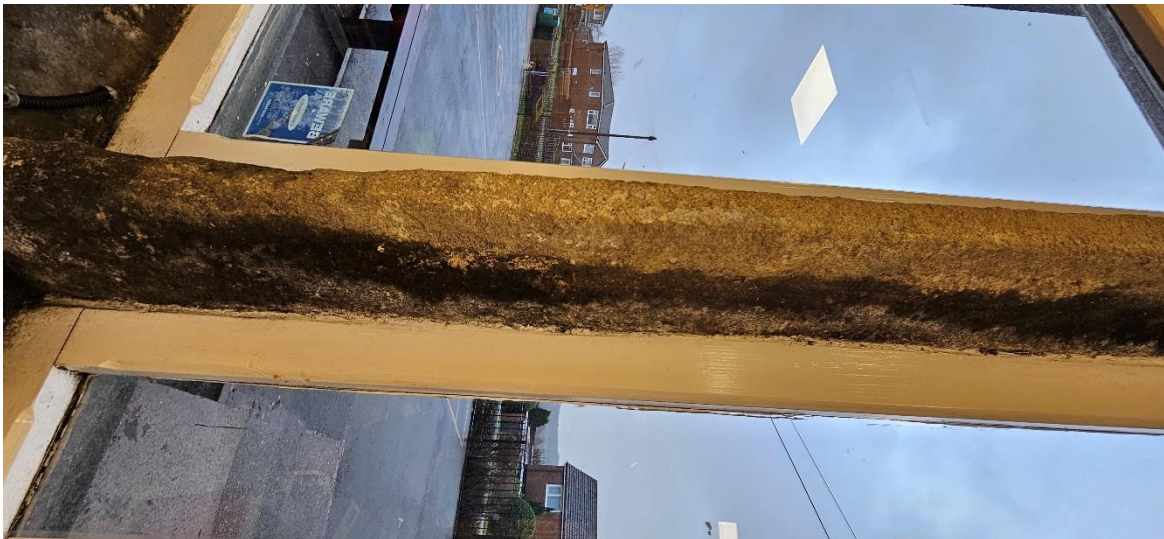
**Photo 17:** Further example of worn stonework.

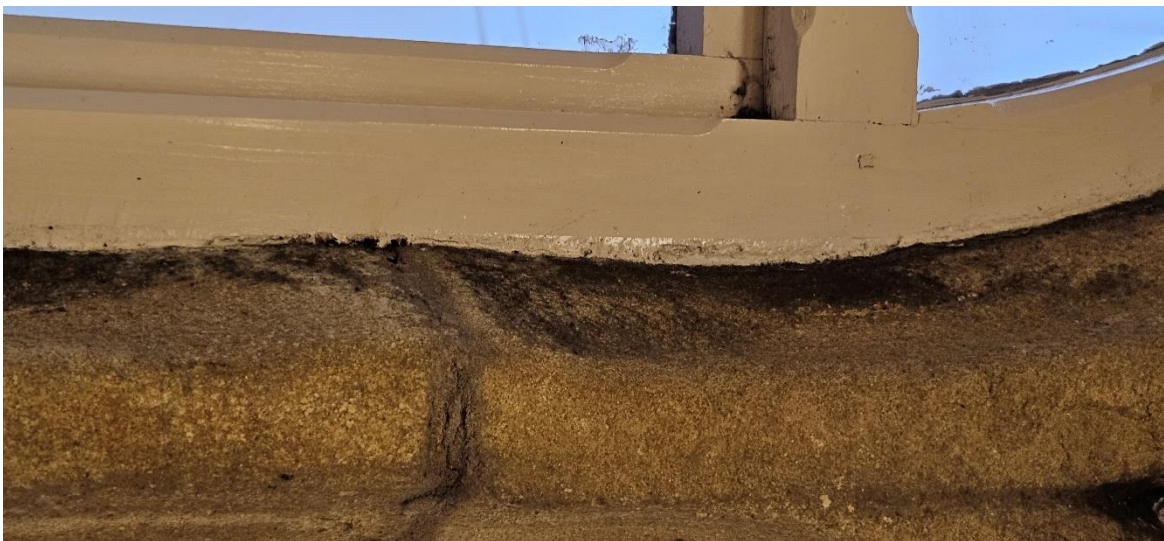
**Photo 18:** Further example of uneven edges to stonework and how gaps between the timber frame and stonework have been filled.

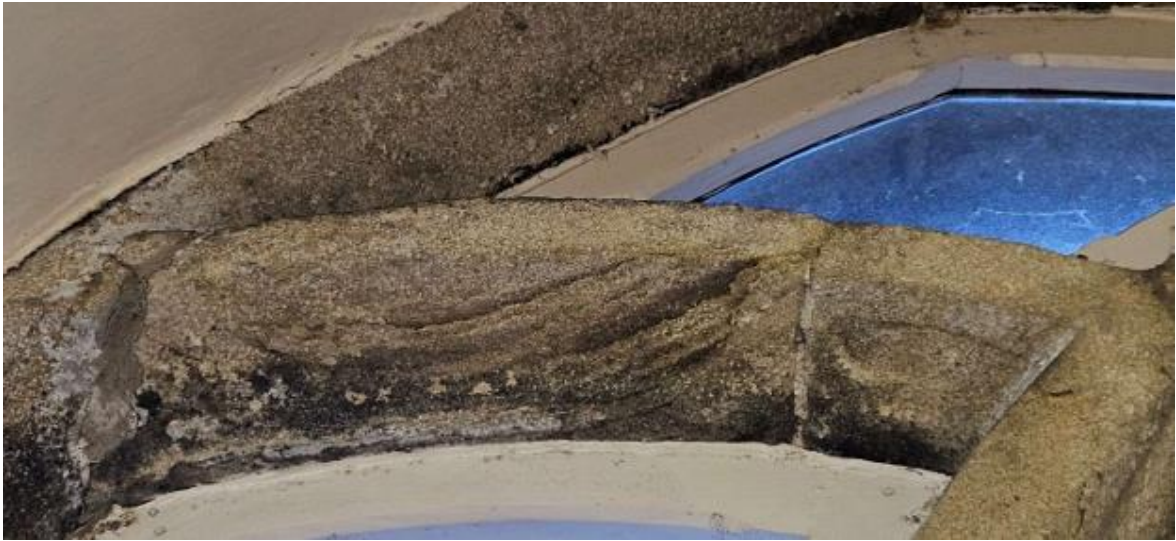
**Photo 19:** Worn and previously pointed sections evident to stonework internally.

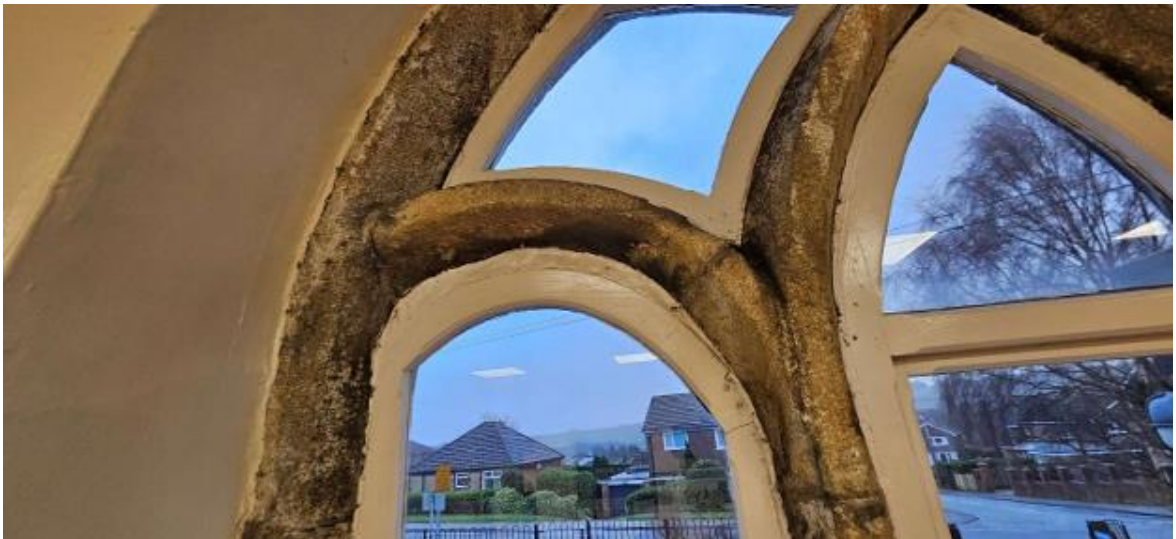
**Photo 20:** Excessive gaps between timber frames and stonework to previous installation evident.

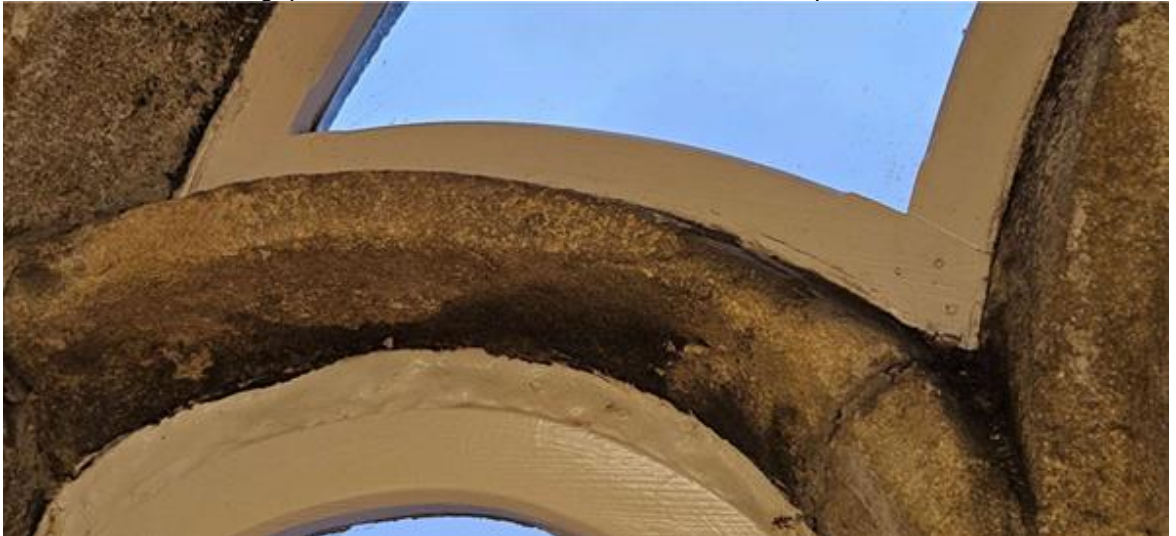
**Photo 21:** Close up view of previous view above.
