ARBORICULTURAL REPORT

& Impact Assessment

***Woodhead Road,
Birstall,
Batley,
WF17 9TD***

Reference: *AWA5815*

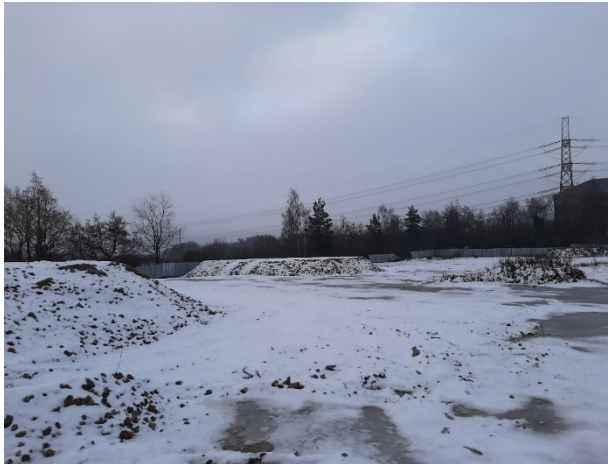
- 3.2.4 Within the central area of the site, there is little of arboricultural significance, with the only vegetation consisting of self-set whips toward the western boundary of the site, which fall outside the scope of a BS5837 survey.

Photo 1: The central area of the site, viewed from the north

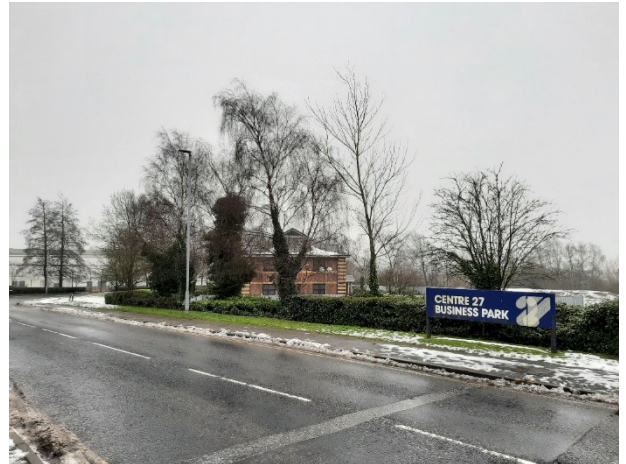
- 3.2.5 At the northern boundary of the site, close to the road, are trees T1 to T9, T26 and T27. These trees are situated in banking, and in dense understory that prevented detailed inspection. Individually the trees have limited value, but have collective value as a screen between the road and the site.

Photo 2: Trees at the northern boundary of the site, situated in dense shrub beds

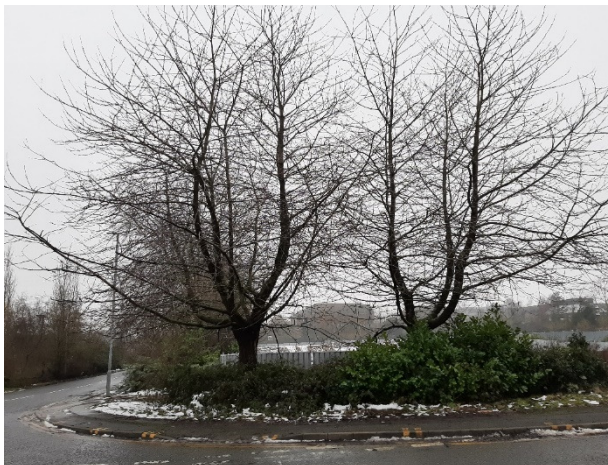
- 3.2.6 In the north-east corner of the site are Birch T14 and Cherry T15 and T16. These trees are currently in reasonable condition and have moderate amenity value, however T15 had some minor dieback and dead wood in the crown which may indicate slightly more limited long-term prospects.

Photo 3: T15 and T16, two of the mature trees on site

4.2.3 T14 and T16 are retention category 'B' trees, with limited defects and moderate amenity value. The removal of T14 and T16 will have moderate arboricultural impact.

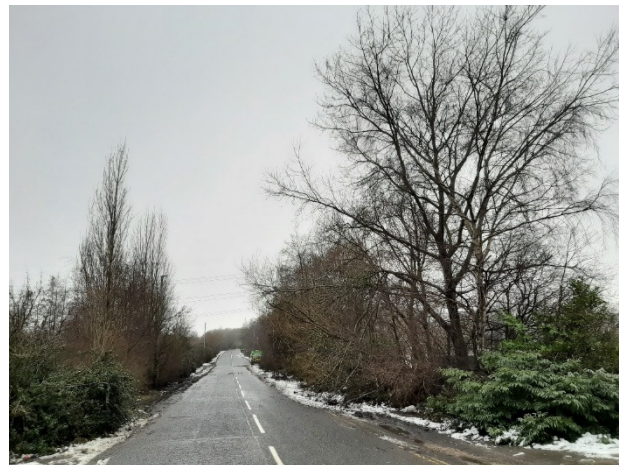
- 3.2.7 At the east, south and west boundaries of the site are large, shelterbelt groups of trees G17, G23 and G25, which contain occasional larger trees T18 to T22, and T26. G23 is a large, dense group of predominantly semi-mature Birch, Alder and Pine that has moderate value as a screen between the site and buildings to the south-west. G17 and G25 have more limited collective screening value. There are occasional failed stems and branches within these groups, including a prominent, low hazard beam failure at the eastern aspect of G17. Trees in groups, including individually numbered trees, have limited individual value, but do contribute to the more moderate collective screening value of the groups.

- 3.2.1 Poplar T19, situated within G17, has a prominent hanging branch at its eastern aspect that should be removed regardless of any new development (as detailed in Appendix 4)

Photo 4: G17, at the eastern boundary of the site

4.2.6 The north-western aspect of G17 will be removed, to the boundary line. The north-western extent of G23 will be removed to facilitate the proposed foodstore, while the eastern aspect will be pruned to the boundary line to facilitate the retail unit and garden centre. Both groups will continue to provide effective screening from the road and adjacent buildings.

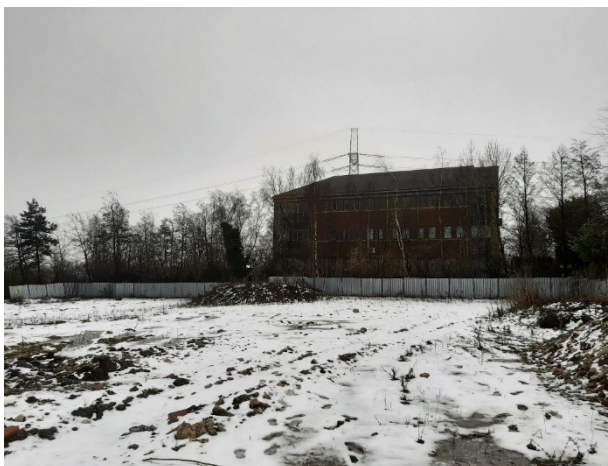
Photo 5: G23 at the southern boundary, screening the site from adjacent office buildings

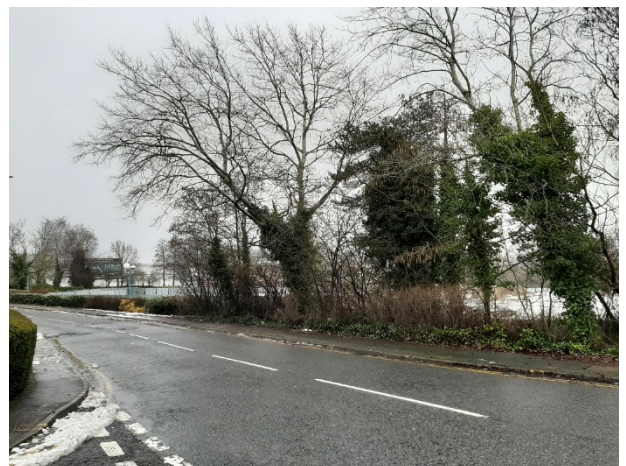
Photo 6: G25 and T26, at the western boundary of the site

4.2.8 The crown of T5 currently overhangs the proposed parking spaces and as such should be raised by 1-2m to facilitate the development. The eastern crown of T26 is currently overhanging slightly into the location of the proposed retail unit. As such, the eastern aspect of T26 should be reduced by 2 -3m to facilitate the development and provide adequate clearance for future growth.

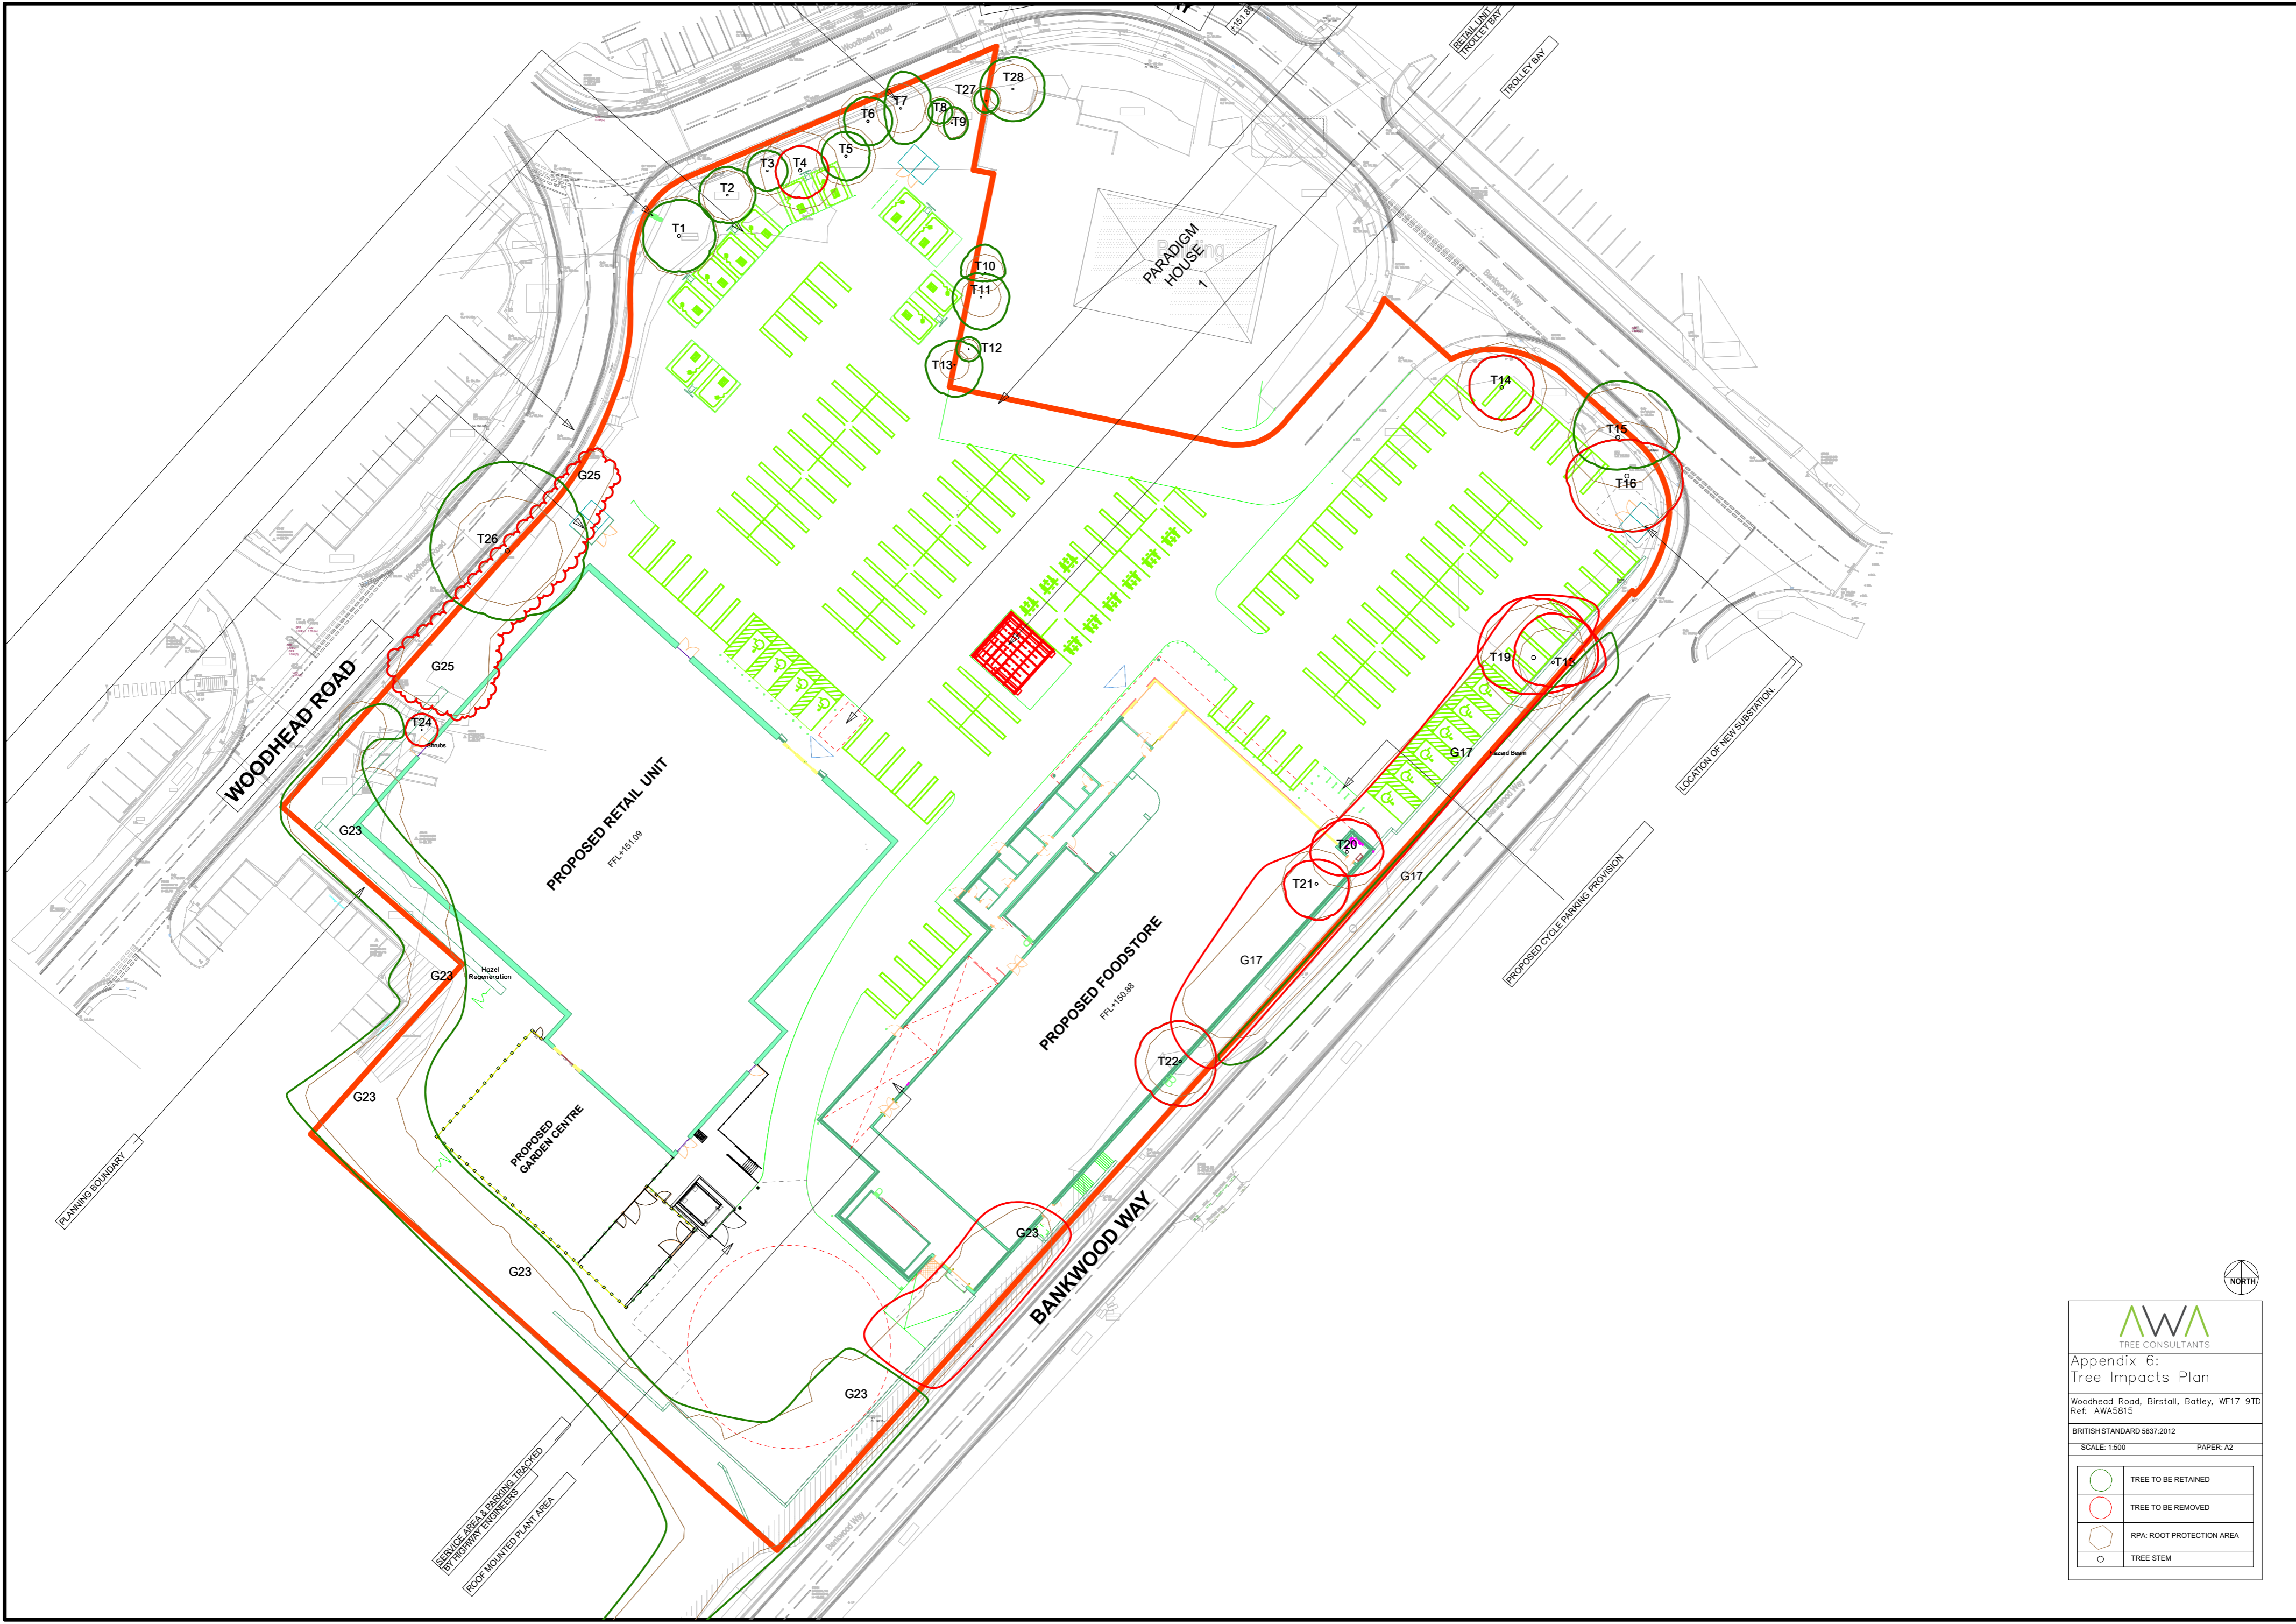
Appendix 6:
Tree Impacts Plan

4.2.2 The trees and groups that are required to be removed are T4, T14, T16, T18, T19, T20, T21, T22, T24 and G25.
