# The Gas Club

## Preliminary Roost Assessment Report

17<sup>th</sup> July 2023

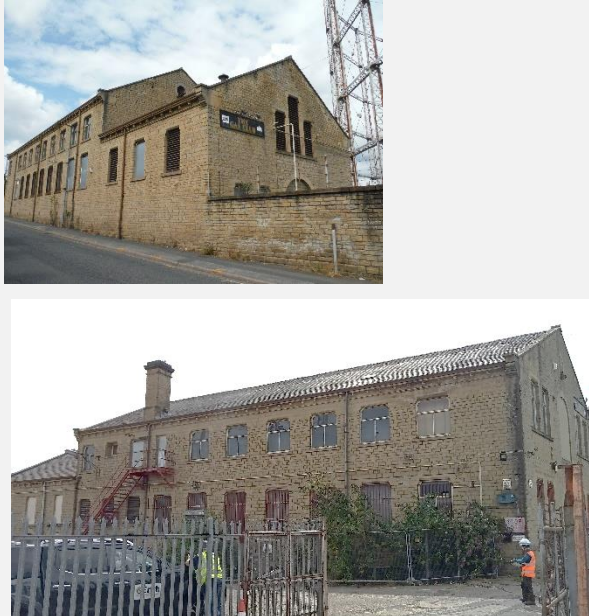
| Structure number | Structure Type/Description | Photos | Bat Suitability |
|---|---|---|---|
| <b>The Gas Club</b> | <p>A large two-story stone building with a pitched slate tiled roof, wooden window frames and wooden fascia's, with an adjoining large single-story building, a basement level is present across the entire building.</p> <p>The building supports features suitable to support roosting bats such as; lifted and missing tiles, open grilled windows, gaps behind boarded windows, broken windows and missing mortar within the brickwork please see Appendix A for full details.</p> | | <b>Moderate</b> |

The Gas Club has been identified to support **Moderate** suitability to support roosting bats.

Following best practice guidelines <sup>2</sup> it is recommended that buildings/structures, with moderate suitability which could be directly and/or indirectly impacted (lost/disturbed etc.) by proposed development, a series of presence/absence surveys should be conducted, to determine if roosting bats are occupying the features, and if so what type of roost is present.

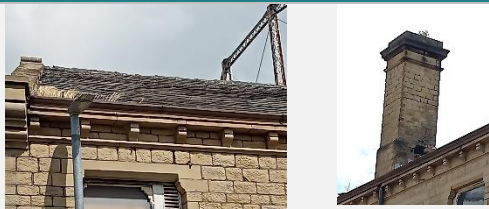
| Facing | Feature Description | Photos | Bat Suitability |
|---|---|---|---|
| All sides | Lifted roof tiles and missing slate tiles across all faces of the building | | Moderate |
| | Gaps in chimney coping stones | | |

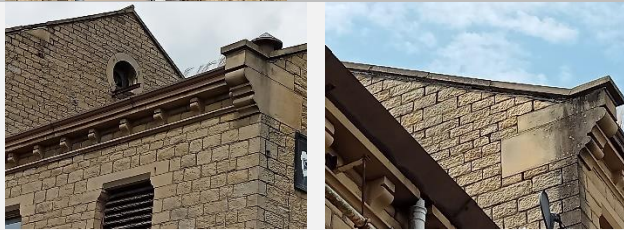
| Facing | Feature Description | Photos | Bat Suitability |
|---|---|---|---|
| Eastern | Open wooden grills on the eastern side of the building leading to internal access of single-story building section | | |
| | Gap in mortar along the eastern gable end approx. 20cm in length possible cavity. | | |
| | Circular window providing access into two story building. | | |
| | Missing gable coping edging stones | | |

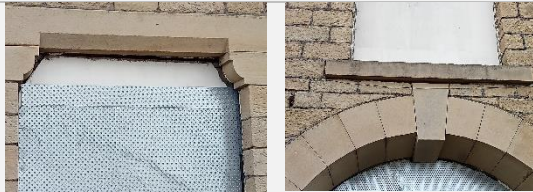
| Facing | Feature Description | Photos | Bat Suitability |
|---|---|---|---|
| North | Gaps behind steel and wooden boards fitted over the windows on the ground floor | | |
| | 2.5cm gap under window stone sill above the doorway | | |
| | Smashed windows leading into the basement | | |

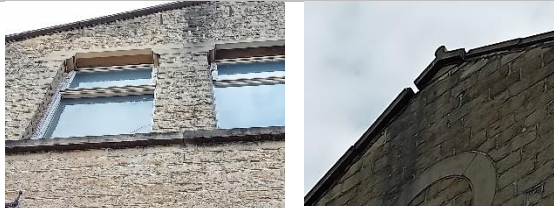
| Facing | Feature Description | Photos | Bat Suitability |
|---|---|---|---|
| Western | Gaps under the window lintels approx. 2cm | | |
| | Gap between the western gable coping edging | | |
| | Gap in the mortar | | |

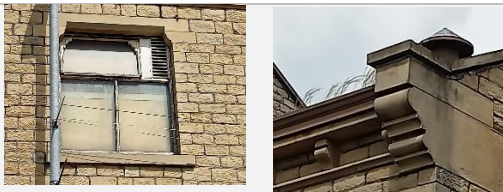
| Facing | Feature Description | Photos | Bat Suitability |
|---|---|---|---|
| Southern | Open grill in window | | |
| | Boarded wooden windows with cavities behind and around edges | | |
| | Smashed lower window | | |
| | Shallow 3cm gap in masonry coping stone | | |

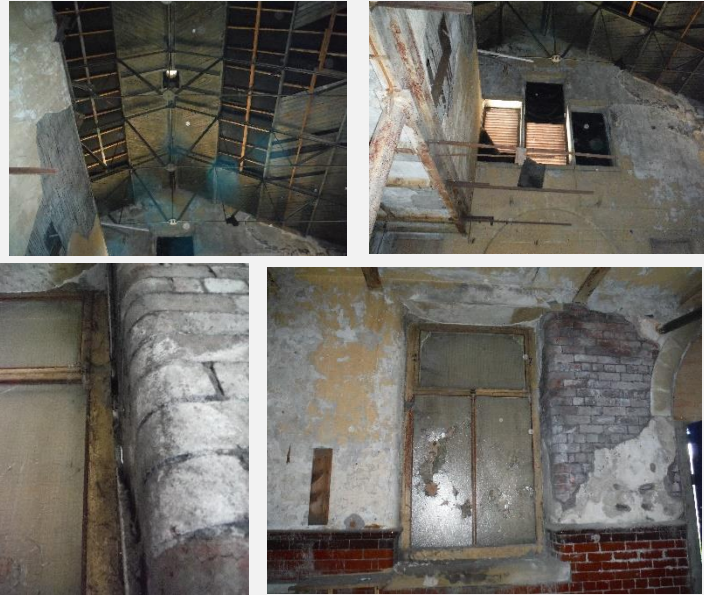
| Facing | Feature Description | Photos | Bat Suitability |
|---|---|---|---|
| <b>Single story internal</b> | Gap between window and brickwork on ground floor | | |
| | <p>Wattle and daub visible with suitable ledges and cavities on the elevated platforms</p> <p>Shallow cavities within the breeze block with missing mortar</p> <p>Partial wooden panelled and roof lining with cavities present and slipped boards.</p> <p>Building has not been used in some time, no evidence encountered, large open room with elevated platforms with wattle and daub panelling in dis-repair, access into the building from the grilled wooden windows.</p> | | |

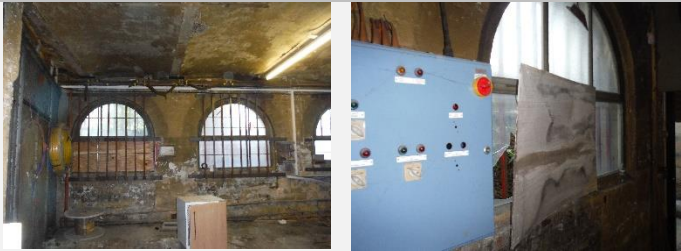
| Facing | Feature Description | Photos | Bat Suitability |
|---|---|---|---|
| <b>Basement internal</b> | Broken lower-level windows leading to the interior of the building. Building temperature stable but damp, interior has not been used in some time, no evidence encountered. | | |
