ARBORICULTURAL REPORT & Impact Assessment

to BS 5837:2012 at:

***Oldfield House Farm
Oldfield Road
Honley
Holmfirth
HD9 6RL***

Reference: *AWA6031*

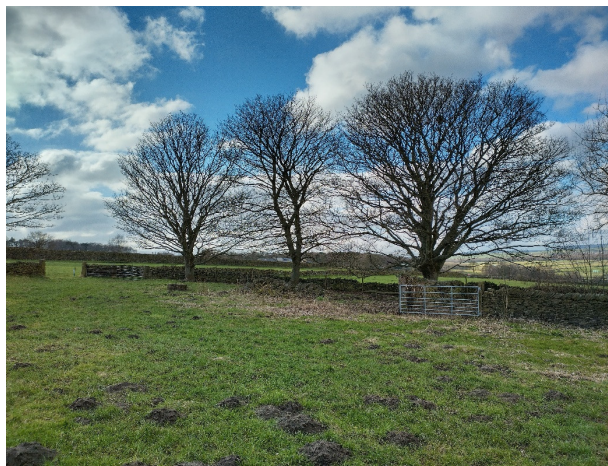
- 3.2.7 Sycamore T5 to T7 run along the north-western boundary. These mature trees are important within the local landscape and provide a good degree of amenity. They contain occasional minor defects but otherwise offer good long-term value.

Photo 3: T5 to T7 within the site, looking west

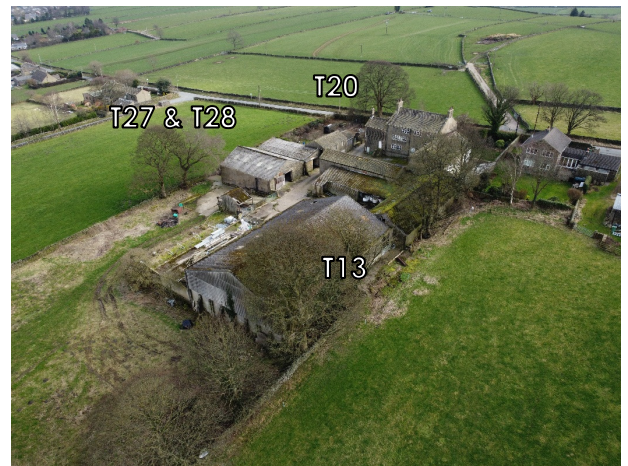
Photo 4: Overview of trees along the southwest boundary, many overhanging adjacent farm outbuildings. Looking east

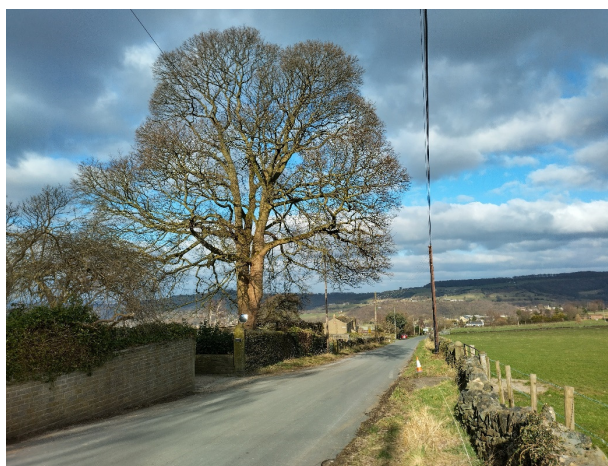
- 3.2.11 T20 is a mature Sycamore in a prominent position by the main road. It is a significant tree within the wider landscape and is likely to provide good long-term value.

Photo 5: T20 is in a prominent location on the main road past the site, looking north-east

- 4.3.4 A new courtyard and wall are proposed that encroaches into the RPA of T20, T27 and T28. Construction of hard surfaces within the RPA can have negative impacts on tree roots. However, the potential negative impacts can often be overcome or minimised by employing a 'no-dig' type construction methods with a porous final surface.

- 4.3.5 Care must be taken during the construction of the wall elements to avoid any trenching works, or significant excavation below the existing ground levels. Careful control of activities within the area surrounding retained trees T20, T27 and T28 must be implemented.

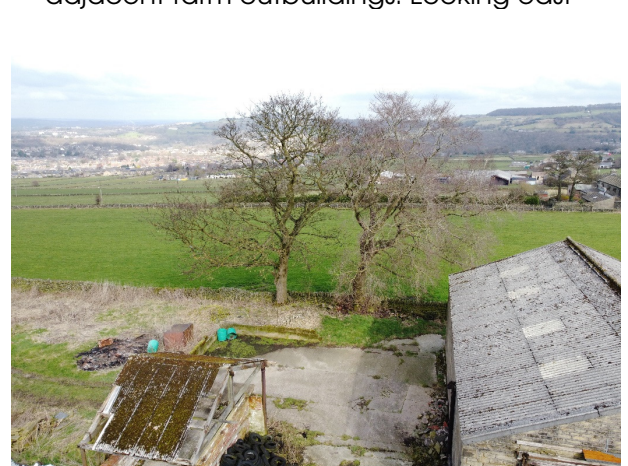
- 3.2.13 T27 and T28 are a mature Lime and Sycamore respectively. They hold a relatively prominent position within the local landscape and offer a good degree of amenity. Both trees appear in good condition following recent crown lifting works, however there is some minor bark damage on a secondary limb within the lower crown of T28.

Photo 6: T27 and T28 are prominent within the local landscape, looking north-east

- 4.3.3 The new development encroaches close to and into the edge of the RPA of retained trees T27. Construction within the RPA can have negative impacts on tree roots. However, the encroachment into the RPA of retained trees is generally minor and the hard surfaces and footings of the existing structures are likely to have limited root development within these areas. As such, it is unlikely that significant roots will be within these areas and the retained trees should remain largely unaffected by the works, provided care is taken during construction.

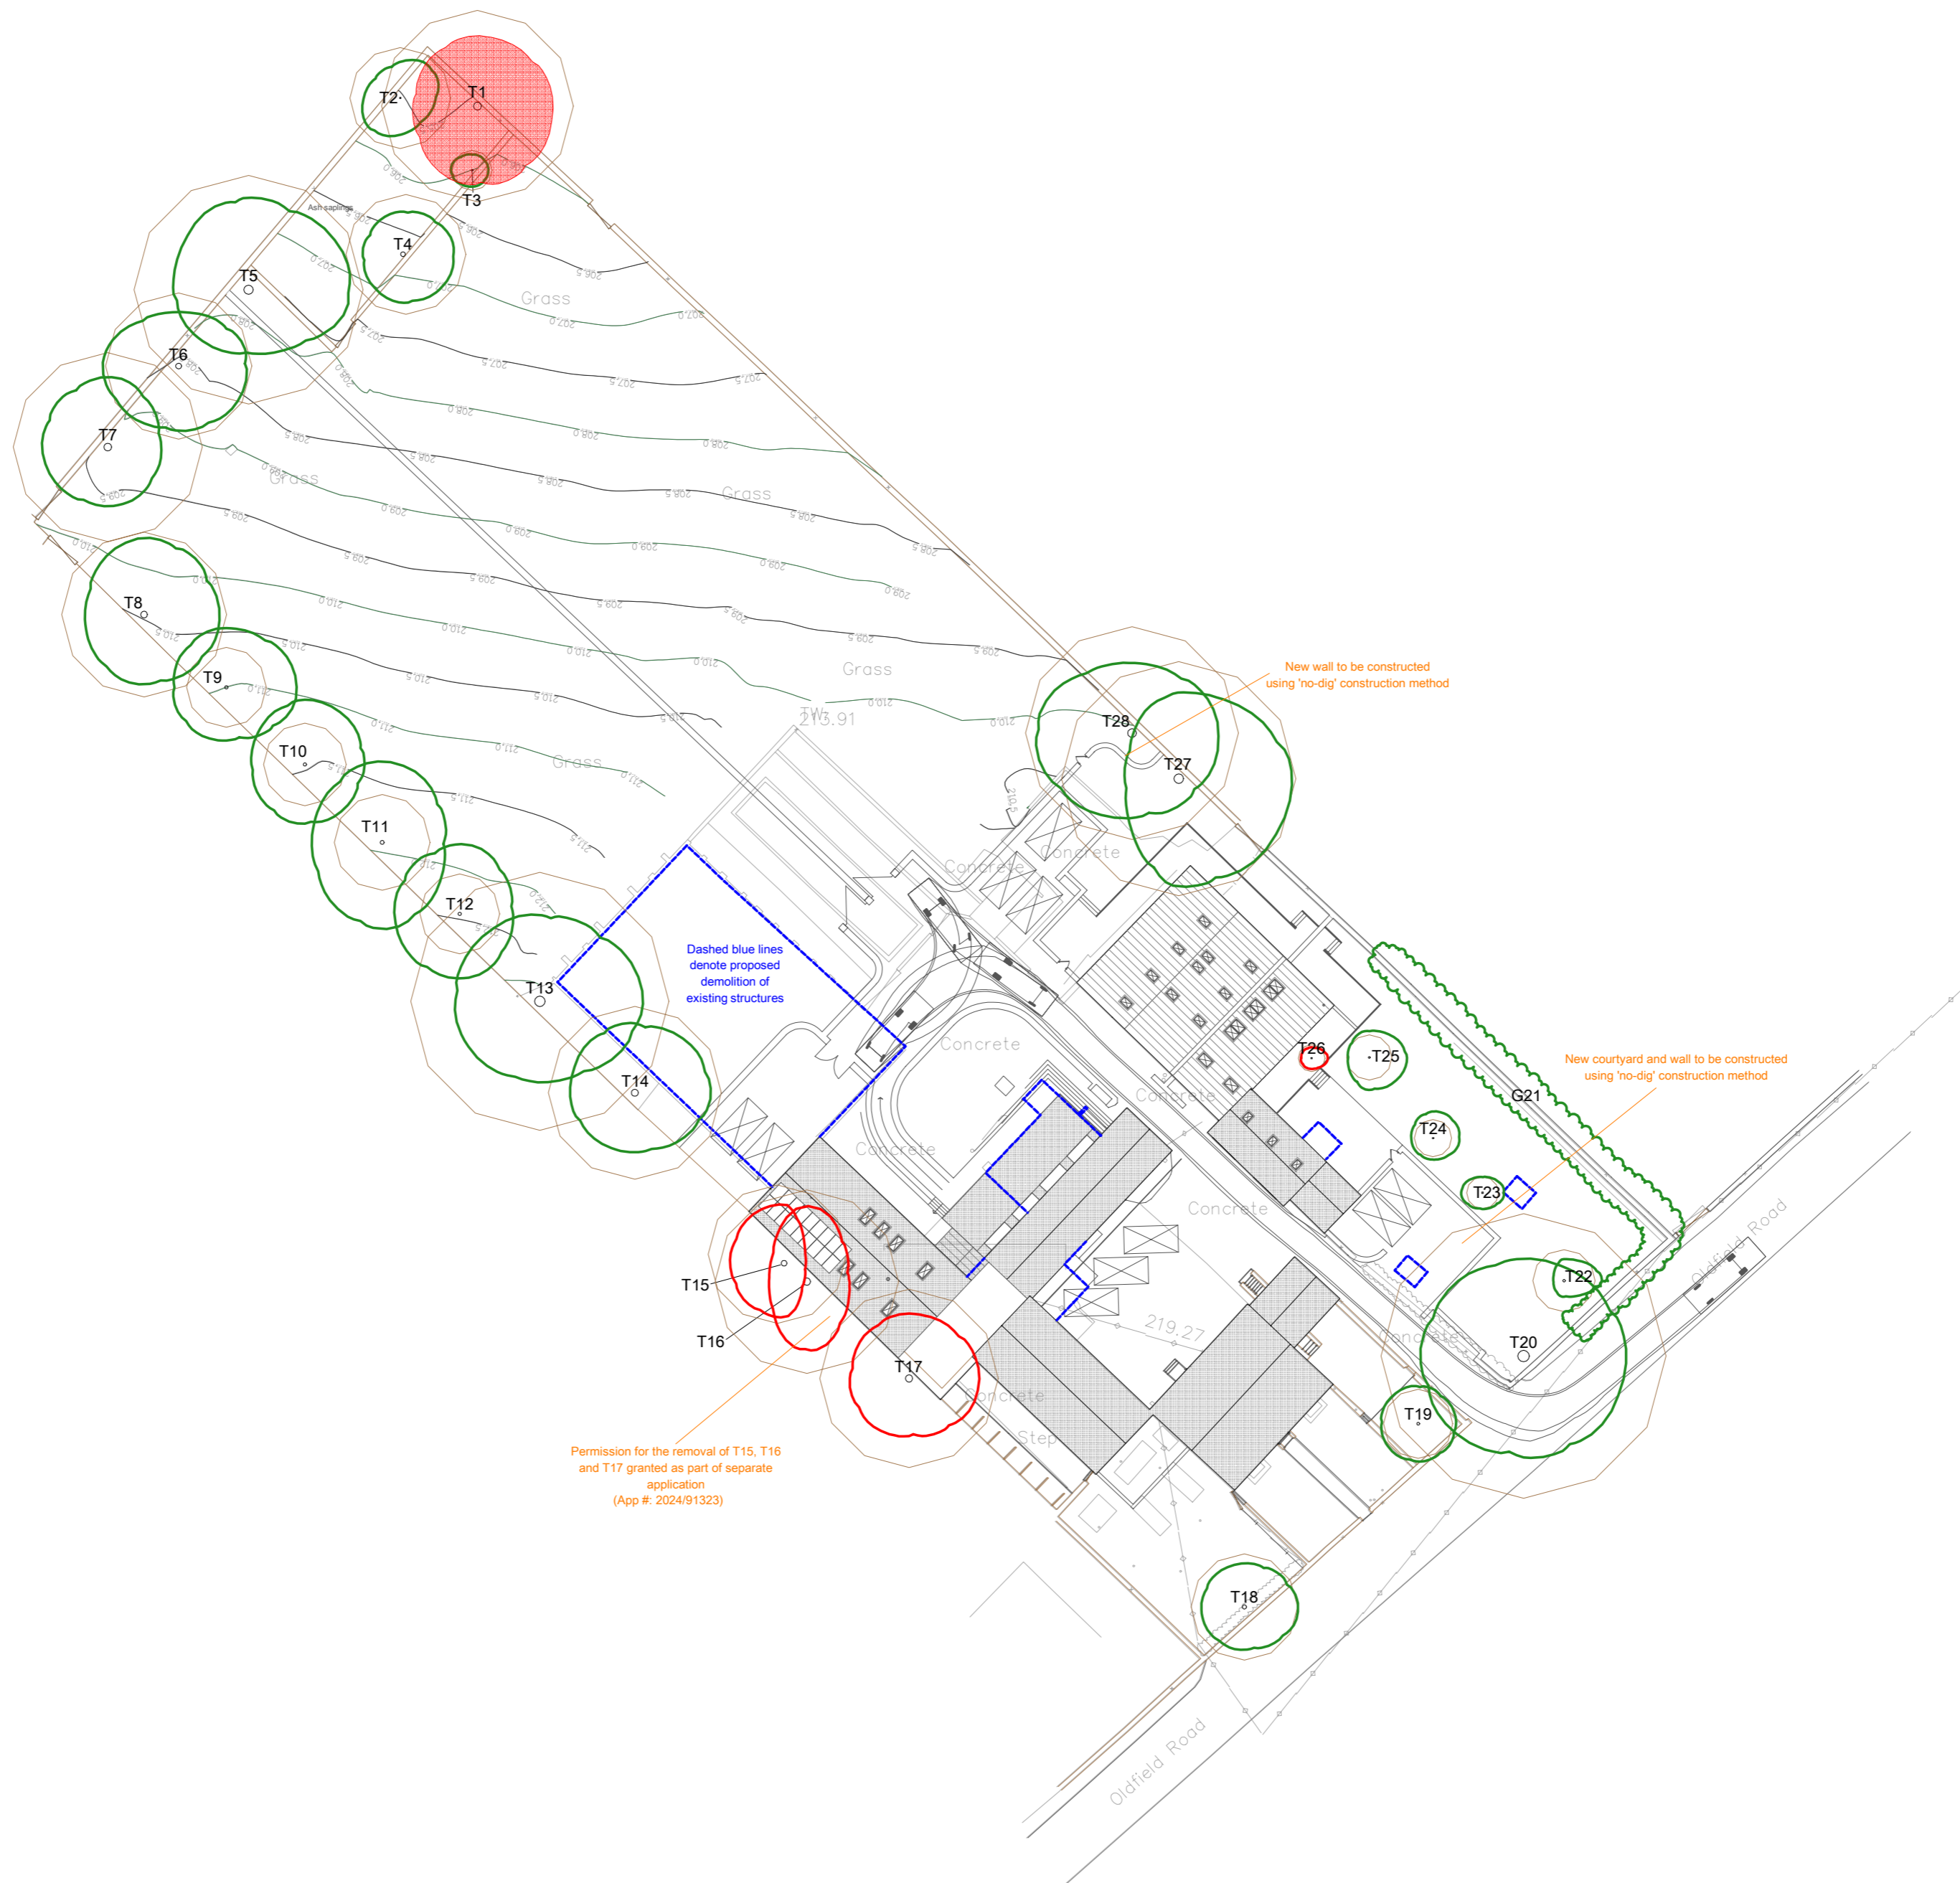
Appendix 6:
Tree Impacts Plan
 Oldfield House Farm, Oldfield Road, Honley
 Ref: AWA6031

4.2.1 From assessing the new development 4 trees will require removal to facilitate the development as they are situated in the footprint of the development.

4.2.2 The trees that require removal to facilitate the development are T15, T16, T17 and T26.

4.2.1 In addition to the required removal, T1 contains significant defects and is recommended for removal regardless of development. However, standing trunks can form a valuable wildlife habitat and T1 could be retained as a standing trunk in a reduced and stabilised form, usually at 4m to 6m height, as what is known a 'habitat pole'.

4.5.1 The retained trees will require protection by fencing in accordance with BS 5837: 2012, during the development phase.
