Methodology Statement

House 2 - Conversion and extension of existing buildings to provide four dwellings including refurbishment of existing farmhouse.

251-24-R1

**Oldfield Road Farm
Oldfield Road
Honley
Holmfirth
HD9 6RL**

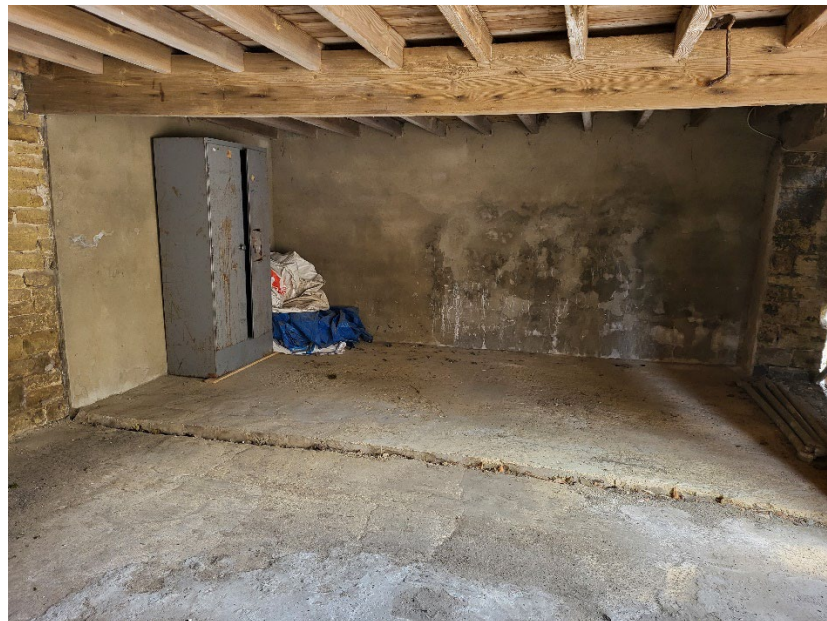
Photo 1

2. The existing internal render in the historic part of house 2 is to be carefully hacked off/removed using hand tools (as shown in photo 1)
3. The existing gable facing Oldfield Road has experienced significant structural movement as shown in photo 2. Given the last use of the site and the location of the gable it is highly likely this has been the result of machinery/vehicle impact. The existing gable supports the purlins above for the existing roof structure. The existing raised floor is constructed of a concrete slab with extensive amounts of rubble fill below. The volume of fill has also contributed to pushing the lower section of gable

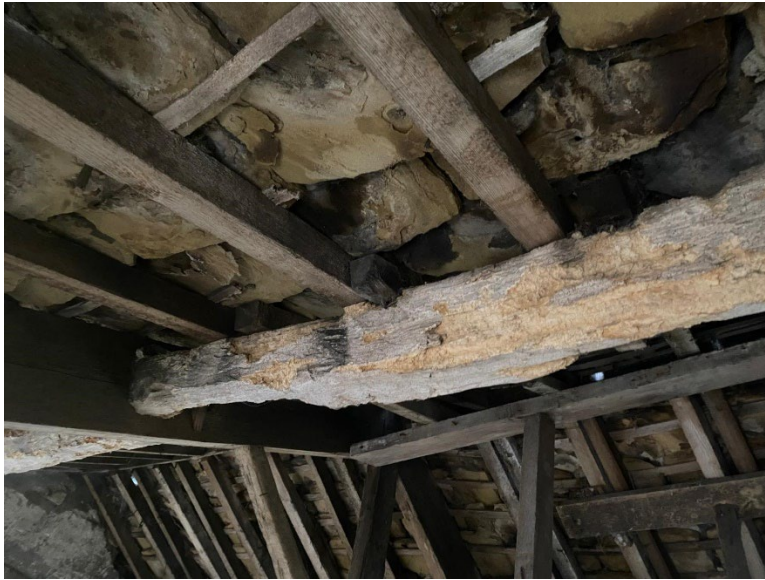
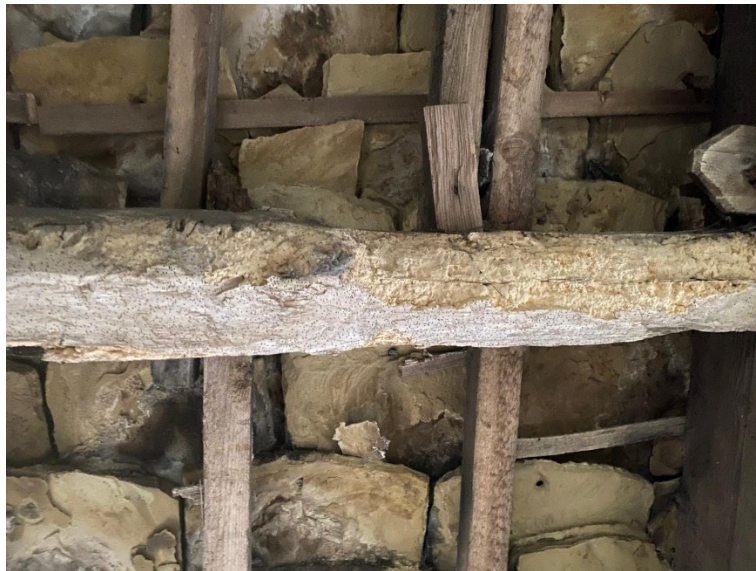
6. The existing roof structure comprises of 2No. timber trusses and 2 purlins to the front and rear pitch. The existing purlins have experienced significant signs of movement and are at the point of failure. The existing purlins have experienced dry rot and wood

worm infestation, this is beyond 60% of the extents of the purlins. In addition, both existing trusses have experienced extensive wood worm damage and now crumble away to the touch. There is no longer any structural integrity to the existing roof structure and the timbers are beyond repair. Given the extensive damage to the existing timbers it is proposed the existing roof structure is removed and replaced fully. The replacement roof structure will comprise of 2No. green oak trusses, green oak purlins, softwood rafters with rigid insulation between and below, breather felt, battens and re-use of the existing stone slates.
