Arboricultural Report: TPO/CA Tree Works Application

Date: 11.02.2024

Job no: 23059

Address: 1A Brendon Drive, Huddersfield, HD2 2DF.

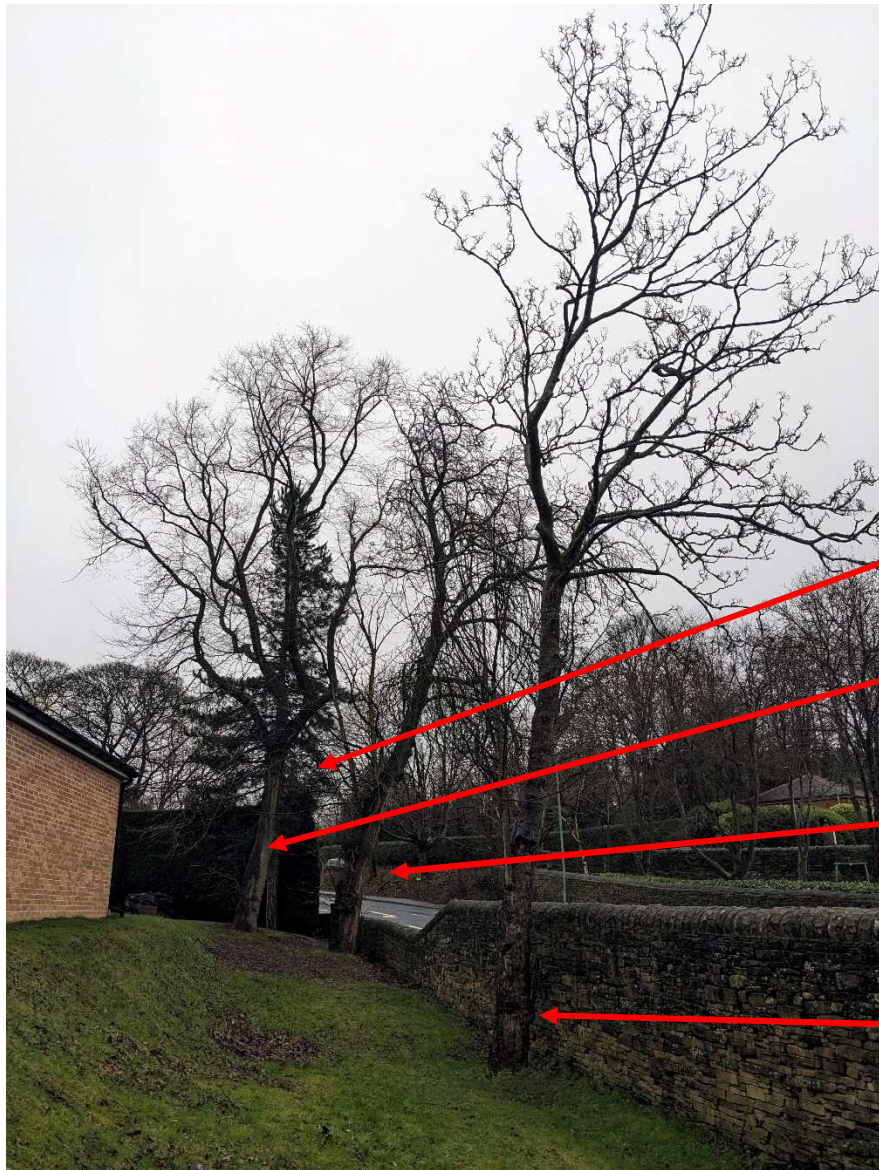
Observations: Heavily crown lifted specimen. Epicormic growth on main stem at 3m. Occasional minor deadwood. Resonance test indicates no decay/hollowing at base.

Observations: Boundary specimen significantly extended over the adjacent roadside. Epicormic growth on main stem. Pruning wounds due to crown lifting. Resonance test indicates no decay/hollowing at base.

Observations: Epicormic growth on stem. Occasional minor and major deadwood in crown. Minor hanger in lower crown. Pruning wounds due to crown lifting. Resonance test indicates no decay/hollowing at base.

Observations: Single stemmed with a well-developed crown, slightly suppressed by the adjacent lime (T6). Resonance test indicates no decay/hollowing at base.

T7: Pine (behind lime)

T6: Lime

T5: Horse chestnut

T4: Sycamore

1. Crown lift to 6m over road. Reduce canopy back from roadside (east) by 2m from branch tips.

1. Crown lift to 4m. Remove deadwood.

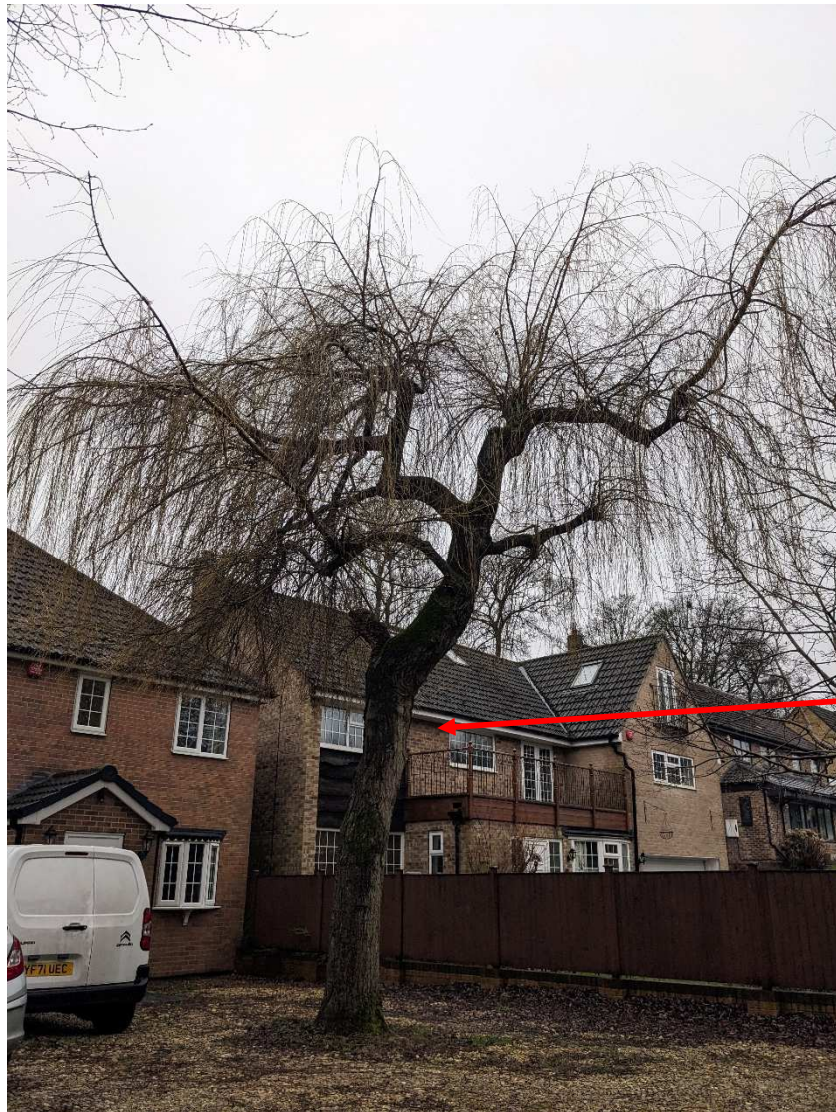
T8: Weeping willow

Observations: Previously pollarded. Dead stub at 4m facing driveway. Resonance test indicates no decay/hollowing at base.

1. Remove dead stub. Continue to maintain at current height and spread.
