**Phase 1 Geoenvironmental Risk Assessment/  
Coal Mining Risk Assessment and Flood Risk Assessment**

**HEADLANDS WORKS  
HEADLANDS ROAD  
LIVERSEDGE**

Report Number 4360

February 2024

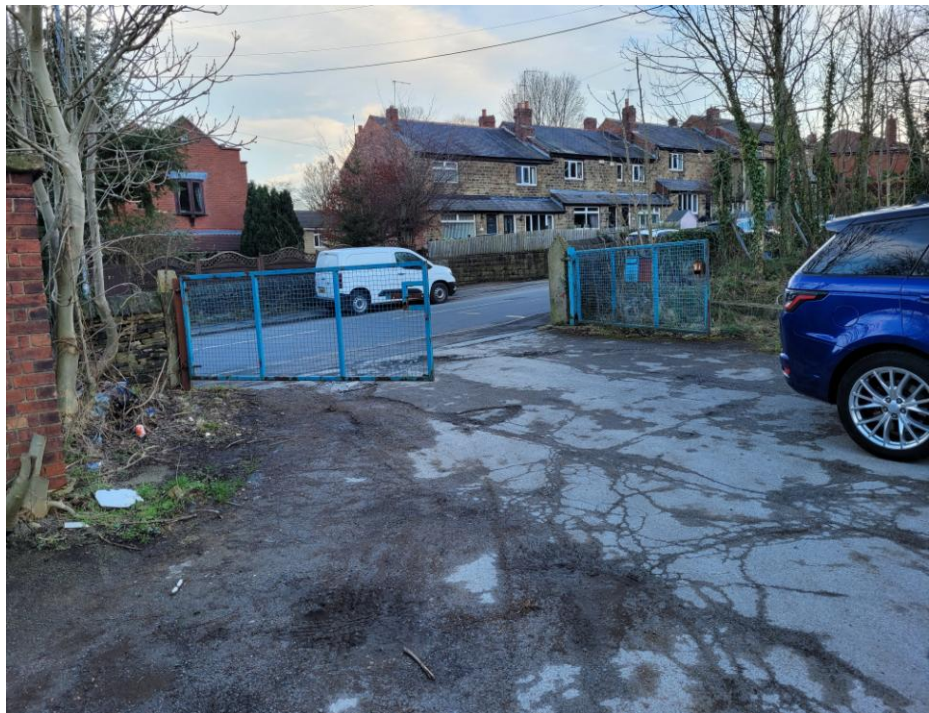
*Site entrance*

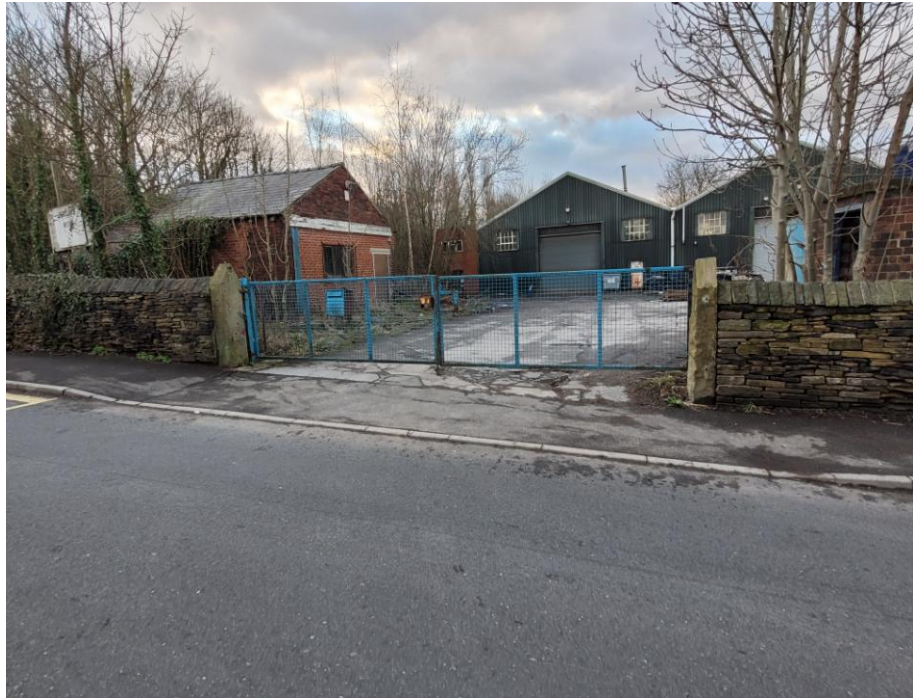
*Site entrance from Headlands Road*

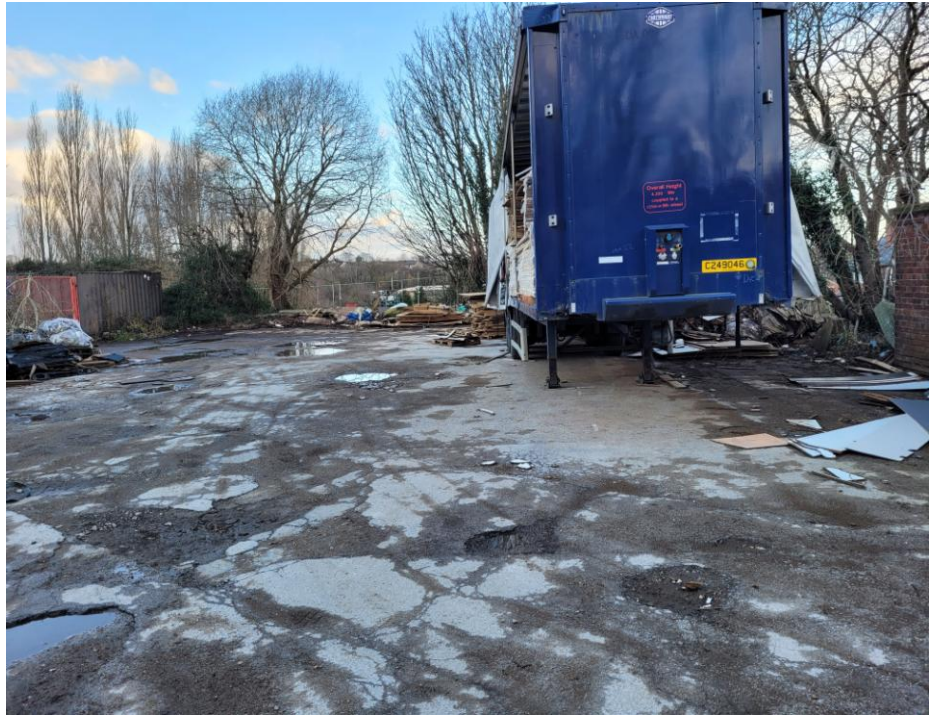
*View of hardstanding, looking north*

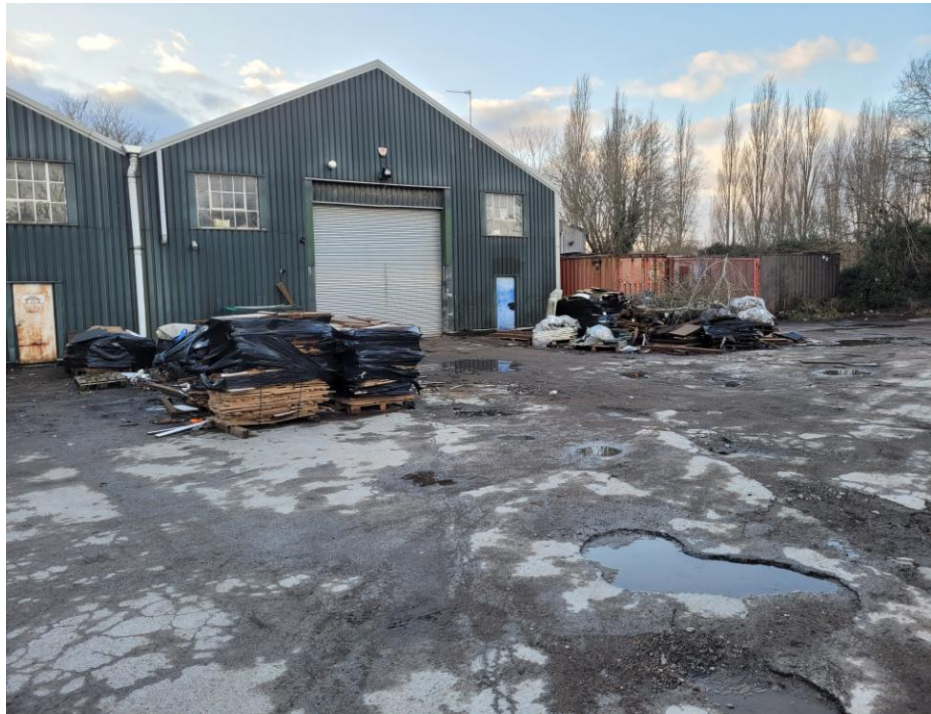
*View of hardstanding, looking northwest towards works building*

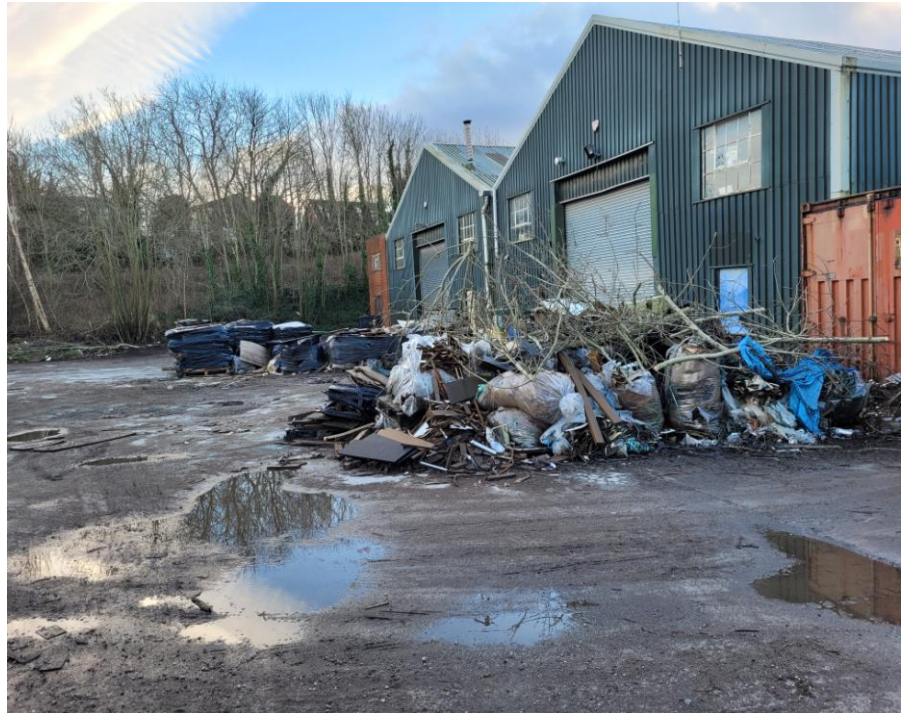
*Waste material to front of works building*

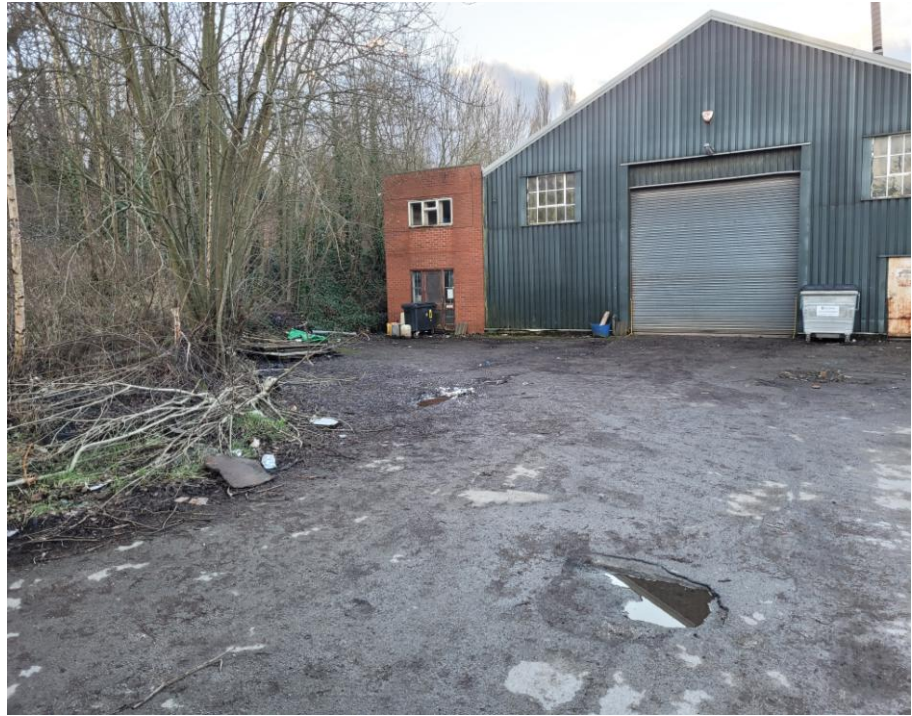
- 2.5 The main works buildings appear to comprise two separate brick buildings with profile metal sheet cladding and roller doors. Access to these buildings was not possible. To the north of this is a smaller building, which appears to be clad in corrugated asbestos cement sheeting. This has a 'compound' to the front, which was also inaccessible.

*Main works building, looking southwest*

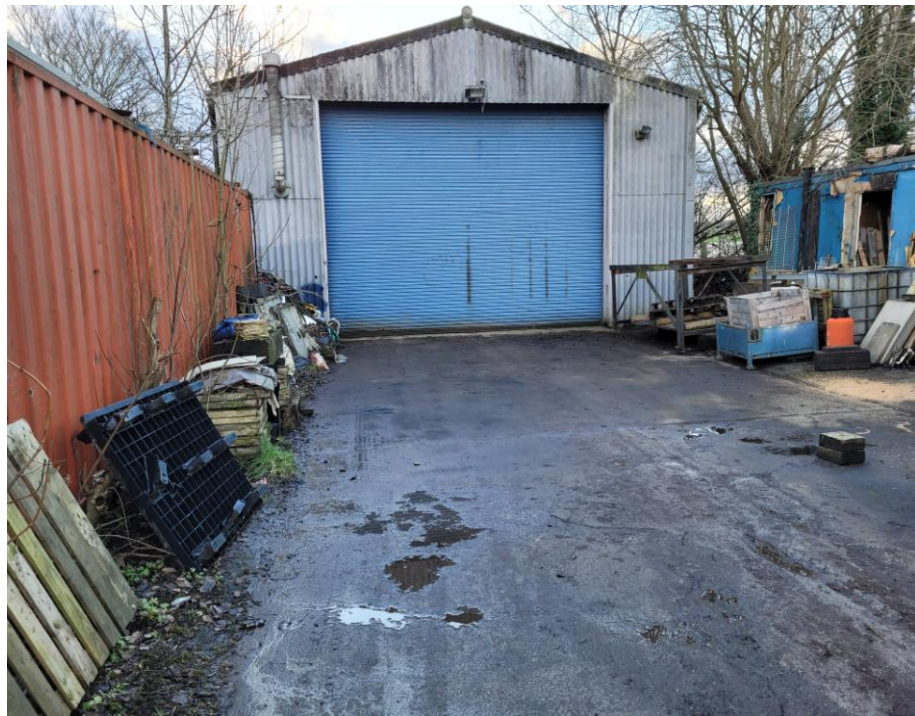
*Smaller building, looking west*

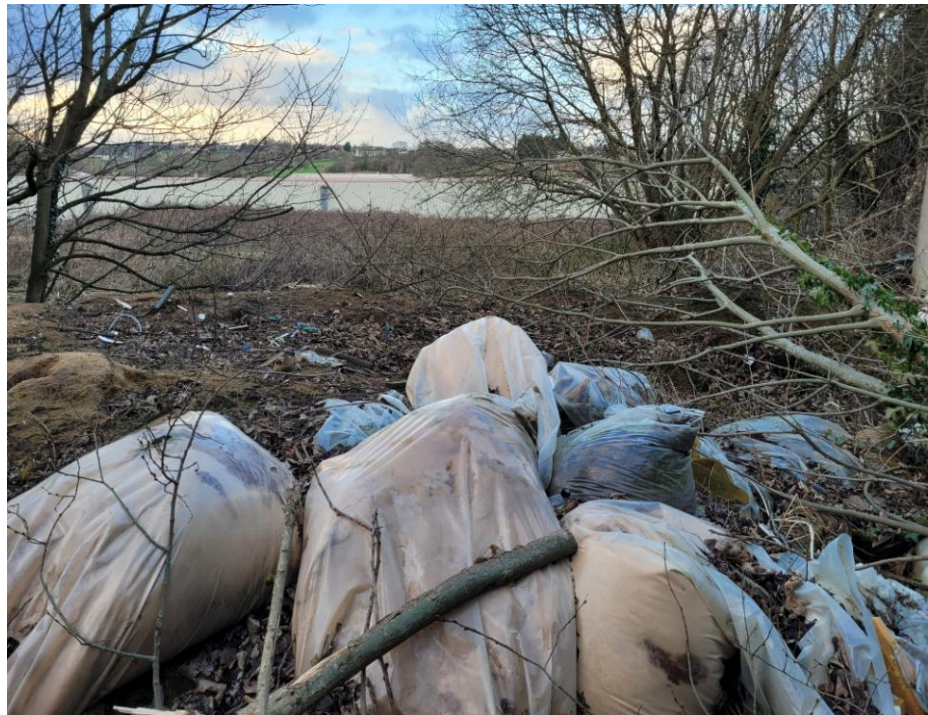
- 2.6 A part concrete and part unmade pathway runs along the southern elevation of the main building, and which leads to its rear. Immediately to the rear are full bags of waste material and a large mound of sawdust.

*Waste material and sawdust to rear*

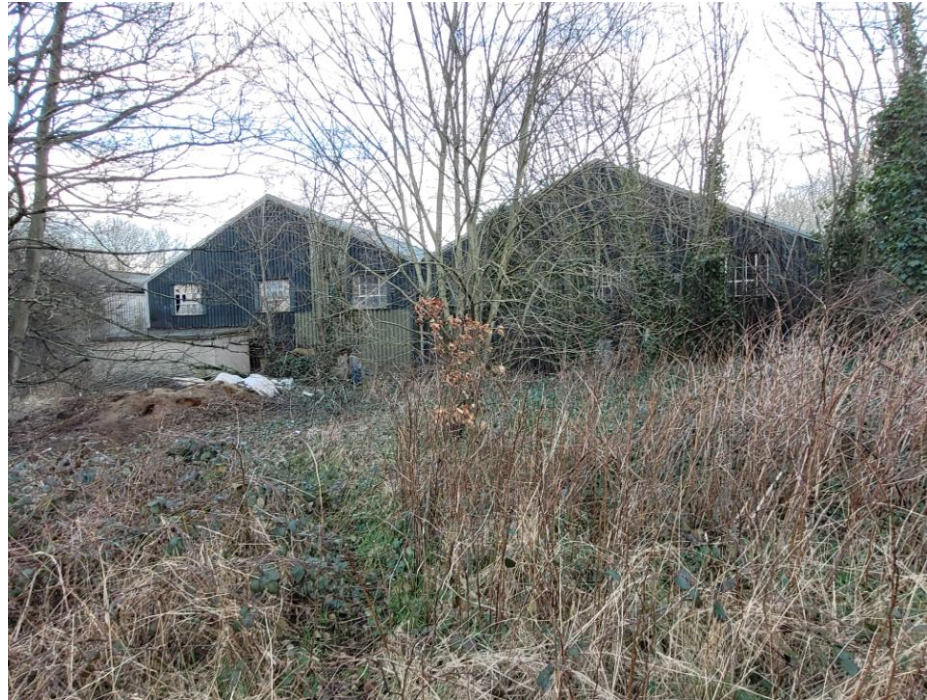
*View of rear of buildings, looking northeast*

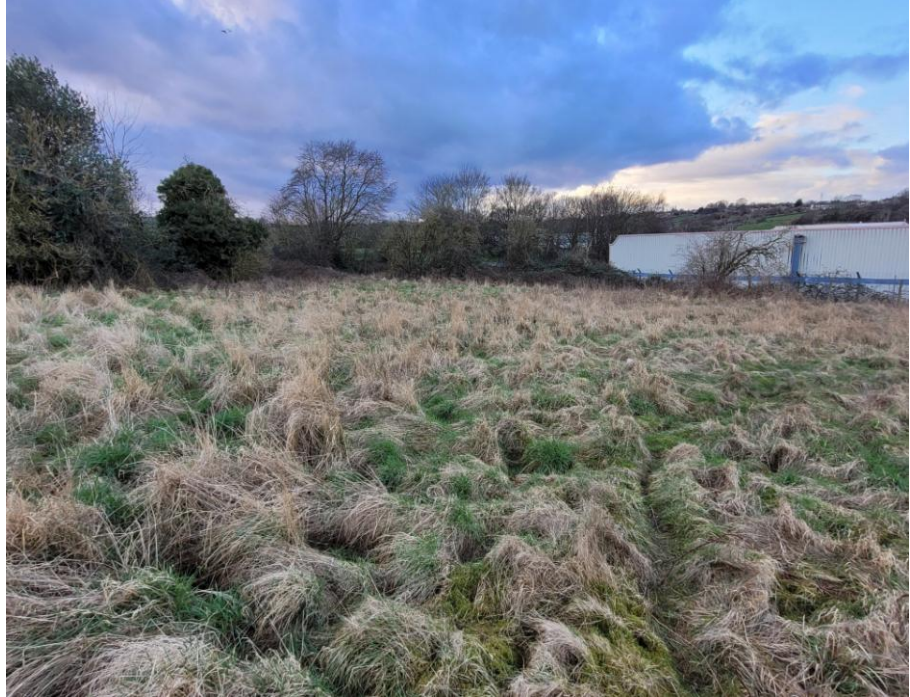
*View to the northwest and the bed factory beyond*

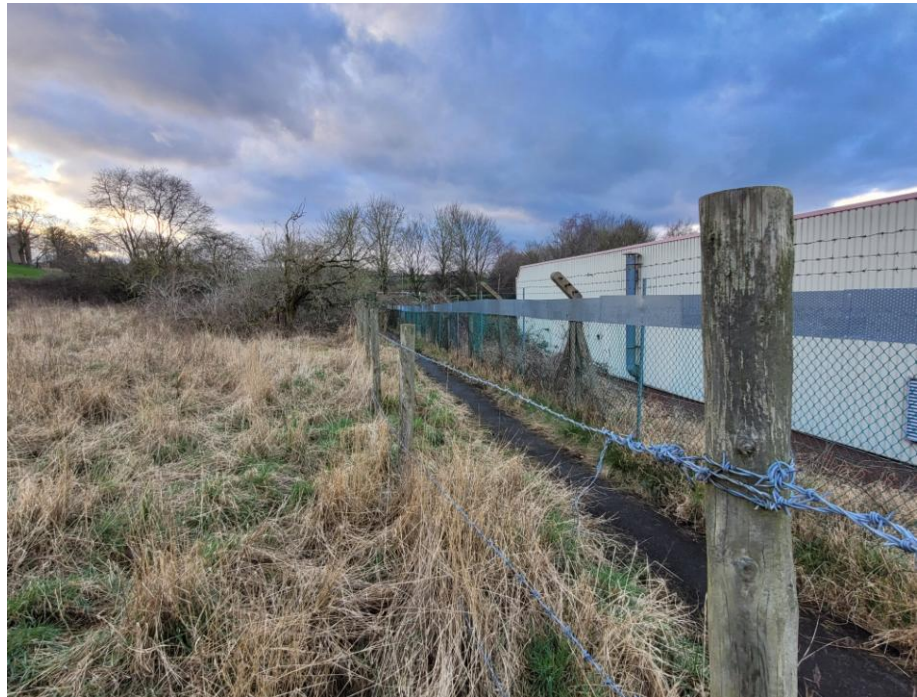
*Northern boundary and footpath*

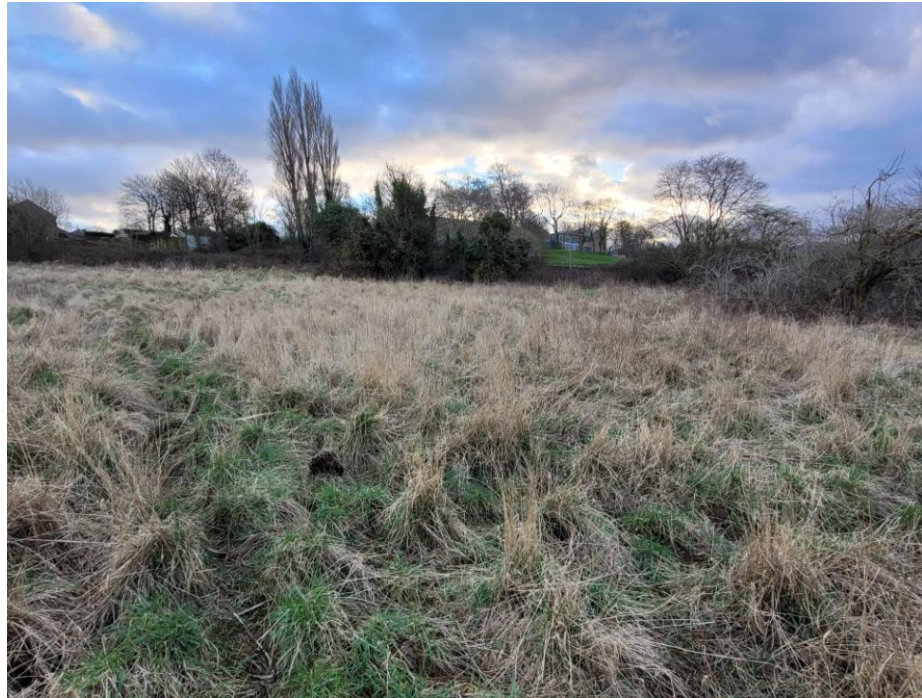
*View towards the western boundary*
