410004-FCA-00-00-SU-A-0750-S2-P01 - Highways Dilapidation Survey

Taken 17/07/2024

For Planning application 2023/92712 and land adjacent, 36 Oxford Road, Dewsbury, WF13 4LL

To be read in conjunction with drawing 410004-FCA-00-00-DR-A-0750-S2-P01

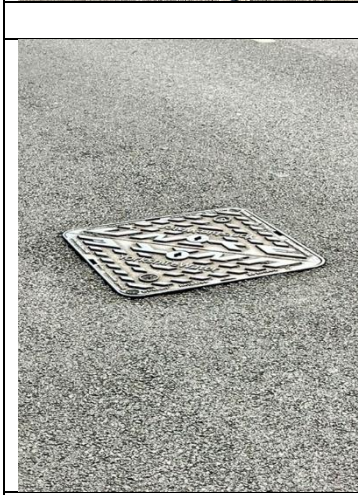
<p>View 04 - Oxford Road 00</p> <p>Location – Adjacent Corner of proposed Site</p> <p>Condition – Reasonable</p>

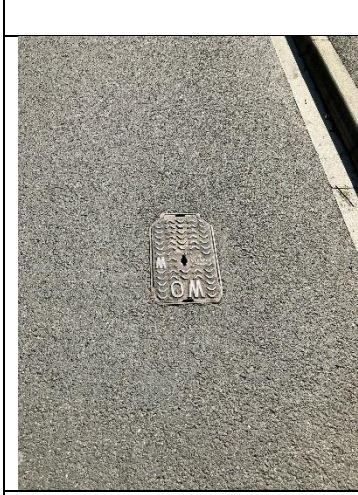
<p>View 05 – Man Hole 01</p> <p>Location – Adjacent Corner of proposed Site (See Plan)</p> <p>Condition – Average.</p> <p><i>The covers appear to be complete and in tacked, but the whole man hole appears to have dropped slightly from the surface.</i></p>

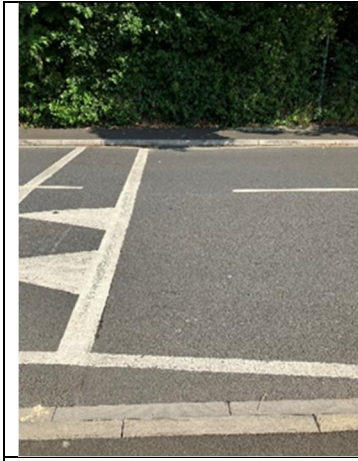
<p>View 07 - Oxford Road</p> <p>Location – Adjacent Corner of proposed Site (see plan).</p> <p>Condition – Reasonable</p>

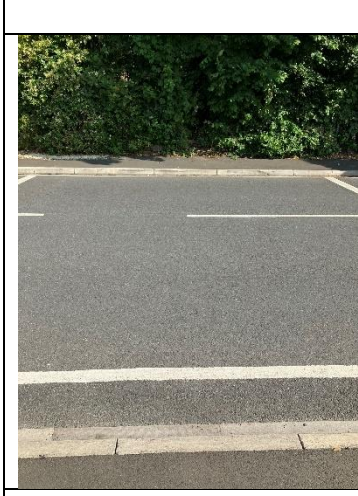
<p>View 08 - Oxford Road</p> <p>Location – Between Corner of Site and Speed Hump (see plan)</p> <p>Condition – Reasonable.</p>

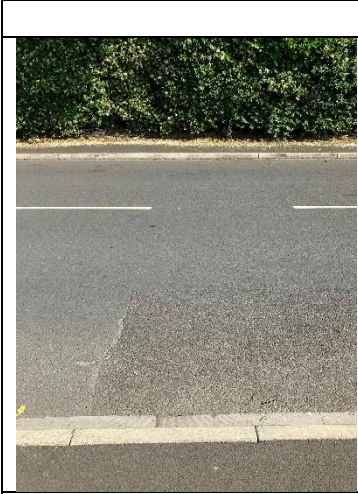
<p>View 16 - Oxford Road</p> <p>Location – See Plan</p> <p>Condition – Reasonable.</p>

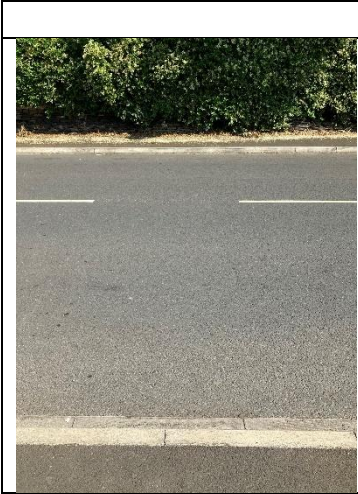
<p>View 18 - Oxford Road</p> <p>Location – See Plan</p> <p>Condition – Repaired.</p>

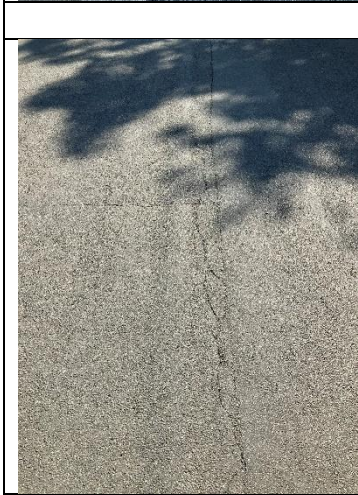
<p>View 62 –Reservoir Street.</p> <p>Location – See Plan.</p> <p>Condition – <i>Poor.</i></p>

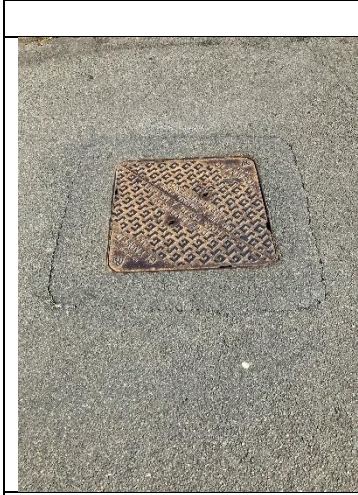
<p>View 63 – Brunswick Street (Pedestrian), Reservoir Street end.</p> <p>Location – See Plan.</p> <p>Condition – <i>Poor.</i></p> <p><i>Road surface cracked and damaged.</i></p>

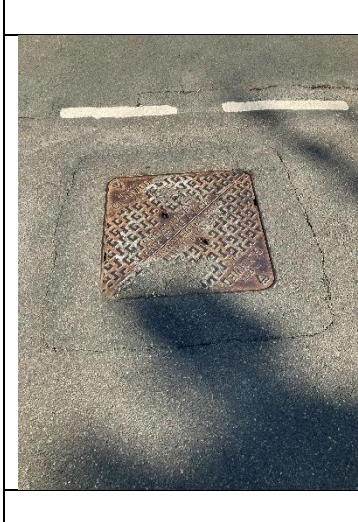
<p>View 64 – Man Hole 05</p> <p>Location – See Plan.</p> <p>Condition – <i>Poor.</i></p> <p><i>Road surface cracked and damaged particularly around the man holes.</i></p>

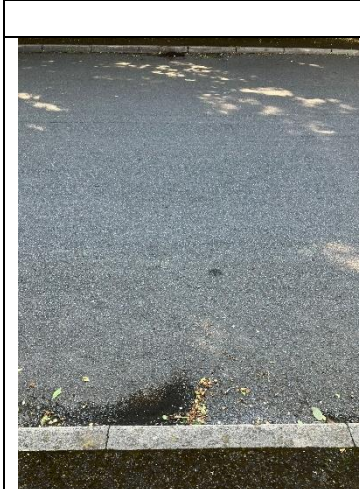
<p>View 70 – Gully 07</p> <p>Location – See Plan.</p> <p>Condition – Reasonable.</p> <p><i>Metal grate has been replaced with composite plastic cover. Appears in reasonable condition, although covered with and containing of debris.</i></p>

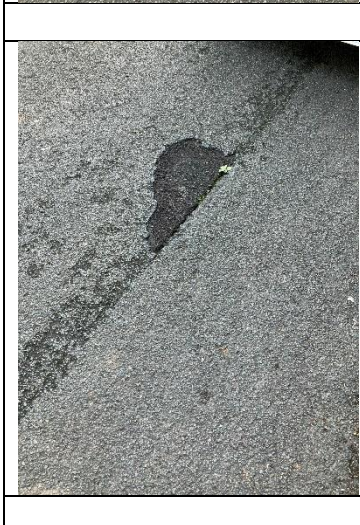
<p>View 76 – Stop Valve</p> <p>Location – See Plan.</p> <p>Condition – Poor.</p> <p><i>Road surface cracked and damaged, particularly around Stop Valve.</i></p>

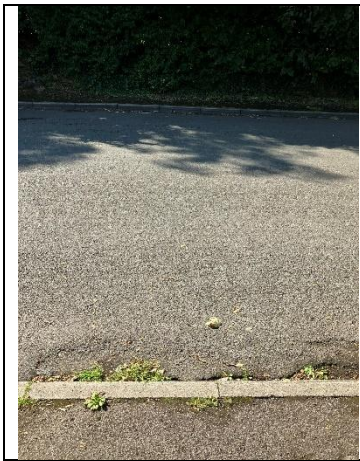
<p>View 77 – Reservoir Street</p> <p>Location – See Plan.</p> <p>Condition – Very Poor.</p> <p><i>Road surface cracked and damaged. Pot Hole in surface.</i></p>

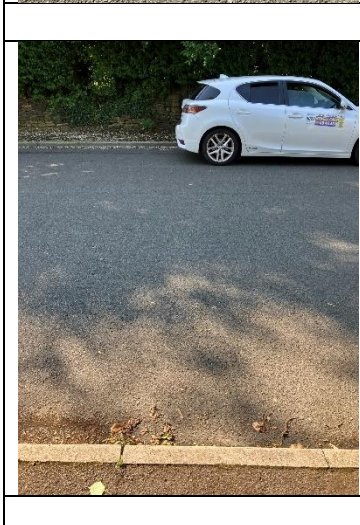
<p>View 80 – Man Hole 07</p> <p>Location – See Plan.</p> <p>Condition – <i>Poor.</i></p> <p><i>Road surface cracked and damaged, particularly around Man Holes. Surface treatment appears to cover some of the Man Hole cover, suggesting it is lower.</i></p>

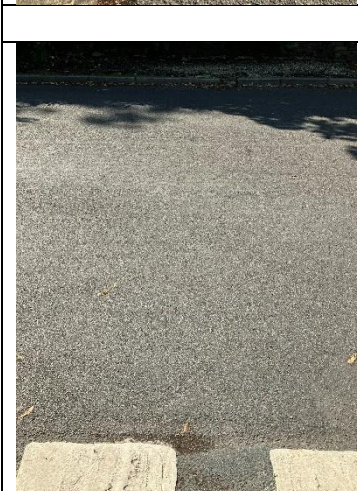
<p>View 100 – Gully 09</p> <p>Location – See Plan.</p> <p>Condition – <i>Poor.</i></p> <p><i>Road surface cracked and damaged, particularly at edges and around gully. Metal grate has been replaced with a composite plastic one.</i></p>

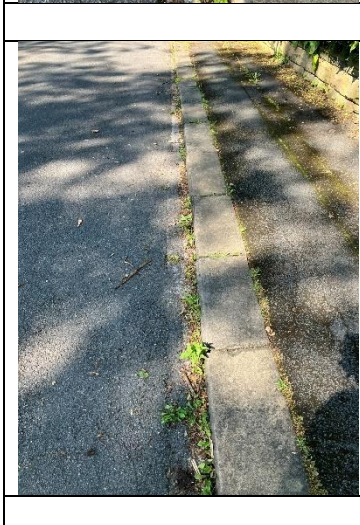
<p>View 112 – Reservoir Street</p> <p>Location – See Plan.</p> <p>Condition – Poor.</p> <p><i>Existing stone kerbs have dropped and are uneven.</i></p>
